ABBREVIATED PRELIMINARY ASSESSMENT

IDOL CITY MINE

Malheur National Forest
Grant County, Oregon

October 2002

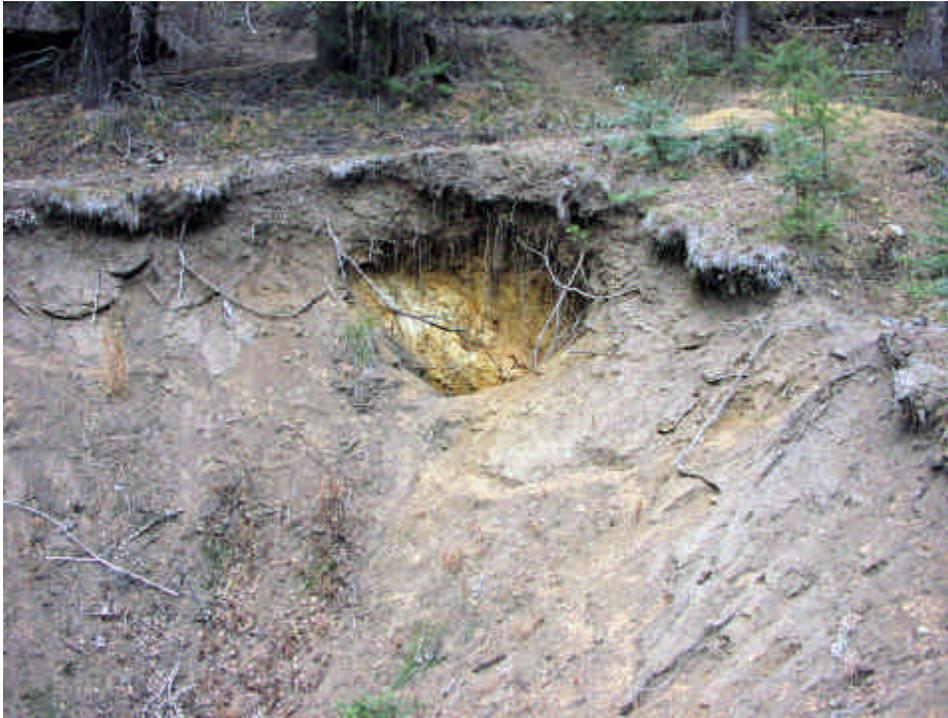
- A waste rock pile is located east of the building on the south side of FR 630.
- Adit 2, which is partially collapsed, located on the east side of FR 630 south of the buildings (Photograph 1).

Photograph 1: Idol City Mine. Partially collapsed adit (Adit 2) near north end of Site. (Photograph by John Martin, CES, October 23, 2002, 10:16).

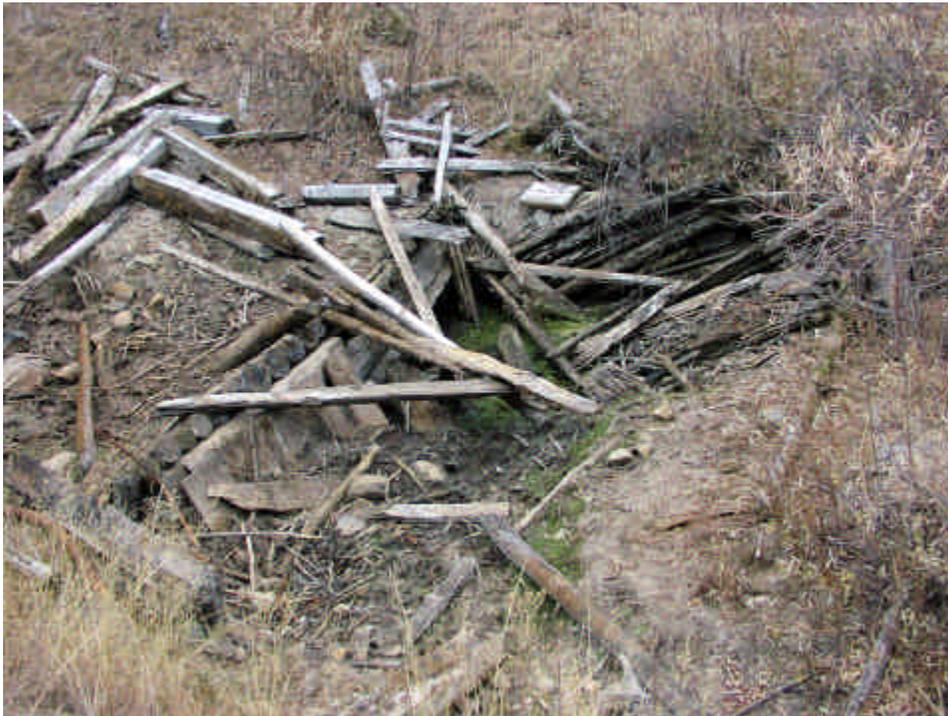
- The shaft and head frame are located southwest of Adit 3, which is collapsed, and adjacent to the Gold Gulch drainage. The shaft is flooded and appears collapsed (Photograph 2).

Photograph 2: Idol City Mine. Filled shaft near north end of Site. (Photograph by John Martin, CES, October 23, 2002, 10:13).

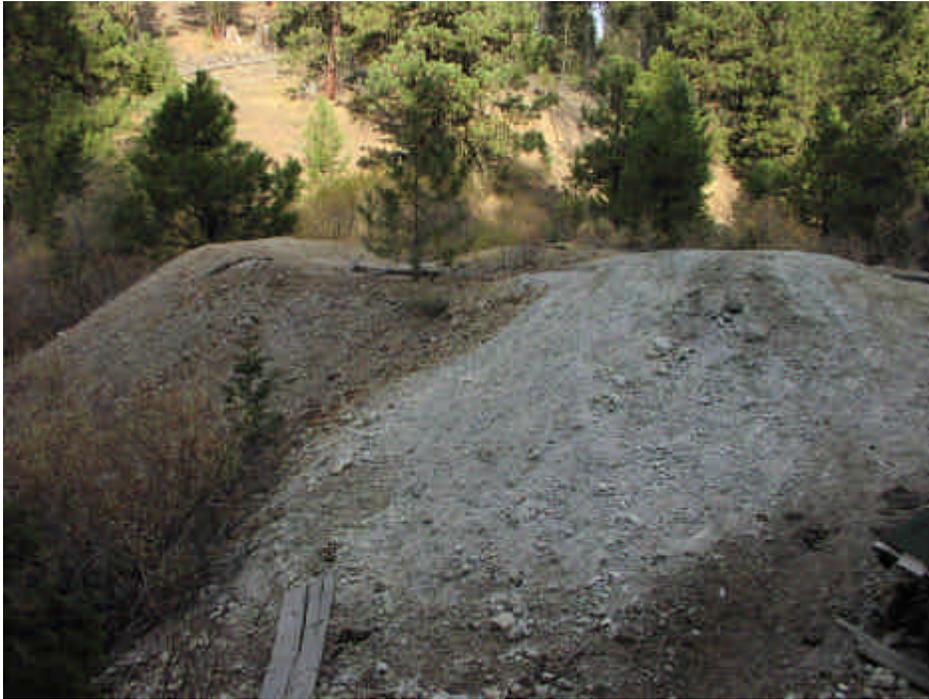
- A large waste rock pile is located west of the cabin and adjacent to the drainage (Photograph 3). Another large waste rock pile is located just across the drainage.

Photograph 3: Idol City Mine. Waste rock pile 5, west of collapsed cabin. Note two colors of waste material. (Photograph by John Martin, CES, October 23, 2002, 10:20).

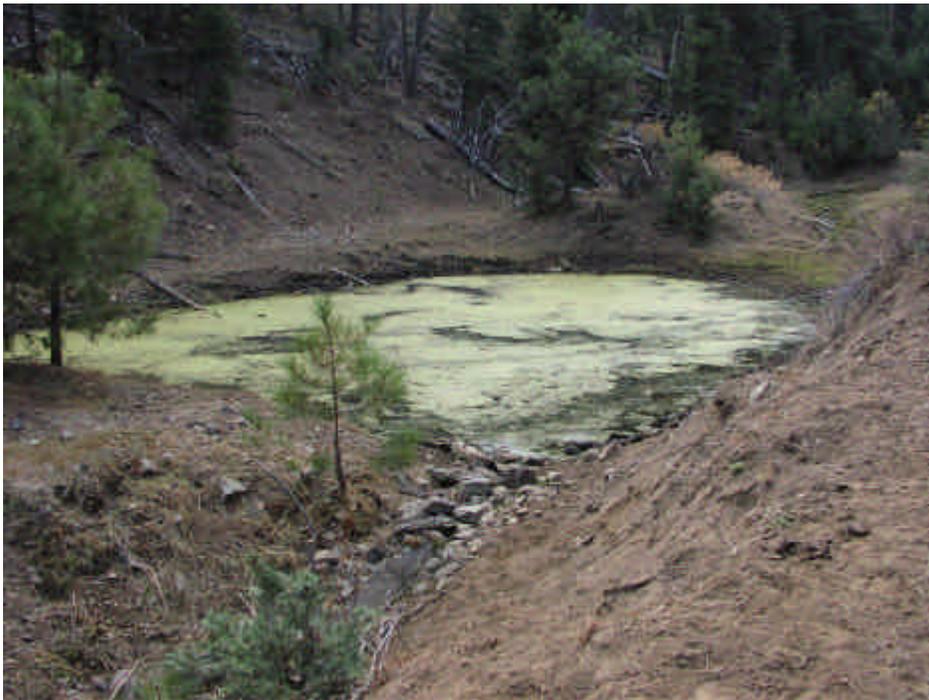
Photograph 4: Idol City Mine. Pond in drainage approximately 0.25 miles south of Road 600. (Photograph by John Martin, CES, October 23, 2002, 10:28).

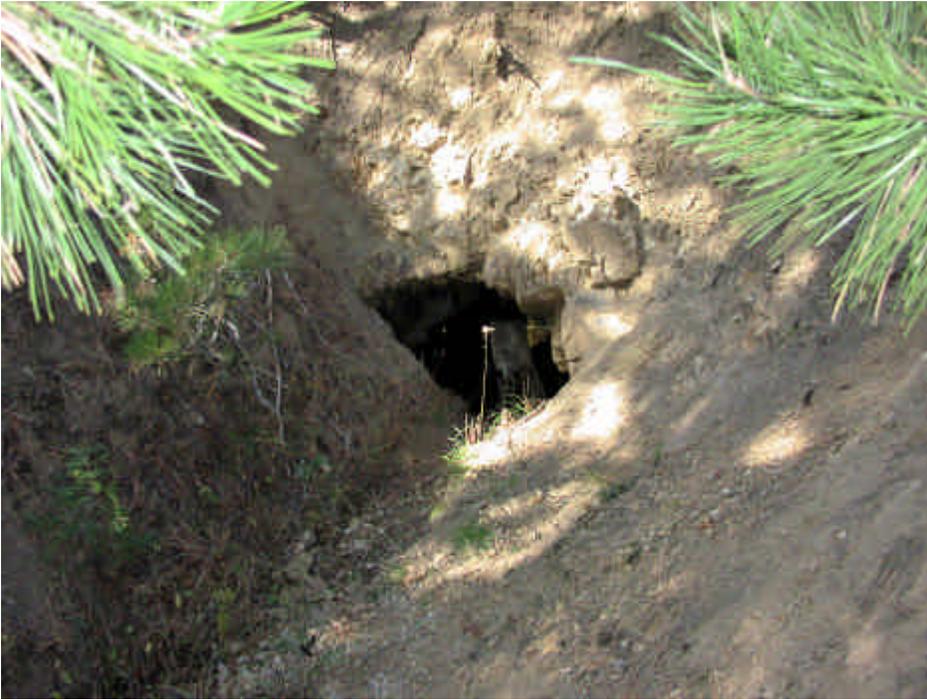
- An open adit (Adit 1) is present on the west side of the drainage approximately 0.8 mile from the junction with FR 600. The adit is on the west side of FR 630 with a waste rock pile and collapsed structure on the east side. The structure appears to have been built on a portion of the waste rock pile. No other significant structures or mining-related works (i.e., trenches, waste piles, adits, etc.) were observed south of this point.

Photograph 5: Idol City Mine. Partially collapsed adit (Adit 1) approximately 0.8 miles south of Road 600 near end of worked area. (Photograph by John Martin, CES, October 23, 2002, 11:38).
