WATERSHED ANALYSIS

CHILOQUIN RANGER DISTRICT
WINEMA NATIONAL FOREST
KLAMATH COUNTY, OREGON
SEPTEMBER 1995

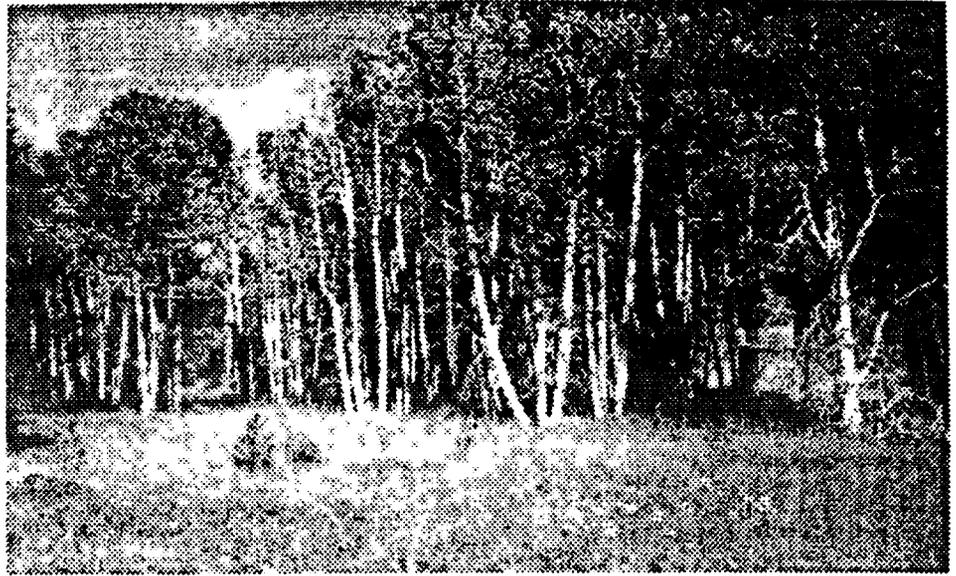
Hardwood community in good condition, Butler Creek drainage.

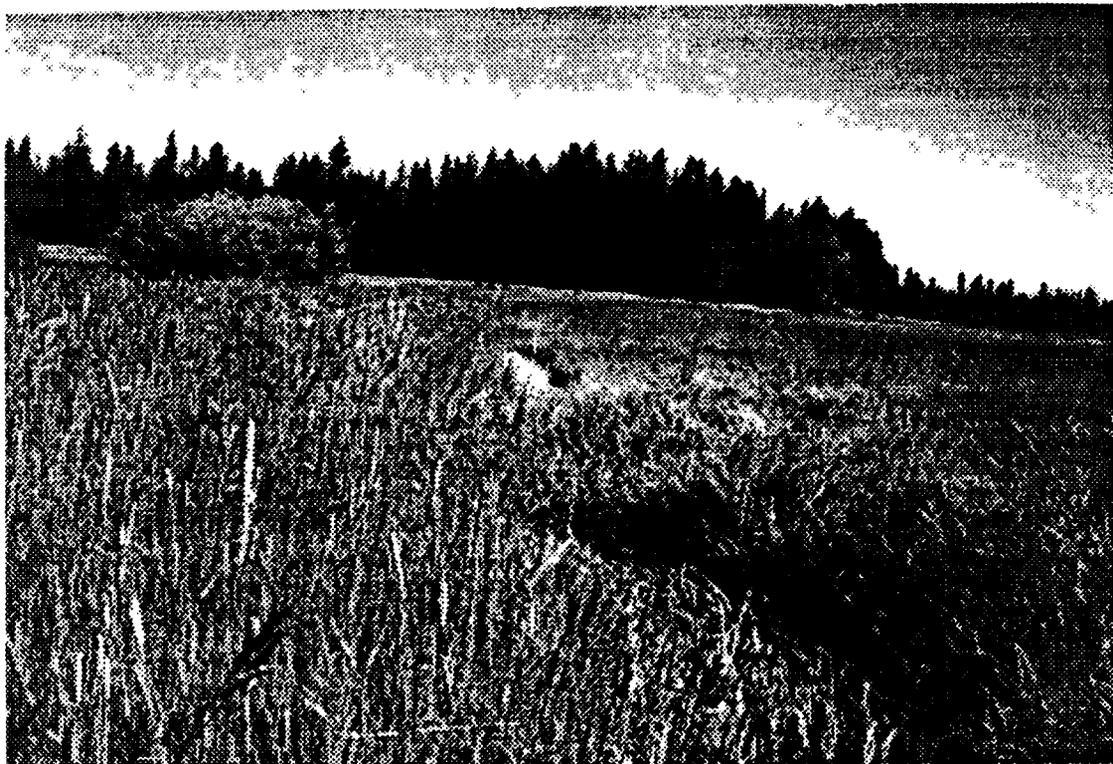
Meadow in good condition, Trout Creek Ranch

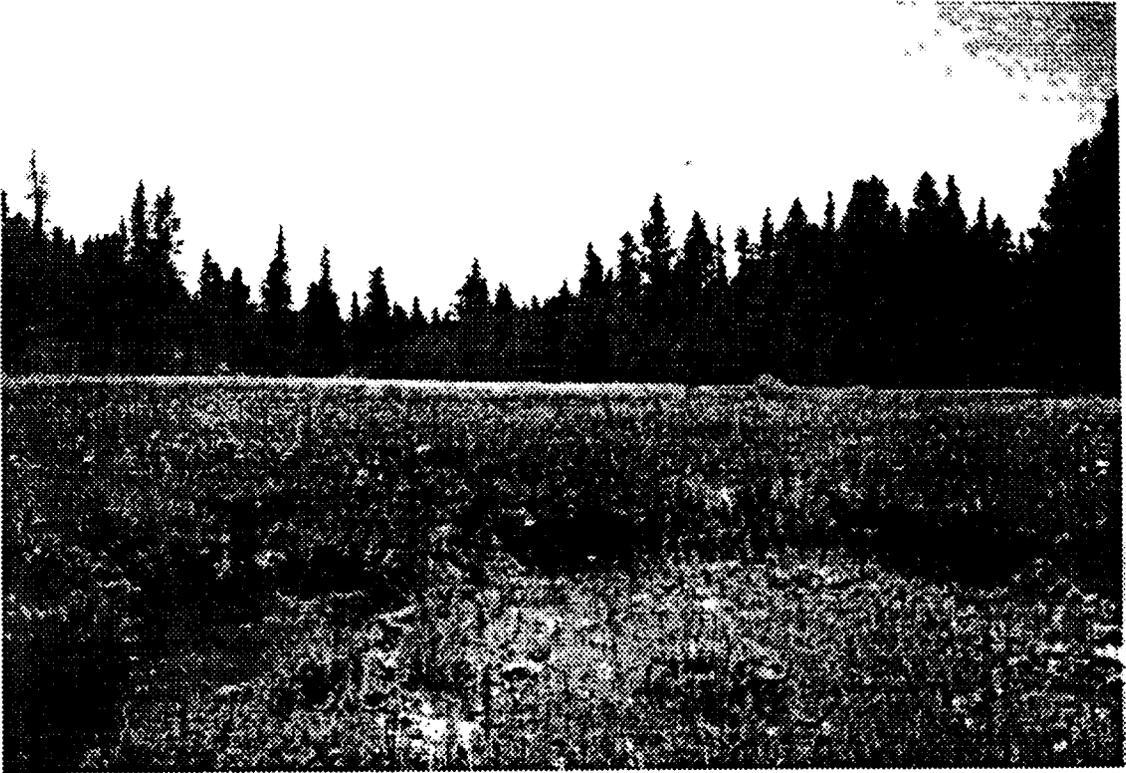
Wrights Meadow, fair to poor condition (at risk).

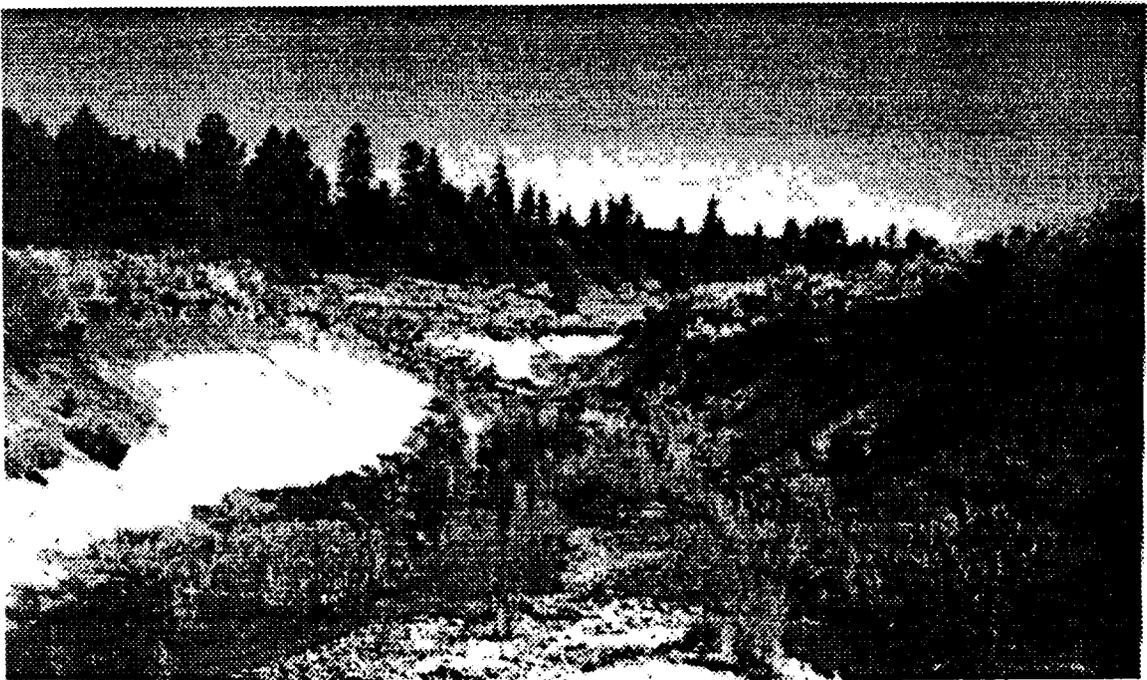
Dams Meadow: Deeply incised, broad channel. Water table well below root zone for major portion of community. Note that new flood plain is forming, and vegetation is establishing on channel bottom.

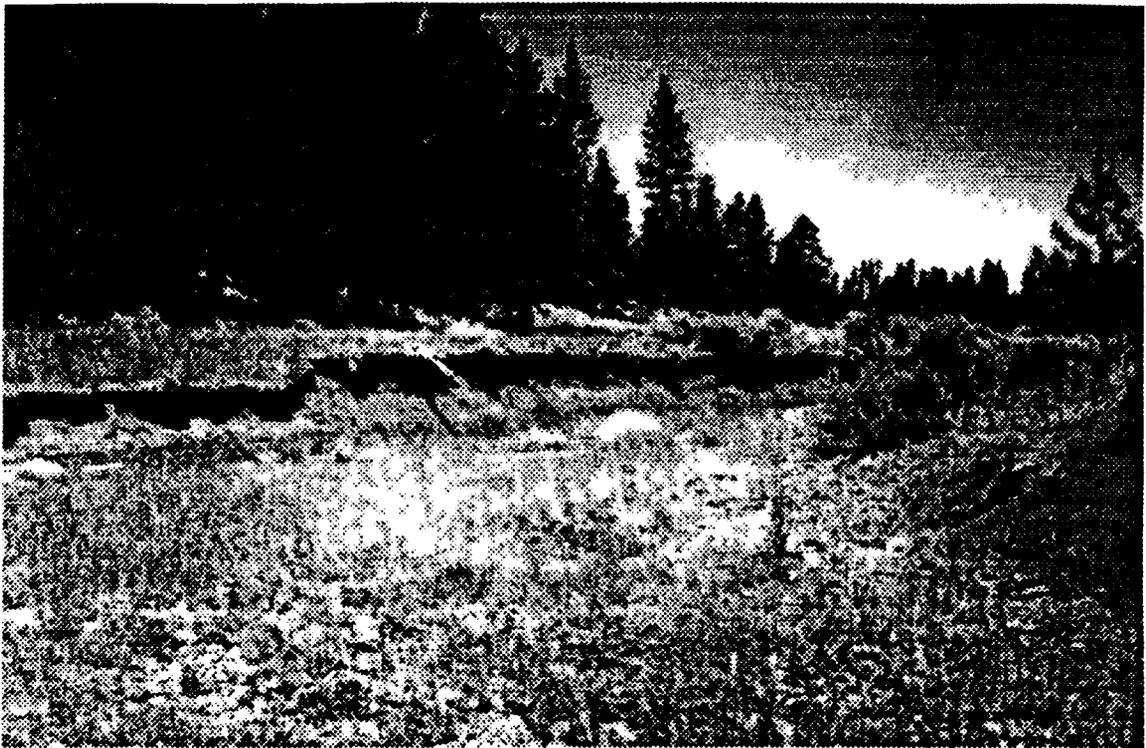
Copperfield Draw: Deeply incised, broad channel. Water table well below the historic flood plain, which has dried out to the point that sagebrush is becoming established. New flood plain has been formed within the channel, and vegetation is establishing on the channel bottom.
