ABBREVIATED PRELIMINARY ASSESSMENT

CAP MARTIN COMPLEX

Wallowa-Whitman National Forest
Grant County, OR

August 2006

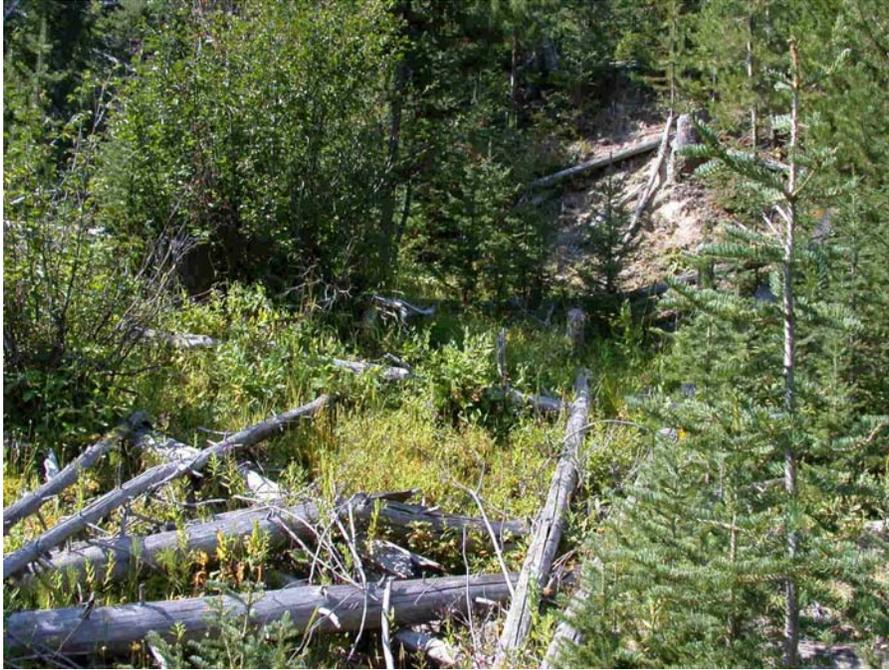
- Adit #1
 - Water discharge from collapsed adit.
 - Visually, does not appear impacted.
 - Marshy area between mine and Granite Creek.

- No signs of distressed vegetation.
 - Water in this area does drain to Granite Creek.
 - Wasterock material could not be located.
 - Either it is within the marshy area, or

Photo 1. Location of Adit #1. (Photo by D. Boles)

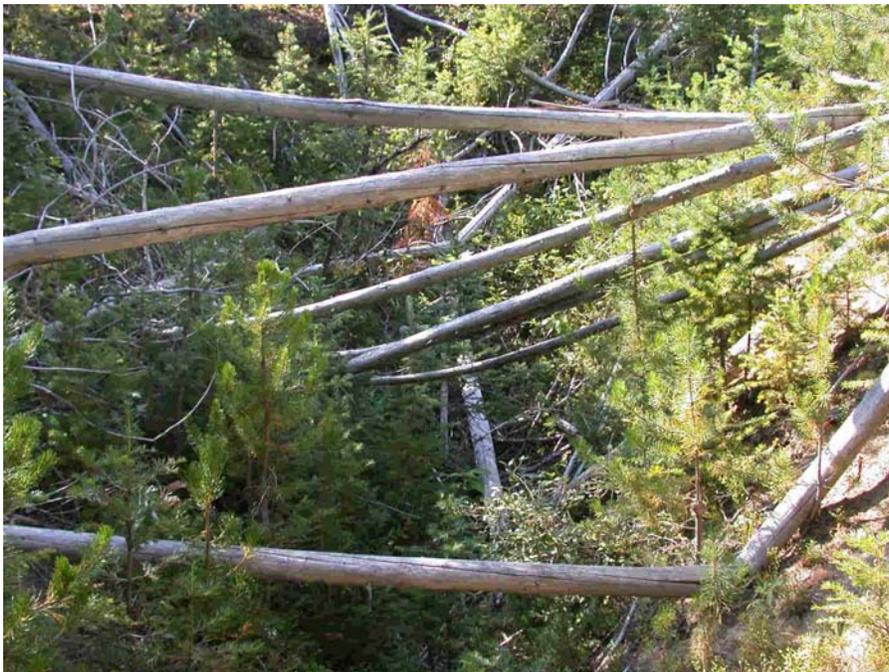
- Part of a logging road that was built post mining operations.
- Adit #2
 - No water discharge from the adit.
 - Marshy area associated with Adit #1 reaches the toe of the wasterock pile on the north side and then drains into Granite Creek

Photo 2. Location of Adit #2. (Photo by D. Boles)

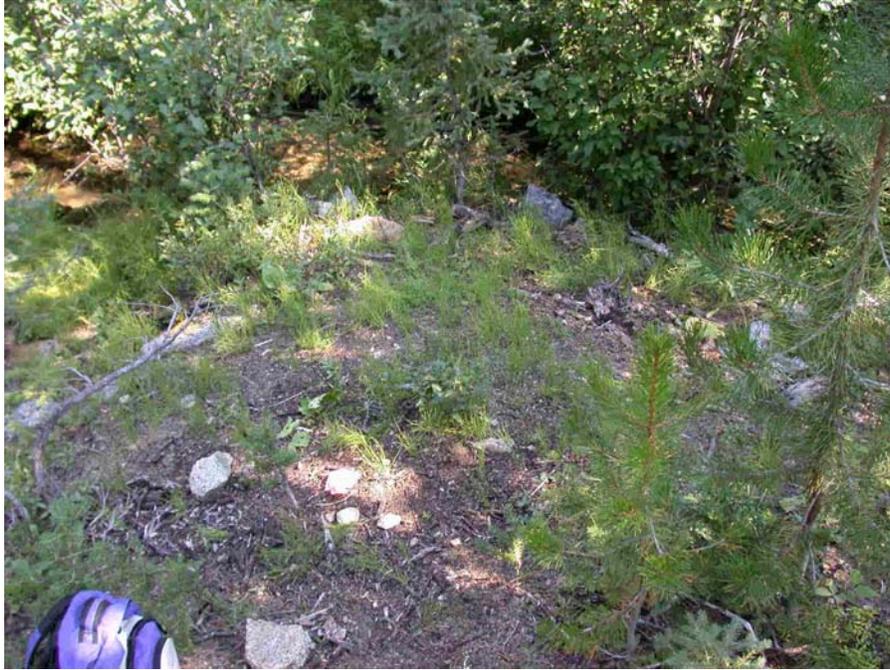
- Approximately 500cy of wasterock.
 - Wasterock extends to the edge of Granite Creek.
- Adit #3
 - Large collapsed adit.
 - Volume of wasterock in the area difficult to determine because of the amount of disturbance. As an approximation – 6000cy.

Photo 3. Wasterock at Adit #2 extending to edge of Granite Creek.
(Photo by D. Boles)

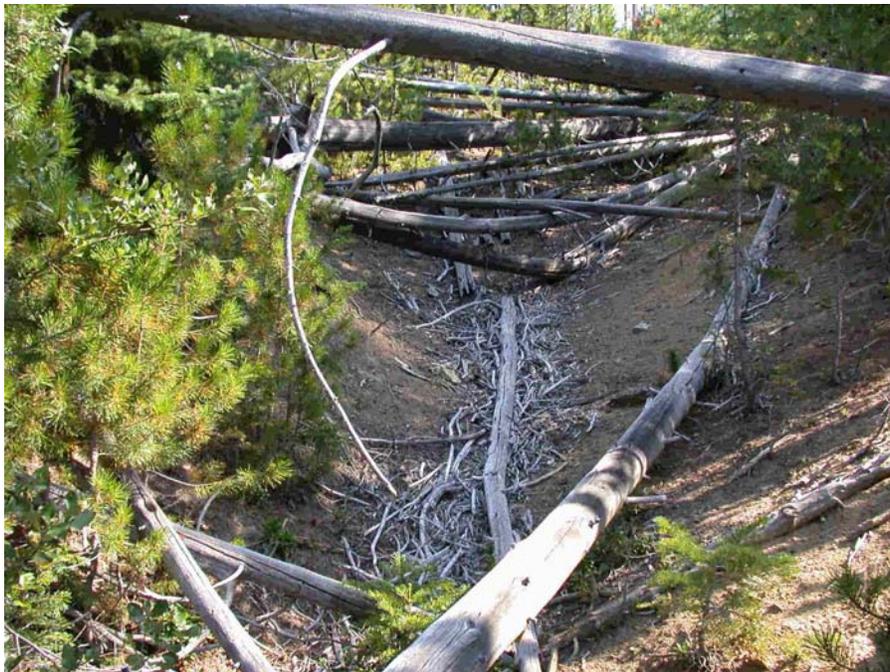
- There may be a second adit above this one.
 - Numerous dozer cuts and possible hydraulic mining.
 - Water discharge was not observed in the area.
- Adit #4

Photo 4. Location of Adit #3. (Photo by D. Boles)

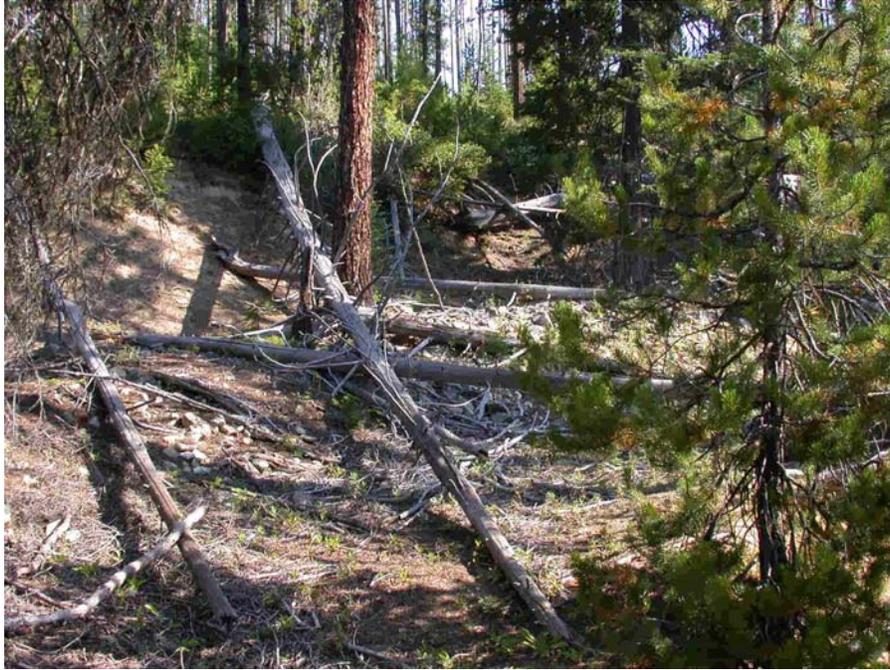
- A large pit exists. Upon closer examination, appears to be a collapsed shaft.
 - A drift or crosscut extends from the area of the shaft. See Photo 6, Appendix C.

Photo 5. Large pit. Appears to have been a shaft with a drift or crosscut, See Photo 6. (Photo by D. Boles)

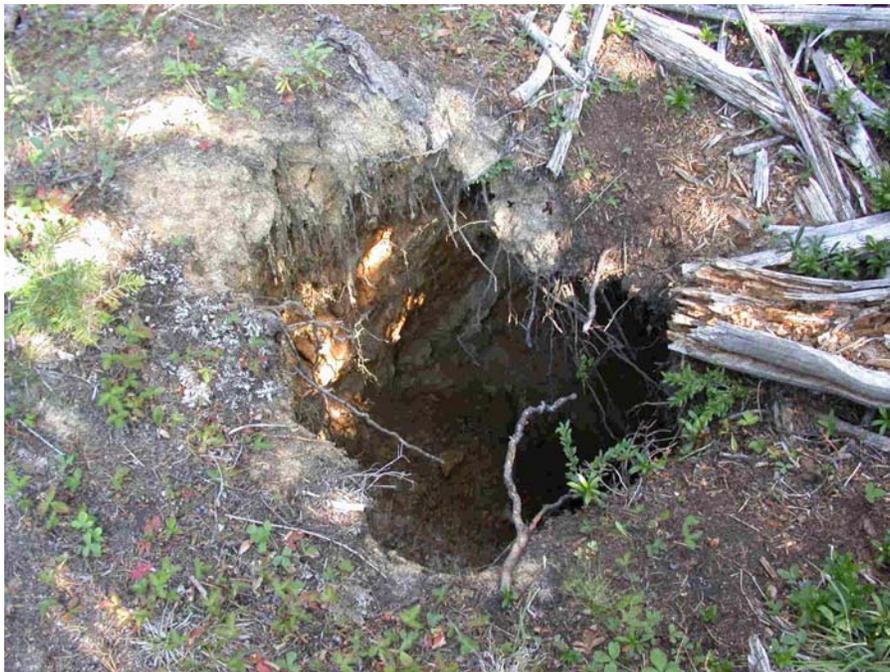
Photo 6. About a 3' diameter hole leading to what appears to be a drift or crosscut coming from the possible shaft as shown in Photo 5. (Photo by D. Boles)

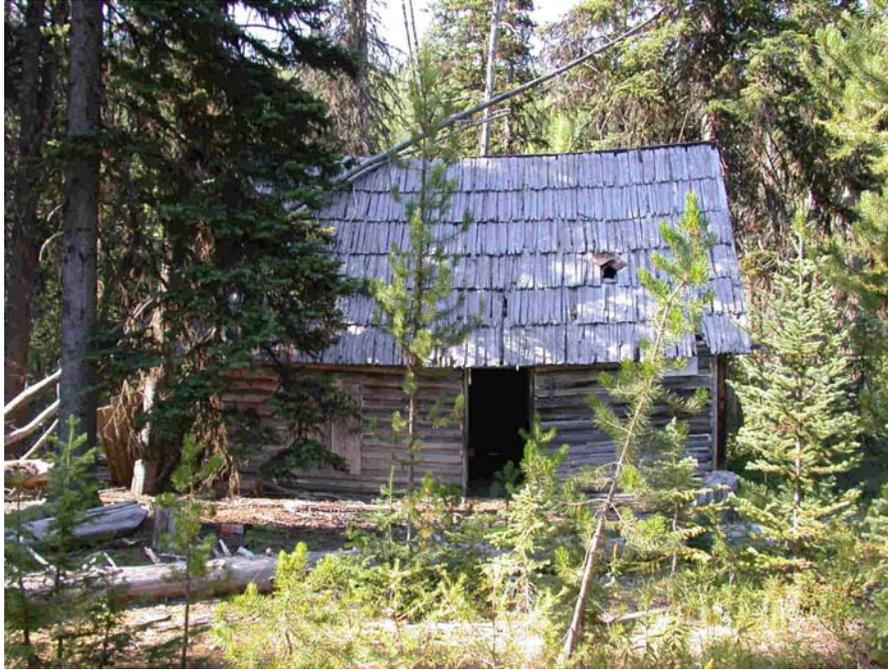
Photo 7. Backside of log cabin as shown on the cover page. (Photo by D. Boles)

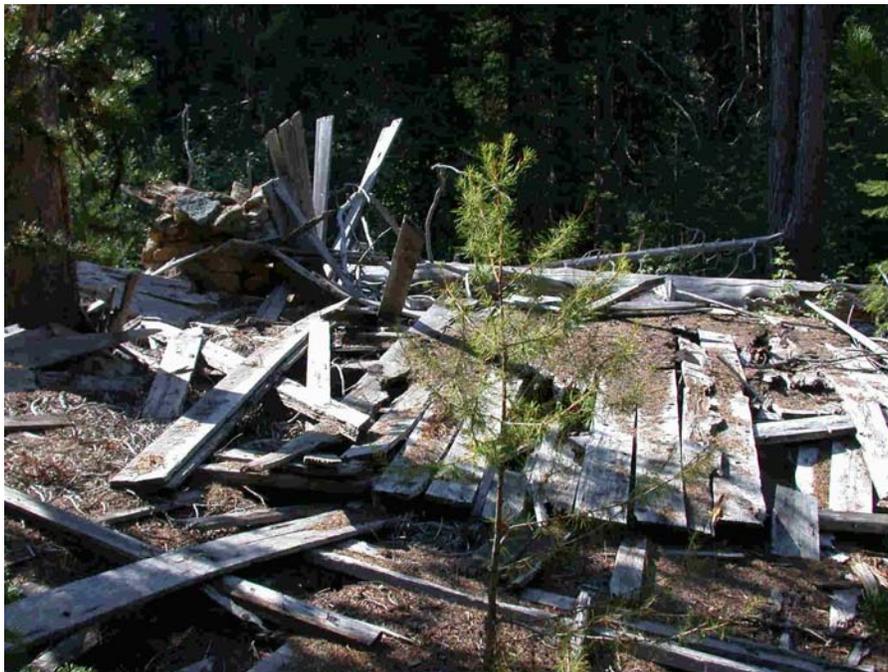
Photo 8. Remains of possible cabin. (Photo by D. Boles)
