Watershed Monitoring Program 2023 Monitoring Report

***USDA Forest Service
Salmon-Challis National Forest
Watershed Monitoring Program***

April 08, 2024

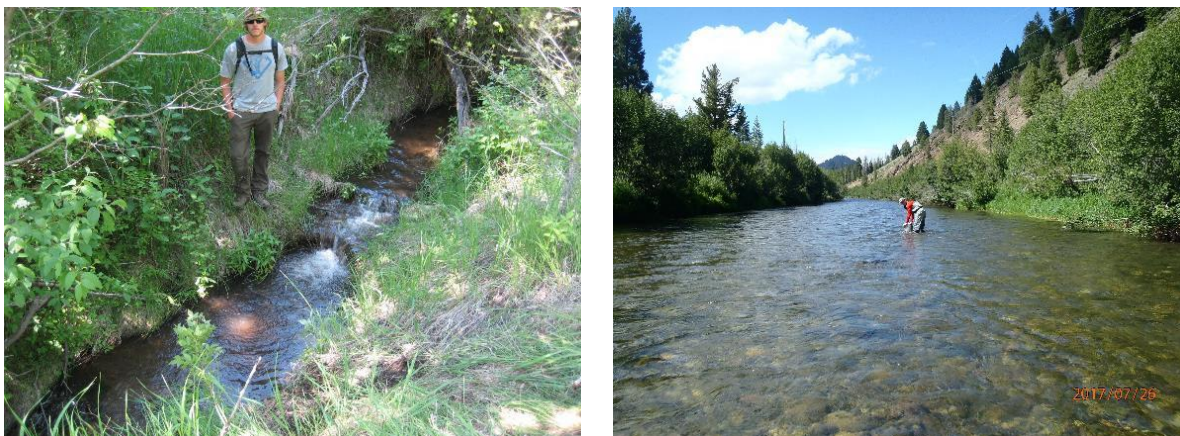
Comparison of a typical small stream (Wagonhammer Creek 1R – 8.4 square mile drainage area) and a typical large stream (Yankee Fork 1A - 164.4 square mile drainage area). Different channel processes occur at each of these sites, affecting the distribution of fine sediment in different ways.

Stream channel size is most often quantified by bankfull width, but it is also directly related to drainage area and bankfull flow. Analysis of the correlation between depth fines and drainage area and bankfull flow suggests that smaller stream channels have a wider range of depth fines, while the larger stream channels (greater than 25,000-acre drainage areas) have a narrower range with depth fines generally less than 30%. Many sites with very small stream channels have been discontinued because of inadequate sampling habitat. Active monitoring sites with small stream channels are more heavily influenced by riparian vegetation, woody debris, and channel bedforms than larger channels. Small channels are therefore more responsive to changes and may exhibit higher variability than in larger channels, where these effects can be averaged out. High fines in small stream channels, therefore, may occur as a result of different mechanisms than in larger stream channels. Additional investigation is warranted. Bankfull width is the most suitable measure for channel size but has proven difficult for monitoring crews to repeat without extensive training. Future analysis may look at relationships between channel width and sediment.
