**BAER Monitoring Report Year One  
Silver Fire  
Gila National Forest, Region 3  
May 2014**

# Silver Fire Burned Area Emergency Response 2013 Level II Monitoring Report

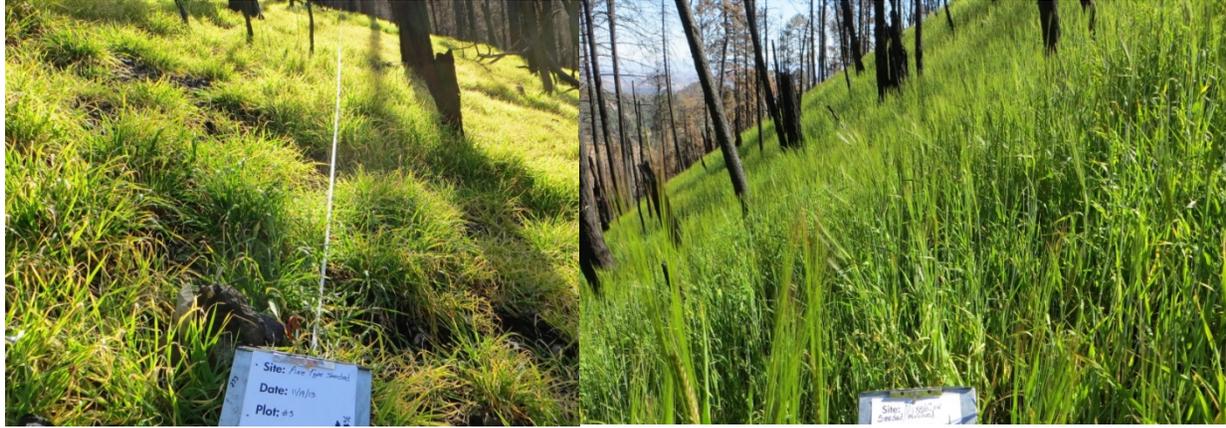
**Seeded only – higher amount of basal leaves and less height**

**Seeded/mulched – single stemmed and taller**

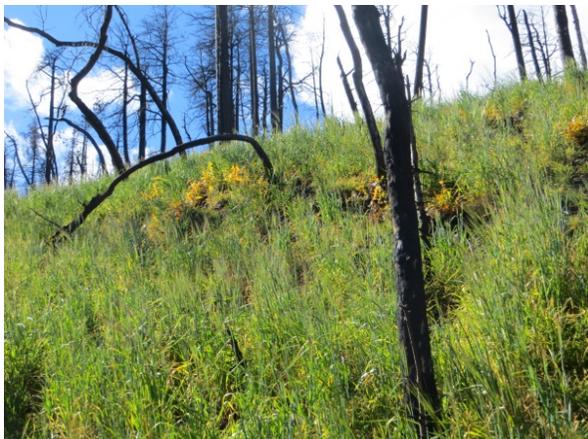
Gambel oak regeneration on a seeded/mulched area

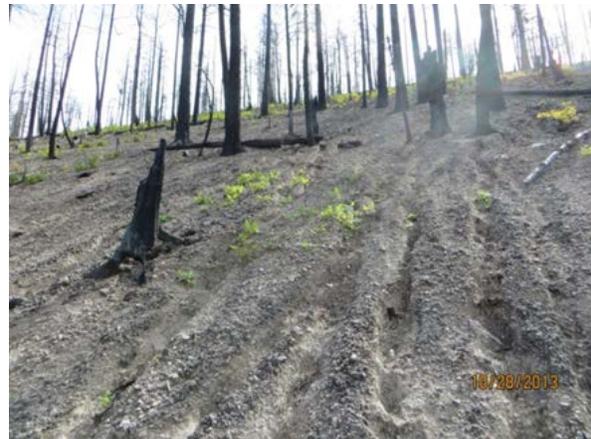
Gambel oak regeneration on a non-treated area
