FY2015 MONITORING REPORT
MOUNTAIN PINE BEETLE RESPONSE PROJECT

INTRODUCTION

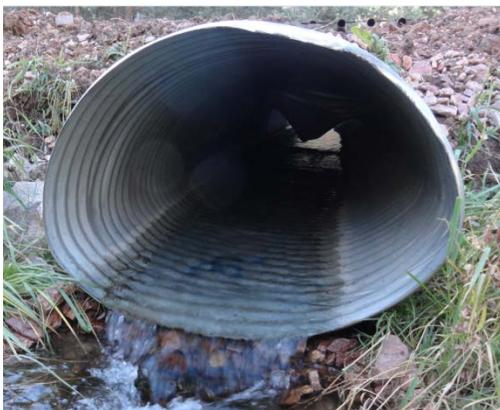
Photo 1.

(FSR) 166.1F on Bogus Jim Creek. FSR 166.1F is a Level 1 (closed) road that was used temporarily to complete timber sale activities. The monitoring was consistent with the PBR Soil/Water/Fisheries Monitoring Guide and followed the Forest Service National BMP Program direction. Specifically, the protocol and form from the USFS Completed Road or Waterbody Crossing Construction or Reconstruction (Roads Management; Roads B) were used. Based on that evaluation, the road-stream crossing installation was consistent with the seasonal instream timing restriction to protect fall-spawning trout, but was not effective in meeting Forest Plan Standard 1203 to provide for fish passage. The culvert did not meet the Forest Service design concept of “stream simulation”, meaning the culvert was not sized equal to or greater than bankful width and natural substrate was not present throughout the structure (i.e., the culvert bottom was not buried; photo 1). This can result in shallow water depths and increased water velocity within the culvert. Also, the outlet was “perched”, resulting in a small waterfall. All of these conditions are likely to impede upstream fish passage under certain conditions.

The culvert collapsed shortly after its initial use (photo 1), but it was quickly fixed. Subsequently, the crossing withstood high flows during May-June 2015 (photo 2) and passed debris/sediment consistent with Standard 1203 and other design criteria.

Recommendations: Remove the culvert and fill material at the FSR 166.1F –Bogus Jim Creek road-stream crossing once vegetation management activities have been completed in that unit. This would restore the crossing to a low-water ford which would insure the passage of high flows, sediment/debris and fish/other aquatic organisms. The removal of the culvert and fill material should occur consistent with the seasonal inwater work restriction (avoid Oct 15- April 1, if practicable). The road should revert to closed status, but would remain available for administrative use.

In the future, install instream structures at road-stream crossings to meet the “stream simulation” design concept to allow for aquatic organism passage. i.e., 1) the structure width is equal to or greater than the stream width and 2) the culvert bottom is buried to avoid perched outlets and to provide natural stream substrate throughout the length of the culvert for the design life of the crossing.

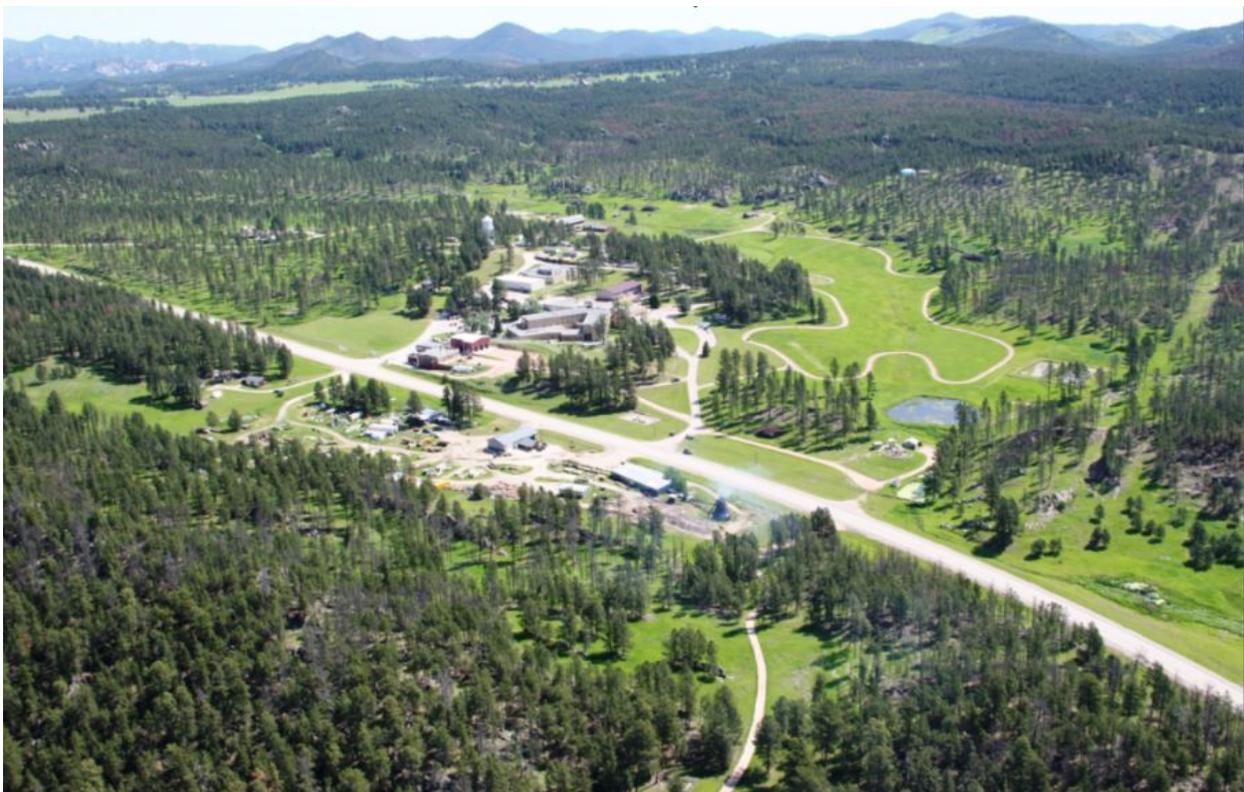
Below is picture of STAR Academy area south of Custer, South Dakota. Timber sale activities were implemented around this facility under the PBR NEPA decision.

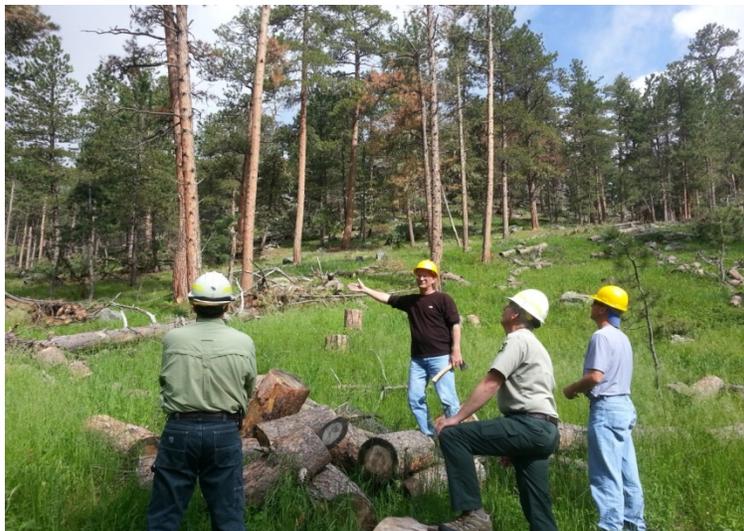
Post-harvest stand conditions achieved commercial thinning prescriptions reducing basal area to minimize the likelihood of mountain pine beetle attack. Follow-up stand improvement of pre-commercial thinning or POL (products other than logs) thinning will rely upon appropriated funds to further improve stand structure. Timber sale preparation and logging operations were not implemented quickly enough to harvest all trees prescribed to be thinned, and some standing dead trees killed earlier by beetle attack were left on the site as unmerchantable. Cut-and-chunk activity has primarily been implemented in the Buck Mountain Timber Sale area. Forest Health Service Center entomologist Kurt Allen, and South Dakota State University forest health specialist John Ball representing the South Dakota Department of Agriculture Forestry Division, documented their findings on cut-and-chunk activity on the Forest in a report cited in last year's monitoring report. They concluded that the "use of cut-and-chunk works best when it is done in conjunction with other treatments that reduce stand density." When this treatment is used alone, pockets of 50-75 trees are about the extent for which it can be effectively applied. This is for isolated pockets. If there are other groups of trees in the surrounding area, the treatments may still not be effective. If this treatment is applied in conjunction with timber sales, it should be used as mop up and should not precede sale activities. Below is a picture of a cut-and-chunk activity area from which mountain pine beetles emerged and flew to infest adjacent trees the following year. Please refer to the Silviculture report, Appendixes C and D, for further information.

Recommendations: No changes to silvicultural design criteria are recommended. However, several recommendations are offered regarding treatments.
