# Caribou-Targhee National Forest

## Jackknife Watershed Restoration

### Priority Watershed Completion Report - FY2014

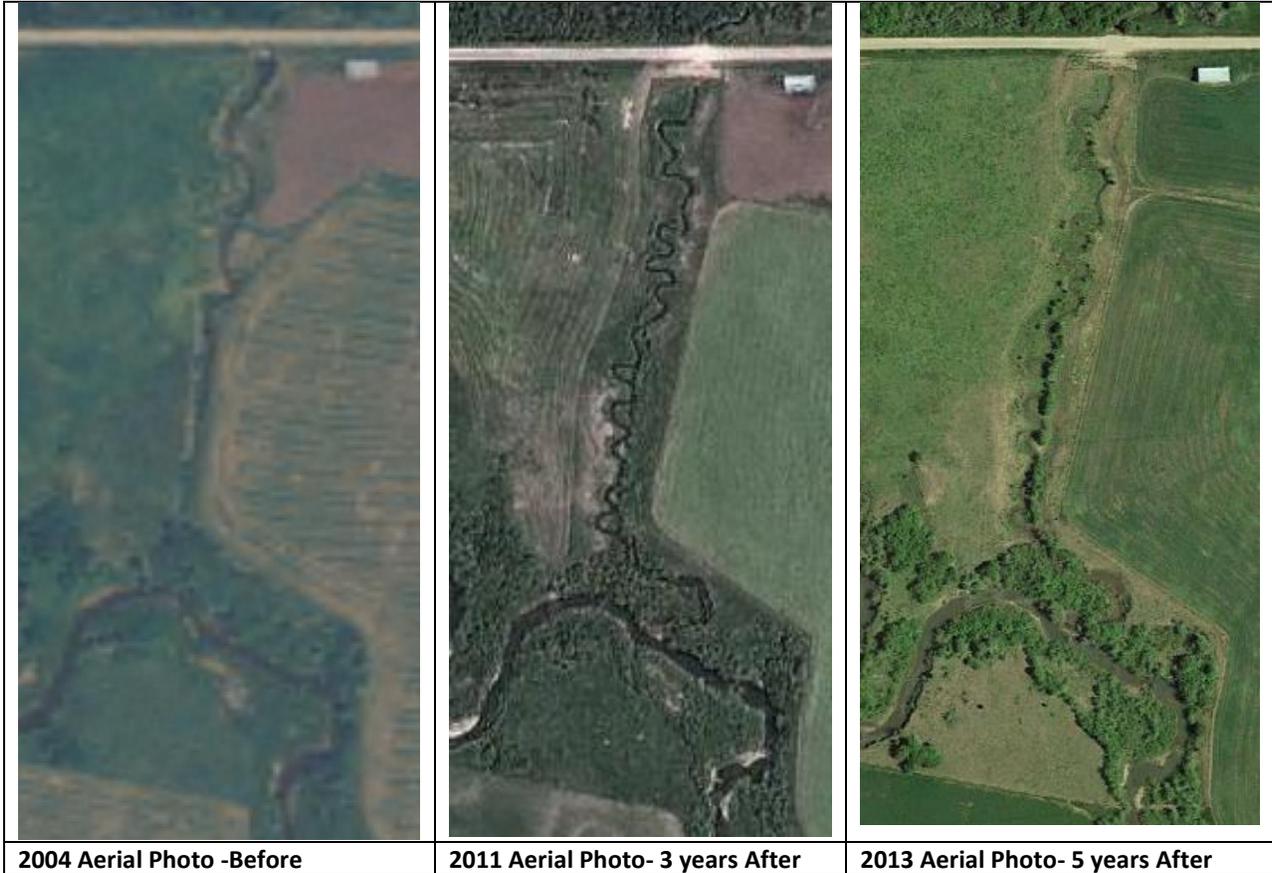
2004 Aerial Photo -Before

2011 Aerial Photo- 3 years After

2013 Aerial Photo- 5 years After

The Caribou-Targhee National Forest has cooperatively worked with Rec Spackman the private landowner, Bonneville Co. and other important partners to replace a fish barrier culvert on Deep Creek and restore over 1100 feet of excessively down-cut and straightened stream channel. Deep Creek is a tributary to Jackknife in the Salt River drainage and a Yellowstone Cutthroat trout stronghold. Replacement of the 4ft diameter culvert with an 8ft wide natural bottom arched pipe by Bonneville Co. on Jackknife Road (FS 136) restored Yellowstone Cutthroat trout passage up Deep Creek onto National Forest Lands. The channel was restored using stable reference conditions. The nearly 8ft down-cut channel bed was elevated a maximum of 5 feet to reconnect the channel to a newly constructed floodplain. The existing flood prone width was increased fivefold from approximately 15ft to nearly 80ft increasing stream stability during flooding events. The straightened channel was re-meandered to match reference condition (sinuosity increase from 1.1 to 1.5) lengthen the channel nearly 220 ft. Stream bed materials of gravel and cobbles mixture were imported to mimic the natural channel. Channel bank reconstruction consisted of outside meander log complexes, whole willow clumps; transplanted sedge clumps, nature sod solutions matting, and native seed mixes were used to provide stream stability.

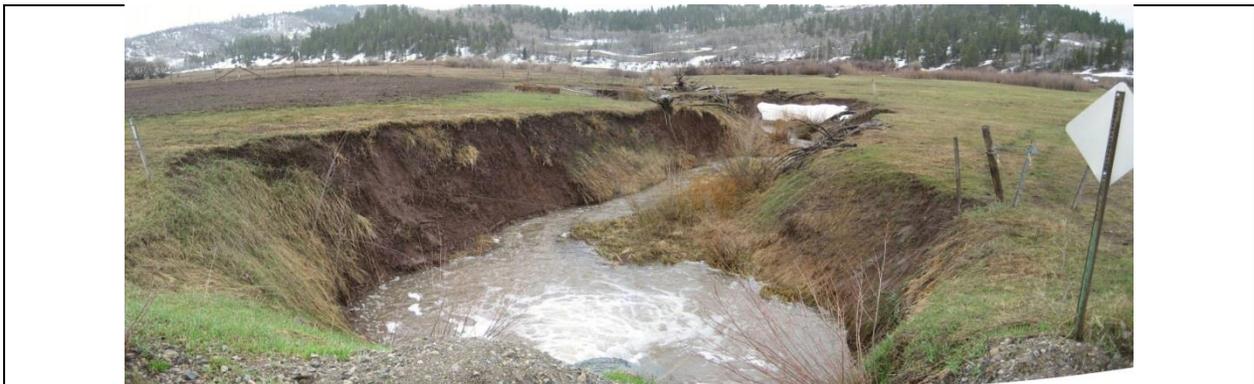
BEFORE – Top of project at culvert outlet looking downstream

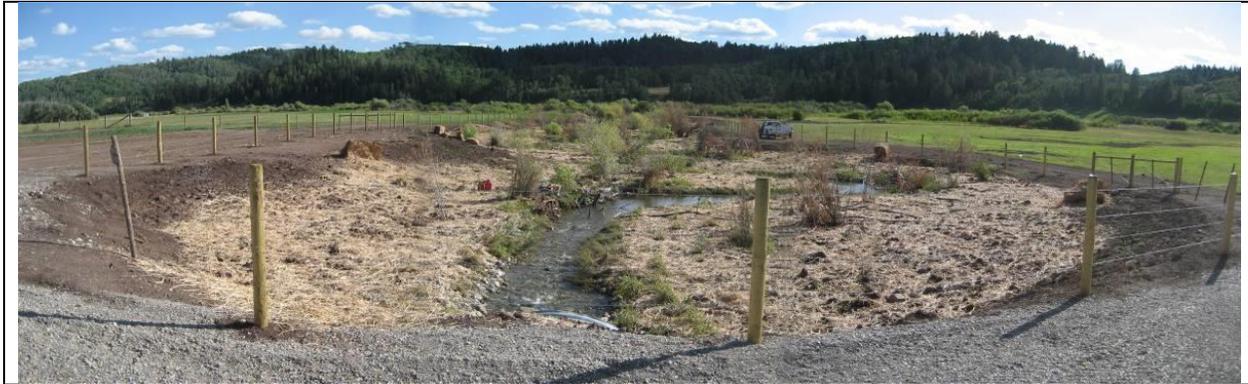
**AFTER – Fall 2008 right after restoration work was completed.**

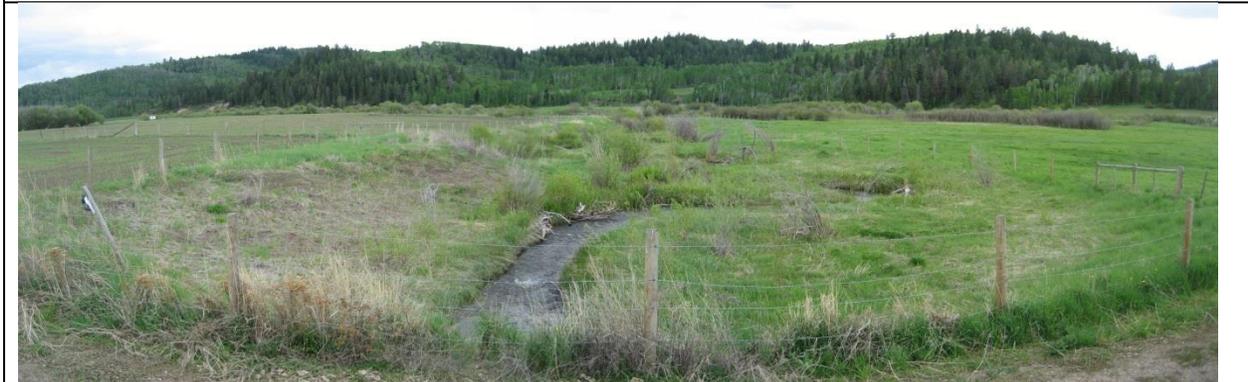
**AFTER – 4 years after restoration was implemented (5-22-2012)**

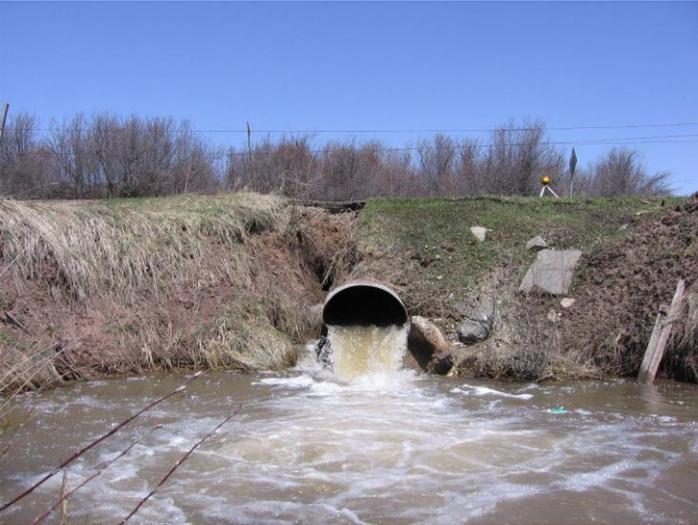
A photograph showing a culvert pipe discharging into a stream. The water is turbulent and white with foam. The surrounding area is a grassy embankment with some trees in the background.	<p>Before-Fish barrier for Yellowstone Cutthroat to get on National Forest upstream</p>

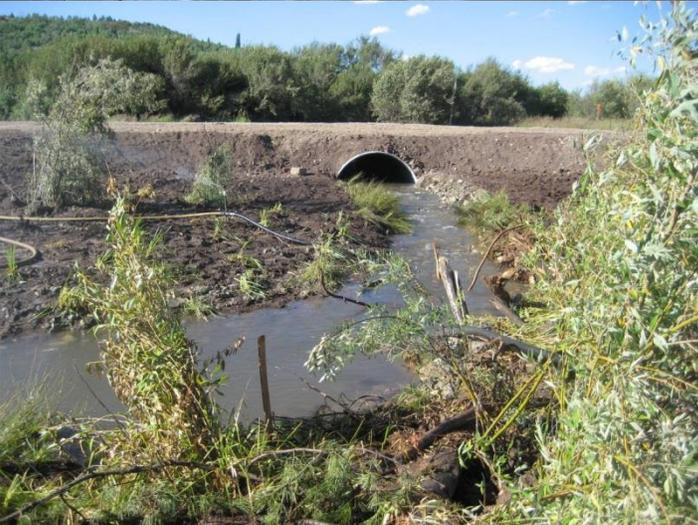
A photograph showing a culvert pipe discharging into a stream. The water is calm and dark. The surrounding area is a grassy embankment with some trees in the background.	<p>After: 8-2008 - Road surface elevation stayed the same. Stream bed elevated up 5 feet at culvert outlet</p>

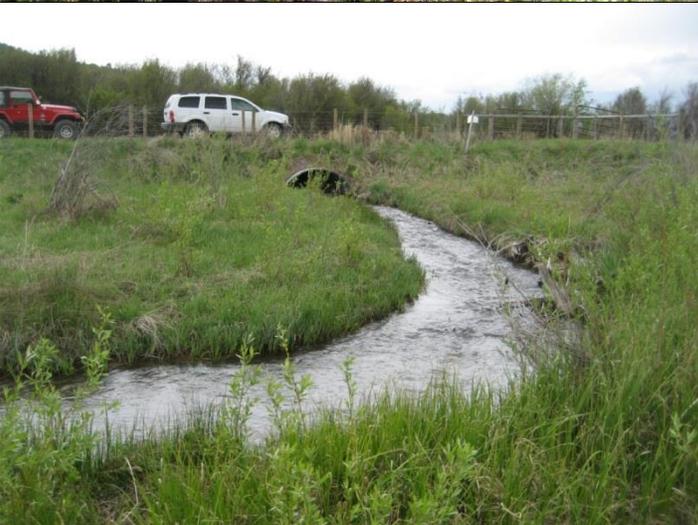
A photograph showing a culvert pipe discharging into a stream. The water is calm and dark. The surrounding area is a grassy embankment with some trees in the background.	<p>After: 7-11-2012</p>

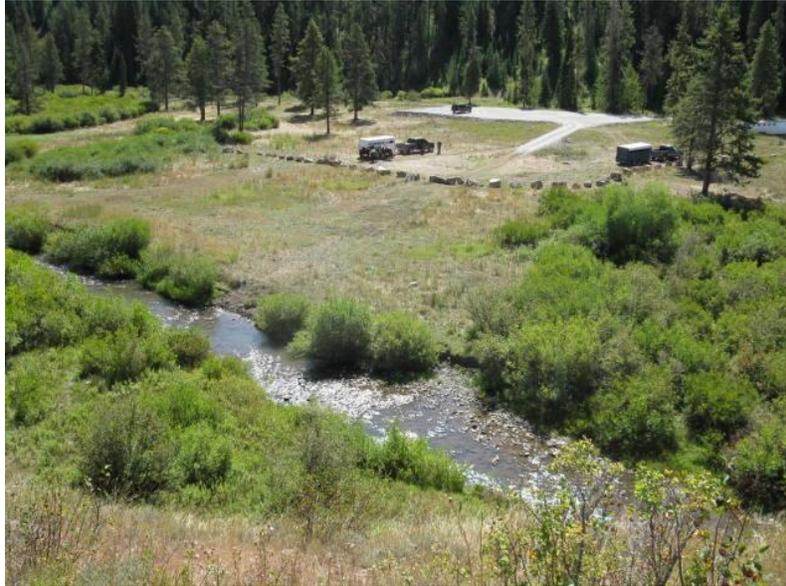
**View of the constructed parking area and placed barrier rock along Jackknife Cr.**

Constructed a designated parking lot 90ft x 150ft to reduce dispersed impacts and improve recreational conditions at the new Jackknife Trailhead. The old Jackknife Trailhead was 1.9 miles further down the Jackknife Road but was administratively close due to slumps taking out the road. This trail head is one of the heaviest used trail systems on the Soda Springs Ranger Districts. Also placed barrier rock to protect about 900 feet (average 190 foot stream buffer) of stream and riparian vegetation to improve water quality and stream health.

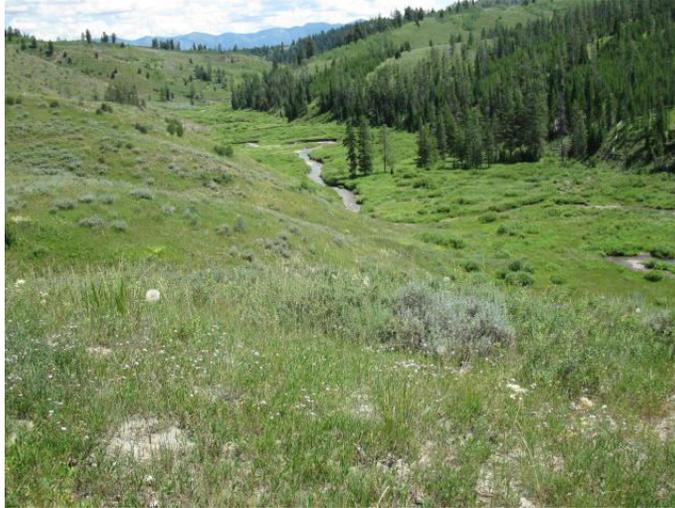
Jackknife Creek from new trail section, looking down where trail used to be.

Approximately one mile of system trail was relocated out of the creek bottom, eliminating sever eroding stream crossing. The project had also reconstructed some existing pack trails and connected them with the new constructed sections

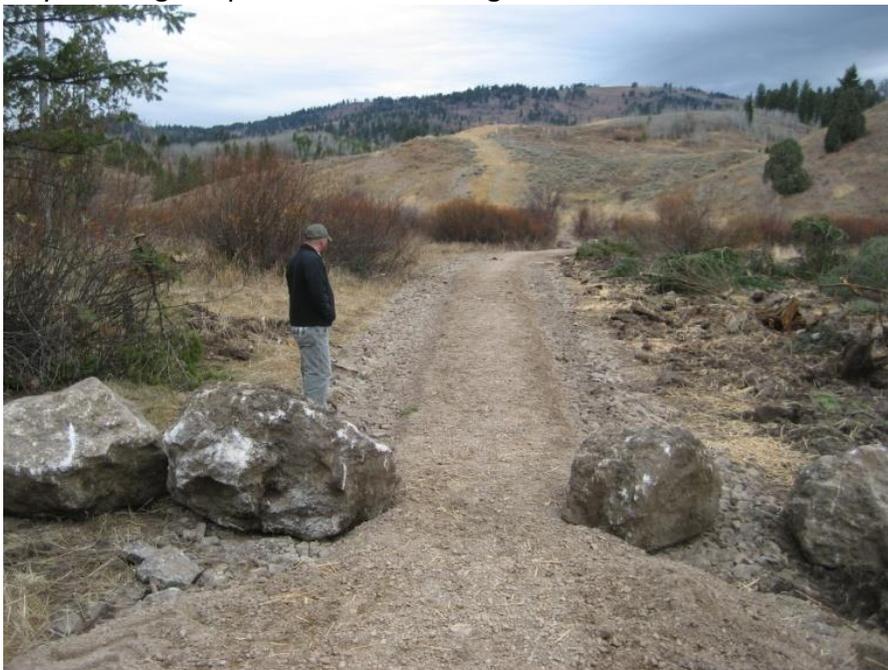
Upon final approval of the 2011 Jackknife Restoration EA and decision a small amount of work was completed in October of 2011 to improve trail and riparian conditions. Nearly 650ft of a road was converted to a trail narrowing the disturbance width and relocating a portion away from Jackknife Creek. The old road fill was removed to match the riparian elevation to allow flooding to utilize the full flood plain. The trail bed was improved via installing geo-textile fabric capped with a layer of angular pit run and crushed gravel.

Partner(s)/Funding: Legacy project where this portion was completed by the FS road Crew \$5,000.

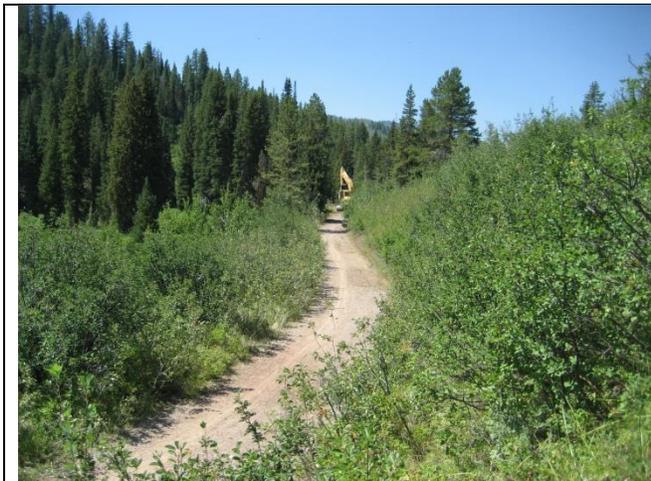
**Before: Road located in the Aquatic Influence Zone (AIZ) and across active slumps decommissioned**

- Decommissioned 1.6 miles of Jackknife road that was within the riparian zone and located on unstable slumping land type features. Sections of the road had failed in the past and were a direct sediment contribution into Jackknife Creek.
- Constructed 1.3 miles of new trail around slump area to replace road access to trail network.
- Converted 0.6 miles of road to trail and narrowed disturbance width from 12ft to 2ft.

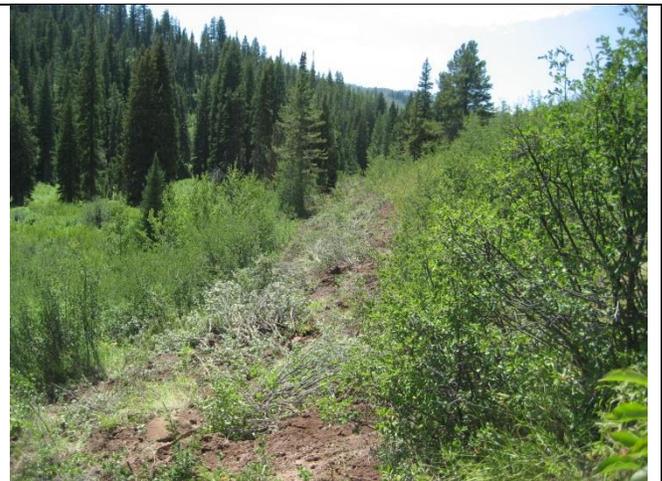
**After: Full re-contouring road decommissioning to remove AIZ and stream impacts.**

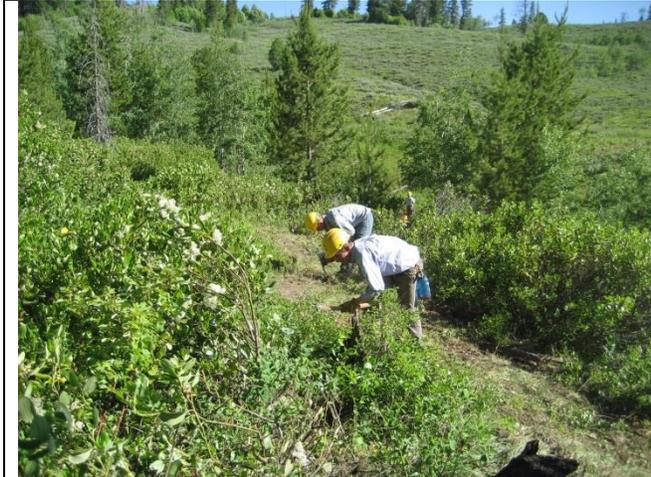
North West Youth Corp constructing a section of new trail that is further away for the Jackknife Creek and avoid unstable slump land features.

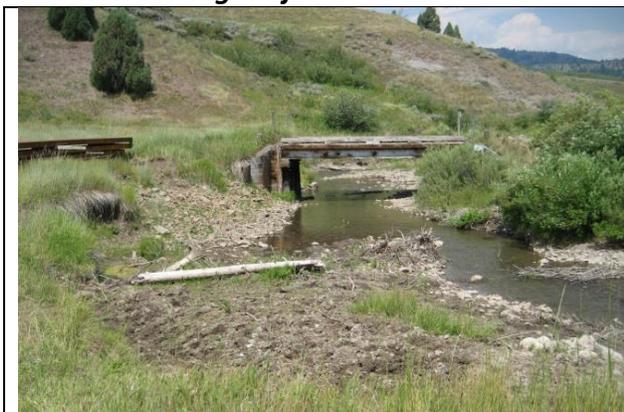
Before: Looking downstream at the old road bridge with an undersized 25ft bridge span in a stream with a 30ft bankfull width.

- The main undersized Jackknife Road Bridge (25ft span) was replaced with a non-motorized trail bridge with a 55ft wide span allowing the 30ft wide bankfull channel to function with constriction.
- Black Canyon perennial flowing stream cross contain a 24 inch culvert and was replaced with a 10 foot timbered bridge. The new bridge utilized timbers off of the main Jackknife road bridge to reduce project costs and recycle useable material.
- Skull Canyon perennial flowing crossing was also an undersized with a 3 foot culvert which was replaced with a 15 foot recycled timber bridge components from the main Jackknife road bridge.
- Upgraded an undersized (18 inch CMP) crossing on a No-Name Spring Channel with a recycled 3 foot diameter culvert from Skull Canyon.

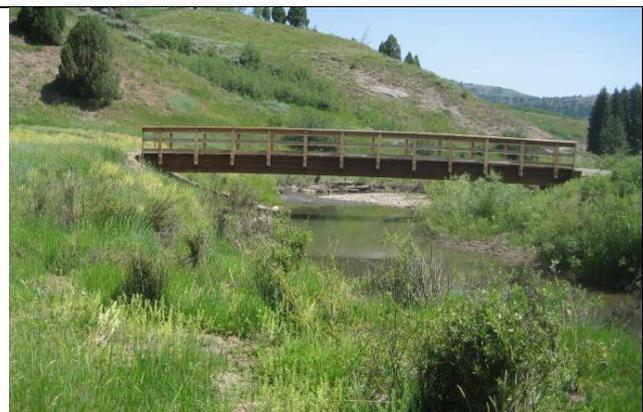
After: Looking downstream at the new non-motorized trail bridge with a 55ft bridge span.

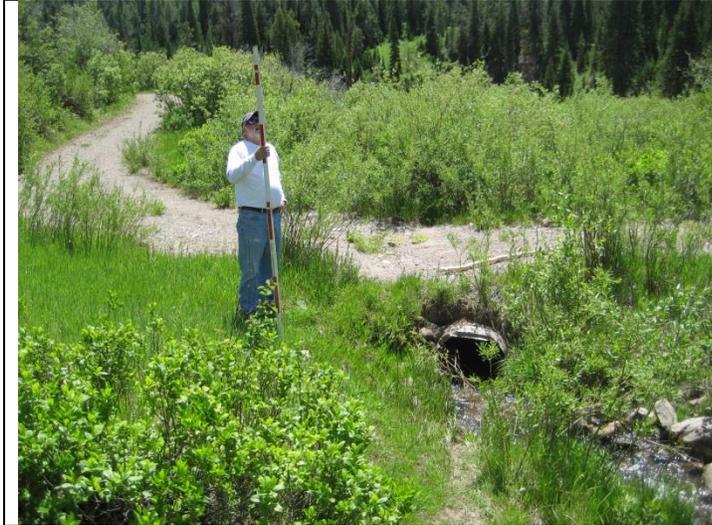
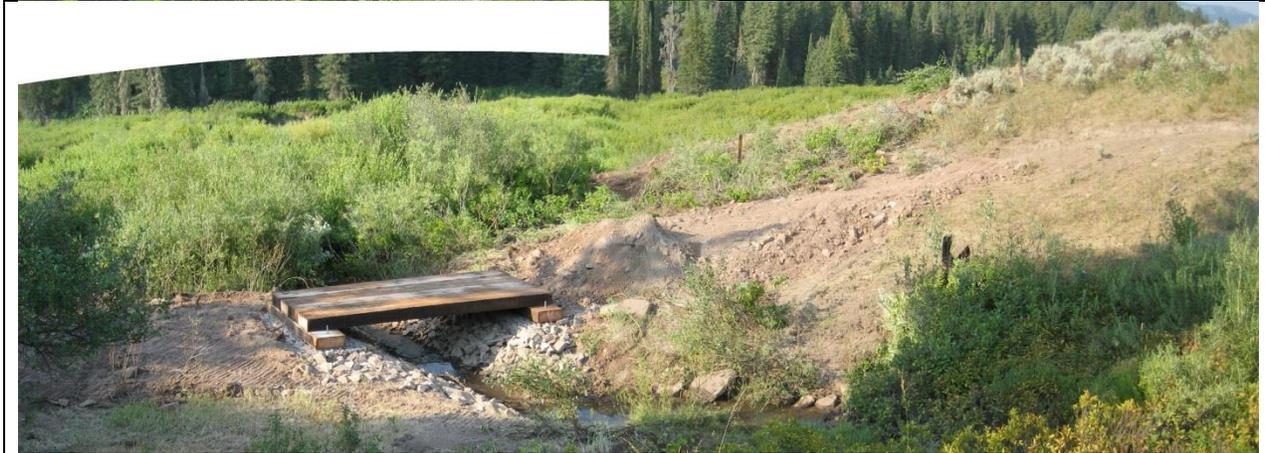
#### Black Canyon Stream Crossing

**Before:** Left photo showing the undersized 24 inch culvert stream crossing on the old road bed.

**After/During:** Bottom photo with a 10ft span timber structure that utilized salvaged timbers off the bigger Jackknife crossing. Old road bed narrowed from 12 to 2 feet to minimize riparian and stream disturbance.

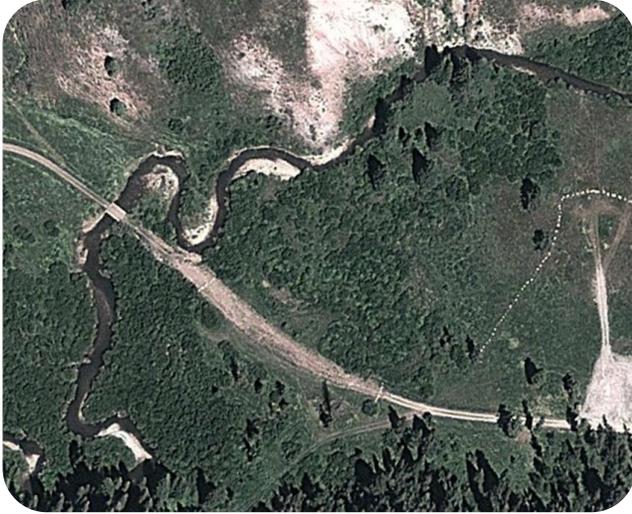
2011 Before - Straighten eroding stream channel

Associated with the main Jackknife road bridge to trail bridge conversion Phase 1 of the Jackknife stream restoration was initiated. Unstable stream conditions caused Jackknife to downcut 3-4ft and straightened losing around 14% channel length and associated aquatic habitat. Restoration efforts in collaboration with Trout Unlimited were initiated address 3,200 feet of channel. The restoration had re-active nearly 750 feet of lost channel in a meander cutoff and re-elevated the channel as much as 3 feet. Eroding outside banks were also stabilized using whole tree revetment type structures intermixed with whole willow clumps. The re-elevation of the channel and the lowering of the cross valley road fill allowed to stream and floodplain to function naturally increasing channel stability and improving water quality, aquatic habitat and riparian health. In cooperation with Trout Unlimited a video was produced to highlight our effort and is on YouTube: [http://youtu.be/TU-Q\\_MZRLCo](http://youtu.be/TU-Q_MZRLCo).

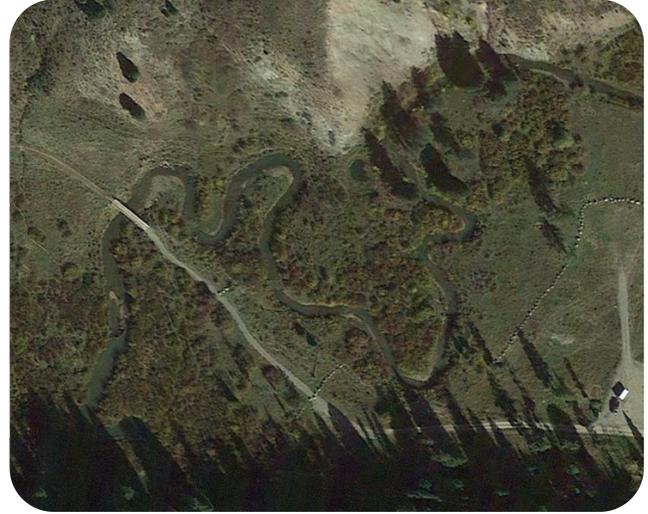
2014 After - Restored abandon stream meander.

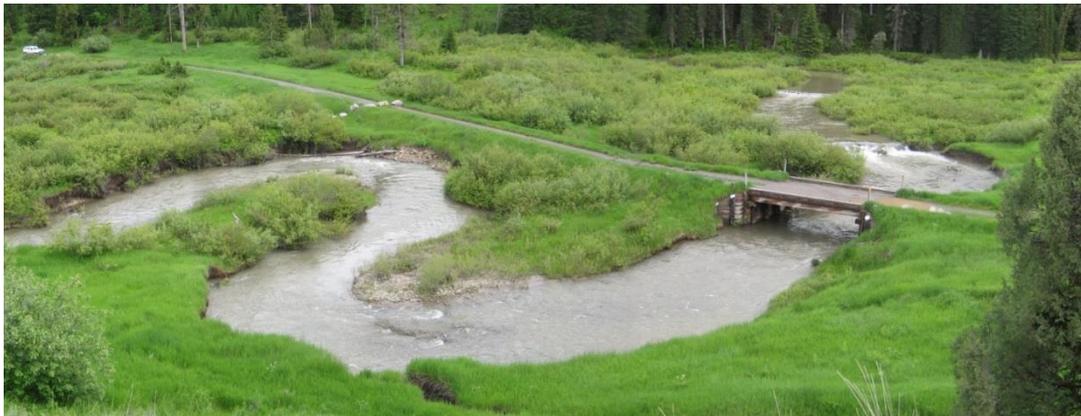
Before: Old undersized road bridge (25ft) which constricted the active channel (30ft) causing it to downcut straighten and erode banks. Elevated road way also force flood flows through the bridge causing additional stream erosion.

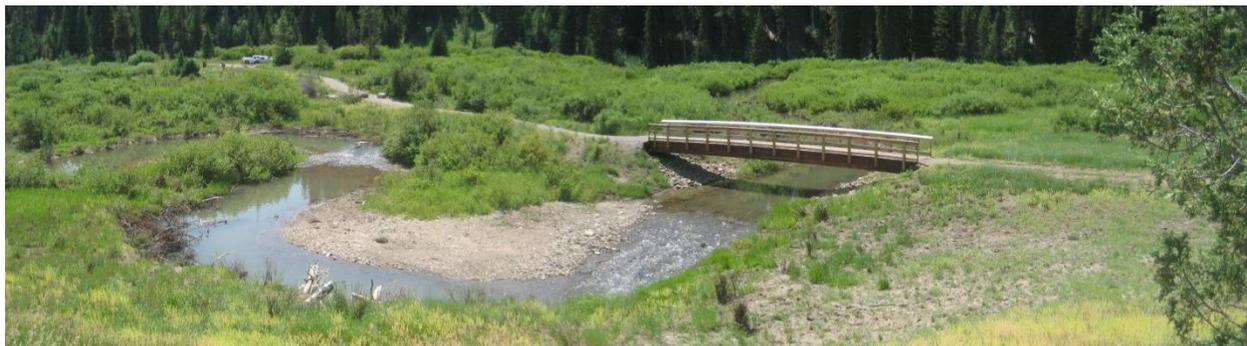
After: Road Bridge replaced with a 55ft span non-motorized trail bridge which allows the stream and flood plain to function naturally. The road bed fill material (2-3ft high) was removed to allow floodplain to function

naturally. The channel was re-elevated as much as 3 feet which can be seen in comparing the bank heights on the left side (downstream) of the before and after photos.

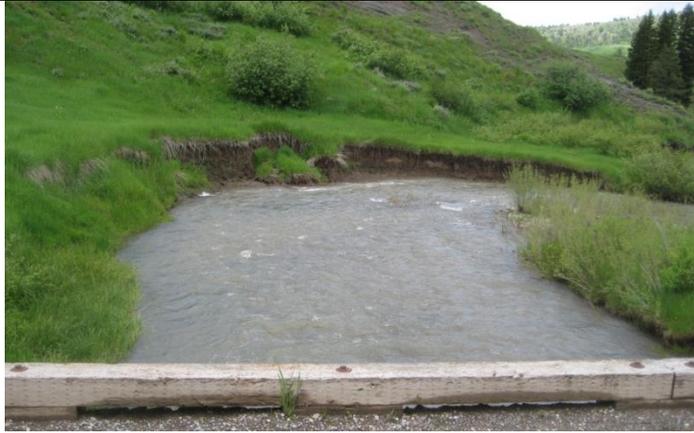
Before: Looking downstream of Old Road Bridge. 6-8 foot tall eroding bank.

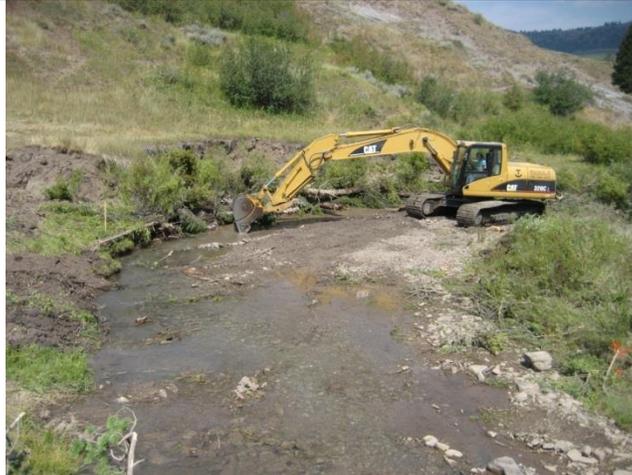
During Restoration installing whole tree revetment and whole willow clump bank stabilization structures

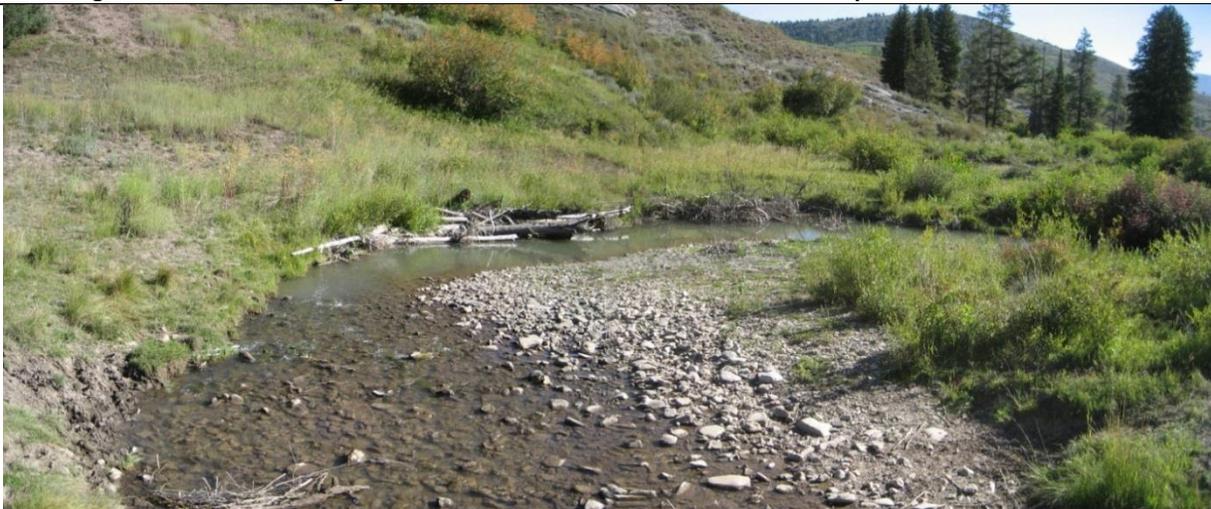
After (Sept, 2014) – Stream re-elevated 3ft and stabilized.

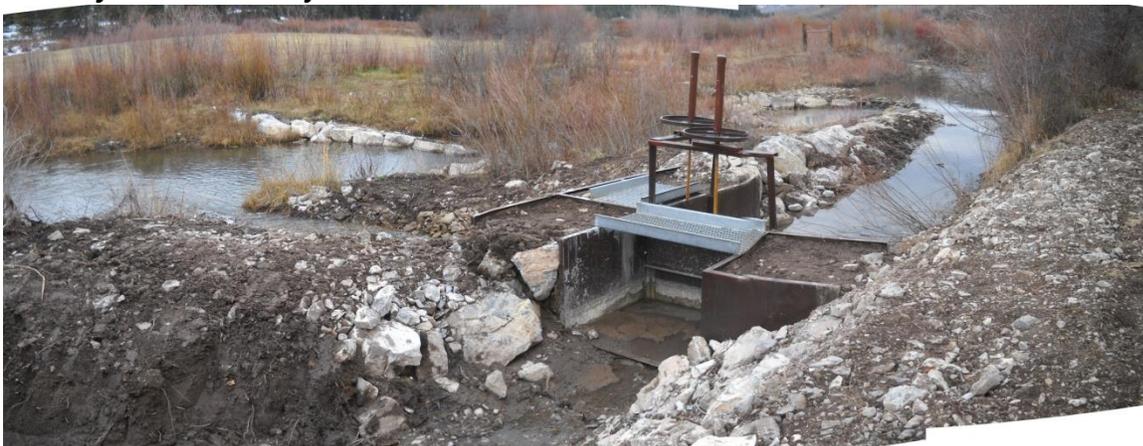
**Diversion head and sluice gates associated with a boulder cross vane in-channel structure.**

The improvements on private lands just downstream of National Forest lands continued as project was initiated in 2011 with 1,300ft of stream restoration being implemented. The restoration ensured the long-term stability for the diversion upgrade project that occurred in 2013. The diversion upgrade project consisted of the installation of a fish screen and diversion structure along with over 2000 feet of piped ditch. TU, FS and USFWS required that the fish screens designed for Yellowstone cutthroat trout and meet NOAA criteria. Idaho Fish and Game designed, fabricated and oversaw the installation of a single drum modular unit that was solar powered. This structure diverted water from Jackknife Creek providing the water users with the legal allocated amount that protected instream flow amounts from illegal use. The pipe line would go under Deep Creek and eliminate the old re-diversion point out of Deep Creek whereby additional water had been illegally diverted in the past. This bypass protected instream flow in Deep Creek and the stream restoration that had occurred in 2008 on Deep Creek (see project details above).

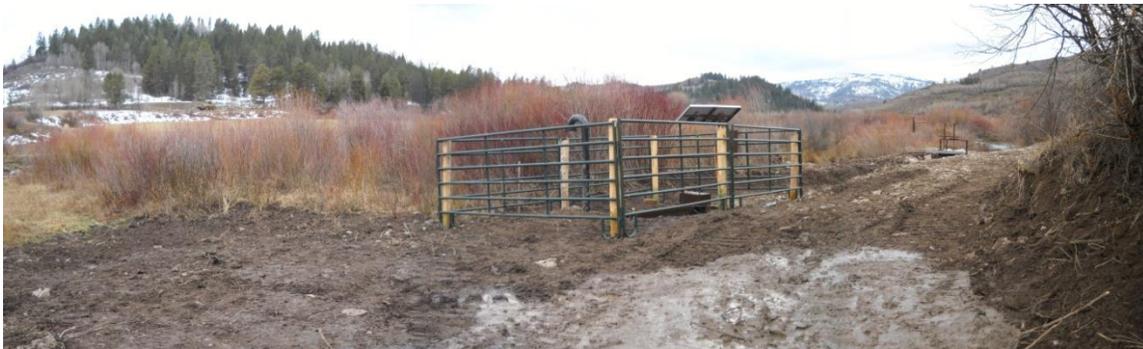
**Fenced off solar power drum screen unit. Head gate structure can be seen to the right of the drum screen.**

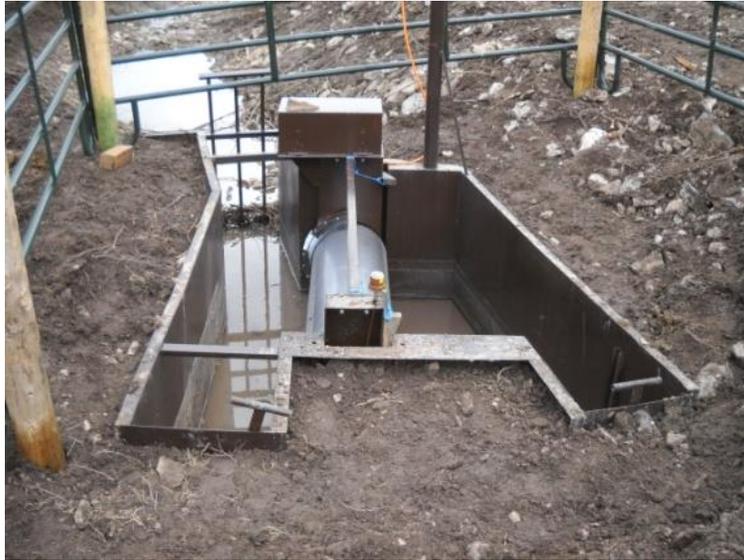
Photo of the installed solar driven drum screen unit. Looking up ditch line with a fish bypass pipe on the lower left and the ditch pipeline entrance on the lower right.

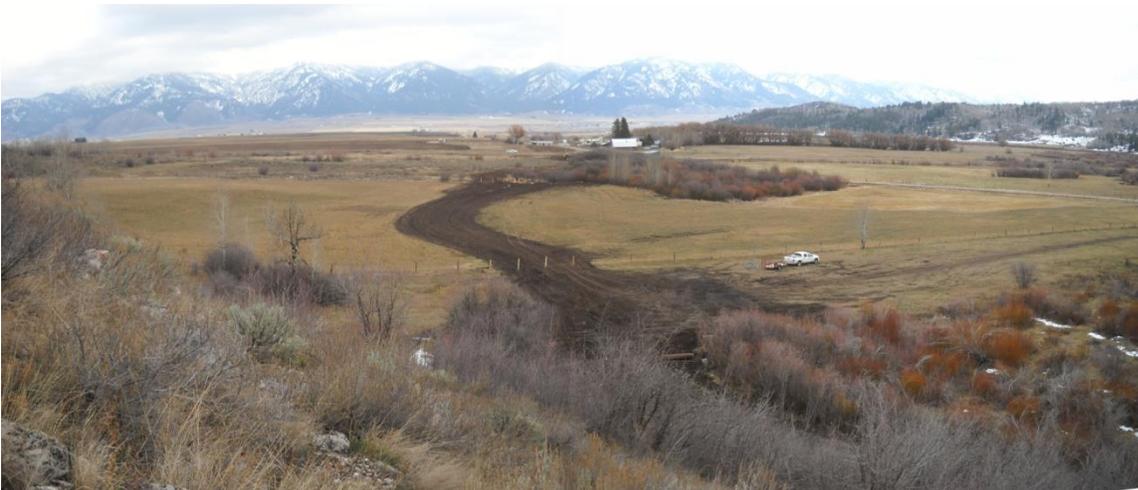
Looking down the Jackknife valley at the buried ditch pipeline location that eliminated the open ditch.

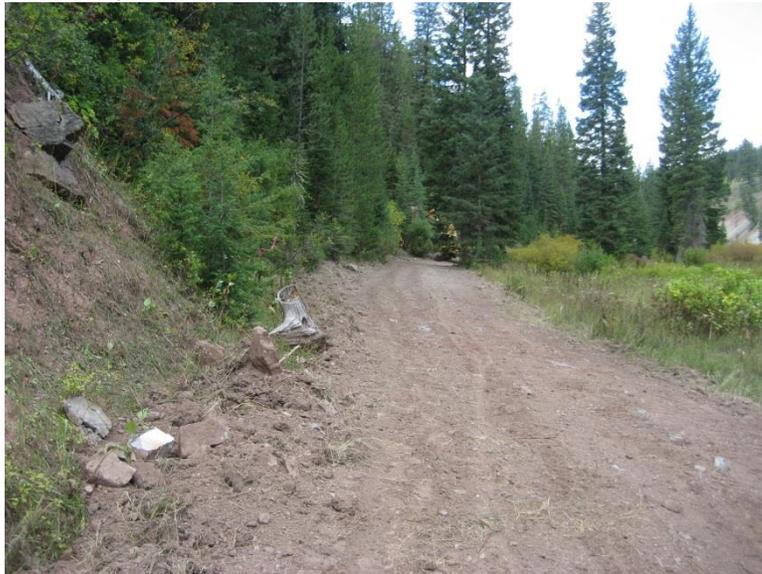
**The old road bed that is being converted to an ATV trail that runs up along Squaw Creek.**

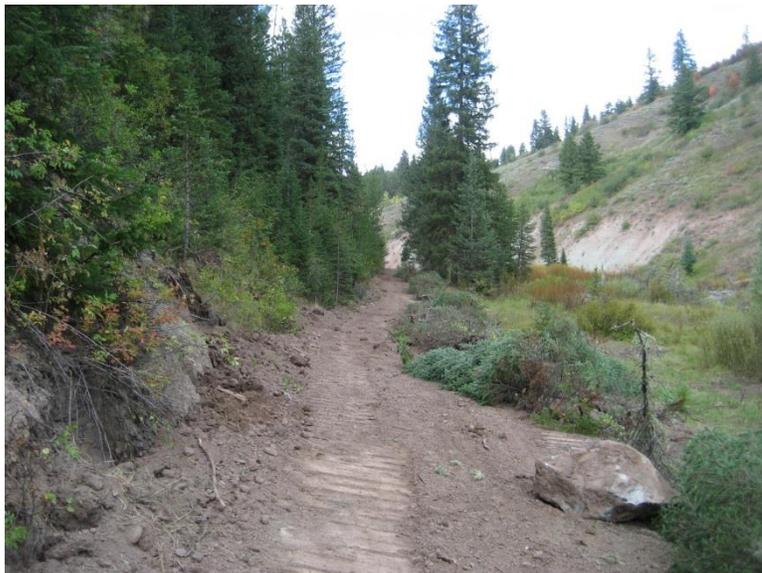
**The old road bed was narrowed to accommodate the ATV trail and outsloped to reduce disturbance and erosion.**

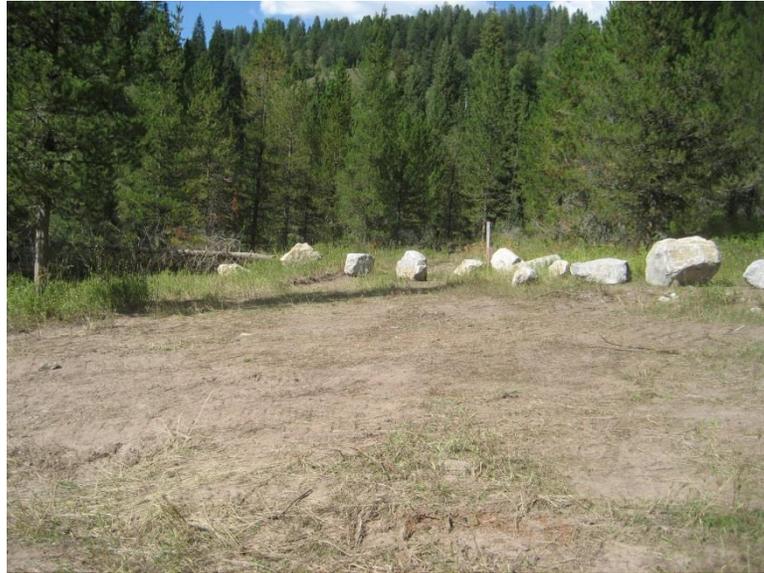
- Placed barrier road at the end of the ATV trail where it switches over to a non-motorized trail to eliminate illegal use.

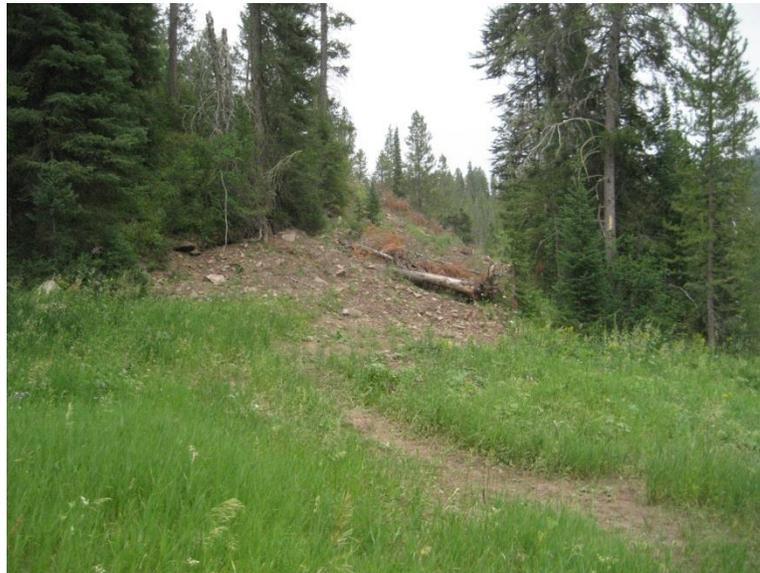
- Decommissioned 0.3 miles of an old logging road where illegal vehicle use was occurring.

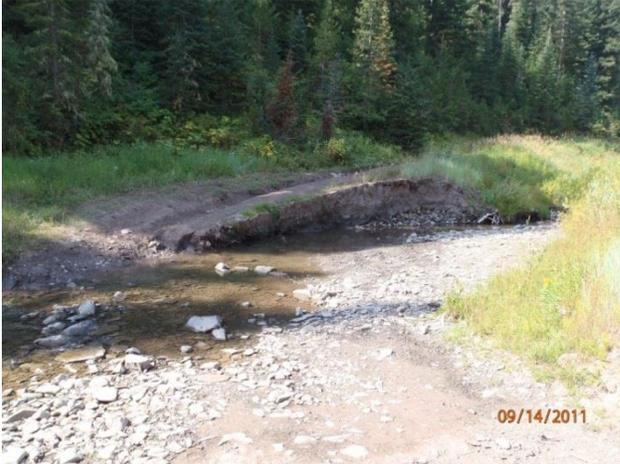
Road ford stream crossing that was washed out in the 2011 spring runoff event and closed the road.

- Upgraded two Squaw Creek stream crossings in the road to ATV trail conversion. One was a ford to a new timbered trail bridge (30ft span) the other was a replacement of an undersized culvert (5ft round) to a 30ft span timbered trail bridge. Restored and stabilized stream and banks at the old crossing location.

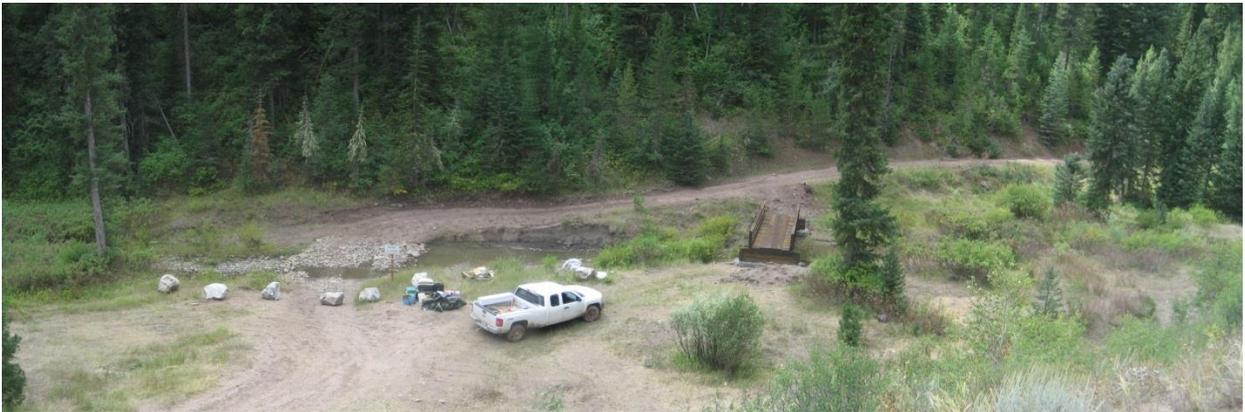
During the project when the road was being converted to an ATV trail. New trail bridge was being installed. Old ford was temporarily improved to allow equipment up valley to install the other trail bridge.

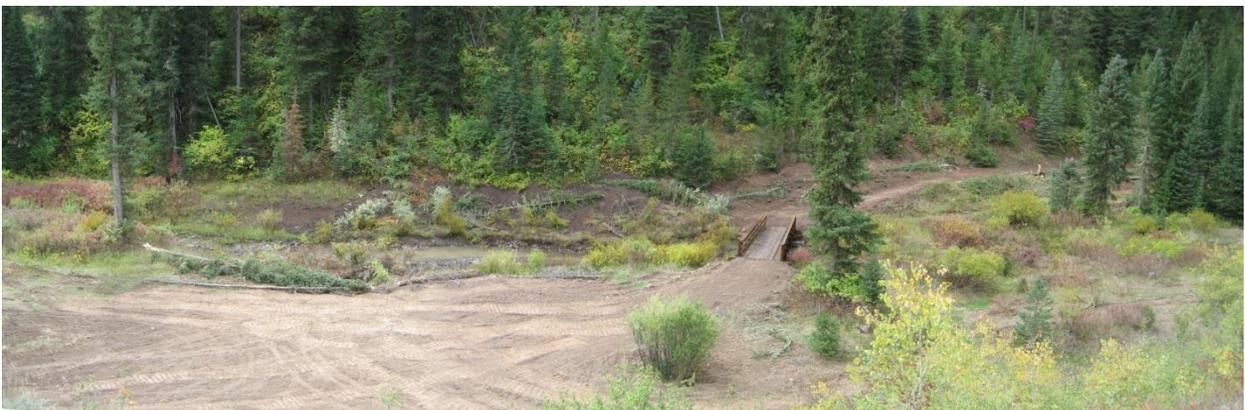
Right after the completion of the trail bridge final installation and the rehabilitation of the old road crossing.

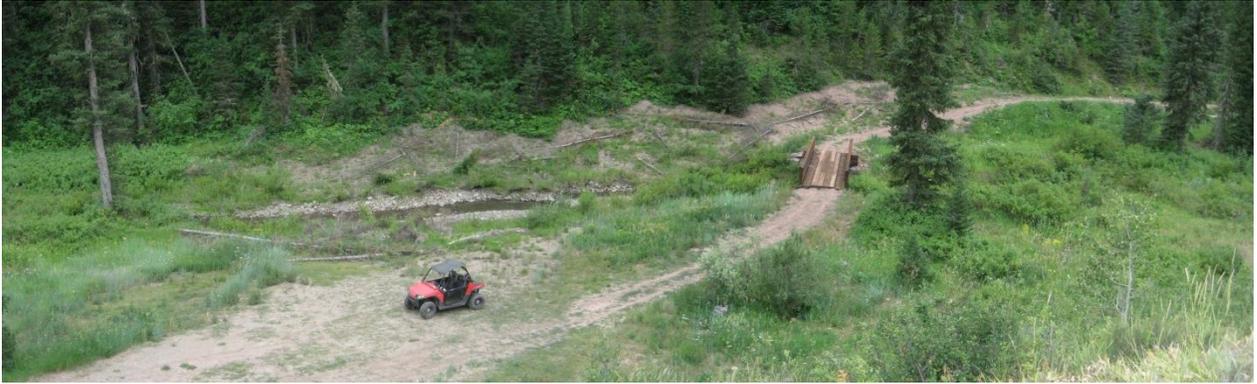
One year after the trail bridge was installed the old road crossing rehabilitated.

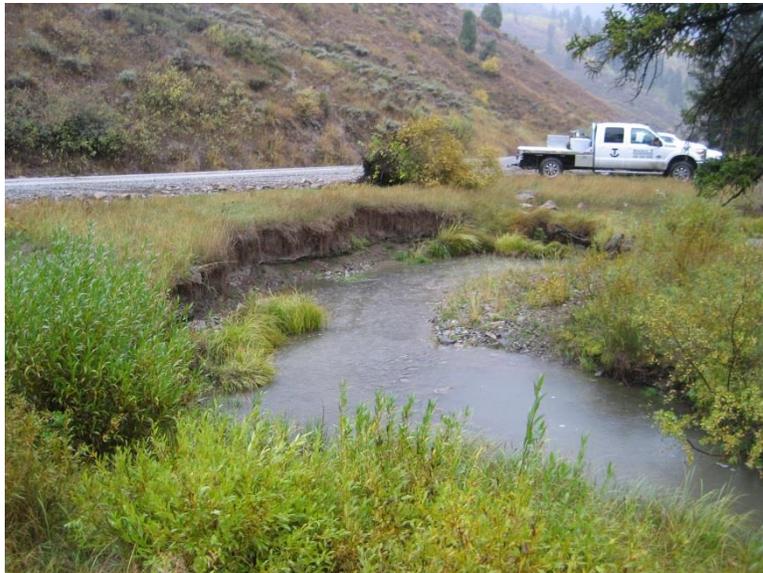
One of three eroding stream banks along the Squaw Creek Road before treatment

- Elevated 0.3 miles of road in multiple locations to prevent beaver dam inundation to impact road conditions. Installed cross drain culverts and reshaped and graveled 1.6 miles of road leading to the corrals and the Squaw Creek Trailhead. Also graveled the parking lot at sheep corrals.
- Stabilized a total of 600ft of stream banks eroding into road edge of the Squaw Creek Road at three different locations.

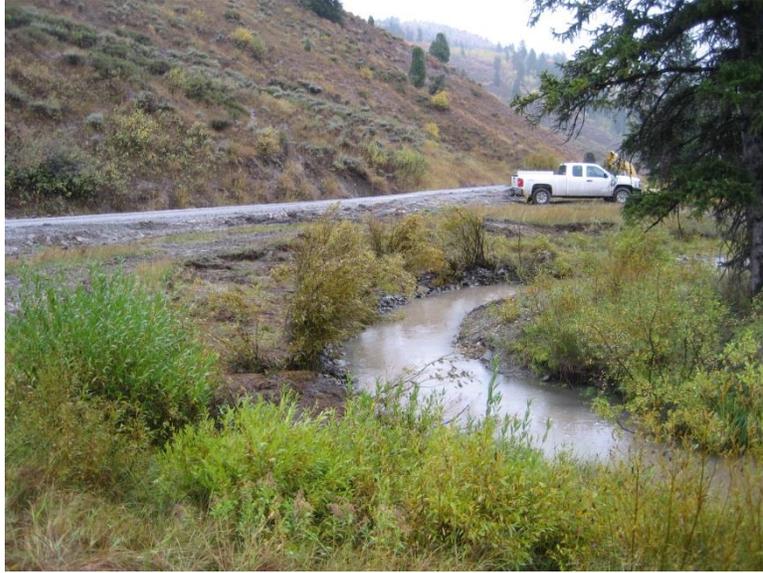
After bank stabilization treatments which incorporated whole willow clump transplants

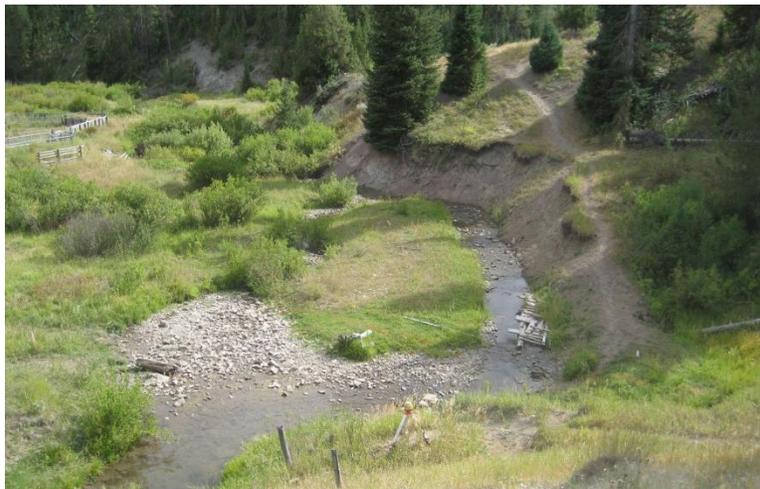
Before trail bridge construction and stream restoration. Project improved poor trail, riparian & stream conditions. Previous bridge collapsed and the over widened channel caused excessive aggradation and a braided channel to occur.

Replace washed out trail timbered bridge with a larger 35ft long trail bridge to span the active channel and portion of floodplain. Reconstructed a degraded stream channel (200 feet of Squaw Creek) and tributary confluence (100 feet of tributary channel).

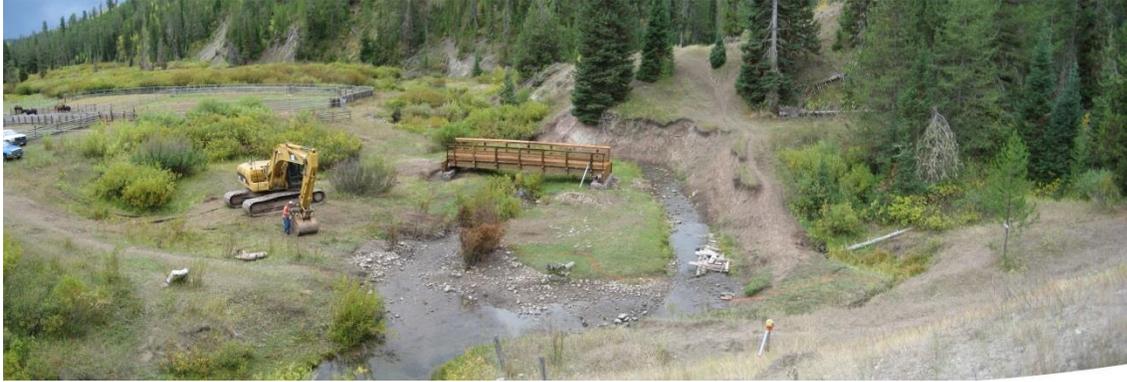
During construction of Squaw Creek trailhead bridge.

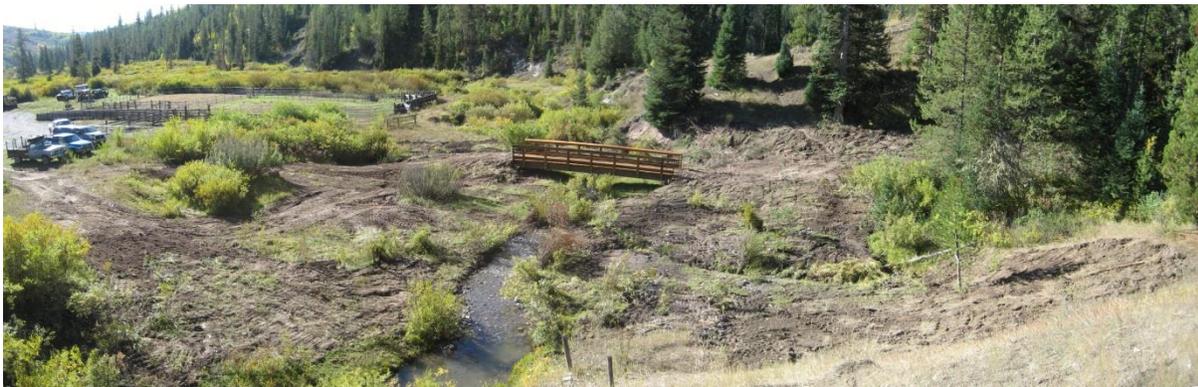
Completed Trail Bridge & Stream Restoration in the fall of 2013 looking downstream

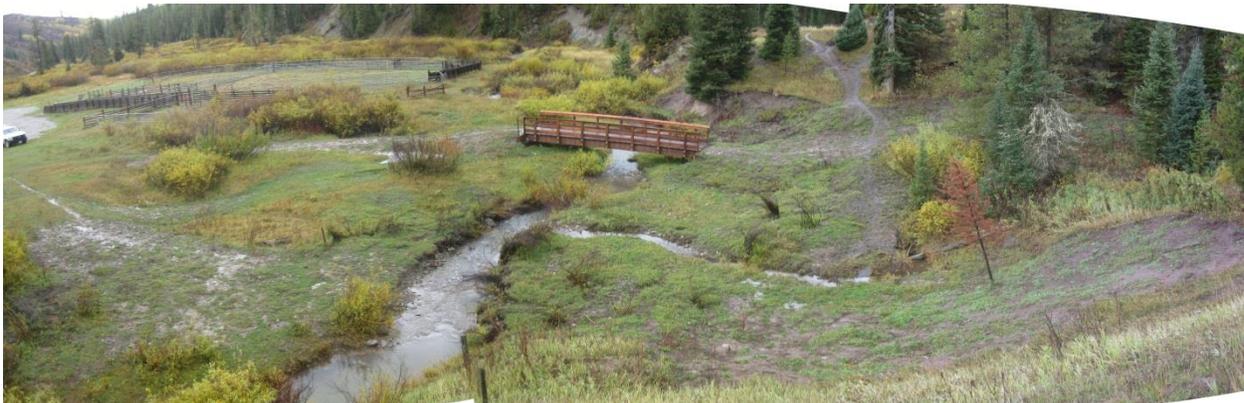
One year after completing Trail Bridge & Stream Restoration (fall 2014) project. Vegetation recovery is occurring and is further reducing erosion below pre-project conditions.

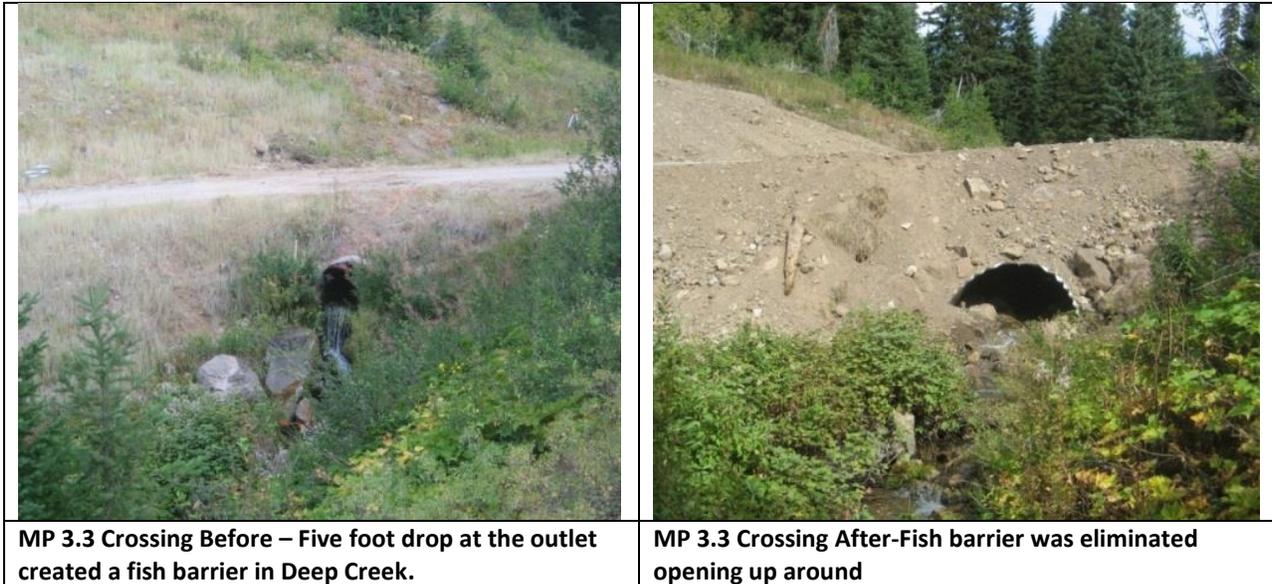
**Deep Creek Road Stream Crossing Upgrade Project Photos**

- MP 3.3- Replaced a 5 foot perched 36" x 54" squashed pipe with an 8 foot open bottom arch. Installed by FS Road Crew.
- Pat Canyon road stream cross ford of Pay Canyon creek was replace with a 4ft squashed pipe to reduce erosion and improve aquatic passage.

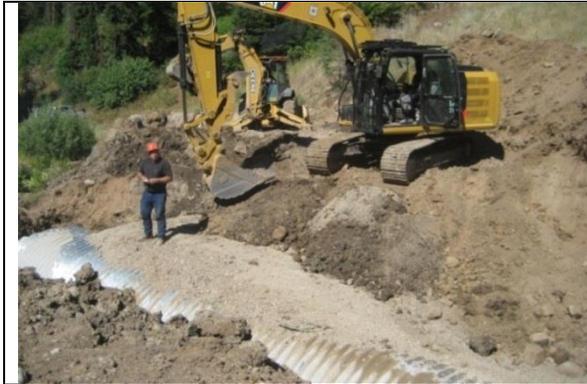
MP 3.3 Crossing During-Force account road crew was used to install the structure saving time and money as compared to running a contract and having contractor costs.
