# Caribou-Targhee National Forest

## Jackknife Watershed Restoration

### Priority Watershed Completion Report - FY2014

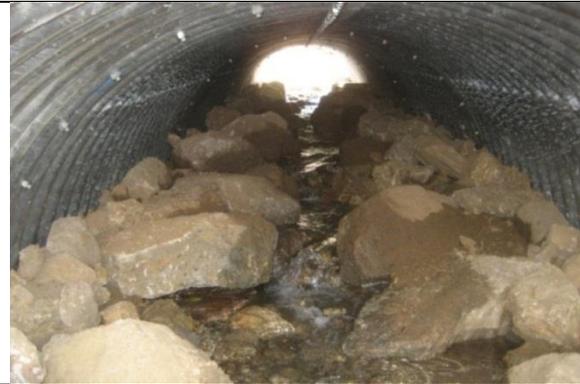
MP 3.3 Crossing- After looking inside bottomless arch pipe showing natural bottom substrate to promote aquatic passage.

- MP 3.3- Replaced a 5 foot perched 36" x 54" squashed pipe with an 8 foot open bottom arch. Installed by FS Road Crew.
- Pat Canyon road stream cross ford of Pay Canyon creek was replace with a 4ft squashed pipe to reduce erosion and improve aquatic passage.

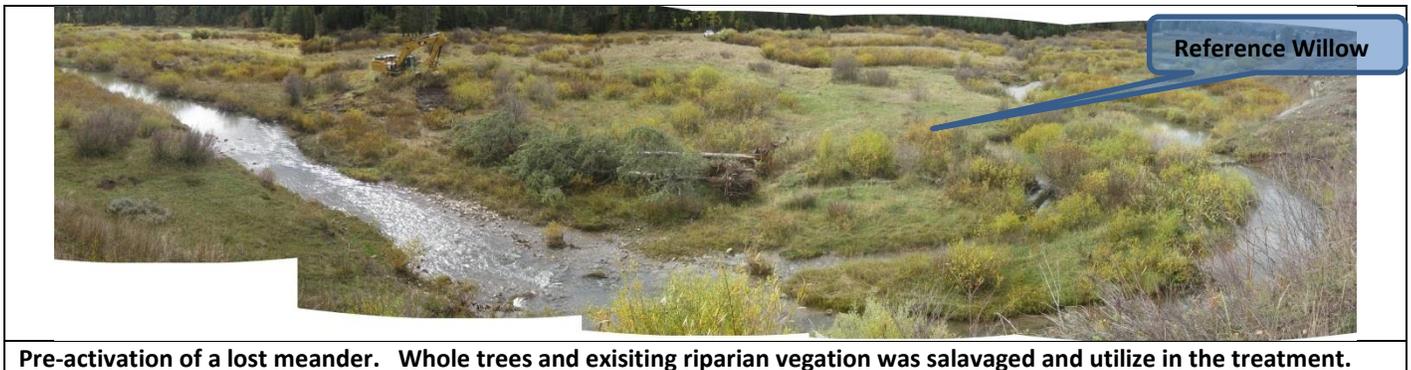
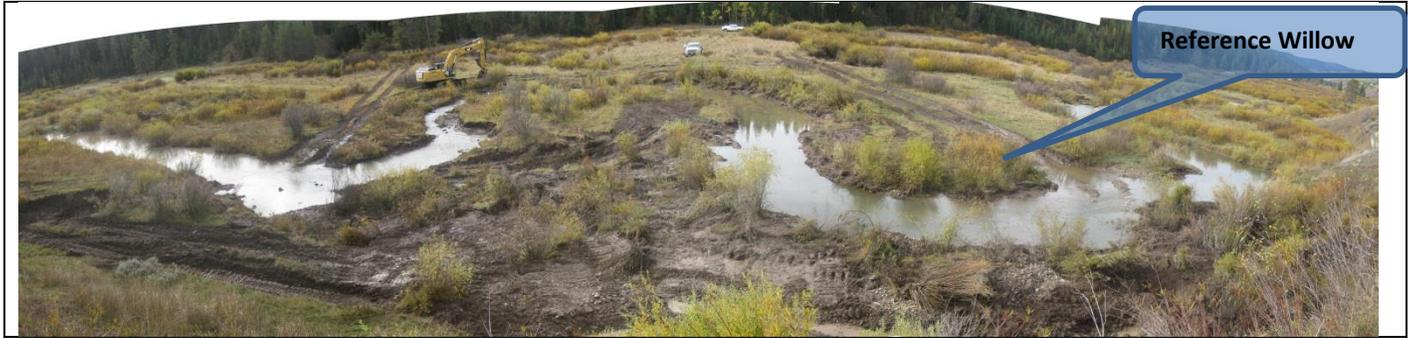
**During construction re-connection and re-activation of a lost meander.**

The following photos are example of the treatments that were performed on the Jackknife Restoration Project. The first treatment example is the re-activation of lost meanders which were typically accompanied by elevating riffle upstream and downstream of the meander.

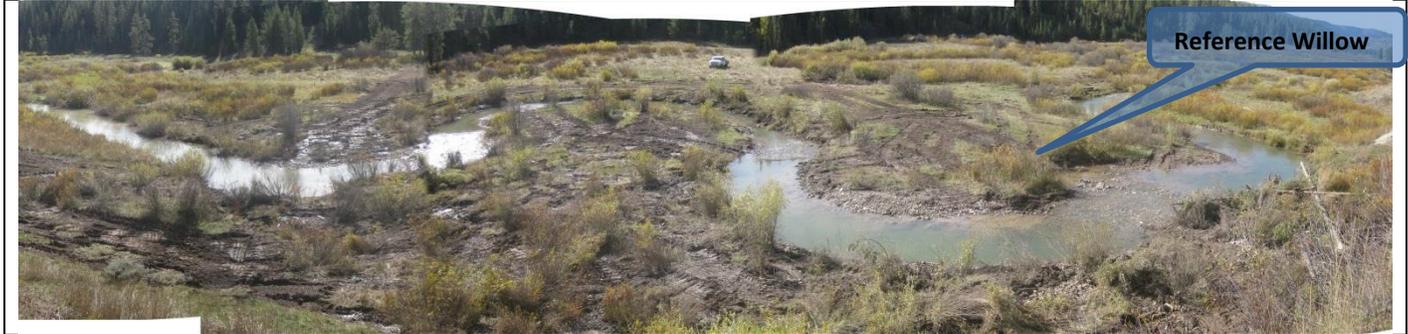
**Post construction of the lost meander re-activation.**

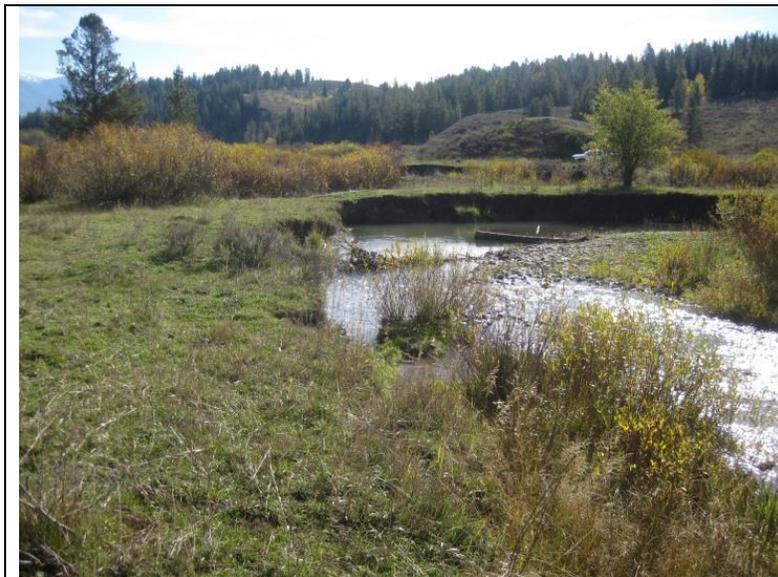
**Before the bank stabilization treatment was implemented. Raw 2-5foot tall eroding stream banks existed that lead to stream instability, reduced water quality and poor fish/aquatic habitat.**

The second series of photos are an example of bank stability treatments that utilized nearby whole willow clumps to re-build lost bank and promote long-term stability. This treatment was usually accompanied by elevating the riffles upstream and downstream to reduce shear stress and let the high flows access the floodplain.

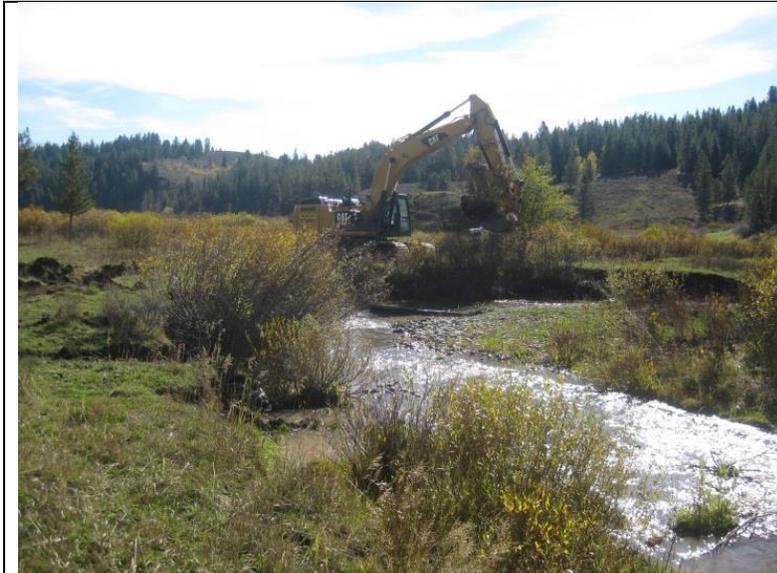
During bank stabilization where nearby whole willow clumps were installed along the outside stream bank to promote stability. This was typically accompanied by elevating the riffles upstream and downstream to reduce shear stress and let the high flows access the floodplain.

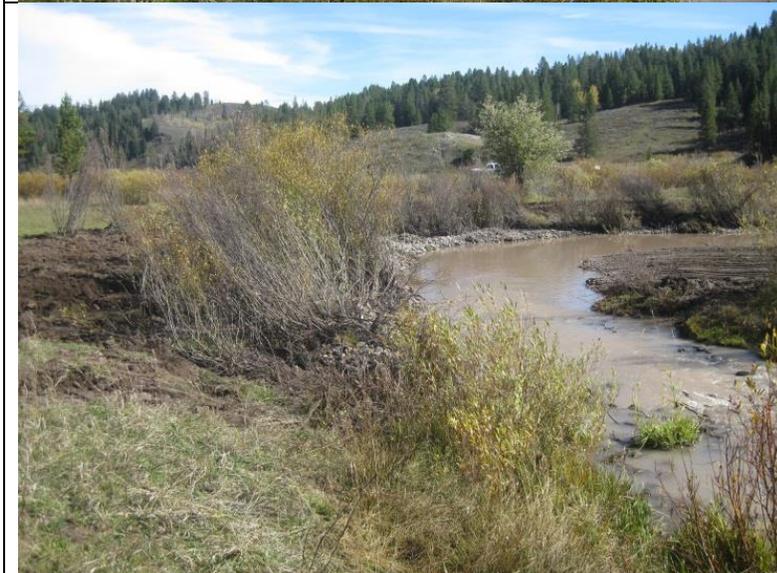
Post construction showing the trenched whole willow clumps and cobble/gravel toe rock protecting the previous eroding bank.

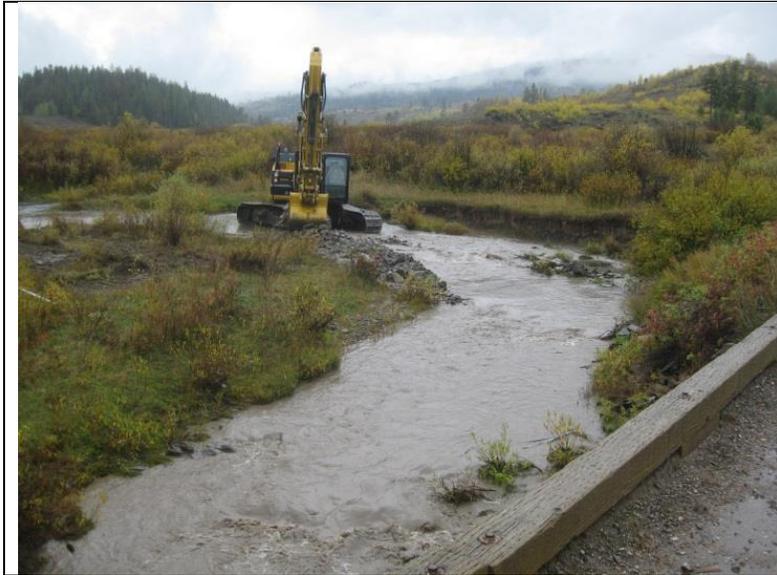
Before construction that shows how the bank had eroded and direct flows against the road and bridge abutment.

The following are another series of photos showing bank stabilization treatment upstream of the Squaw Creek road bridge. 5-15 feet of lost stream bank was re-built to direct flows through the center of the bridge. Whole willow clumps and cobble/gravel toe rock was used to stabilize the bank. A hardened riffle and a boulder cross vane was installed below the bank stabilization and above the bridge to help protect the bridge and elevate the 2-3 foot downcut stream bed.

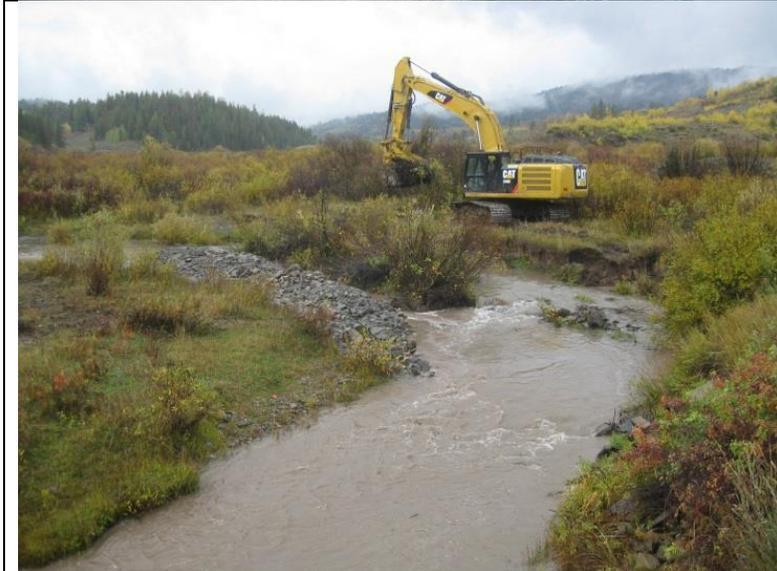
During construction where whole clump willows from nearby were relocated to form the new outside edge of the stream bank. About 5-15 feet of lost bank was re-established.

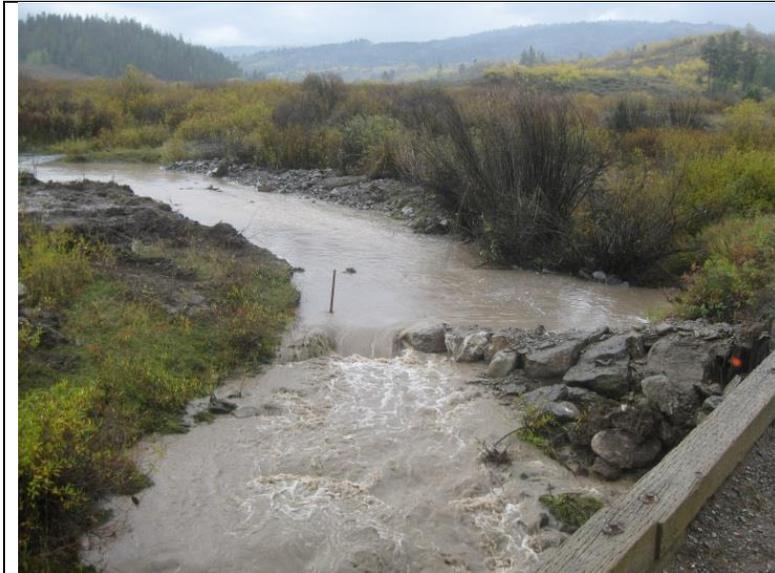
During construction showing the boulder cross vane at the head of the hardened riffle that helps direct flow towards the center of the bridge.

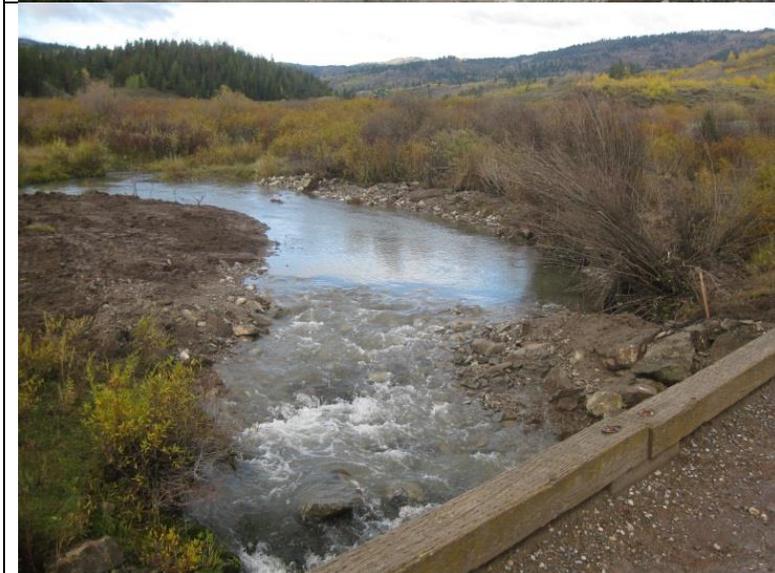
Completed bank stabilization and elevated riffle treatment above the Squaw Creek road bridge.

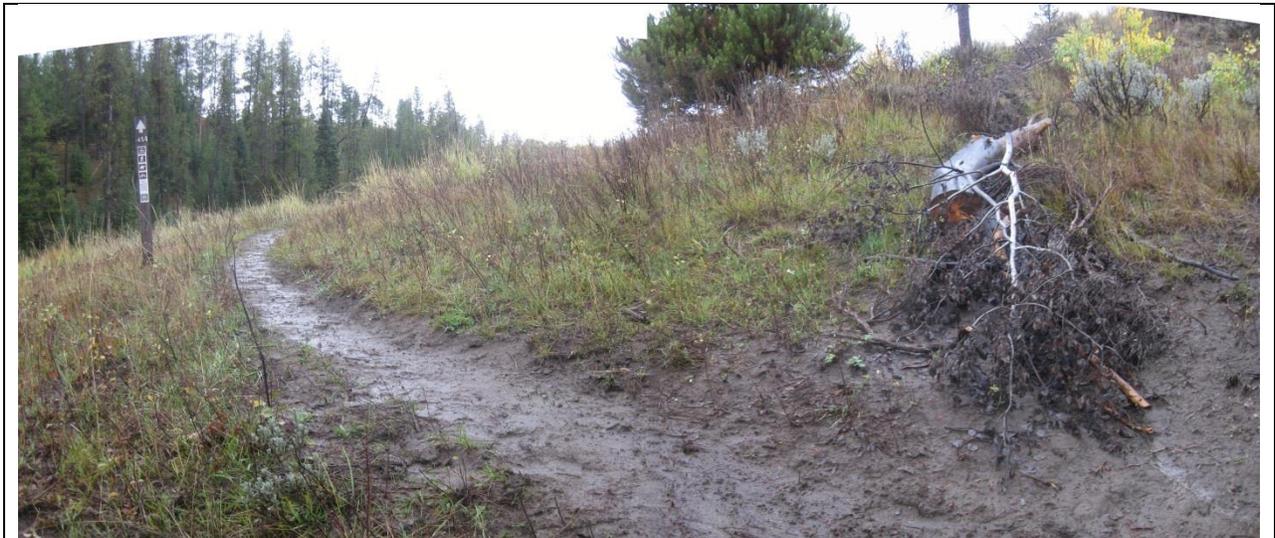
The beginning portion of the Squaw Creek Trail (458) that was re-routed to avoid steep problematic trail sections. The slash on the right hand side is the obliterated over steepened trail that was re-routed.

Trail improvements have occurred on the 43 miles of trail in the Jackknife watershed which made up some of the essential projects that helped to change watershed condition class in the Jackknife Priority Watershed. The 2014 remaining trail project utilized the Northwest Youth Conservation (NYC) crew to relocate and improve conditions on the 458 trail from the Squaw Cr. corrals up to Bald Mtn. The trail originally followed the overly steep and problematic old fire dozer line. The crew with guidance from the district recreation staff completed 3 relocations totaling about 2,500 feet of brand new trail. The crew also reworked last year's relocation of trail 456 up Squaw Creek and improved the West Fork creek crossing and fixed three mud holes on the Squaw Creek ATV system trail. The crew also covered 3.5 miles of the main Jackknife Creek trail #448 to maintain and repair as needed, particularly along the 2 miles of relocations built in the past 2 years.

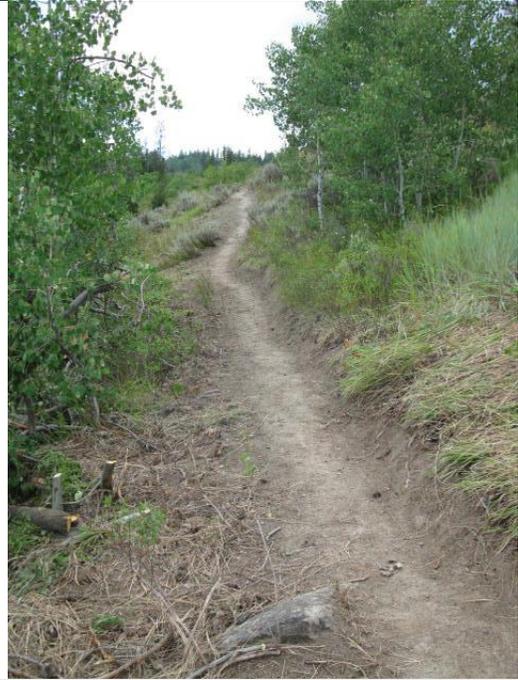
**A completed portion of the Squaw Creek Trail 458 by the NYC Crew.**
