Kruzof North Beach ATV Area, Sitka Ranger District, Tongass National Forest

September 9, 2014

Background

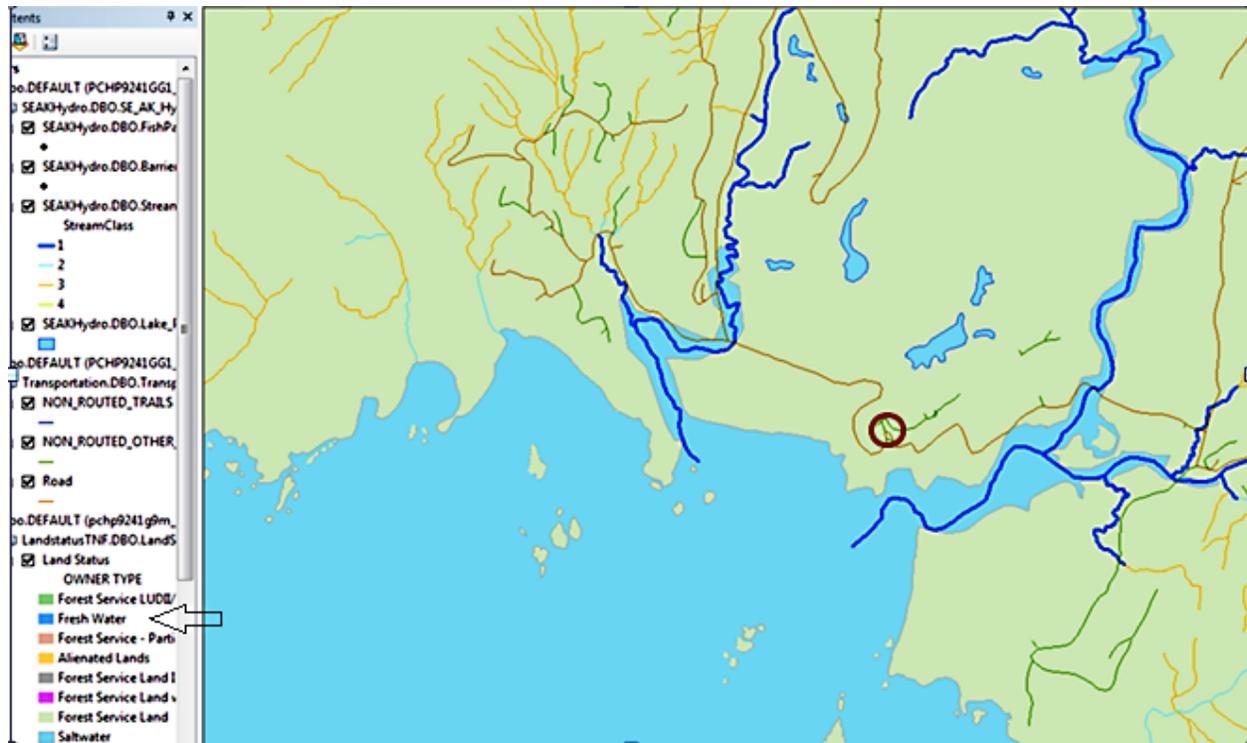
The OHV use area was established in 1993 as a way to separate OHV users from non-motorized users. The North Beach cabin is near the use area and users have access to the beach. A small Class II stream runs along the southern end of the use area that changes outlets annually due to shifting sands and wave action. This stream is not mapped in GIS SEAKHydro geodatabase or surveyed elsewhere that anybody on the IDT could find (Figure 1).

Kruzof North Beach Figure 1. Use area with circle over the cabin. Note lack of stream mapping near the cabin.

Map and survey the Class II stream near the North Beach Cabin. Knowing more about this stream will drive any future management of the use area.

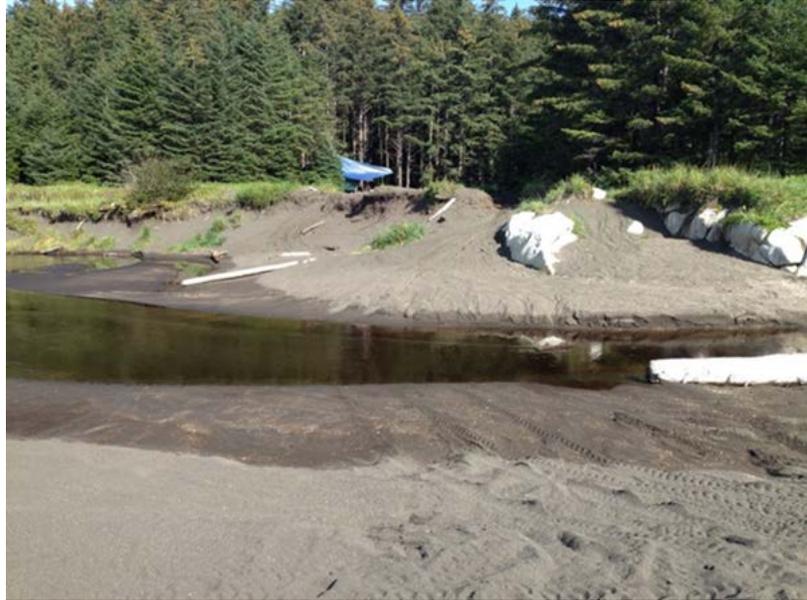
A few years ago (it is not well-documented how many) this stream turned northwest and began running between the un-vegetated sands of the beach area and a sandy bluff. This stream is eroding the bluff at a rapid rate (Photo 1). The bluff is the habitat of the rare dune tansy. Users are not supposed to ride on any vegetated areas, but since the beach started eroding, they were using the bluff for access. Some fencing and signs were placed to protect the rare plant.

North Kruzof Beach Photo 1. Stream running between beach (foreground) and the bluff with the cabin (blue trap, background)

Currently there are five trails between the North Beach cabin and the use area, all of which cross an unmapped, un-surveyed stream (Photo 1). This stream is at least Class II and possibly Class I. There are several user created trails in the vegetated areas adjacent to the OHV use area. The IDT did not measure or investigate these trails. Some of the trails between the cabin and the use area are very steep and actively eroding.

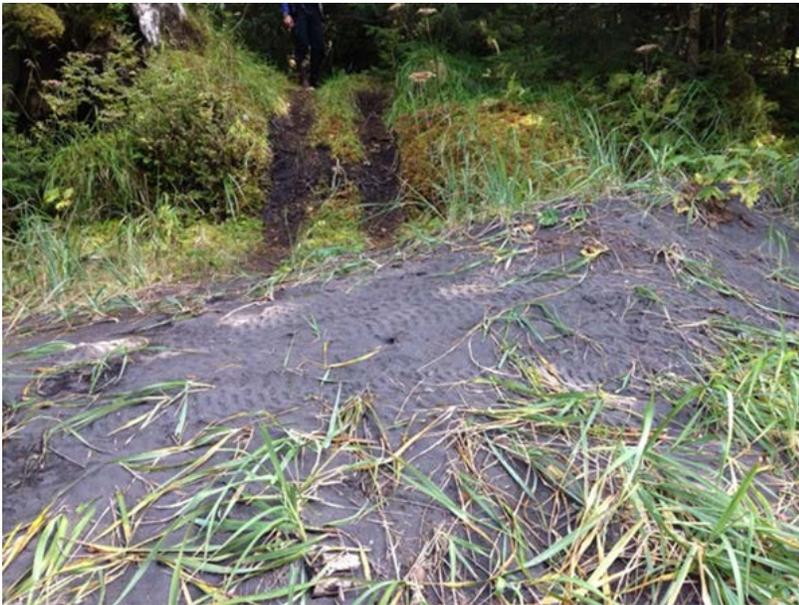
North Kruzof Beach Photo 2. OHV trail in a vegetated area. The foreground is along the un-vegetated sandy area. The grasses are colonizing the sands and are found in the transition areas between the un-vegetated sands and forest.

Several trails initiate in the legal portion (the un-vegetated sands) of the OHV use area and go into the woods (unauthorized/illegal portion). Three of these are legal trails to access the three dispersed campsites cited on the MVUM but since they are unmarked the IDT could not determine which

the legal trails were and which were not legal (Photo 2). Many of these trails terminate in openings that could be used as campsites. Since the IDT was confused, the user may be confused as well.

There was evidence of minimal to considerable OHV use in some vegetated areas adjacent to the use area. Some of the vegetated areas have very sparse plant growth and some OHV users may confuse these travel restricted areas with the unvegetated open areas (Photo 2).

Create a management plan that clears up some of the vague language in the ATM and MVUM. Also, this document should describe why and how the district will allow OHV crossings of the currently unmapped stream. It is important to clarify what is/is not considered “vegetated.” Some of the places with OHV use were mostly sands with a few plants colonizing the area. The USFS should decide which percent cover constitutes vegetated.

Place signs, blazes, or other features to delineate the high tide line and designate the legal trails and dispersed campsites. This could be outlined in the management plan. The use area has seemingly expanded from the unvegetated beach sands and designated campsites located in the adjacent forest fringe into travel restricted areas. If something looks like a trail, it will likely continue to be used as a trail unless measures are taken to control access. These areas should be designated as trails or blocked.

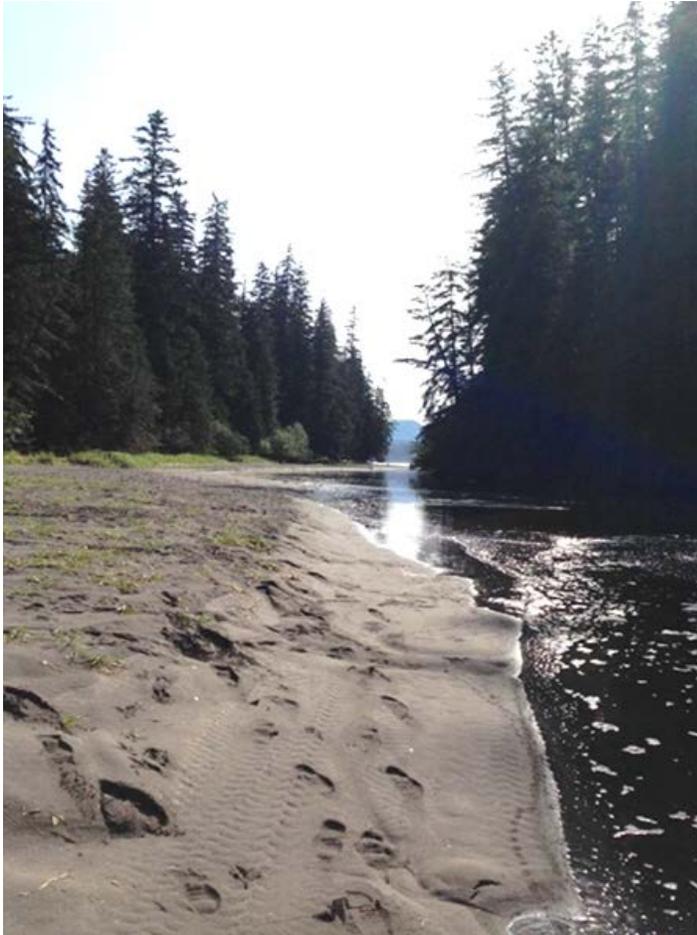
The OHV use area on the MVUM allows some use in the tidal portion of the stream at the northern end. It is unclear from the MVUM where users are actually allowed to ride adjacent to this anadromous stream, but it is clear they are riding on the banks of the stream (Photo 3). The OHV area is inaccessible at high tides so users resort to traversing a short section of vegetated beach area to round the corner from North Beach proper to the open finger along the anadromous stream.

North Kruzof Beach Photo 3. OHV use on the banks of an anadromous stream

Add language to the MVUM that clarifies what exactly is open along the anadromous stream at the northern portion of the use area. The stream itself through the open area is tidal and so could be construed as open.

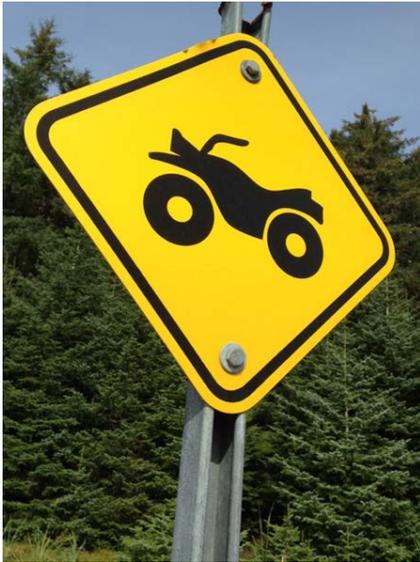
North Kruzof Beach Photo 4. OHV use area sign

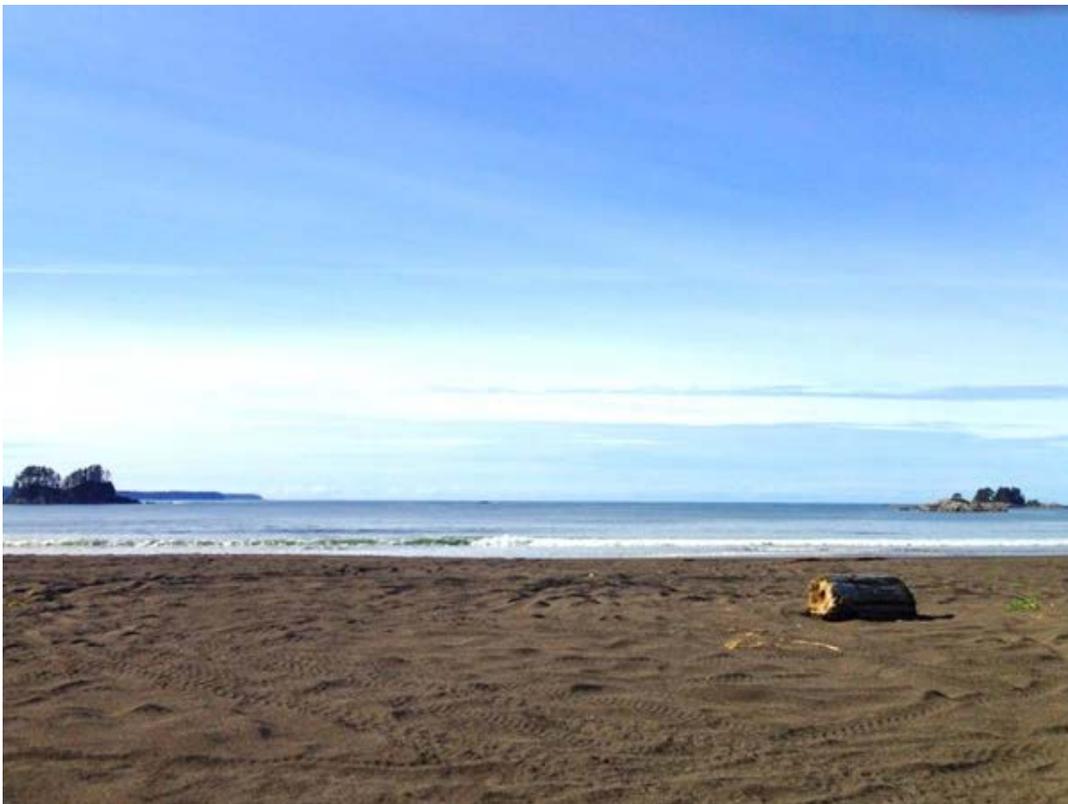
North Kruzof Beach Photo 5. OHV use area

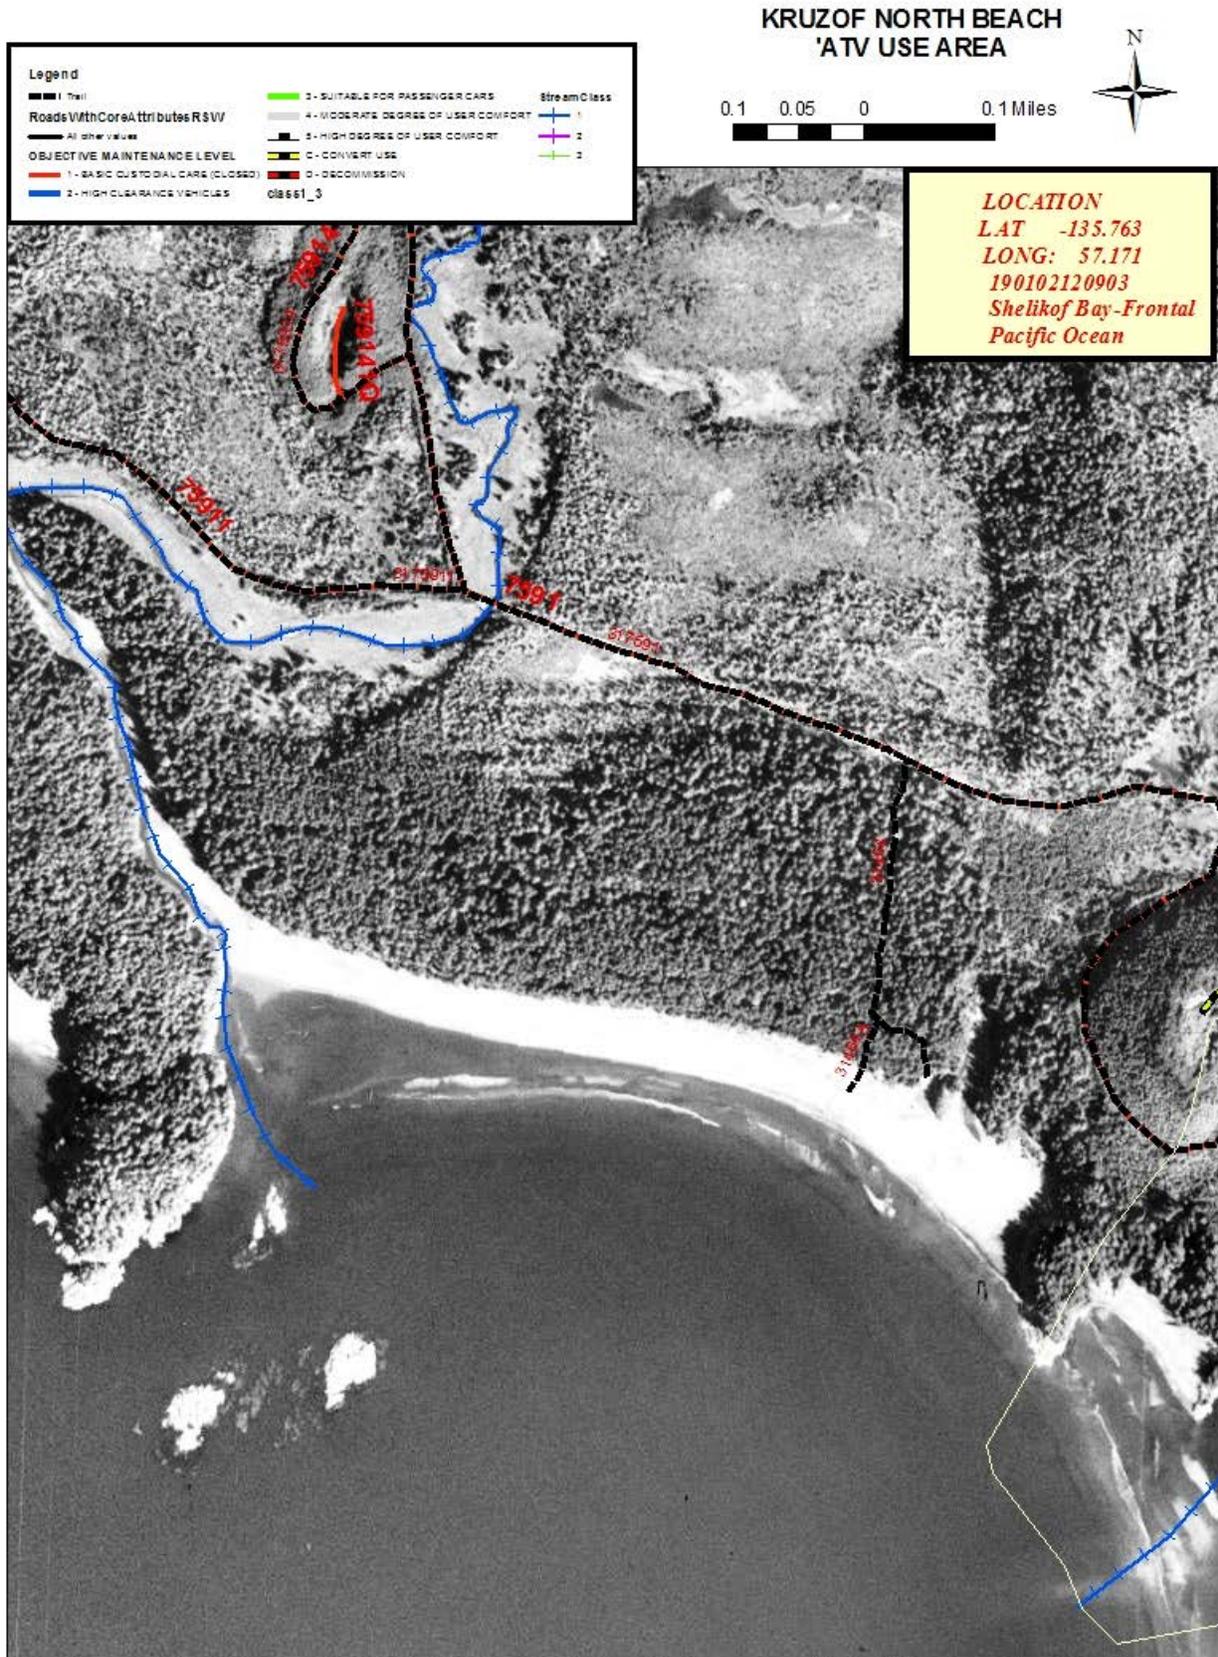
Kruzof North Beach Figure 2. Orthophoto of Kruzof North Beach ATV use area

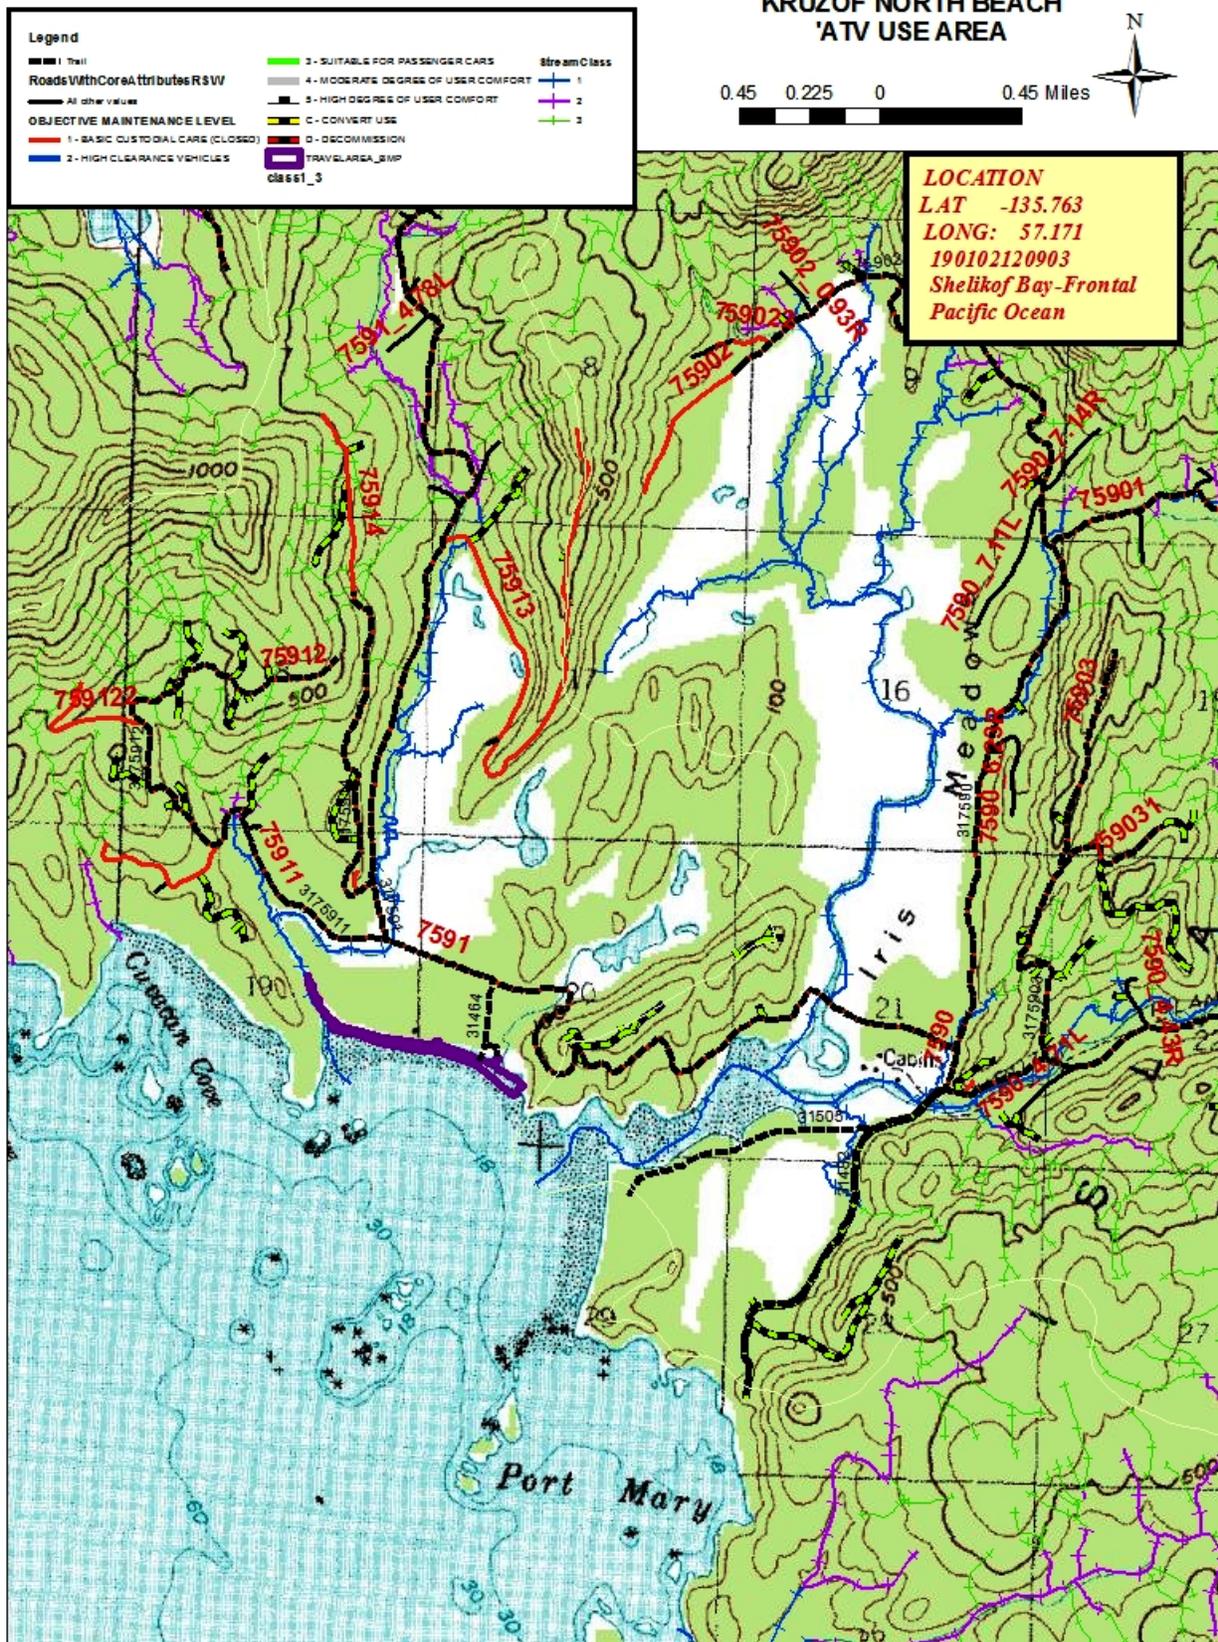
Kruzof North Beach Figure 3. Map of Kruzof North Beach ATV use area
