# Aquatic Habitat Improvement, Mainstem of Saginaw Creek, Petersburg Ranger District, Tongass National Forest

July 17, 2014

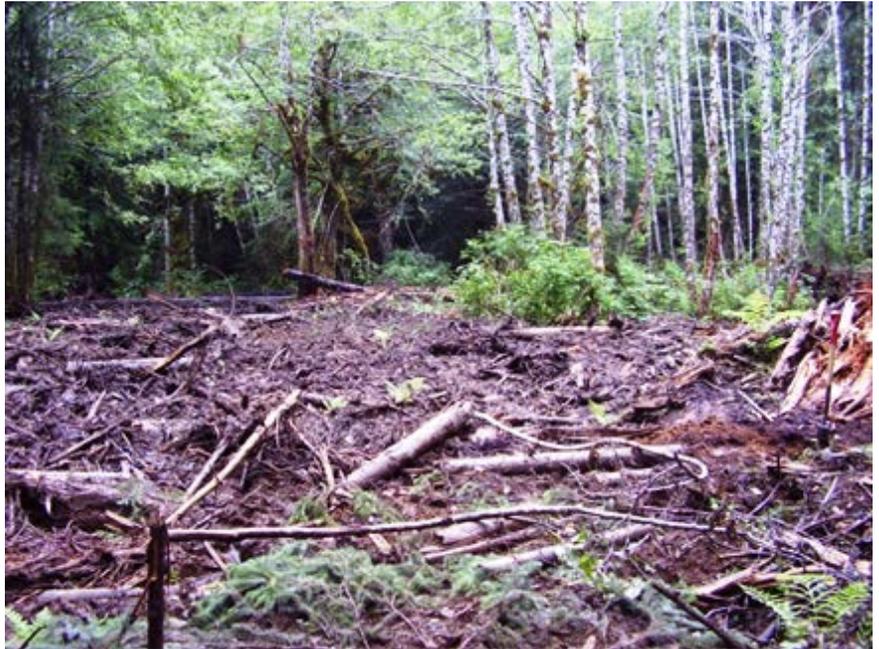
Puncheon trails were used for the heavy equipment to operate on to prevent soil disturbance. Project maps for the puncheon trails were very helpful. The trails average about 10 meters in width and were created by felling 46-year-old young-growth trees and laying down a nearly continuous mat of cull logs and slash. Under repeated passes with equipment, the cull logs and slash were forced into the soil to a depth of 20 to 30 centimeters, altering the structure of the O, E, and upper B soil horizons. The puncheon trail was fluffed after stream restoration was complete. Fluffing broke up the dense slash mat and likely loosened the upper layers of soil that the slash had penetrated. Fluffing did not move all of the slash and some slash is still evident in the upper mineral soil horizons.

Puncheon trail rehabilitation is needed. Hand-slash and seed for bare areas were recommended by soil scientist. Seeding was not mentioned in the NEPA but is going to occur with force account funds.

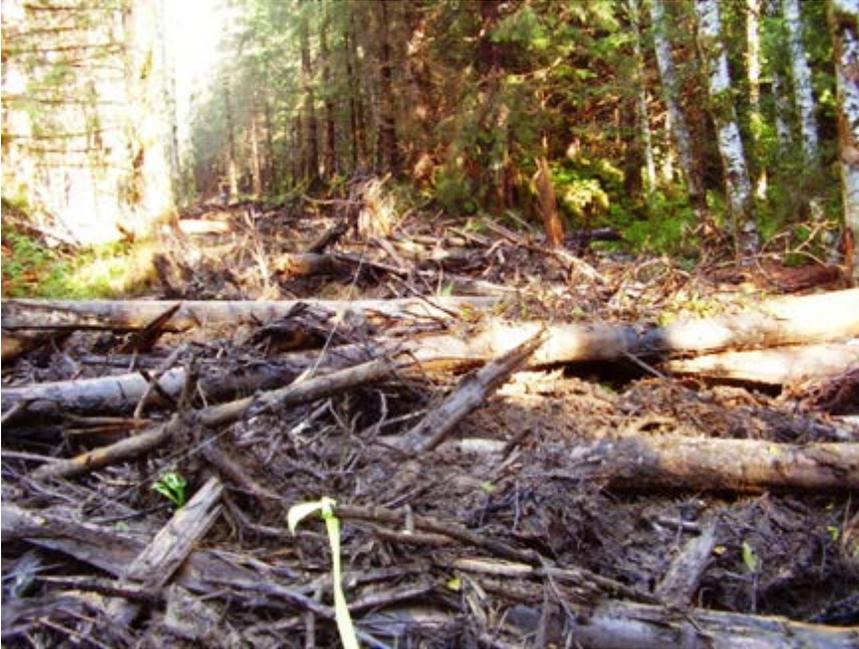
Saginaw Creek Photo 2. Another puncheon access trail with a felled young-growth mat.

Clearing limit widths should be defined for puncheon trails in the contract, so they are not larger than needed.
