# Completed Construction of Transmission Lines, Facilities C Form, Swan-Tyee Intertie, Shrimp Road System Crossing, Ketchikan-Misty Fiords Ranger District, Tongass National Forest

August 21, 2014

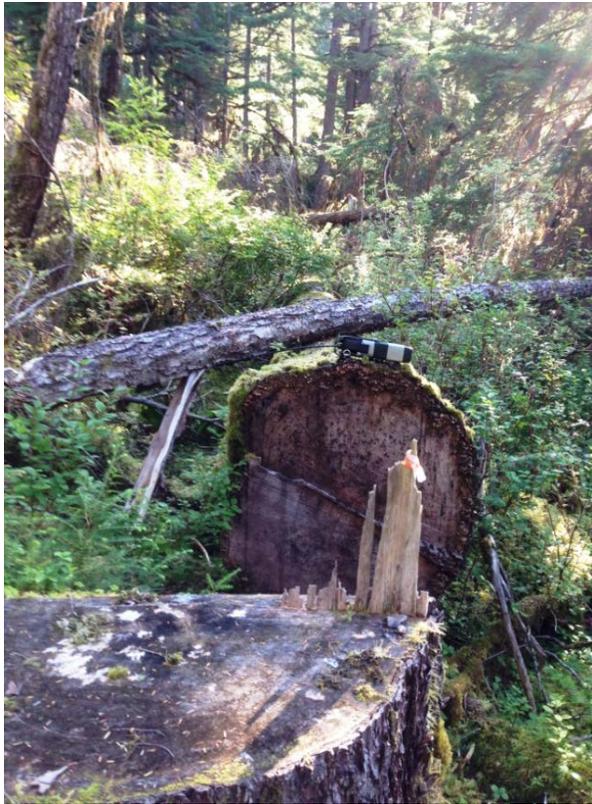
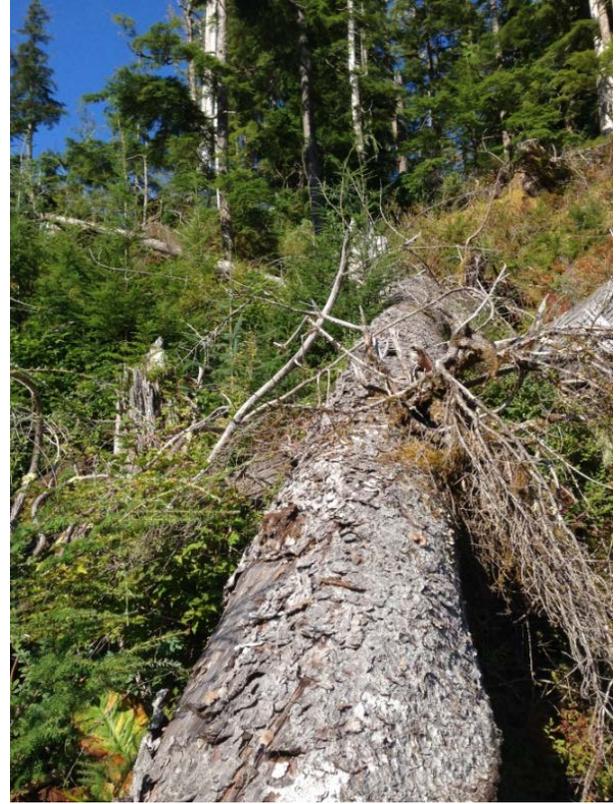
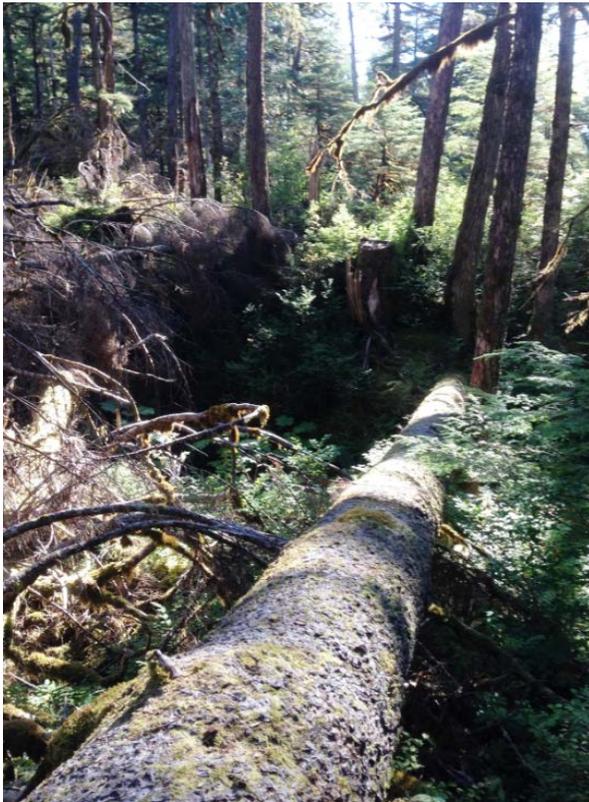
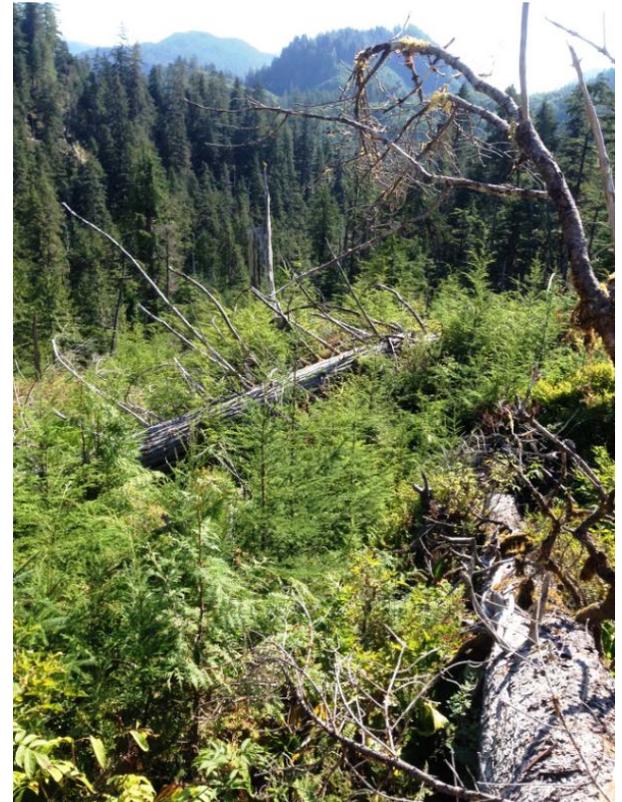
Although unrelated to BMPs, contract specifications required utilization of merchantable timber within 2 miles of an LTF. This segment was within the 2-mile limit, but it appears no merchantable timber was salvaged. See the photos below of merchantable timber that was not used.

*Shrimp Rd Swan-Tyee Photos 1-4. Merchantable timber not used*
