## Angora Creek Stream and Floodplain Restoration

In 2014 and 2015, the USFS implemented a stream channel/floodplain restoration project on Angora Creek and its tributaries, located upstream of the Lake Tahoe Boulevard stream crossing. The Angora Fire of 2007 had stripped large wood from the channel and adjacent riparian zone. In addition, a legacy man-made pond disrupted historic flow paths from one of the tributaries, and had become a breeding ground for invasive bullfrogs. And finally a section of channel was incised due to past urban development.

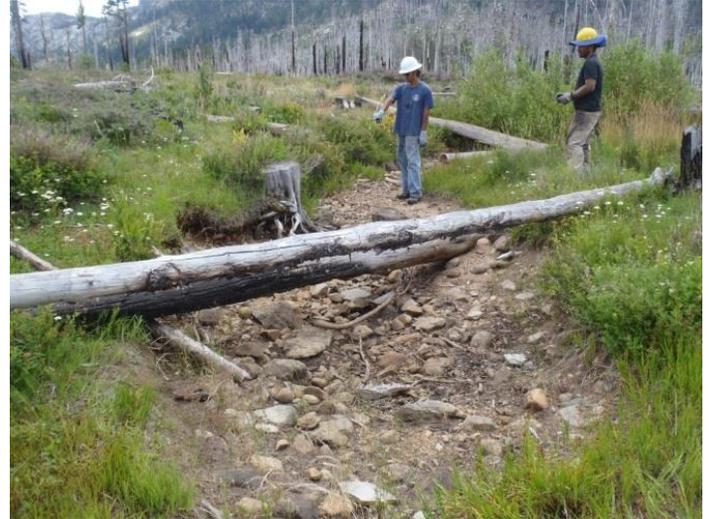
**South Fork of Angora Creek, prior to installation of large wood**

In 2014, restoration actions included the strategic placement of large wood along 2 miles of head water tributary channels. Large wood was placed to restore fish habitat and encourage sediment storage and sorting. In 2015, 750 feet of new channel was constructed to replace a section of incised channel in the main stem of Angora Creek, and additional strategic placement of large wood was installed for 1000 feet above the newly constructed channel. A total of 208 individual multi-log structures were installed, over the two years. Also in 2015, the legacy Seneca Pond was decommissioned through regrading to restore historic flow paths and topography, converting this 5 acre site to wet meadow habitat.

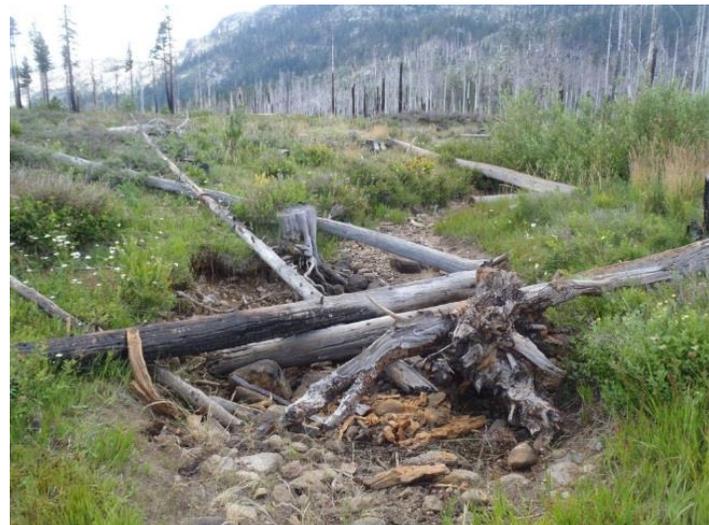
**Same location on South Fork of Angora Creek, after placement of large wood**

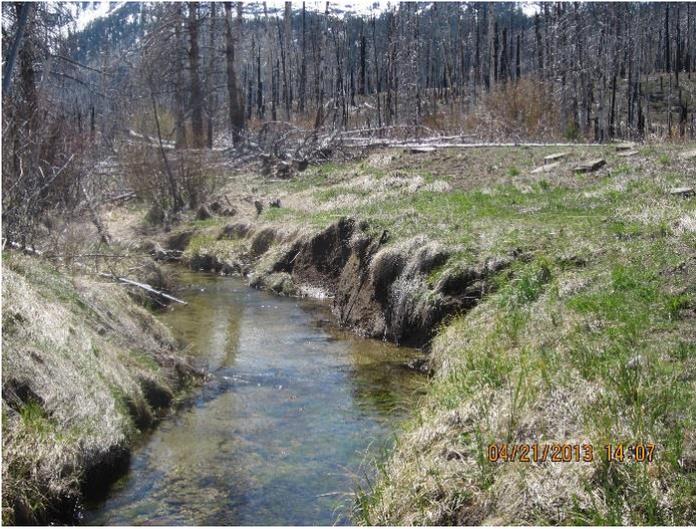
**Incised Angora Creek channel above Lake Tahoe Boulevard, prior to restoration, 2013**

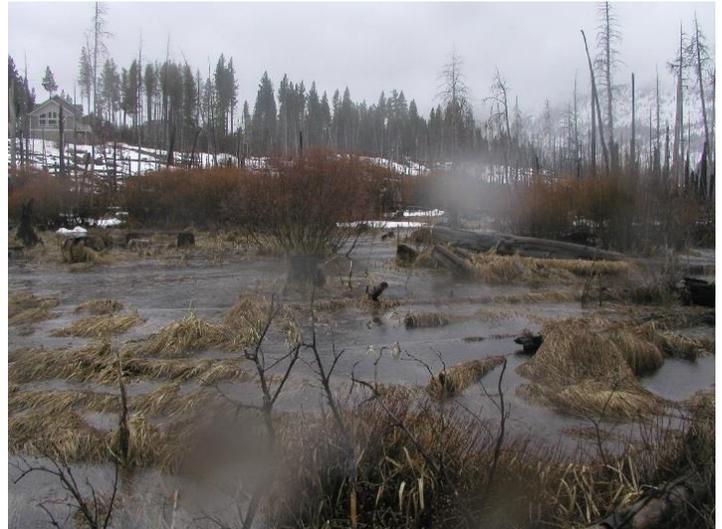
**Flooding of meadow adjacent to Angora Creek February, 2016**

Several moderate floods occurred during the winter of 2015-16. A storm in February resulted in flows spreading over the entire meadow near Lake Tahoe Boulevard, resulting in some flooding of the roadway. However beaver dams just upstream of the restored reach are thought to be the main cause of enhanced lateral spread of flood flows. The Forest Service will continue to monitor this situation, and work with El Dorado County to determine if any modification of the placed wood structures is needed to reduce future potential for roadway flooding. As of May 2016, all restored sites are stable and functioning as expected. Revegetation through sod plugs and willow planting at the Seneca Pond site will be completed in June of 2016, which will complete planned restoration actions for this project.

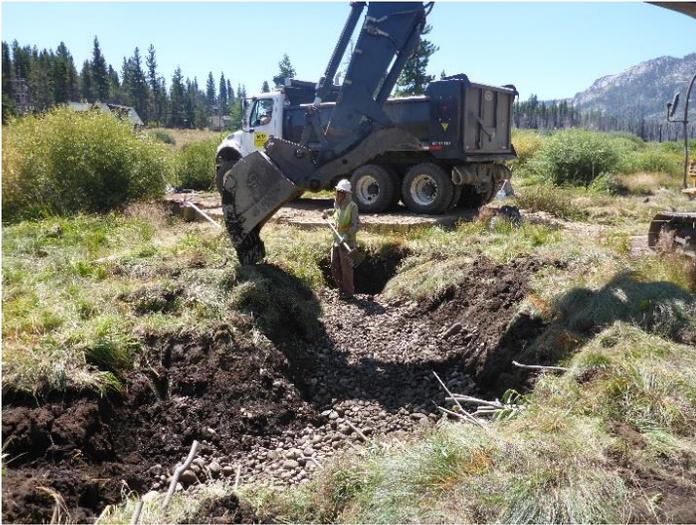
**New channel construction, 2015**

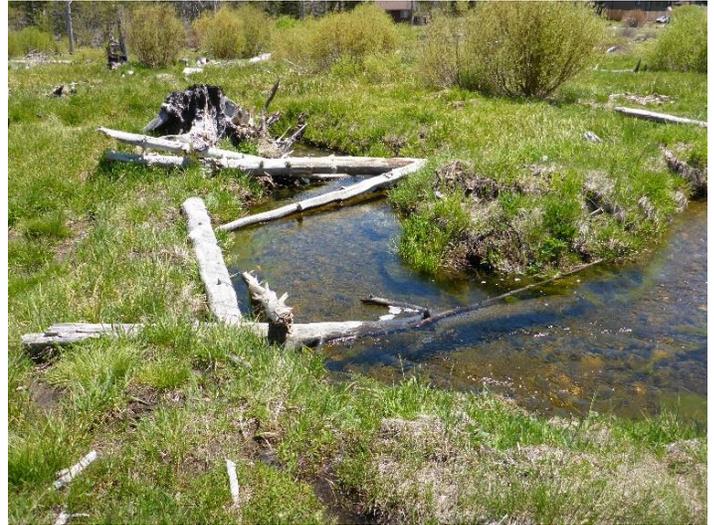
**Reconstructed Angora Creek Channel, May 2016**
