**Kaibab National Forest**

**Forest Plan Monitoring Report**

**Fiscal Year 2015**

# APPENDIX A. Kaibab National Forest Wetland Inventories for Proper Functioning Condition

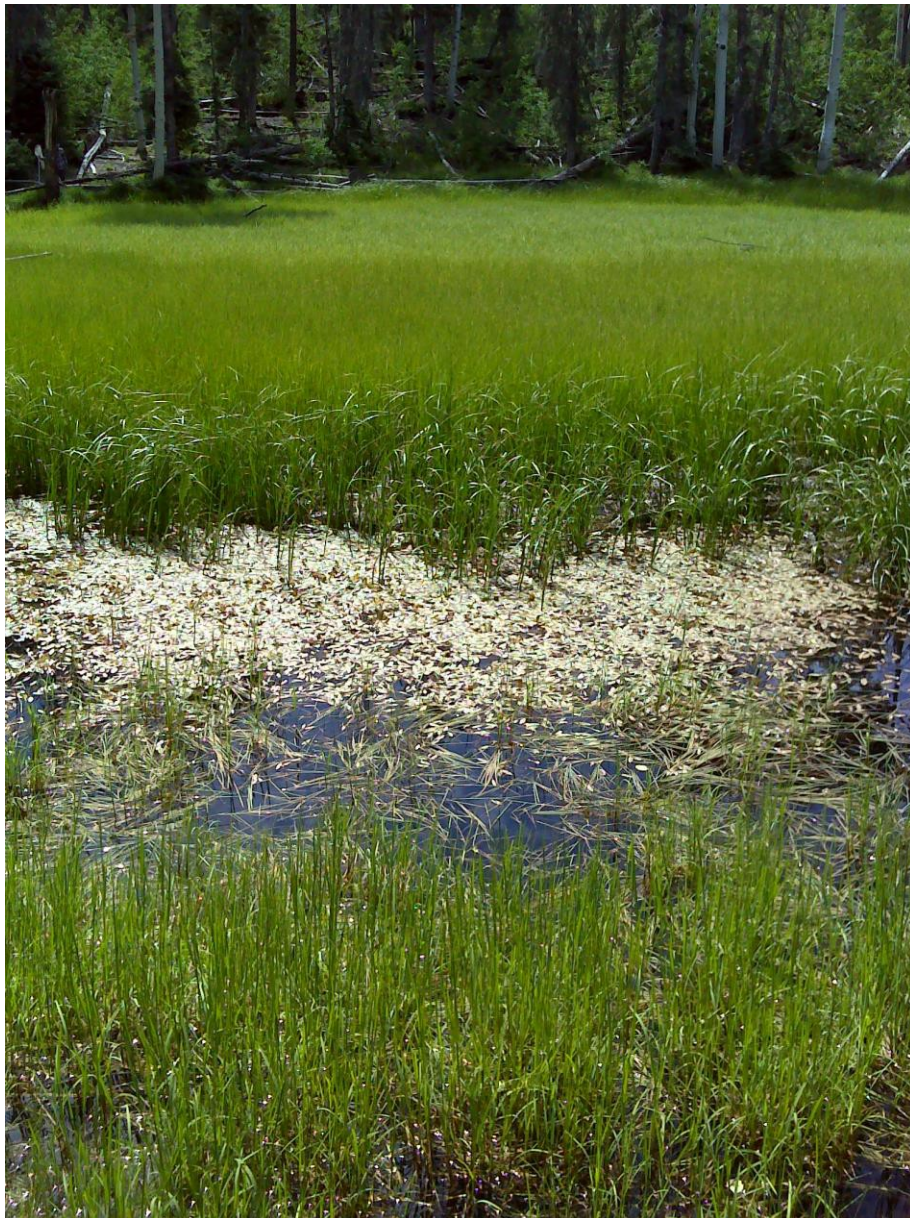
**Fig 1.1 Bear Lake.**

**Physical Description:** Bear Lake is a limnocrone feature that, according to Larry Stevens, this lake may be an ephemeral groundwater-dependent system. Bear Lake emerges as a seepage or filtration spring from the Kaibab Limestone, a sedimentary, limestone rock layer. The emergence environment is subaqueous-lentic freshwater, with a gravity flow force mechanism. The distance to the nearest spring is 806 meters. The site receives approximately 92% of available solar radiation, with 6902 MJ annually.

**Survey Notes:** Hydrarch succession has occurred over the past 15 years, with loss of open water. Adjacent Populus and Picea have suffered.

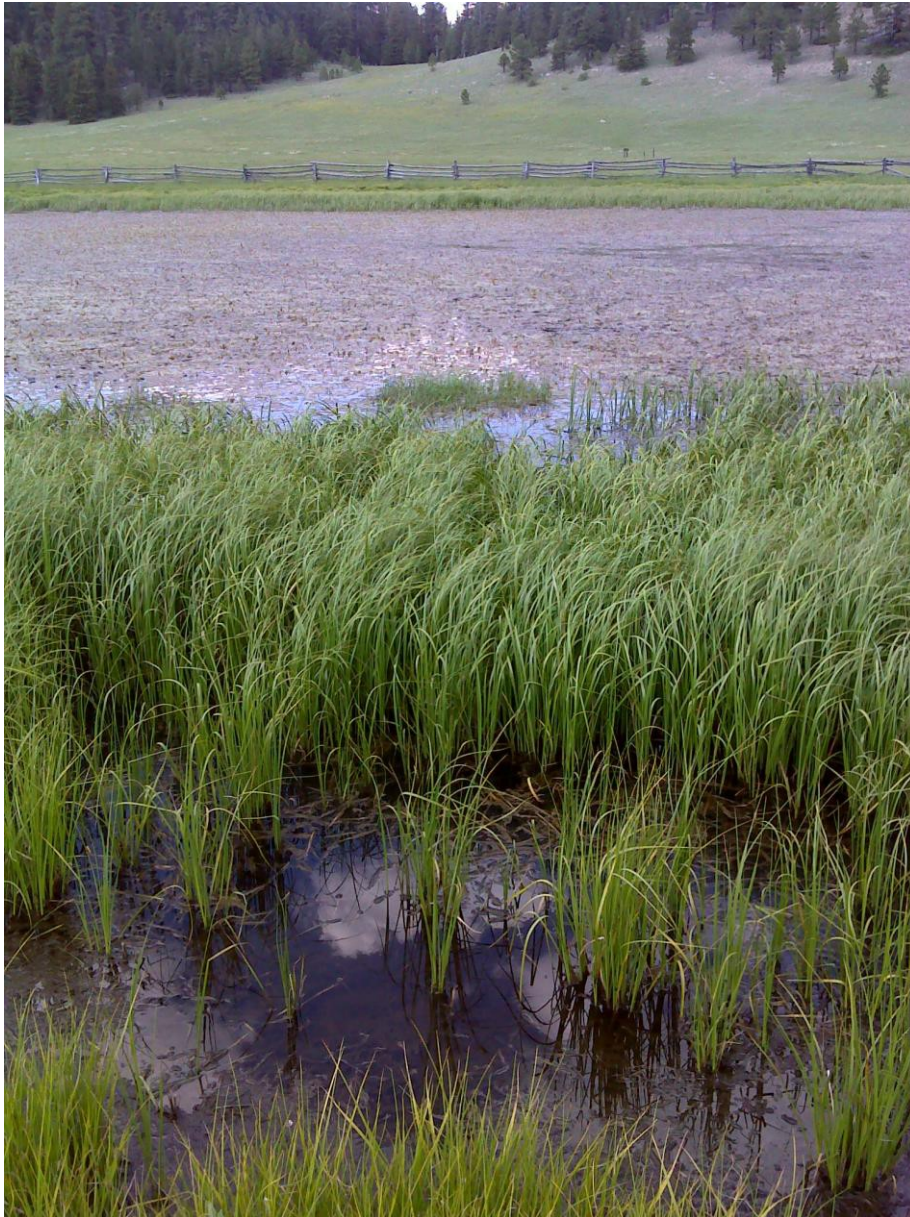
**Fig 2.1 Crane Lake.**

**Physical Description:** Crane Lake is a limnocrone feature that, according to Larry Stevens, may not be groundwater-dependent. It is ephemeral, as it dried up in 2000 and 2002. If it is a spring, it appears to discharge directly into the lake. There is evidence of overflow into the depression next to the lake, but no outflow channel.

Crane Lake emerges as a seepage or filtration spring from the Kaibab Limestone, a sedimentary, limestone rock layer. The emergence environment is subaqueous-lentic freshwater, with a gravity flow force mechanism. The distance to the nearest spring is 4373 meters. The site receives approximately 97% of available solar radiation, with 7234 Mj annually.

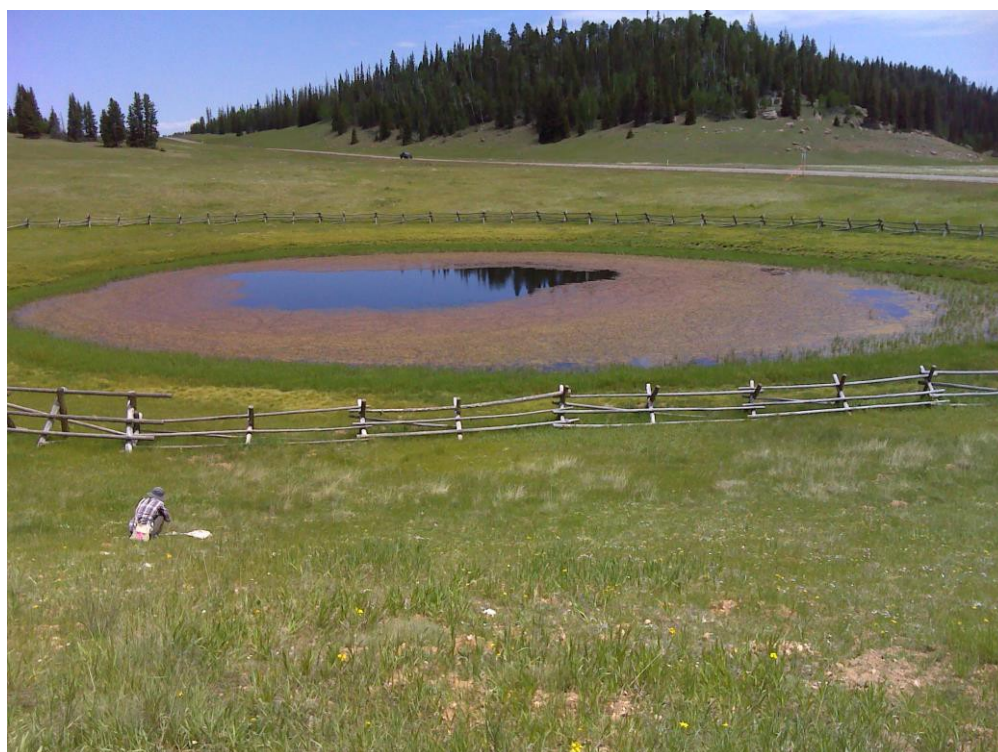
**Fig 3.1 Deer Lake.**

**Physical Description:** Deer Lake is a limnocene feature that, according to Larry Stevens, may not be groundwater-dependent. Deer Lake is located in the Toroweap, a sedimentary, limestone rock layer. The emergence environment is subaerial. The distance to the nearest spring is 4099 meters. The site receives approximately 98% of available solar radiation, with 7309 Mj annually.

**Survey Notes:** This site, aside from road effects, appears to be in good condition with little evidence of impairment.

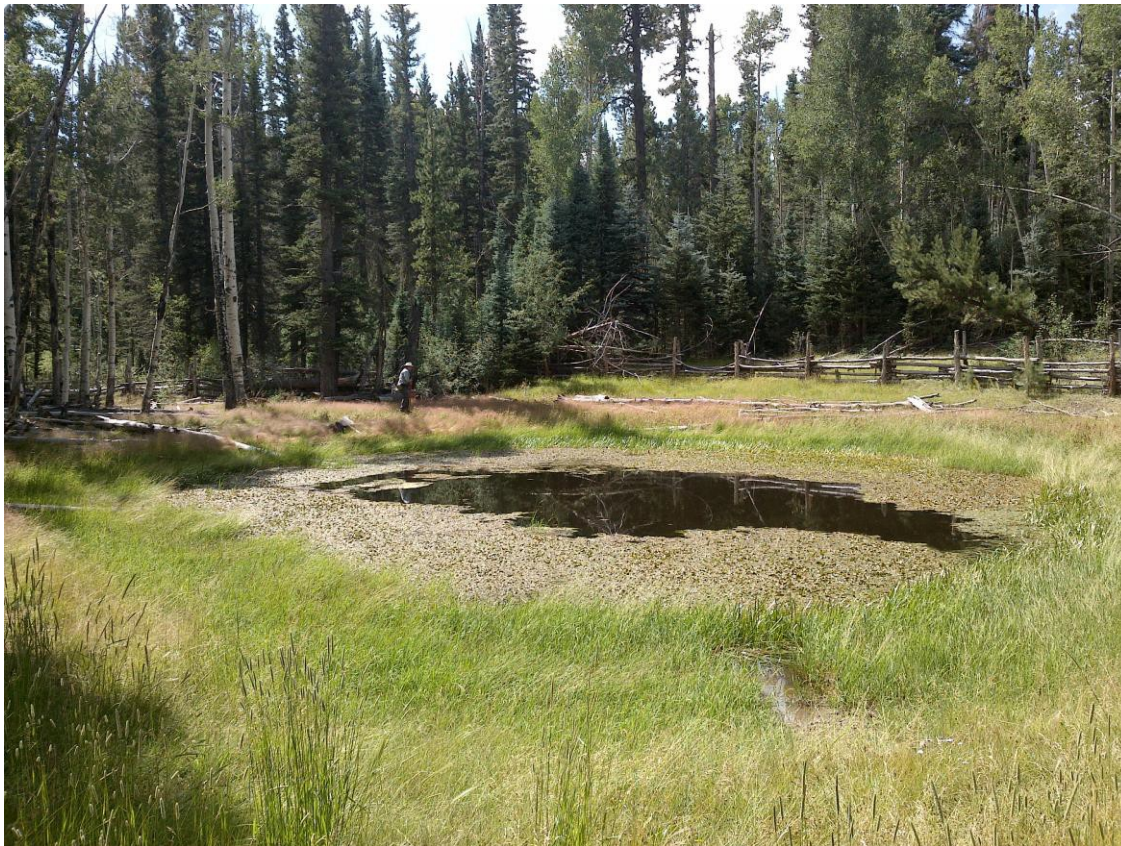
**Fig 4.1 Dog Lake.**

**Physical Description:** Dog Lake is a limnocrone feature that, according to Larry Stevens, may not be groundwater-dependent. Dog Lake is located in the Kaibab Limestone, a sedimentary, limestone rock layer. The emergence environment is subaerial. The distance to the nearest spring is 83 meters. The site receives approximately 85% of available solar radiation, with 6170 Mj annually.

of repair. An excavated area, possibly dug by deer (another salt lick?) should be backfilled, and salt lick used to bait deer should be removed.

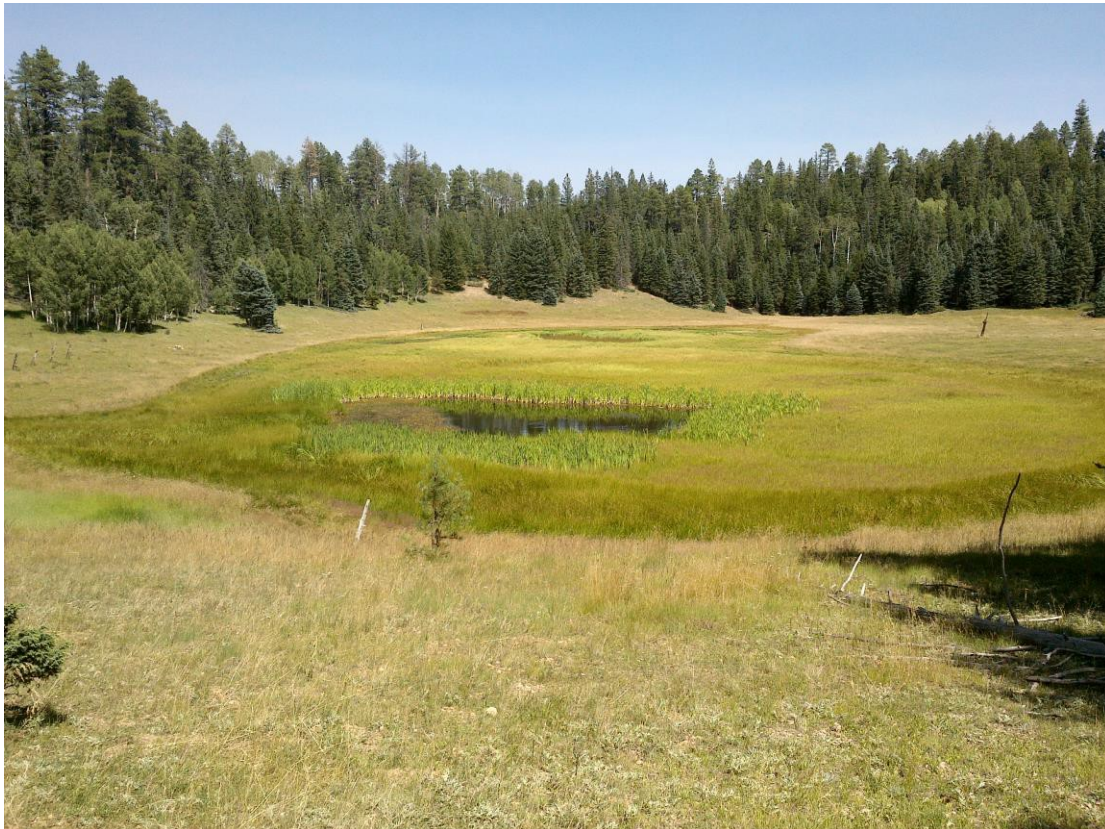
**Fig 5.1 Franks Lake**

**Physical Description:** Franks Lake is a limnocrone spring that emerges in a lake and a surrounding meadow. Franks Lake emerges from the Kaibab Limestone, a sedimentary, limestone rock layer. The emergence environment is subaqueous-lentic freshwater, with a gravity flow force mechanism. The distance to the nearest spring is 4373 meters.

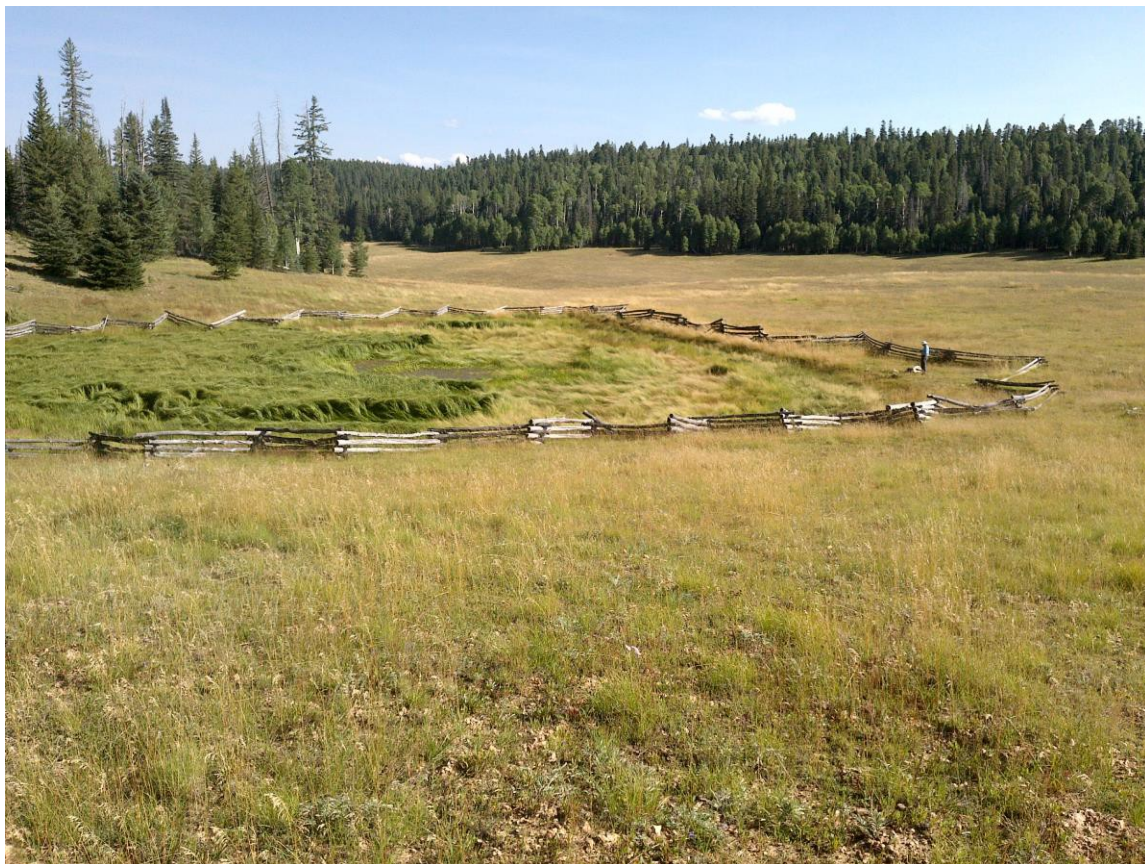
**Fig 6.1 Lookout Lakes:** Lookout Lakes 1

**Physical Description:** Lookout Lakes is a limnocrone spring. This site is not referred to as a spring on any other layer, but was included in the Brown and Moran study as a spring. It is a perennial pond that may be spring supported and is located in a natural depression on the surface of the Kaibab limestone.

**Survey Notes:** Ungulate beds were found at the site. The fence was down in several places. There was little evidence of recent grazing or trampling. Less water is found than in previous surveys, and vegetation is overgrown.

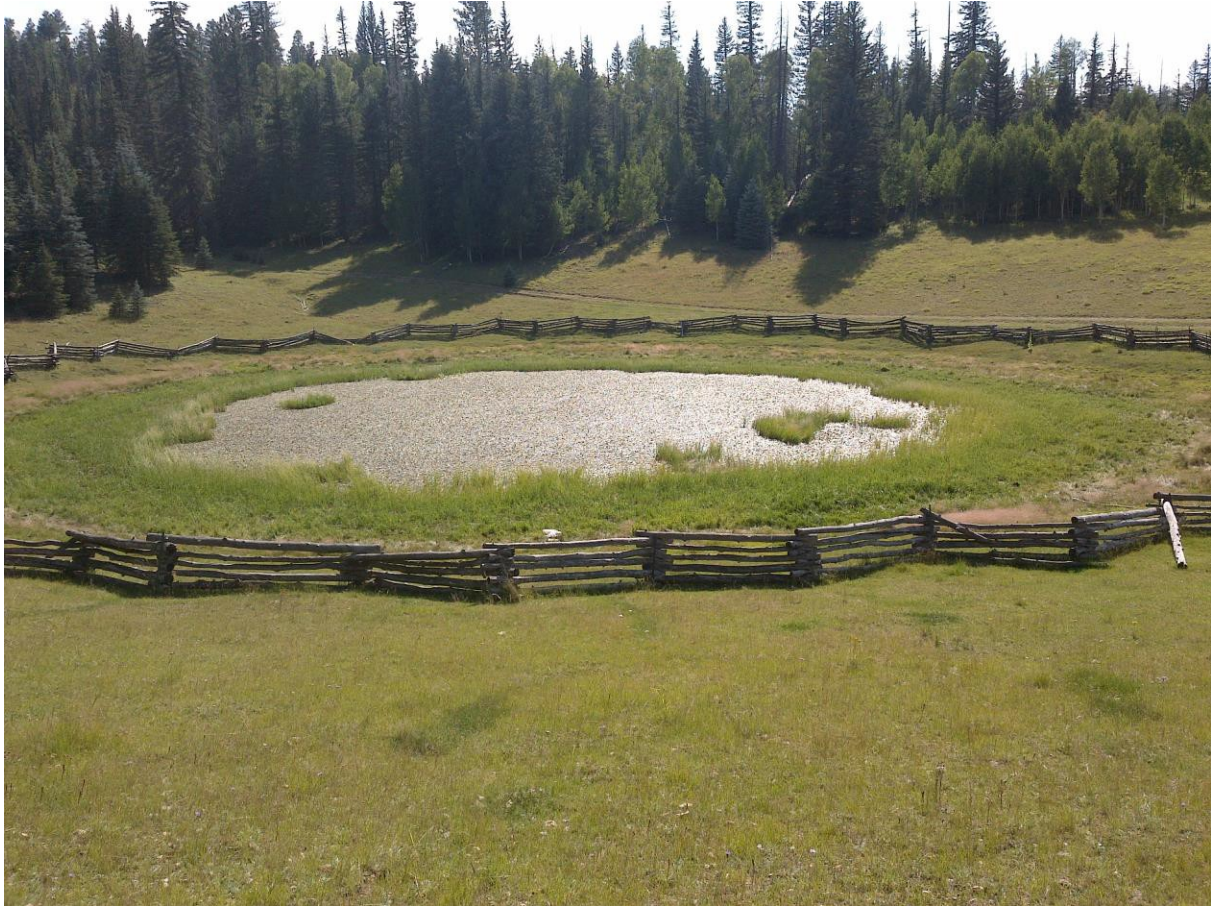
**Fig 7.1 Oquer Lake**

**Physical Description:** Oquer Lake is a natural wetland.

**Survey Notes:** Seventeen domestic cattle were inside the fence when surveyors arrived, but soon left. Townsend solitaire and house wren were also observed. The site is heavily trampled with old and fresh cow feces.

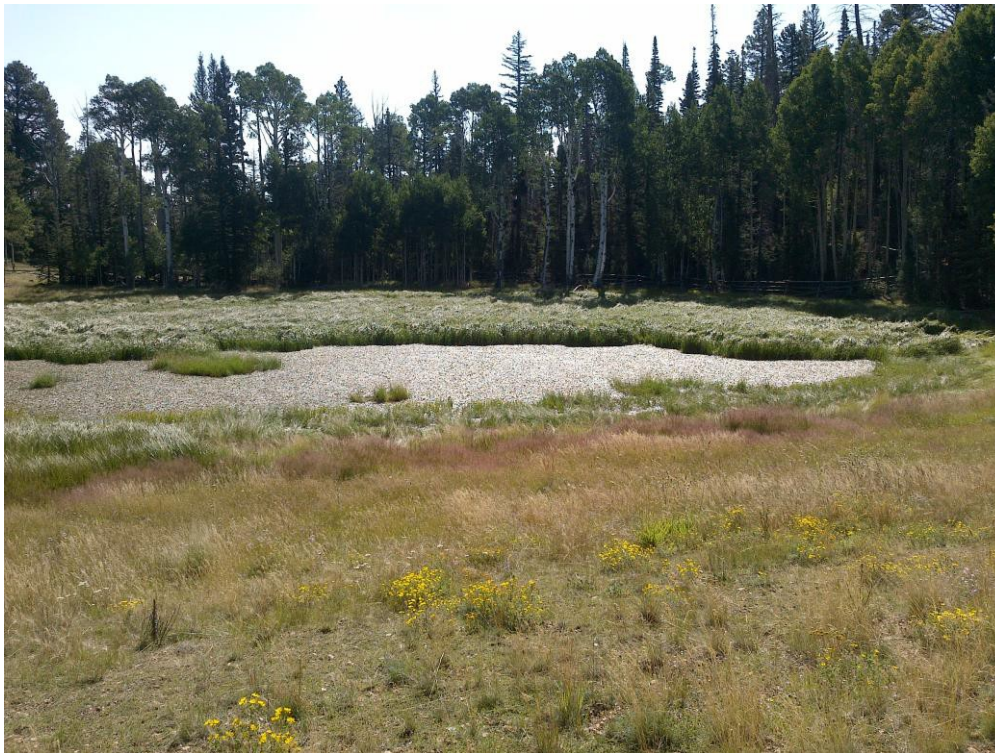
**Fig 8.1 VT Lake.**

**Physical Description:** VT Lake is a limnocrene spring. This is depicted on the DRG as a lake; however, the survey crew suspected that it is heavily influenced by groundwater after examination of the surrounding soils and water table. On 8/22/2015, the survey crew noted this site as a lacustrine/palustrine wetland near Hwy 69. The site is surrounded by spruce and aspen.

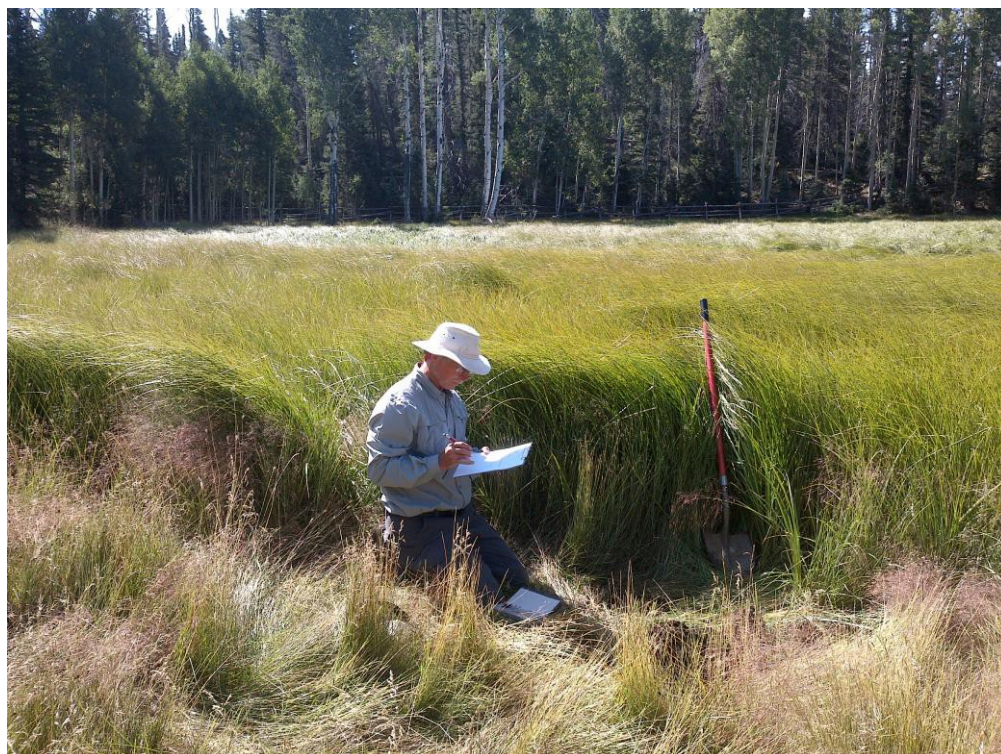
**Fig 8.2 VT Lake:** soil pit location
