## Angora Creek Stream and Floodplain Restoration

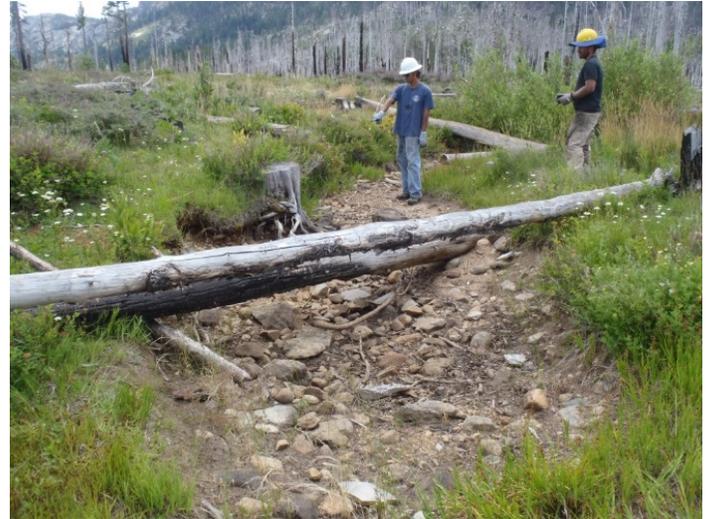
South Fork of Angora Creek, prior to installation of large wood

In 2014, restoration actions included the strategic placement of large wood along 2 miles of head water tributary channels. Large wood was placed to restore fish habitat and encourage sediment storage and sorting. In 2015, 750 feet of new channel was constructed to replace a section of incised channel in the main stem of Angora Creek, and additional strategic placement of large wood was installed for 1000 feet above the newly constructed channel. A total of 208 individual multi-log structures were installed, over the two years. Also in 2015, the legacy Seneca Pond was decommissioned through regrading to restore historic flow paths and topography, converting this 5 acre site to wet meadow habitat.

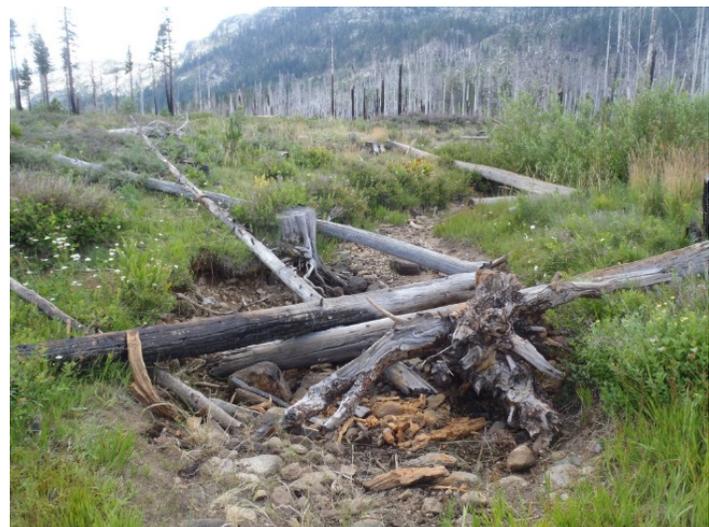
Same location on South Fork of Angora Creek, after placement of large wood

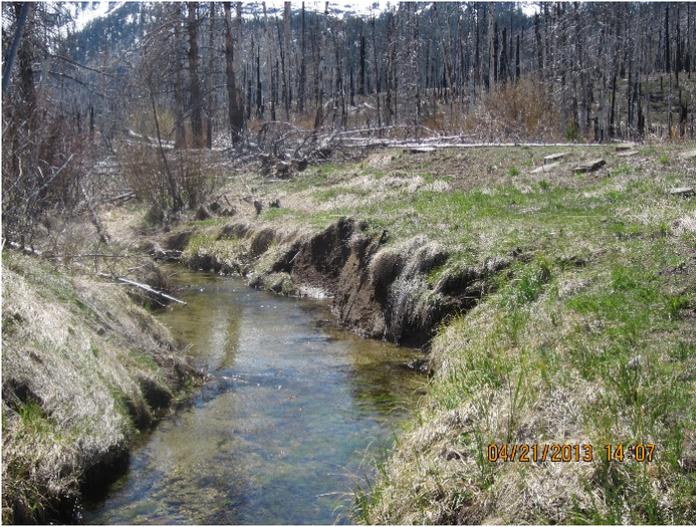
**Incised Angora Creek channel above Lake Tahoe Boulevard, prior to restoration, 2013**

In 2014 and 2015, the USFS implemented a stream channel/floodplain restoration project on Angora Creek and its tributaries, located upstream of the Lake Tahoe Boulevard stream crossing. The Angora Fire of 2007 had stripped large wood from the channel and adjacent riparian zone. In addition, a legacy man-made pond disrupted historic flow paths from one of the tributaries, and had become a breeding ground for invasive bullfrogs. And finally a section of channel was incised due to past urban development.

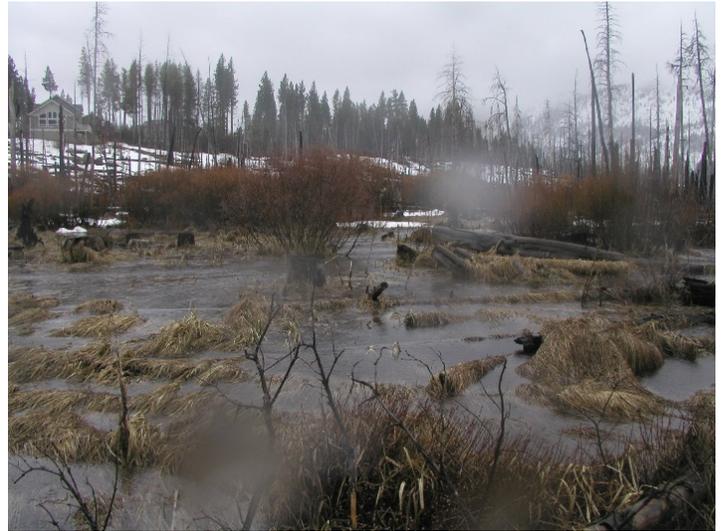
**Flooding of meadow adjacent to Angora Creek February, 2016**

Several moderate floods occurred during the winter of 2015-16. A storm in February resulted in flows spreading over the entire meadow near Lake Tahoe Boulevard, resulting in some flooding of the roadway. However beaver dams just upstream of the restored reach are thought to be the main cause of enhanced lateral spread of flood flows. The Forest Service will continue to monitor this situation, and work with El Dorado County to determine if any modification of the placed wood structures is needed to reduce future potential for roadway flooding. As of May 2016, the creek site is stable and functioning as expected.

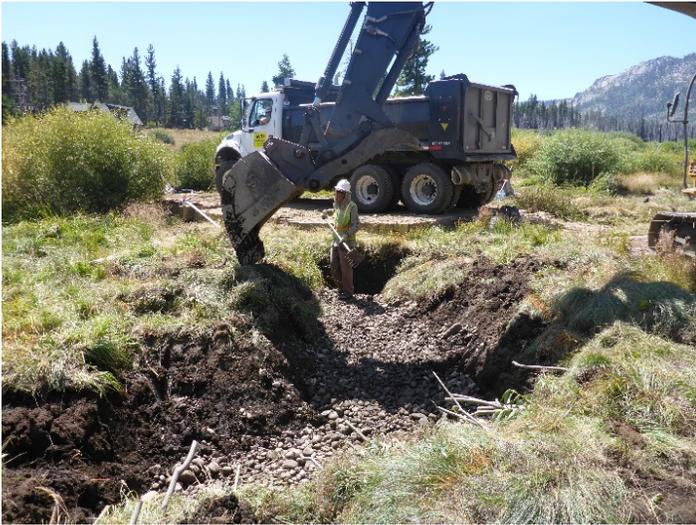
**New channel construction, 2015**

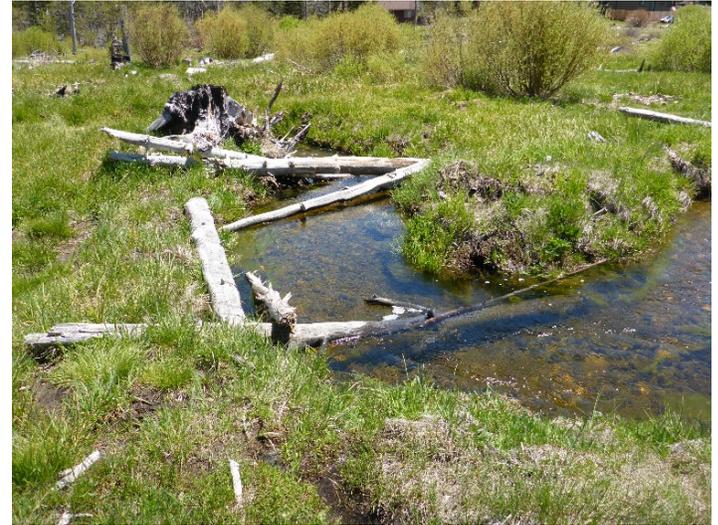
**Reconstructed Angora Creek Channel, May 2016**

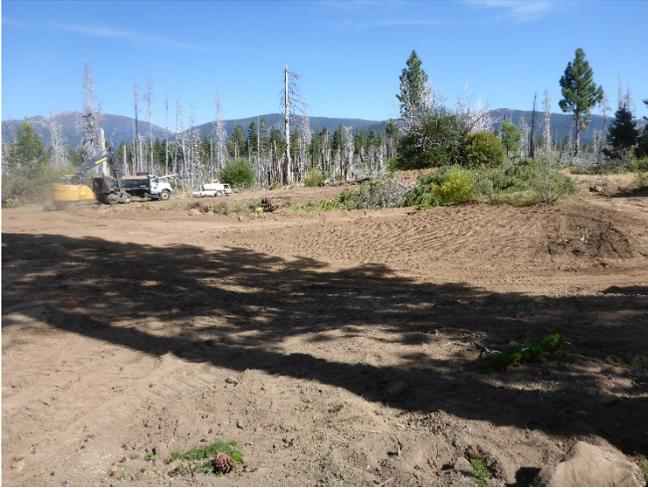
**Pond removal and regrading – September 2015**

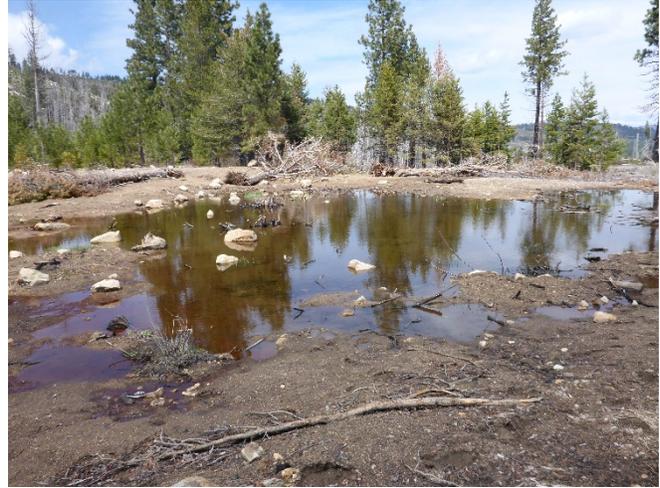
**Ponding from side-hill spring inflow– May 2016**

2015-16 winter snowpack and precipitation were slightly above average in the Angora Watershed. Runoff from side slope springs on the uphill edge of the old pond resulted in shallow ponding with outflow into the South Fork of Angora Creek. Revegetation with grass plugs and additional willow staking was completed in June 2016. In summer the pond dried up but there appears to be enough sub surface flow to support the planted grasses, as well as the emergence of wetland grasses along constructed flow paths in the old pond. Inspection in late summer indicates a willow stake survival rate of 50 to 70 percent. The constructed surfaces are stable and will become more so as vegetation continues to colonize constructed surfaces in the future

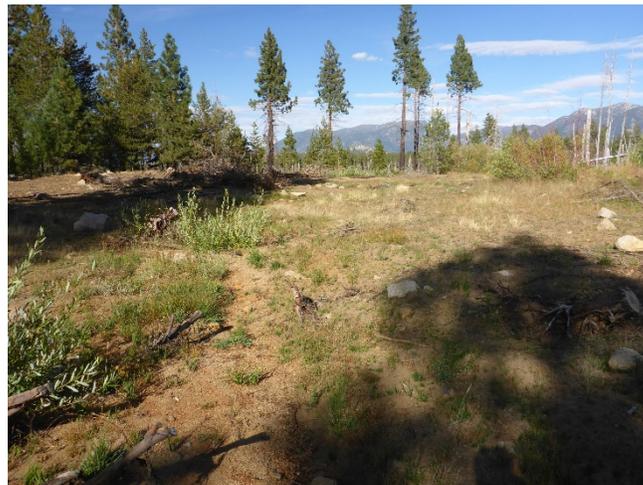
**Emerging shrub and grass vegetation – September 2016**
