# **Fire Lookout History of the Santa Fe National Forest**

**Barbara Zinn**

Prepared for  
Santa Fe National Forest  
Fire Management Program  
11 Forest Lane  
Santa Fe, New Mexico 87508

Report No. R2017031000012

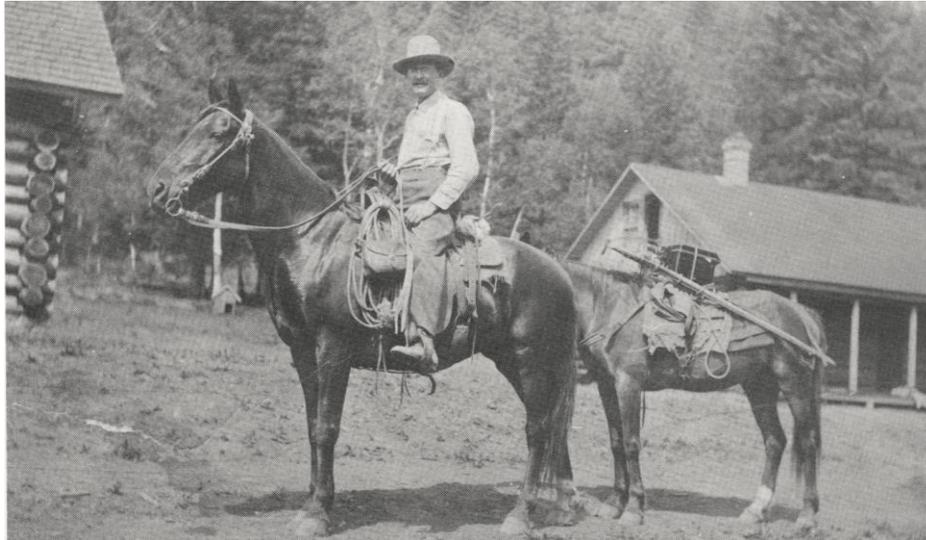
**Figure 3. “Ranger Stewart, circa 1914, with a mountain telephone packed for transport at Panchuela Ranger Station, Pecos N. F.” (Edwin A .Tucker, *The Early Days: A Sourcebook of Southwestern Region History*, Book 3, (Washington, DC: USDA Forest Service, 1989), 106)**

fighting fire. The first telephone lines were built on the Jemez by 1906 and on the Pecos by 1910. Rangers sometimes carried portable telephones so that they could call from anywhere along a line (Figure 3). Telephones also linked the Forest to local cooperators, called per diem guards, who provided supplementary detection and suppression.<sup>4</sup>

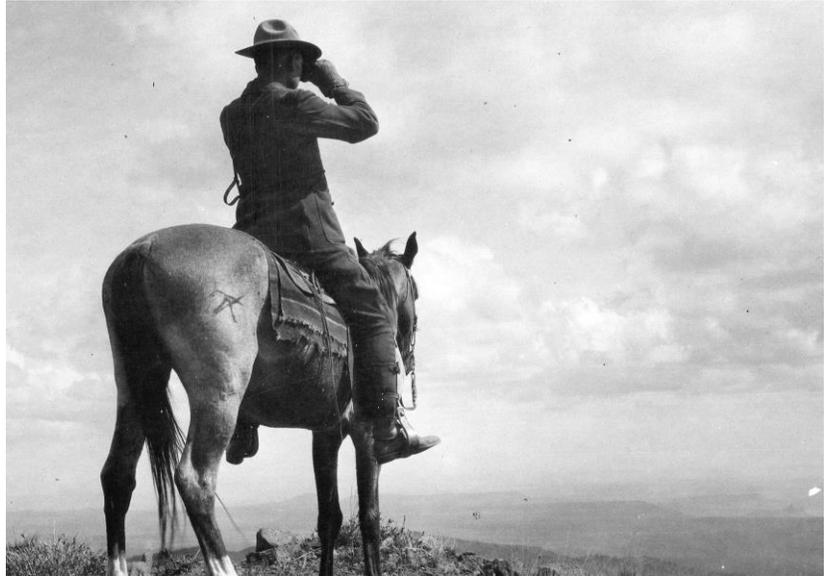
**Figure 4. Ranger looking for smokes along his beat (undated, archeology binder 45, no. 9149, SFNF SO)**

The earliest fire detection on the Reserves and Forests was provided by rangers riding trails, stopping at high points and scanning for smokes. A ranger provided one or two horses, carried binoculars, map and compass, and was assigned a patrol route known as a “beat” (Figure 4). When he spotted a smoke, he either put it out alone or rode to the nearest settlement or telephone line for help. Trails and telephone lines were the essential infrastructure of the early fire program, and rangers constructed and maintained them when not

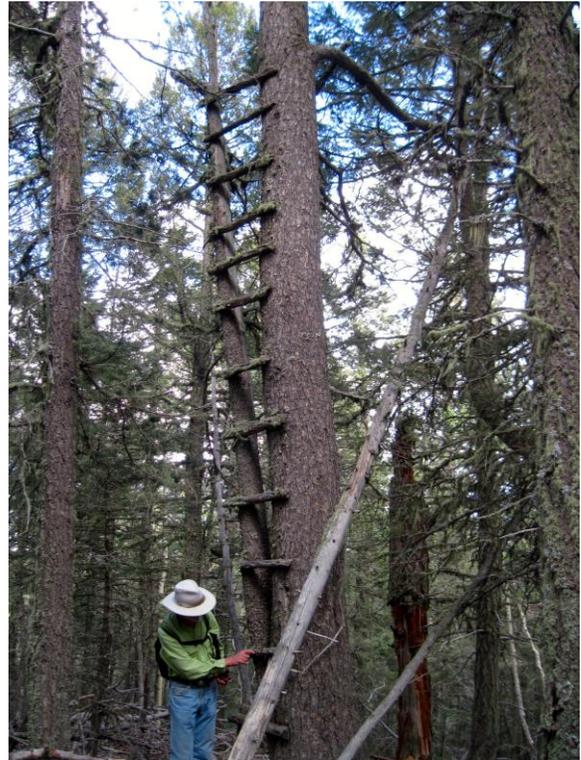
**Figure 5. Lookout tree on the Forest (2014, author)**

During the first decade of lookout development many sites had only a map board and telephone. As yet there was no standardization, so various types of structures were constructed using available materials. A tree lookout provided a simple and inexpensive way of obtaining a view from forested sites, and was often the first structure built. A tall tree was selected and modified to allow climbing to the top, sometimes incorporating lag bolts, metal ladders, wooden rungs and treetop platforms. A “wolfie” tree was often chosen, as it was naturally contorted with limbs closer to the ground allowing easier climbing. Firefighters climbed trees in the general area of a reported fire to pin down its location, sometimes using spurs they carried for maintaining telephone lines. The Forest also built lookout trees near some developed lookouts as patrol points to cover areas blind to the main lookout; Figure 5 shows one that still stood on the Forest in 2014.<sup>14</sup>

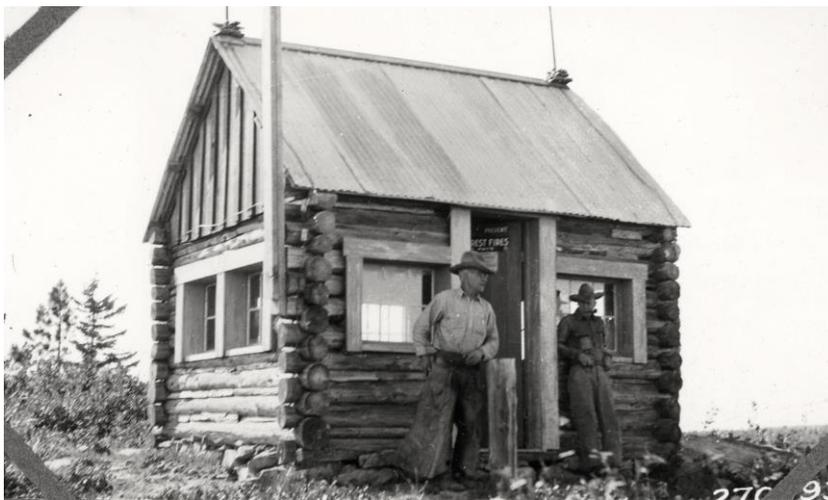
**Figure 6. Red Top Lookout in 1932. According to Mary Caldwell the man wearing chaps is Mac Fenton and the other is fire guard Jim Curry. (1932, Stanley F. Wilson, Inspection, Jemez Division, NARA, 5/52)**

were frame buildings with windows on all sides. The other six were of log construction, with Red Top (Figure 6) the only one with enough windows to qualify as an “observatory.” Inspectors noted the Forest’s lack of compliance with the directive that new lookout cabins have many windows, and described Forest lookouts as generally below the regional standard. By 1926 all fire guards on the Forest were living on top, using tents where cabins were still under construction. Lightning protection had been installed at most Forest lookouts by 1928.<sup>19</sup>

In 1925 the Forest considered Red Top the most valuable lookout on the Jemez, partly due to its view of the San Diego Grant, yet a tent on top was still the only shelter. The Forest had planned to build a cabin and pasture at the spring a mile down the trail, but new fire policy in 1921 mandated that lookout cabins be built "on top" with proper lightning protection. Red Top was especially lightning-prone, and a suggestion to blast a dugout from the side or top of the mountain was (incorrectly) said to be "safer [from lightning] than any cabin can be." The Forest decided to construct a log cabin on top instead; it was begun in 1926 and completed by 1928, with John Ketcham hauling construction materials. This was the only log lookout cabin on the Forest with enough windows to meet the national directive to build observatory-type lookout cabins (Figure 6 in the Introduction and Figure 37).<sup>41</sup>

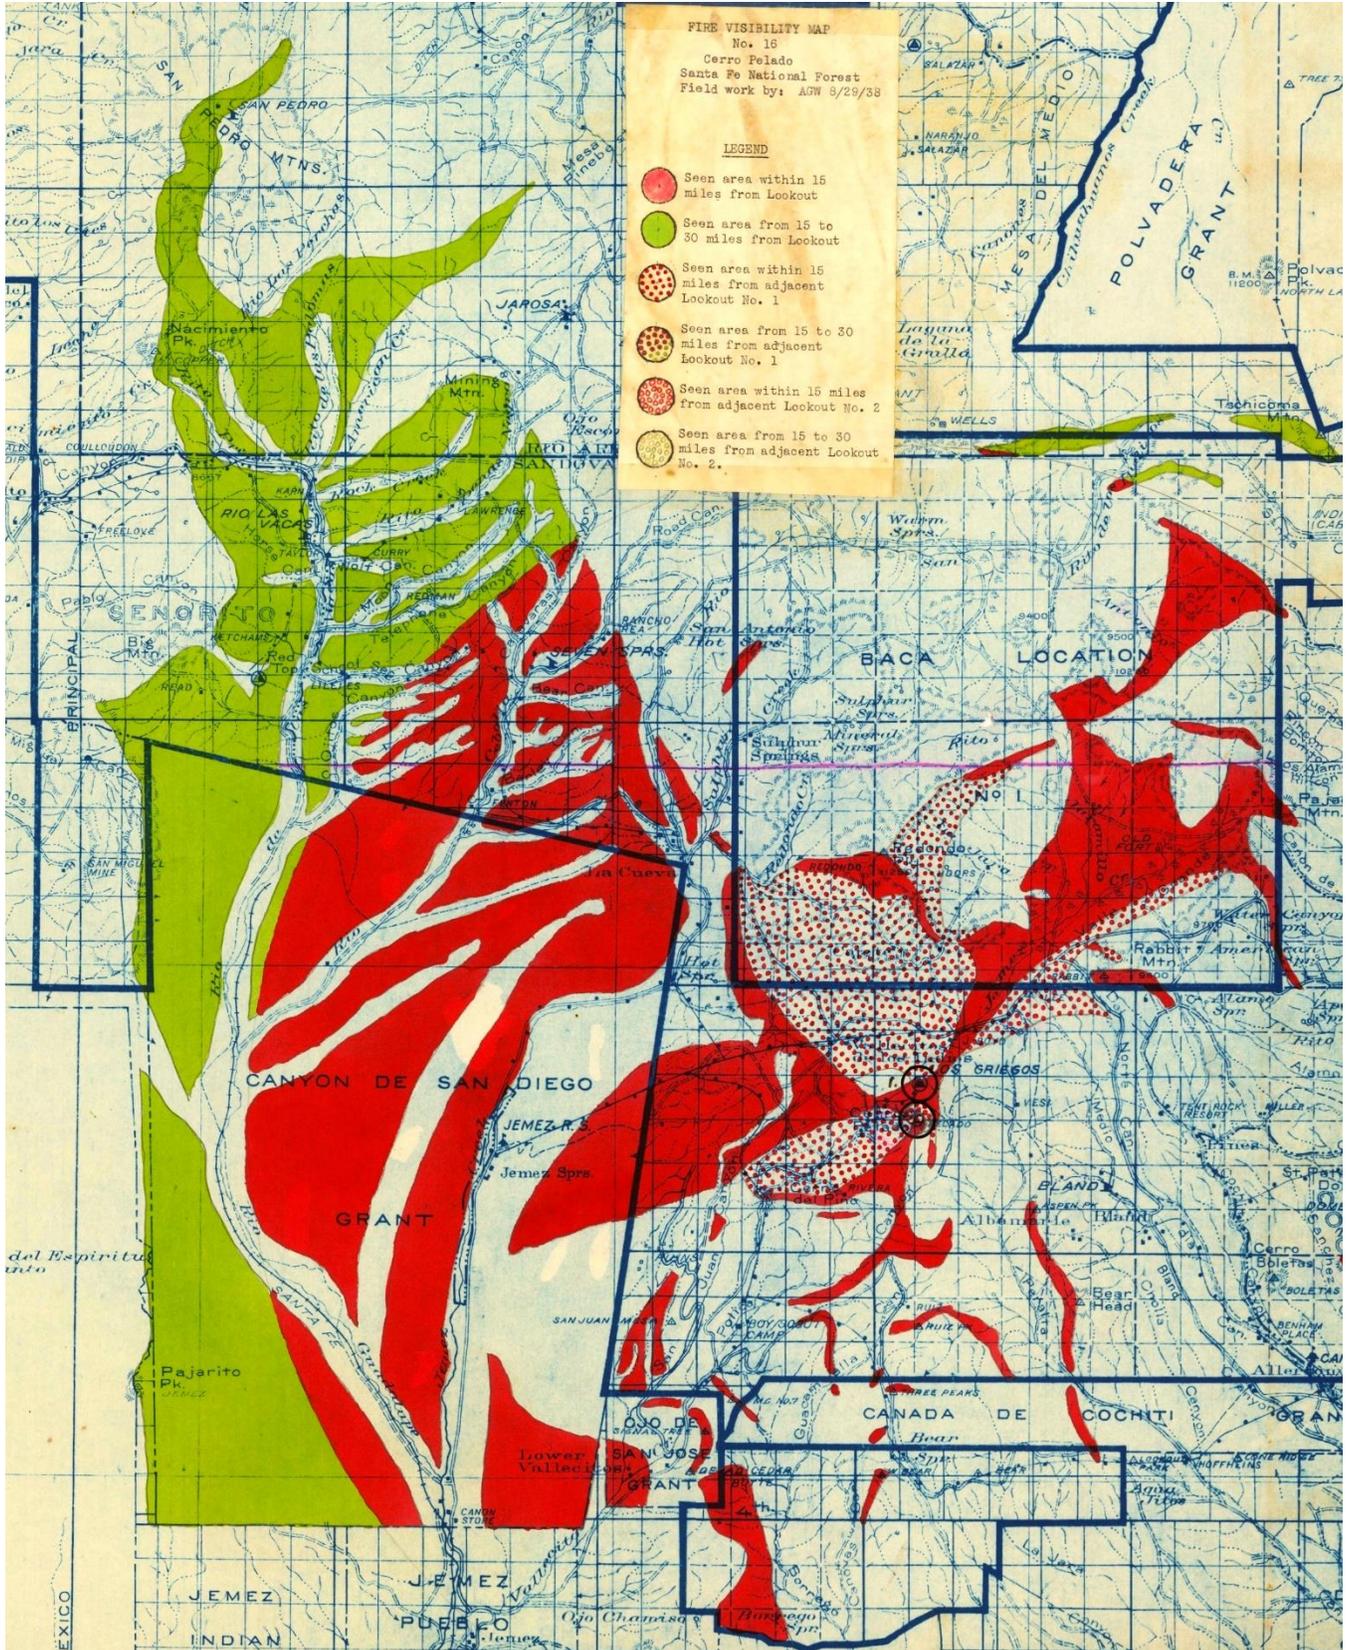
Figure 9. Seen-Area Map, Cerro Pelado Lookout (1938, SFNF SO, Dispatch)

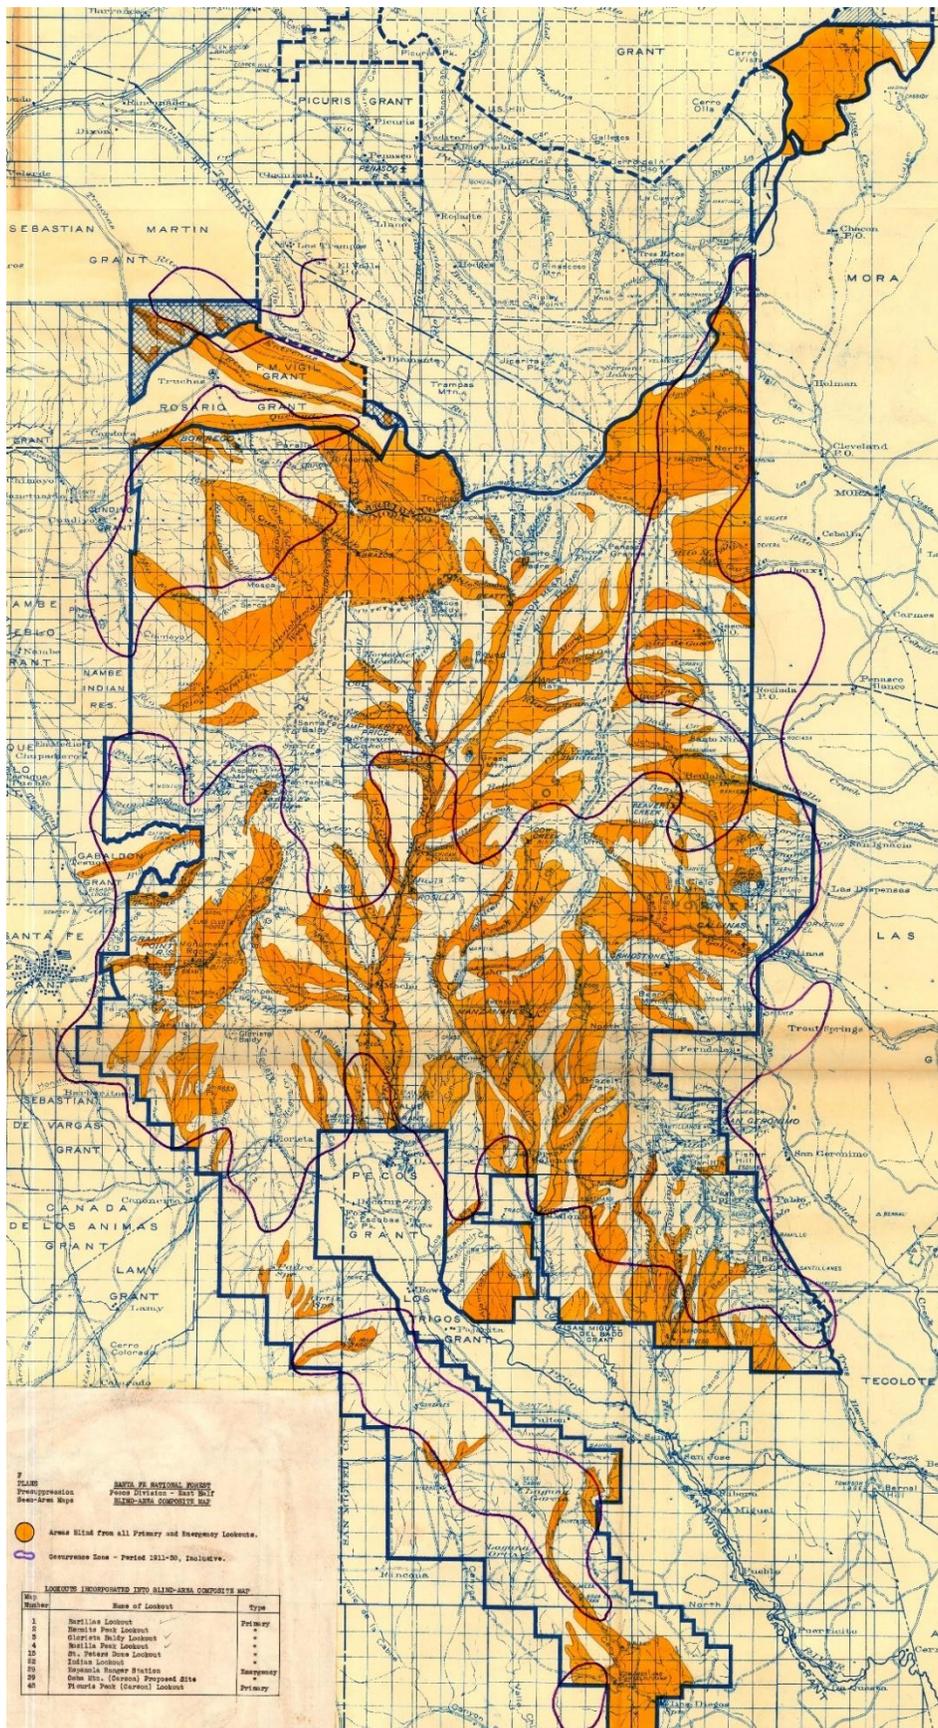
Figure 10. Santa Fe National Forest, Pecos Division - East Half, Blind Area Composite Map (c. 1938, SFNF SO, Dispatch)

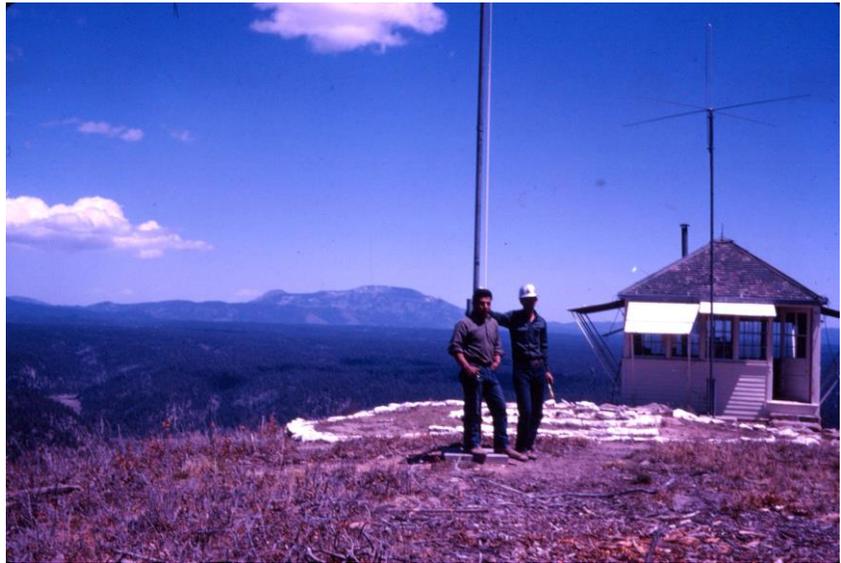
**Figure 11. Red Top Lookout and aircraft marker made of whitewashed rocks, men unidentified (1964, Cuba photolog book 2, Jemez District Office)**

The Forest used these markers (listed in Appendix 1) from the mid-1940s until the 1970s, and remnants are still visible at most sites today. Figure 11 shows the Red Top marker in 1964. Lookout duties included weeding and whitewashing the markers. The Barillas marker was painted on the cabin roof rather than on the ground, and identification numbers were also painted on top of vehicles used in the field.<sup>34</sup>

In 1933 the CCC replaced the log cabin with an L-4 ground cabin located at the far end of the point (Figure 38 and Figure 11 in the Introduction). Worthington (Worth) Karn hauled the material up to build it, and he told Jack Curry’s wife Betty Jane that the hardest thing to haul on the pack animals was the copper wire used for lightning protection. Janie O’Rourke’s interview notes with Betty Jane describe her experience at Red Top:

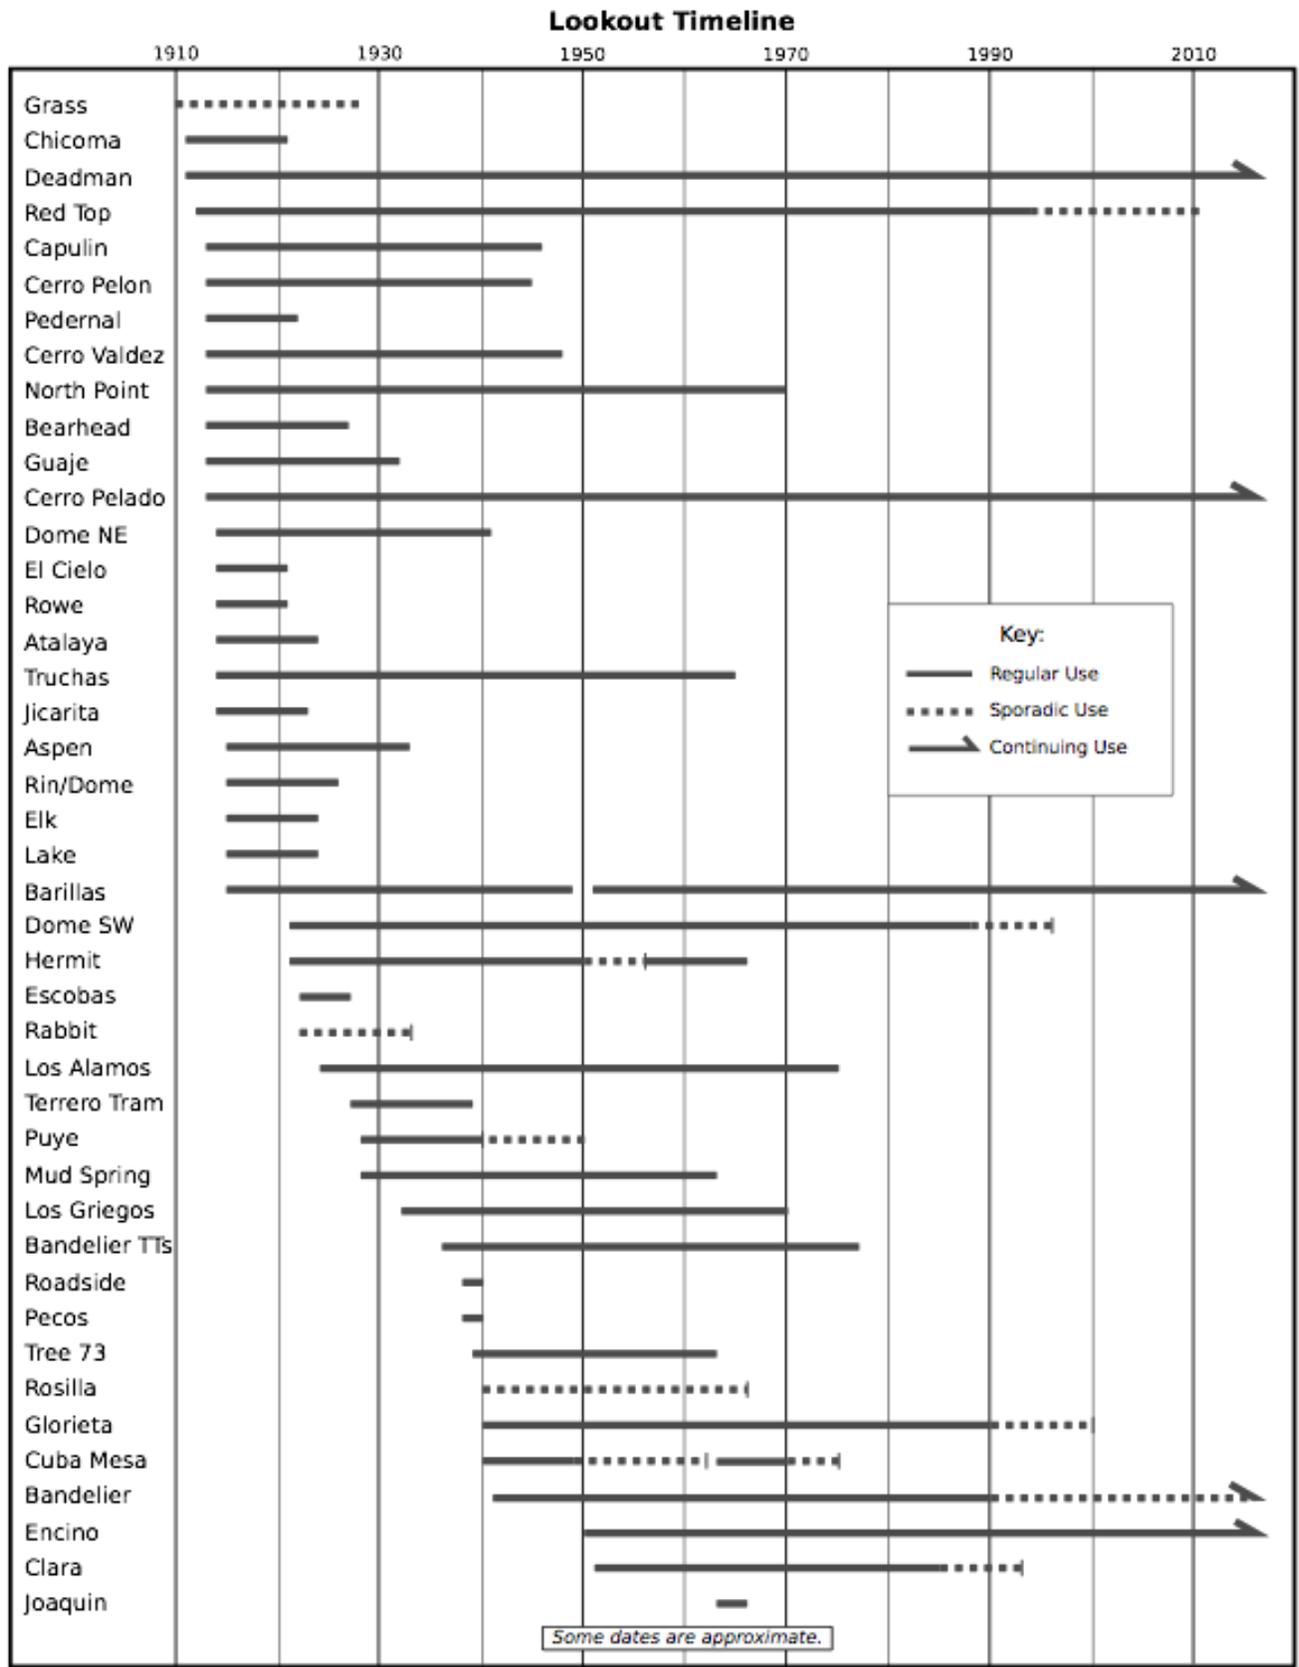
Figure 12. Lookout Timeline. Some dates are approximate.

Figure 12 is a timeline for Forest and key cooperator lookouts, showing dates of their creation and abandonment as well as periods of sporadic staffing. Some timeline dates are approximate. Figure 13 graphs the total number of lookouts in use at certain dates. The peak in lookout numbers (28) occurred in 1916 during initial site development. The second-highest peak was in the mid-1930s, with the New Deal programs enabling increased development. Lookout numbers dropped slightly through the 1950s, then more in the 1960s as aerial reconnaissance was fully adopted. Numbers plateaued between 1960 and 1990, followed by decline to the current levels. Figure 14 graphs total Forest lookouts and total cooperative lookouts in use at the same dates. Cooperative lookouts were established in the 1910s and 1920s as many of the initial Forest lookouts were being abandoned. Thereafter, cooperative lookouts followed the same plateaus and declines as Forest lookouts.

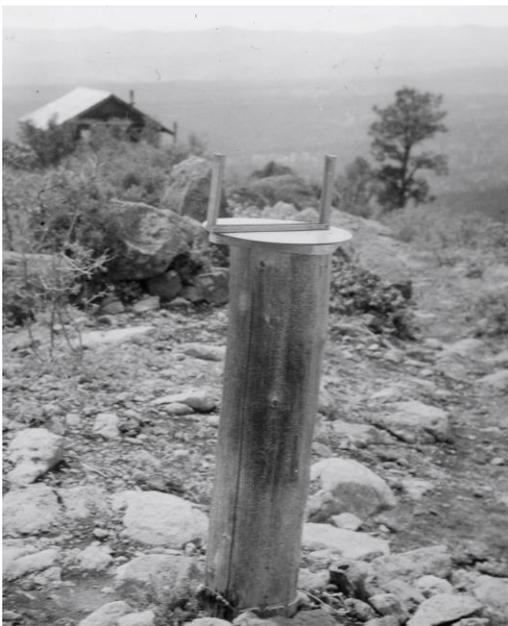
**Figure 15. St. Peter's Dome metal map board with alidade (1930s, Improvement and Construction Detail Pictures, SMC, RO coll bldg folio/73)**

The alidade was a flat ruler-wide piece of steel about sixteen inches long with an upright piece of steel at both ends. One upright was fixed with a narrow slit to look through and the other with a horizontal horsehair centered in an open aperture. With the length of steel against the pin, I swung it around to the direction of the distant smoke, looked through the slit and lined up the hair with the smoke. In order to see the reading on the circle, it was necessary to walk around the board to the slot end of the alidade.<sup>5</sup>

Early map boards were mounted outdoors on posts or stumps and were often made of metal to better withstand the elements. Figure 15 shows the St. Peter's Dome metal map board with alidade, and in

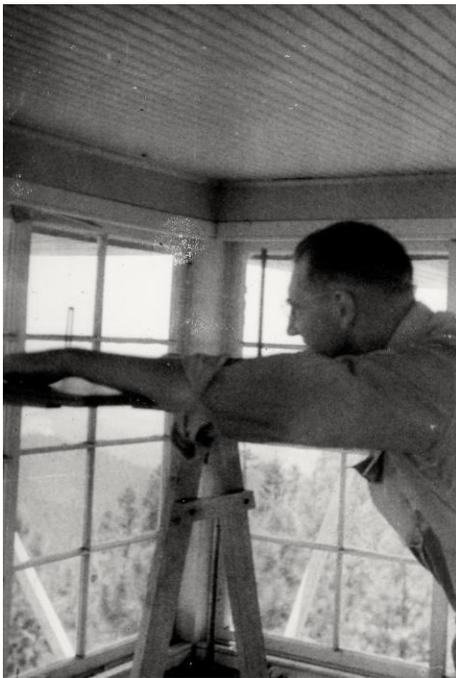
**Figure 16. Forest Supervisor Wang using Deadman’s firefinder (June 14, 1946, Edward Ancona, NARA, 46 Fire Inspection/28)**

Great variation...in map boards and their mounting. The rail mounting at Deadman...[is] a nuisance, takes up too much room and is a hazard to unwary skulls—as I can testify to a hunk of skin off my forehead and one other of the party who clipped his head painfully on the rail [Figure 16]...Red Top map board mount not too steady. Cerro Valdez map board mount much too high...Glorieta Baldy has a map board on a rolling table, reorients each time. Somehow it looks a bit makeshift...The Barillas map board is very bad, and the map worse. Held on with stones...the detection equipment...in the main looks haywire.<sup>7</sup>

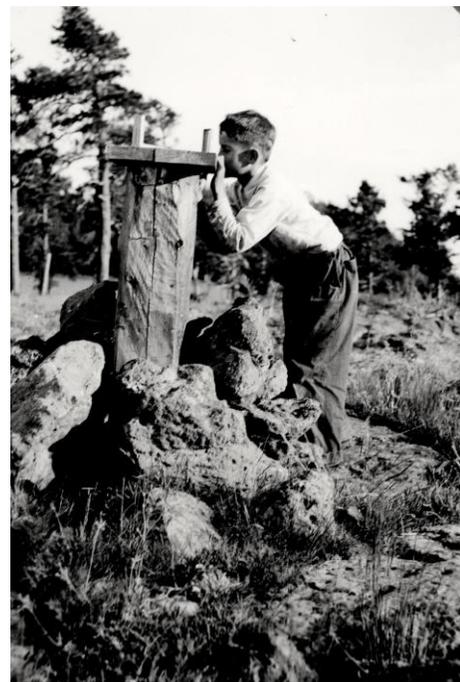
**Figure 17. Cerro Valdez wooden map board and alidade (1932 Inspection, Jemez Division, NARA, 5/49)**

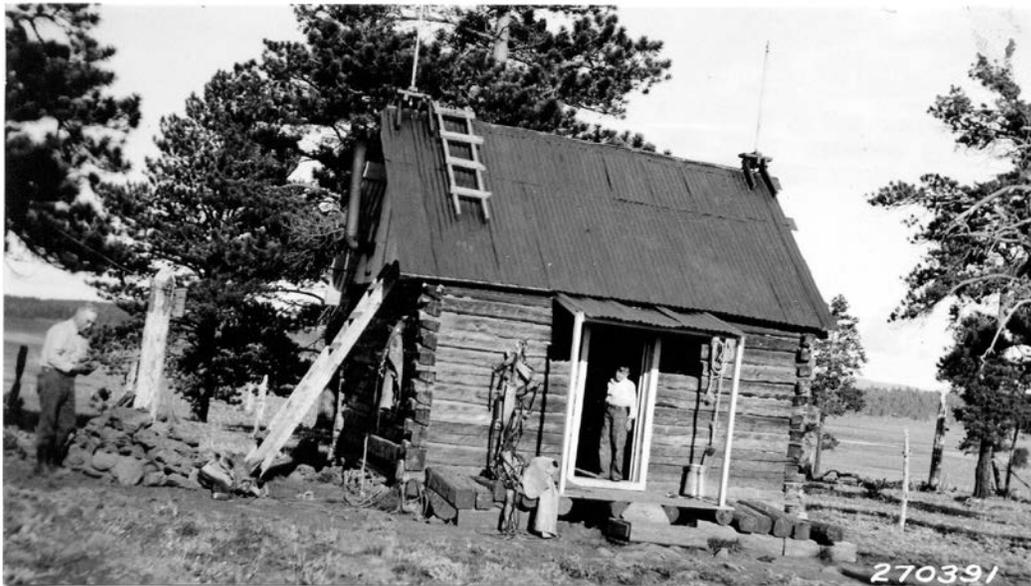
**Figure 20. Original lookout cabin at Cerro Valdez, built in 1922 (1932 Inspection, NARA, 5/47)**

In 1913 a patrolman was based at the old Encino Ranger Station in Encino Canyon, and patrolled both Cerro Valdez and Pedernal. The Forest completed seen-area maps of these two points in 1921 and by comparing them, it selected Cerro Valdez over Pedernal for a permanent lookout. In 1922 a trail crew cut logs for a lookout cabin that was built by Eloiso Montoya of Youngsville. It was set back from the rim, as shown in Figure 20. The Forest also

Cerro Valdez is shown as a lookout on maps from 1924 through 1950. The map board pedestal and foundations for the two cabins remain at the site, while the view to the meadow in Figure 20 is now blocked by a thick forest of young ponderosa pine.

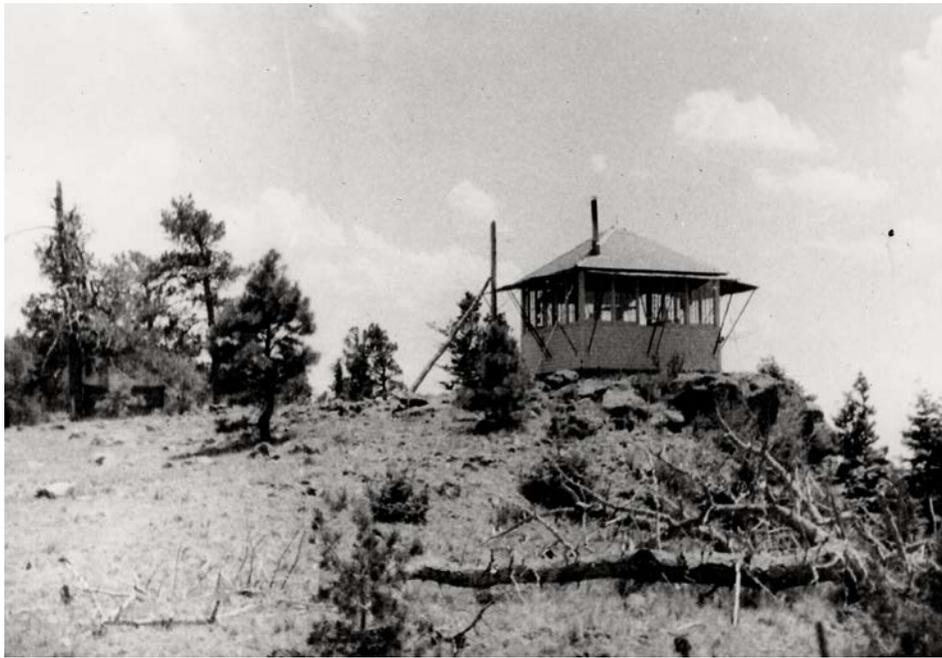
**Figure 21. L-4 lookout cabin at Cerro Valdez, built by the CCC in 1933 (June 14, 1946, Edward Ancona, NARA, 1946fireinsp/24)**

was unacceptable to that year's inspector, and the Forest installed a new toilet in 1947. An Osborne firefinder replaced the map board in 1947 as well.<sup>10</sup>

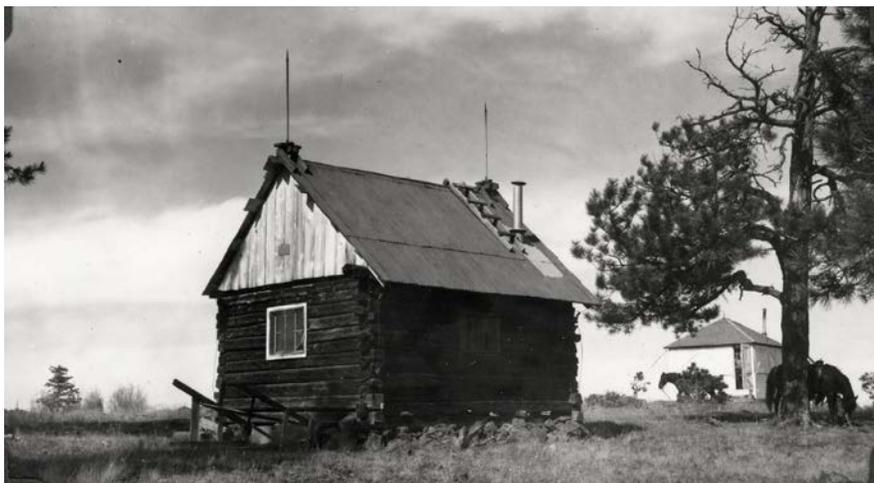
**Figure 22. Relative placement of both Cerro Valdez cabins (October 1946, Improvement and Construction Detail Pictures, SMC, RO coll bldg folio/57)**

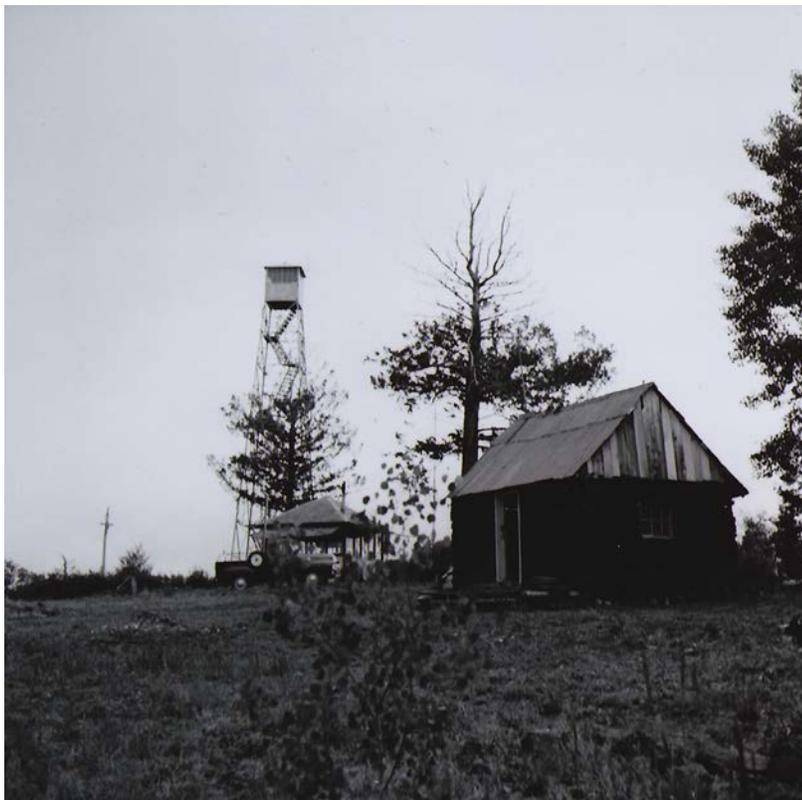
**Figure 23. Encino Lookout tower with cabins moved from Cerro Valdez (mid-1950s, archeology binder 53, negative no. 10058, SFNF SO)**

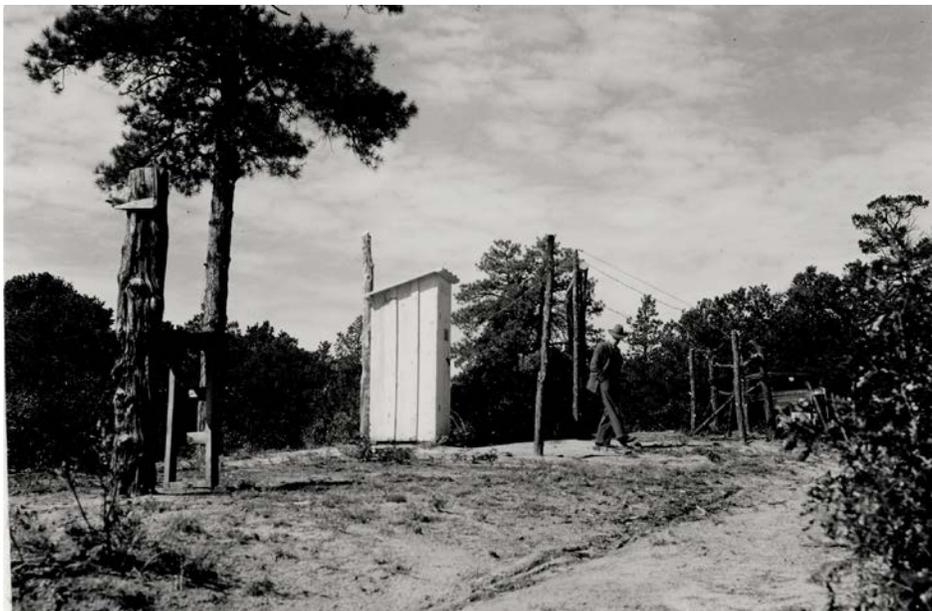
**Figure 28. Earliest facilities at Cuba Mesa Lookout (September 25, 1940, C.W. McKenzie, 1940 Inspection, NARA, 5/131)**

In 1936 the Forest wanted "organized detection" for the west slope, and in 1938 selected a spot east of the current electronic site for an emergency lookout and made a seen-area map. Ranger Barlow looked over this site in September 1939. By 1940 the CCC had installed the earliest facilities (Figure 28). They were quite primitive and included a post with a ladder as an observatory, a fire toolbox, and a pole tent frame with wire strung around it as lightning protection. The CCC completed a telephone spur line to the Lookout that year. In 1941 the Forest planned to build a tower at this spot but funding did not materialize.<sup>6</sup>

**Toolbox:** A fire cache containing tools. These were placed throughout the Forest, especially near cooperators' ranches. Ranchers were responsible for maintaining the tools. The box had a metal seal that could be broken in an emergency. See Figure 28 in the Cuba District chapter.

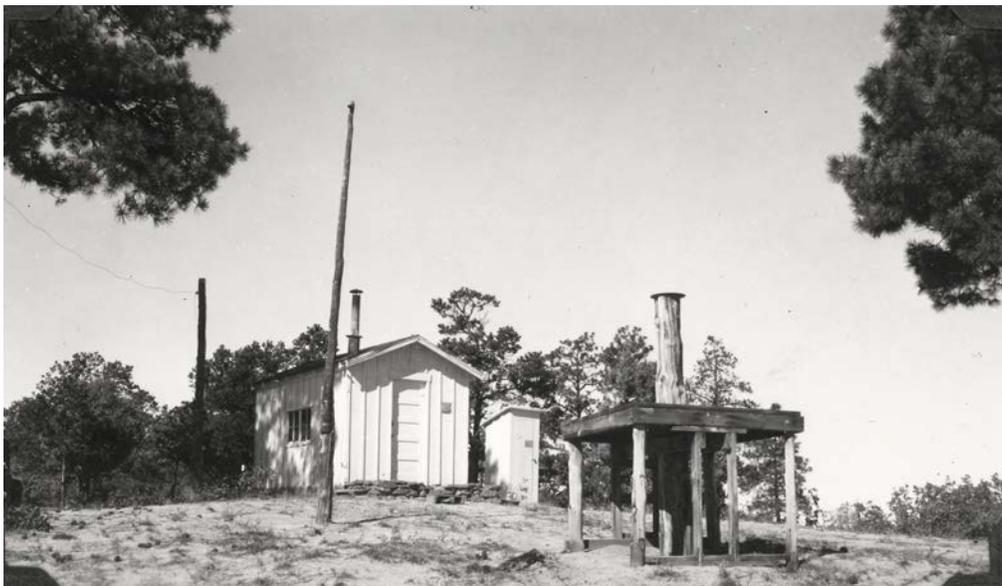
**Figure 29. Improved facilities at Cuba Mesa Lookout (October 1946, Improvement and Construction Detail Pictures, SMC, RO coll bldg folio/49)**

The earlier post-and-ladder observatory had been upgraded to a wooden stand. It had stairs to a 5-foot-high platform holding a galvanized map board. Gallegos climbed the stand early each morning, scanned the west face

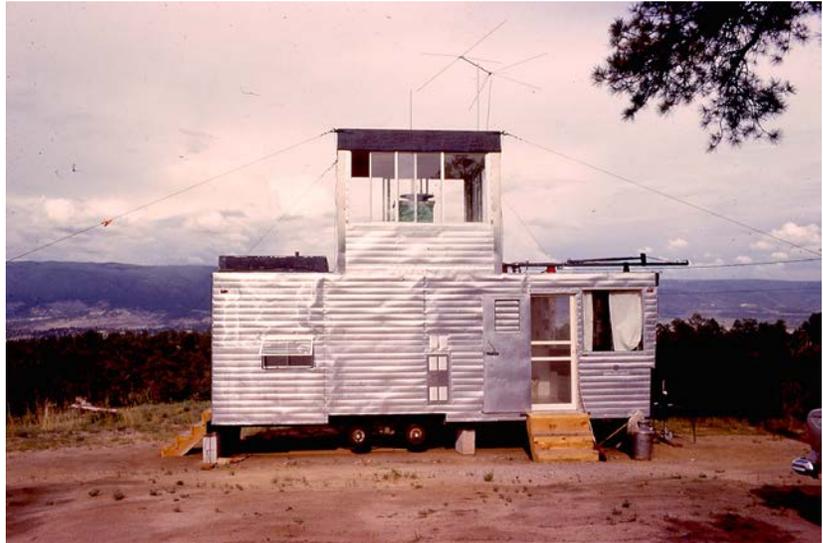
**Figure 30. “Mobile” or trailer lookout, ordered new for Cuba Mesa, installed 1963 (c. 1971, Public Affairs binder, SFNF SO)**

In 1962 Cuba Mesa was not regularly staffed, but one duty of an early-season patrol was to “install the alidade at the Cuba Mesa Lookout point,” and it was then visited by patrolmen as needed. That year there was a flurry of discussion about re-establishing this Lookout, and in early 1963 a modified commercial camp trailer with a pop-up lookout cab on top (Figure 30) was ordered from Region 1. It was called a “mobile lookout,” designed for locations with temporary needs such as logging sales. This lookout trailer was the Forest's top priority in fire equipment acquisitions for that year, and was constructed to specifications at a cost of 5,800 dollars. An Osborne firefinder was also purchased, a definite upgrade from the old outdoor map board.<sup>12</sup>

Perfecto Casaus and his wife moved from Deadman Lookout to staff Cuba Mesa in 1964. The Forest still staffed Cuba Mesa in 1970, and smokes were reported from it. But in the early 1970s the Forest once again discontinued full-time staffing, and only used the lookout sporadically after lightning. Figure 30 was probably taken in 1971. In the mid-1970s the Forest moved the trailer up to Red Top, and after that only an occasional patrol visited the Cuba Mesa site. It is shown as a lookout on maps from 1941 through 1975. In 2014 only small artifacts remained there.<sup>14</sup>

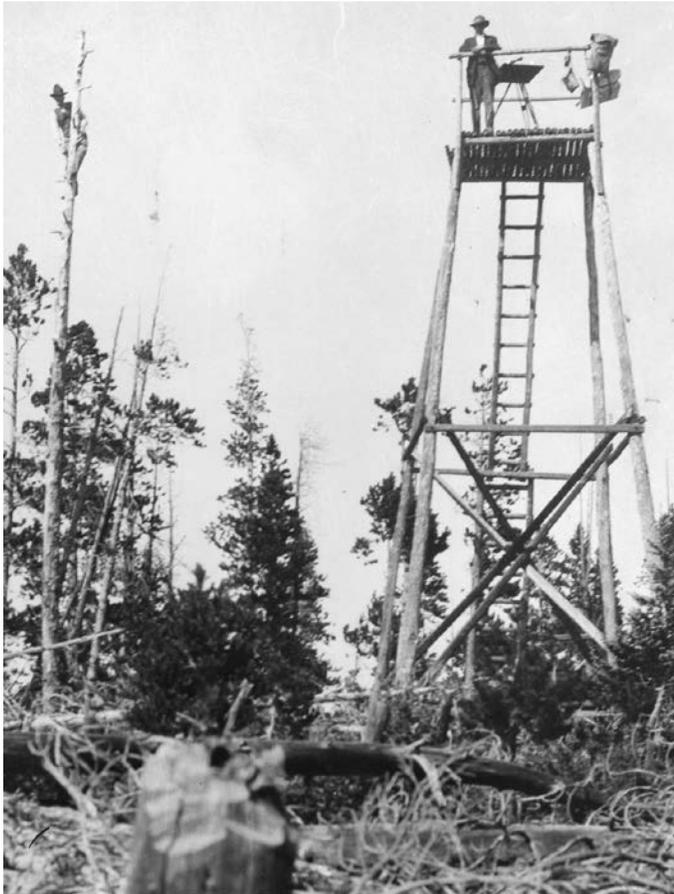
**Figure 31. Pole lookout tower at Jay’s Roost, Wyoming that may be similar to the earliest tower at Deadman Lookout. Note the man at the top of the snag on the left. (1916, Courtesy of the Forest History Society, Durham, NC)**

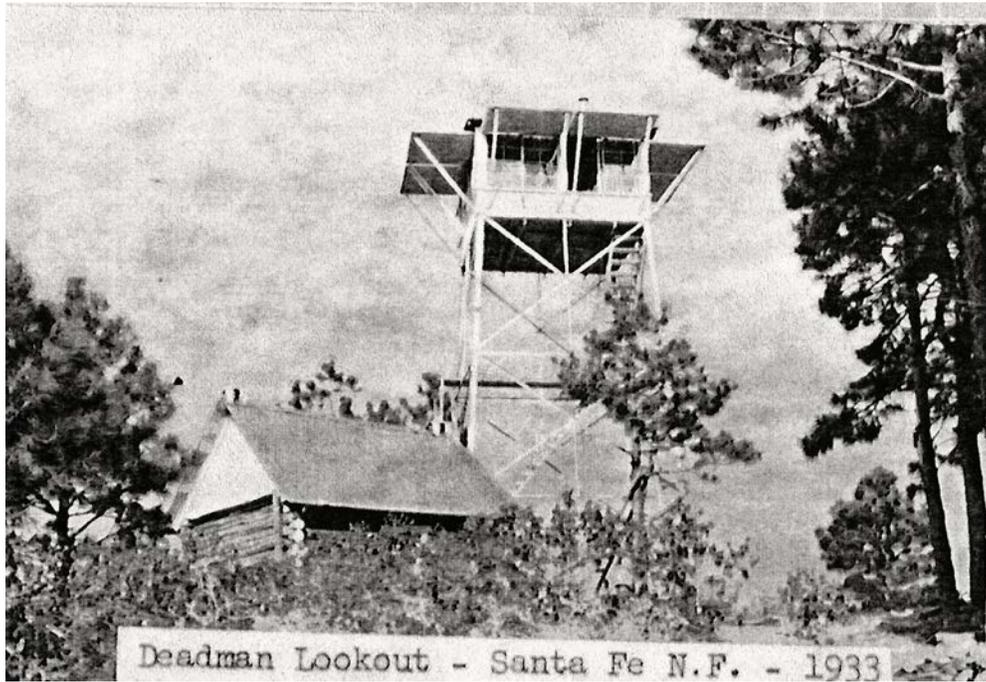
**Figure 32. MC-24 erected at Deadman by the CCC in 1933 (1933, Continental Divide Training Center Museum photograph collection, archeology binder, SFNF SO)**

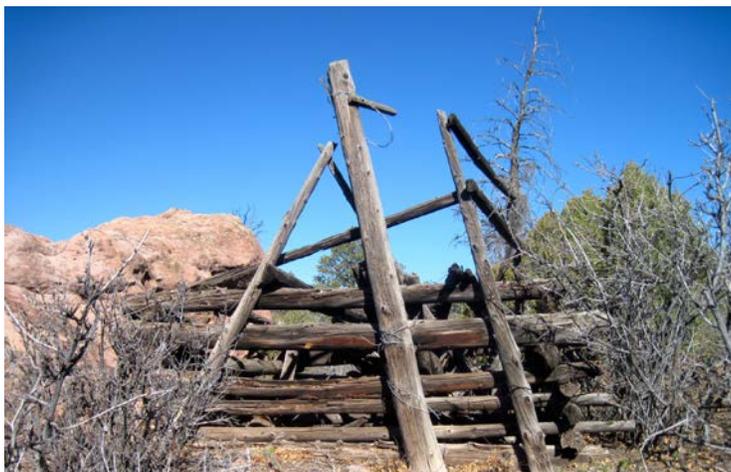
**Figure 35. Pole platform at Mud Spring Lookout, south side of mesa (2014, author)**

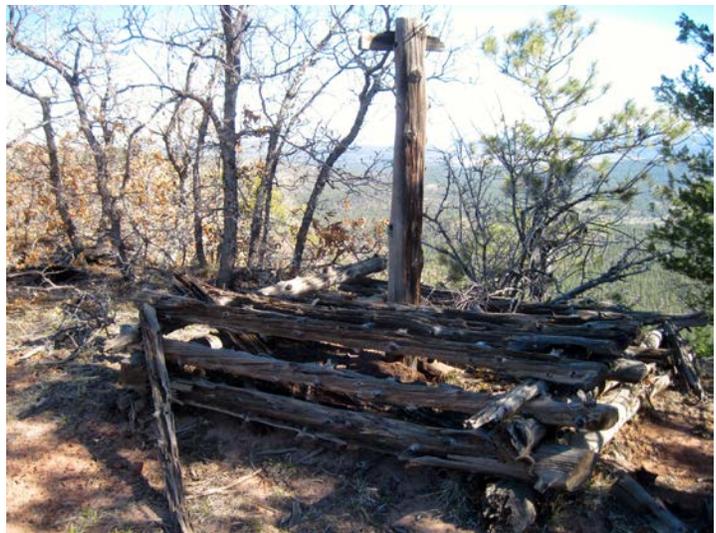
**Figure 36. Pole platform at Mud Spring Lookout, north side of mesa, note map board pedestal (2014, author)**

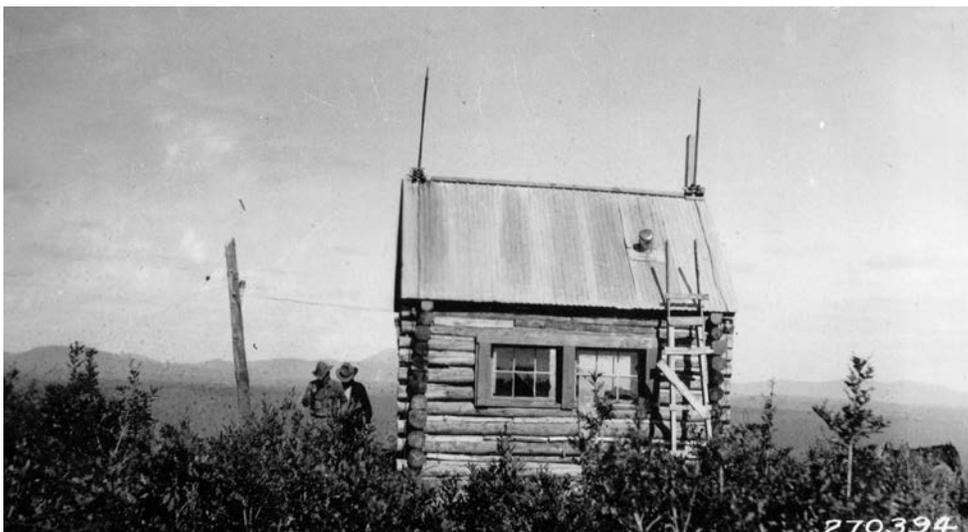
Figure 37. Original Red Top Lookout cabin (1932, Stanley F. Wilson, Inspection, Jemez Division, NARA, 5/53)

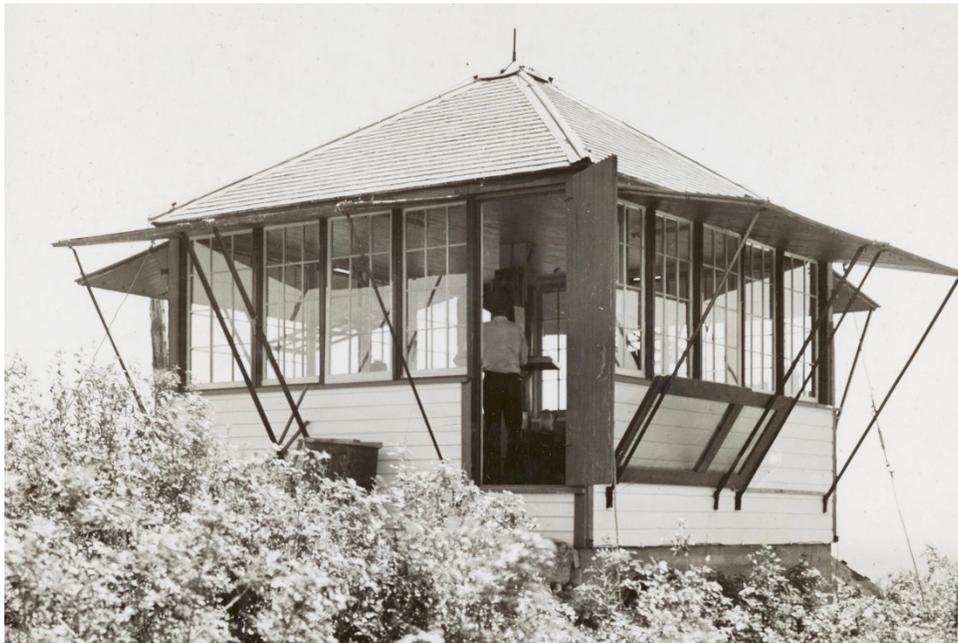
**Figure 38. L-4 built at Red Top by the CCC in 1933 (1936, W.A. Jackson, Photograph No. 95-GP-4738-325077; Records of the Forest Service, 1870 - 2008, Record Group 95; National Archives at College Park, College Park, MD.)**

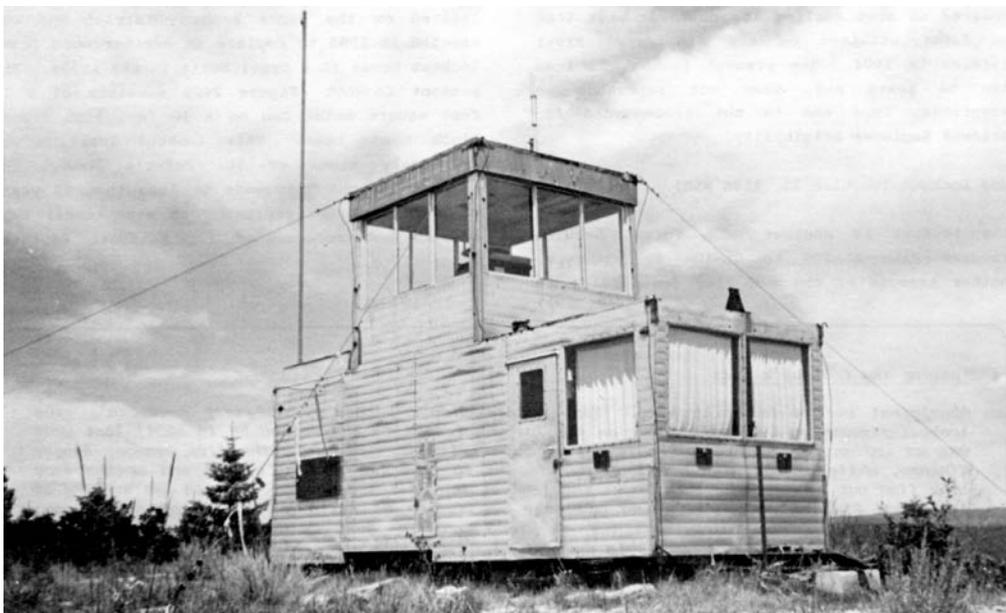
**Figure 39. "Mobile" or trailer lookout moved from Cuba Mesa to Red Top around 1976 (c. 1987, USFS, Lookouts in the Southwestern Region, 124)**

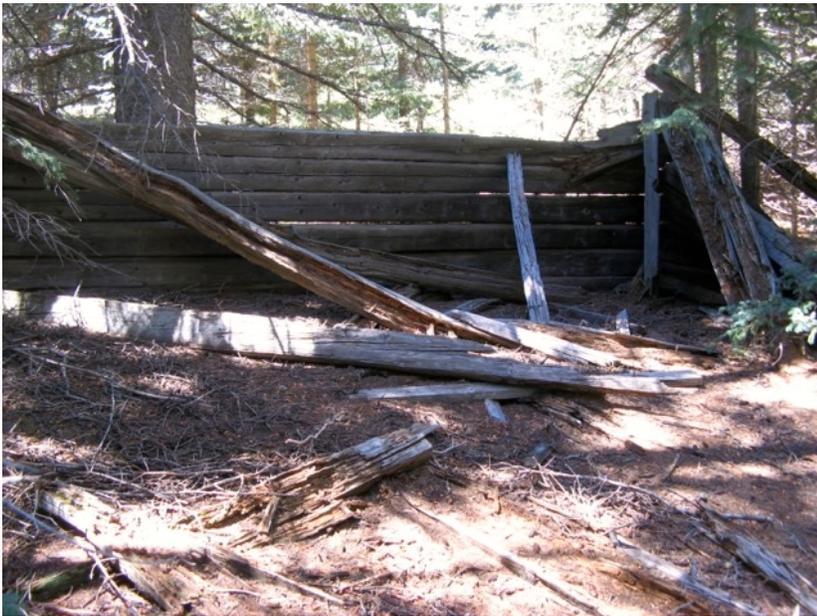
**Figure 42. Chicoma Lookout cabin (2014, Courtesy of Janie O'Rourke)**

In 2014, a distinct trail marked with old blazes led across the south slope of the Mountain to the ruin of a large well-made cabin at the mapped location (Figure 42), with constructed trail continuing to a developed, but now dry, spring.

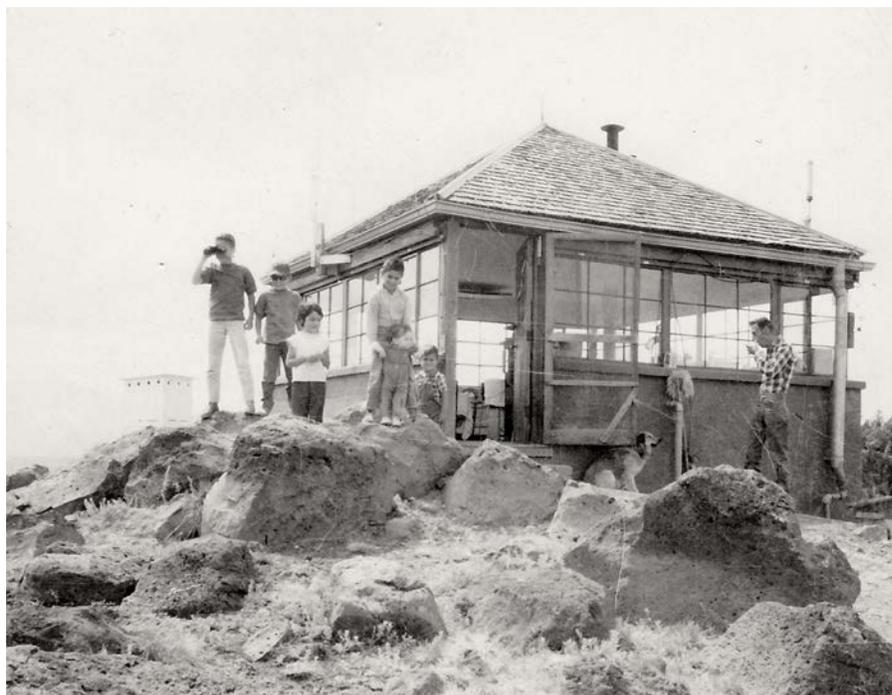
**Figure 43. Clara Peak Lookout with Trujillo family members (1960s, Courtesy of Adelires Trujillo)**

The new lookout was a 14- by 14-foot modified L-4 ground cabin of cinder block (Figure 43), and the Puye scaler's cabin was placed just below the summit as a storage shed (Figure 44). The Forest improved the road over the next several years, and added a cistern in 1957 (Figure 45). Clara Peak was considered a primary lookout due to its view

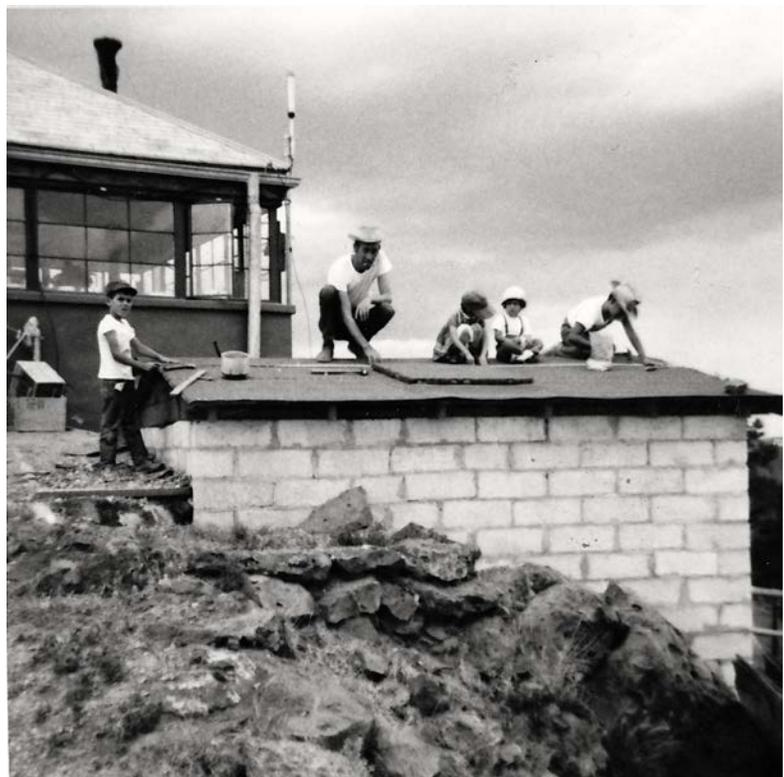
**Figure 45. Trujillo and his children working on the Clara Peak Lookout cistern (1960s, Courtesy of Adelires Trujillo)**

Water was hauled from the Ranger Station to fill the cistern; a hand pump delivered the water inside the lookout. Figure 45 shows Trujillo and some of his children working on the cistern. Nine children meant lots of laundry, including diapers. Laundering by hand was a long process of washing, rinsing, and hanging clothes on bushes to dry. Adelires said “We had to learn how to live there,” but she nonetheless loved the lookout life.
