# **Fire Lookout History of the Santa Fe National Forest**

**Barbara Zinn**

Prepared for  
Santa Fe National Forest  
Fire Management Program  
11 Forest Lane  
Santa Fe, New Mexico 87508

Report No. R2017031000012

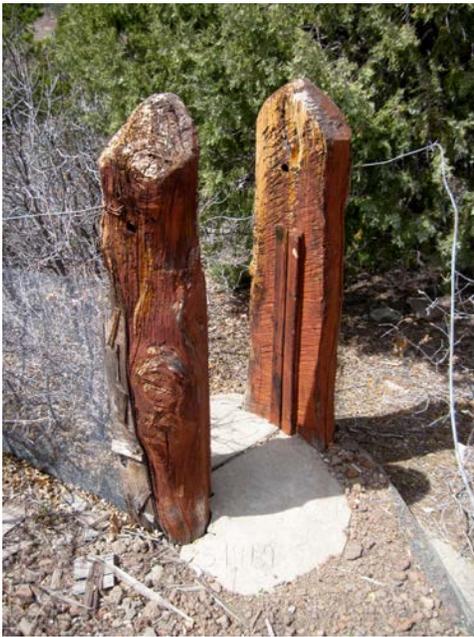
**Figure 46. Rattlesnake gate on the path to the outhouse at Clara Peak Lookout (2014, author)**

In 1969 the children encountered several rattlesnakes at the Lookout. The Ranger immediately arranged for a “snake fence” to be built around the compound, which stopped the problem. Most of this fence is still standing, with a concrete foundation topped with woven wire mesh and a narrow gate for outhouse access (Figure 46). The Forest also installed concrete walkways making it easier to spot any snakes. Next to the Lookout, a large circle of rocks enclosed the number 32; it was the aircraft marker and was repainted yearly by the lookout.

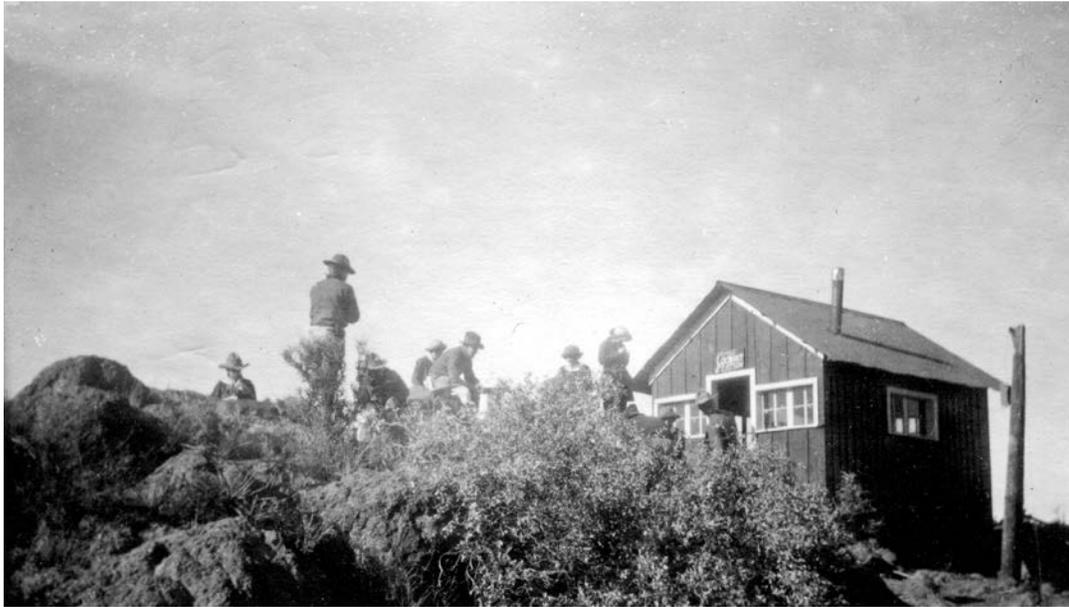
**Figure 47. Los Alamos Ranch School students visiting Guaje Mountain Lookout; a man is peering at a map board in the middle of the photograph. Note the date of construction on the sign over the door. (undated, Courtesy of Los Alamos Historical Society Archives)**

Guaje Lookout was a weekend destination for groups from the Los Alamos Ranch School. In a photograph taken on one of their visits (Figure 47), the wood frame lookout cabin looks new. The sign over the door says “5/22/1922 Lookout Station” in a flowing script, giving the date of construction. A man in the center is peering at a map board. When Aldo Leopold inspected Guaje Lookout in 1923, he evaluated Manuel Maestes, the lookout fireman, and reported that there was no tower or pasture. In 1924 the Forest made a seen-area map. The 1926

inspector approved of the “good combined observatory and cabin” with its many windows, and lightning protection was completed that year. In 1930 Guaje reported a fire right under the St. Peter’s Dome Lookout.<sup>21</sup>

Johnson did all the development himself: reconnoitering the location, removing the telephone line from Rowe Peak and installing one to Escobas, building the cabin, and finding and training lookouts. He was able to haul supplies by wagon to within 300 yards of the summit, and built a trail up the north side from that point. No photographs have been found of this cabin. It was probably framed with dimensional lumber like Guaje Lookout (Figure 47 in the Española District chapter), which was also built in 1922.<sup>41</sup>

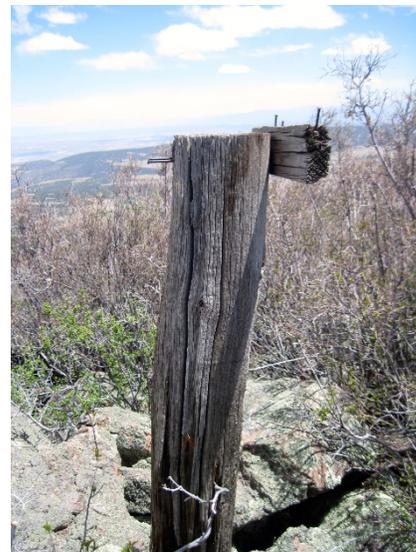
**Figure 50. Map board pedestal at Tree 73 Lookout (2014, author)**

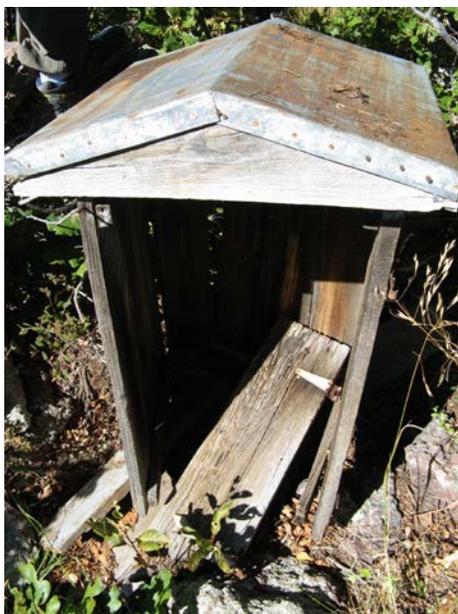
**Figure 51. Telephone box at Tree 73 Lookout (2014, author)**

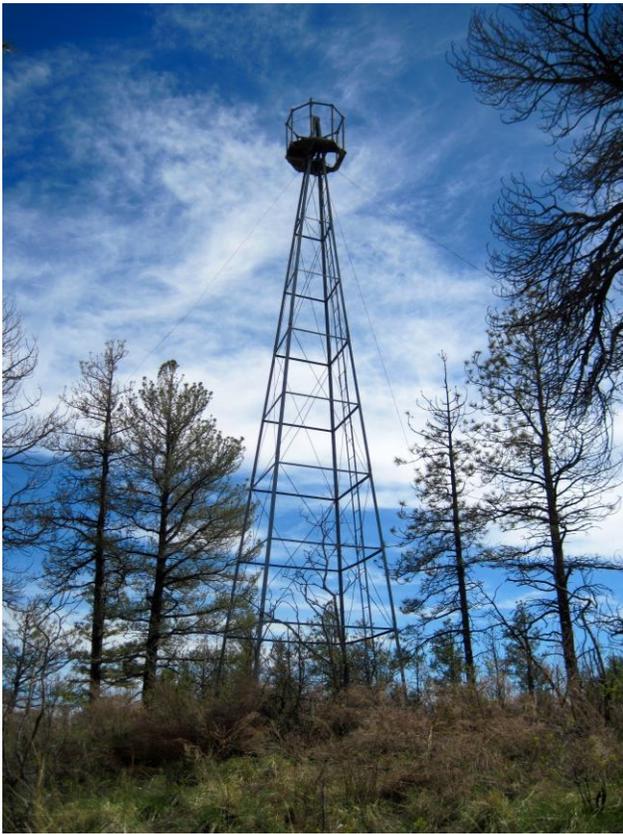
**Figure 54. Bearhead Lookout (2015, author)**

In 1913 Bearhead was a riding patrol point, probably with a tree lookout to improve the view from its forested summit. In 1915 the Forest erected a steel tower on Bearhead that it obtained from the U.S. Weather Bureau. This tower, still standing on the summit in 2014 (Figure 54), is stamped "Local Office Weather Bureau Santa Fe New Mexico." Its tiny wooden platform barely has room for a map board, and although the Forest reportedly installed lightning protection on it in 1926, this was probably never completed and it has none today.<sup>3</sup>

A seen-area map was made in 1915 or 1916. The earliest tower on Barillas was an “[o]ld Weather Bureau Tower erected prior to 1920.” The Forest obtained at least one such tower from the U.S. Weather Bureau in Santa Fe around 1915 and erected it on Bearhead Peak (Figures 54 in the Jemez chapter and 76). It probably also got a second and placed it on Barillas. In 1915 Barillas replaced the unnamed lookout point just southeast of it. The 1916 inspector said

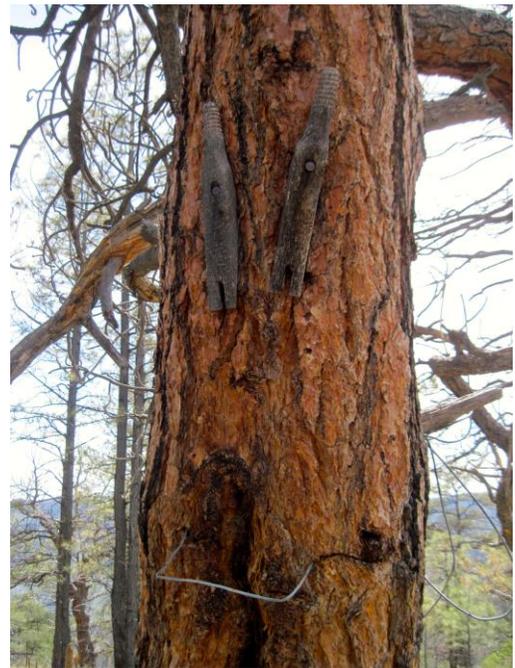
**Figure 55. Telephone tree at Bearhead Lookout, with wooden brackets for glass insulators (2015, author)**

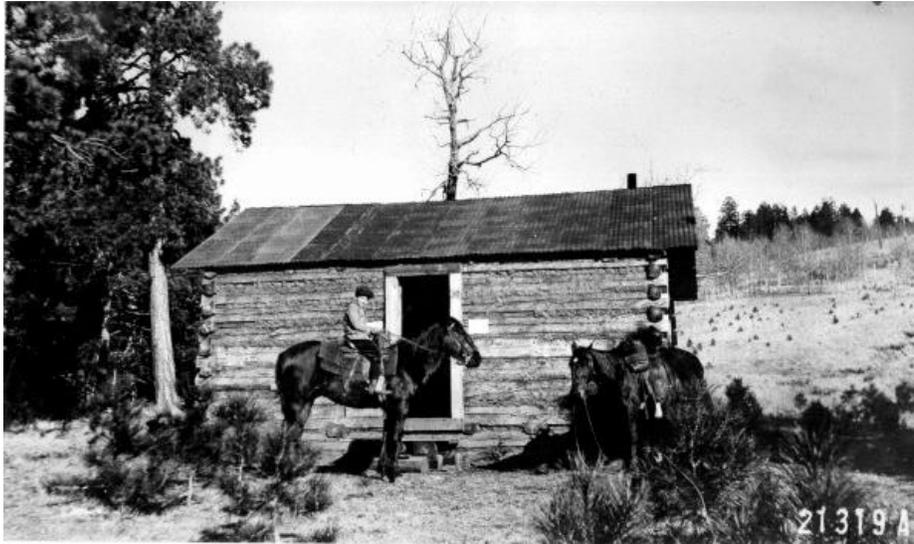
**Figure 58. Original Lookout/Administrative Cabin on Cerro Pelado, one mile west of the summit (c.1914, A.J. Connell, USFS Southwest Region Historic Photos Online Collection)**

Until timber sales declined in the 1970s, Forest Service timber sale officers counted and stamped, or "scaled" timber. The Forest placed small temporary cabins at timber sales for the scaler's use, then moved them to the next sale. Scalers' cabins were also used at a few lookout sites. They were "of rough lumber and unpainted, usually constructed at the warehouse in Santa Fe...substandard but serve a useful purpose at low cost." One is shown in Figure 58 in the Jemez District chapter.<sup>2</sup>

Fire guard Pedro (Pete) Sandoval, Moises Sandoval's uncle, built this log lookout cabin (Figure 58) by 1912 and served as the first Cerro Pelado lookout. The cabin and pasture cost 325 dollars to construct. From this cabin the lookout walked or rode the mile to the summit for observations. Also called the Cerro Pelado Ranger or Administrative Cabin, it served as "a supply house for outfitting forces gathered in that vicinity," including Bearhead Lookout. The boy on horseback in Figure 58 may be Pedro Sandoval's son Simon, who later staffed Cerro Pelado for many years.<sup>12</sup>

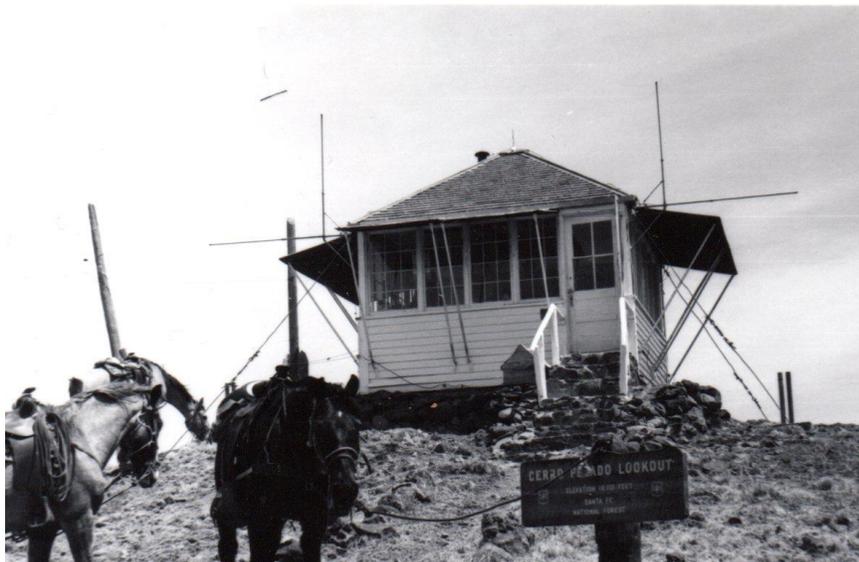
**Figure 60. L-4 built at Cerro Pelado by the CCC in 1933 (undated, archeology binder 23, no.4535, SFNF SO)**

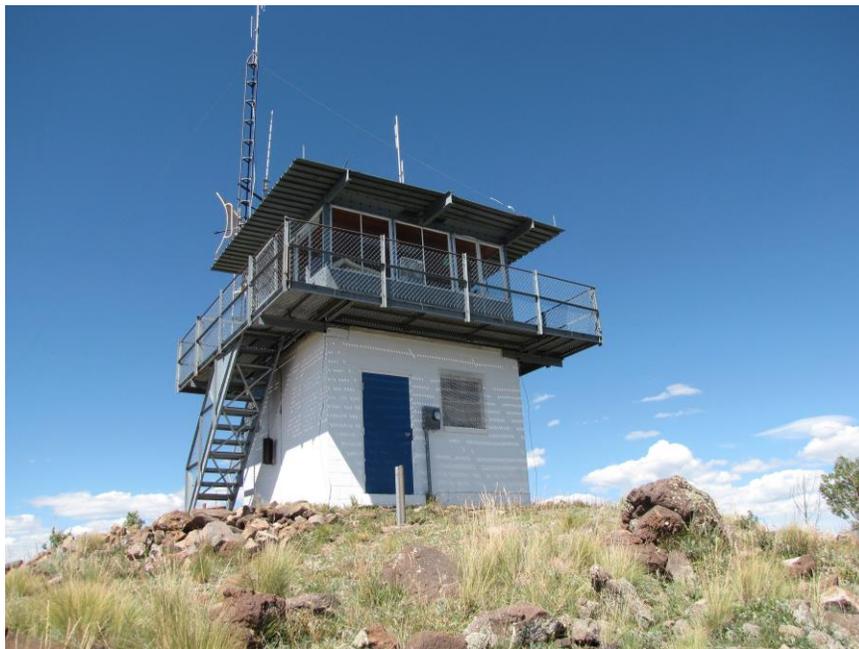
**Figure 62. Current Cerro Pelado Lookout, an R6 flat CL-100. (2010, Courtesy of Janie O'Rourke)**

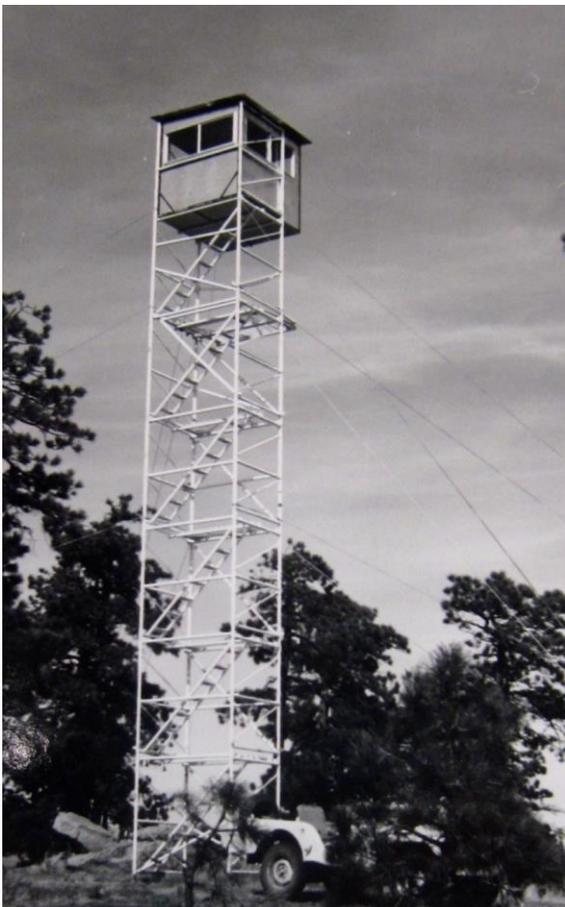
**Figure 64. Turkey Lookout built by State Forestry, very similar to Joaquin Lookout (1964 GII, State Forestry Cooperative Review, NARA, A1/105)**

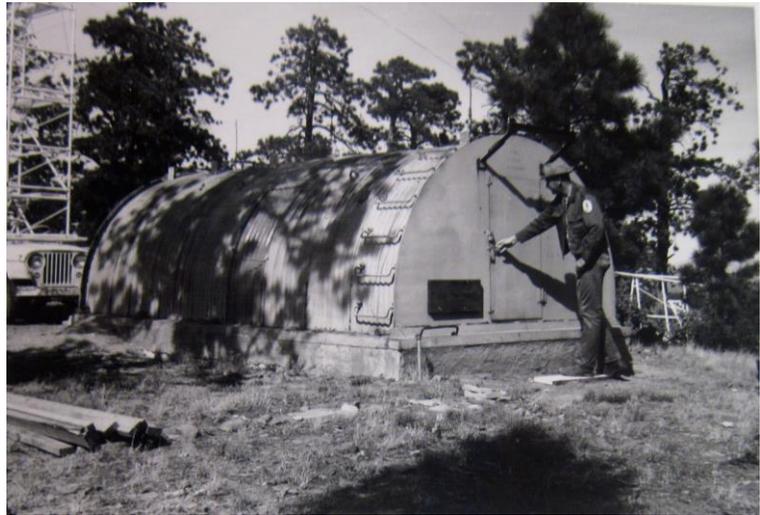
**Figure 65. Turkey Lookout quonset hut built by State Forestry, very similar to Joaquin Lookout cabin (1964 GII, State Forestry Cooperative Review, NARA, A1/103)**

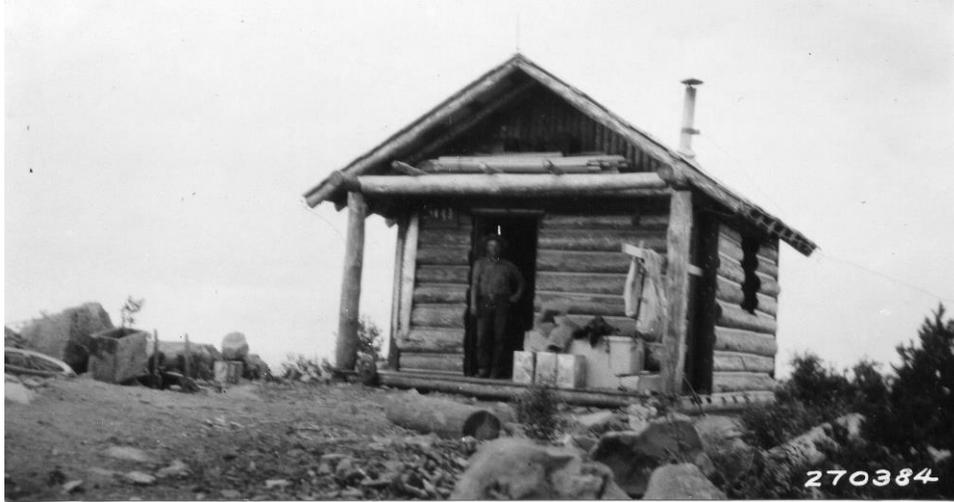
**Figure 67. First lookout cabin on St. Peter's Dome. The Forest was chided for not putting enough windows in this lookout. (1932 Inspection, NARA, 5/41)**

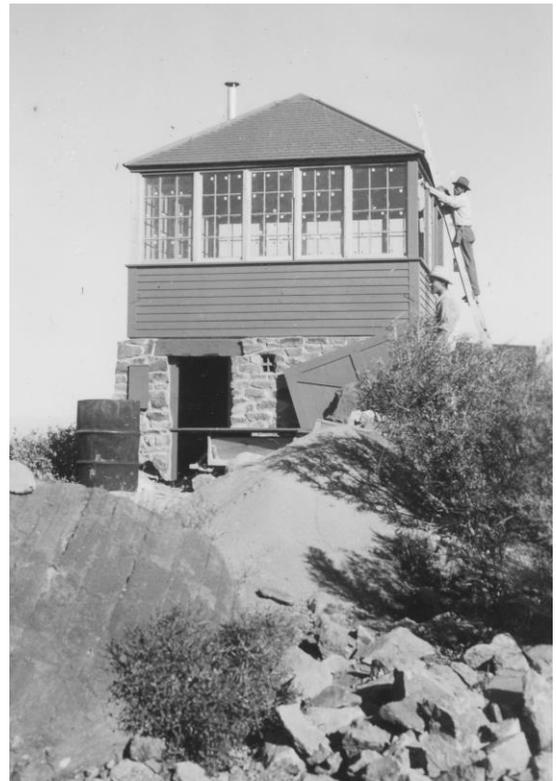
**Figure 68. Construction of the L-4 on St. Peter's Dome by the CCC in 1940 (1940, Improvement and Construction Detail Pictures, SMC, RO coll bldg folio/73)**

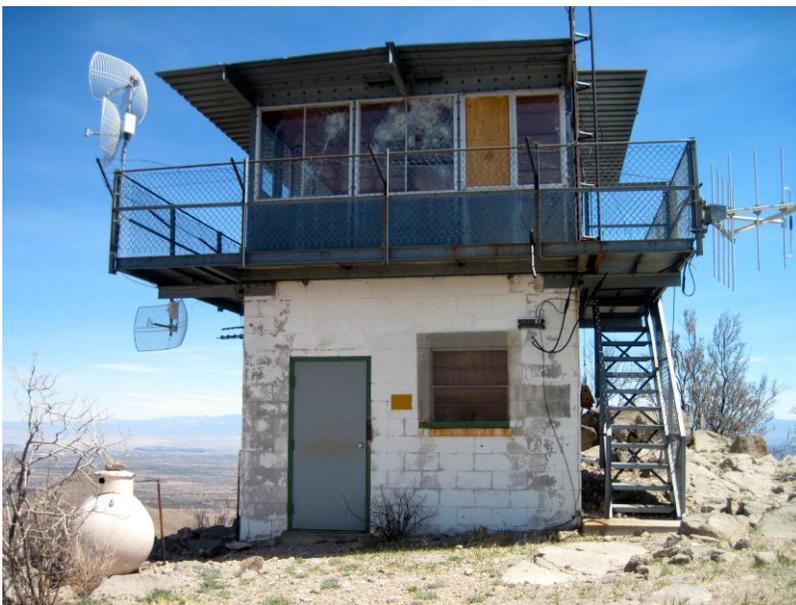
**Figure 70. Current CL-100 (R6 flat) St. Peter's Dome Lookout; note vandalism. (2014, author)**

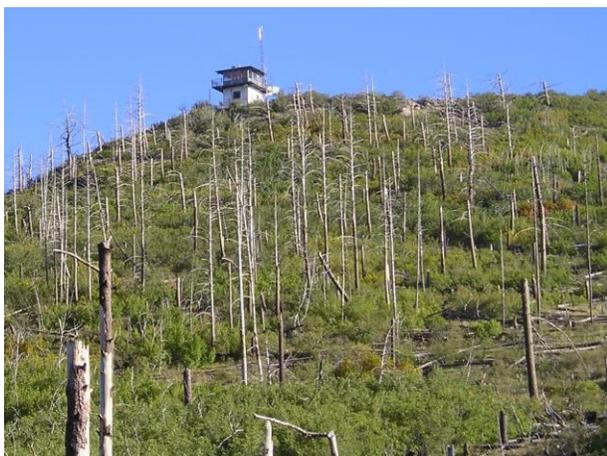
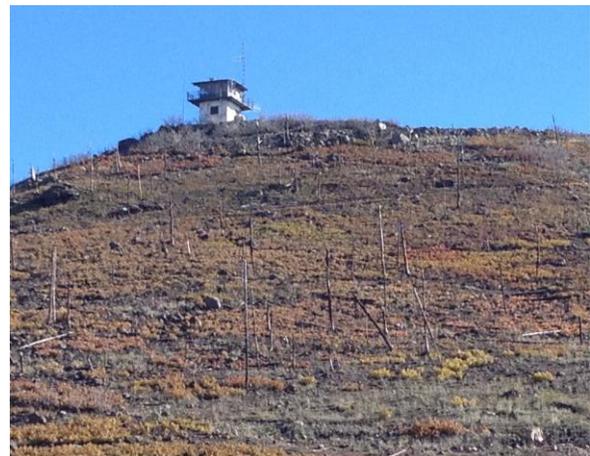
**Figure 71. St. Peter's Dome Lookout area 10 years after the 1996 Dome Fire (2006, Courtesy of Janie O'Rourke)**

**Figure 72. St. Peter's Dome Lookout area 3 years after the 2011 Las Conchas Fire; compare deforestation with figure 71. (2014, author)**

remaining from the Dome Fire, the area was essentially deforested and the lookout was closed for good. Figures 71 and 72 show the tower and surrounding area 10 years after the 1996 Dome Fire, and 3 years after the 2011 Las Conchas Fire, respectively. Several agencies now keep radio equipment in the lookout basement.<sup>54</sup>

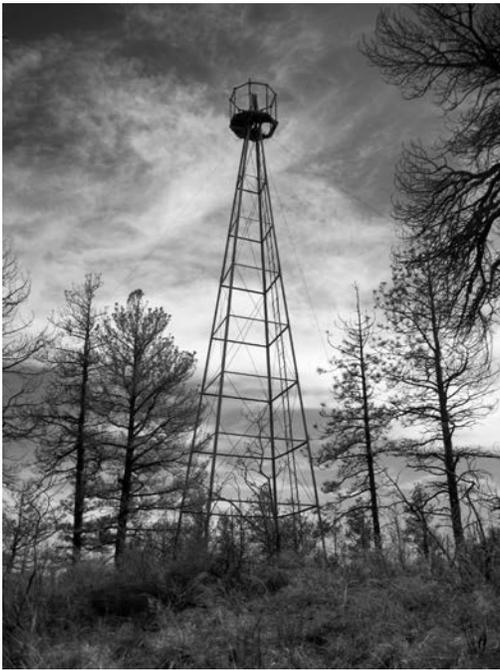
**Figure 76. Probable first tower on Barillas Peak. The photograph is of Bearhead Lookout, and the Forest probably installed an identical tower on Barillas Peak around 1915. (2015, author)**

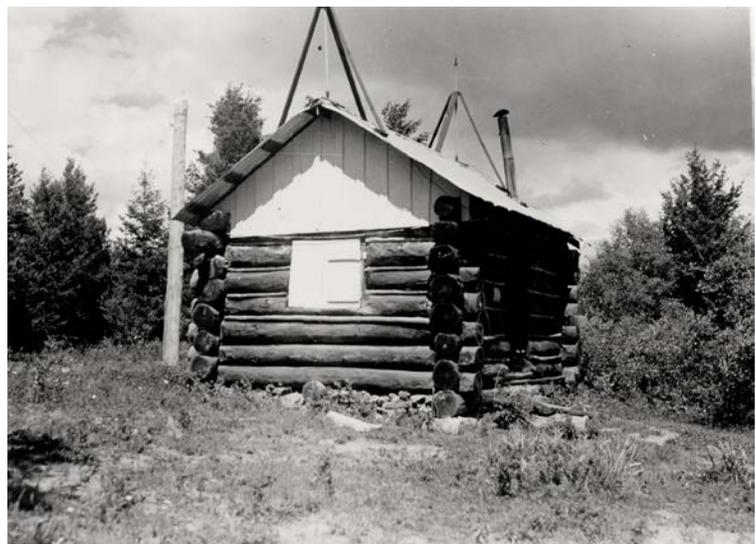
**Figure 77. Barillas Peak Lookout cabin built in 1925-1926 (C.W. McKenzie, 1940 Inspection, NARA, 5/138)**

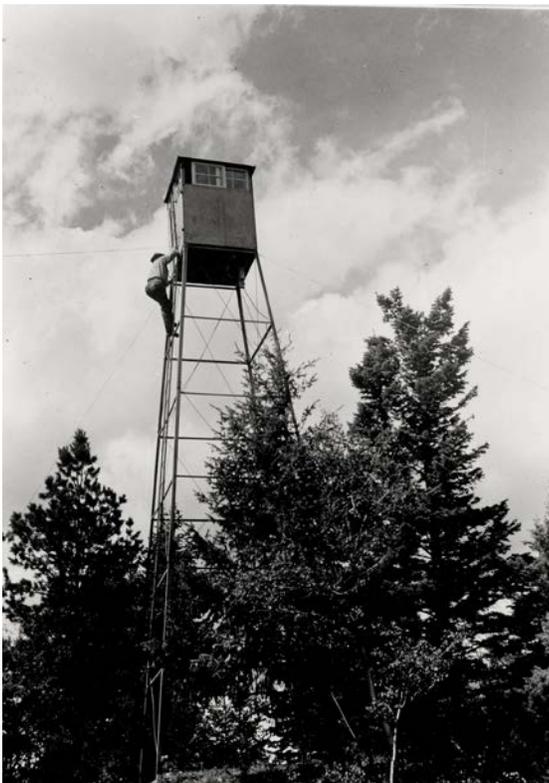
**Figure 78. Second Barillas Lookout tower, built by 1928. Forest Supervisor Andrews is trying and failing to open the cab door from the ladder. (C.W. McKenzie, 1940 Inspection, NARA, 5/139)**

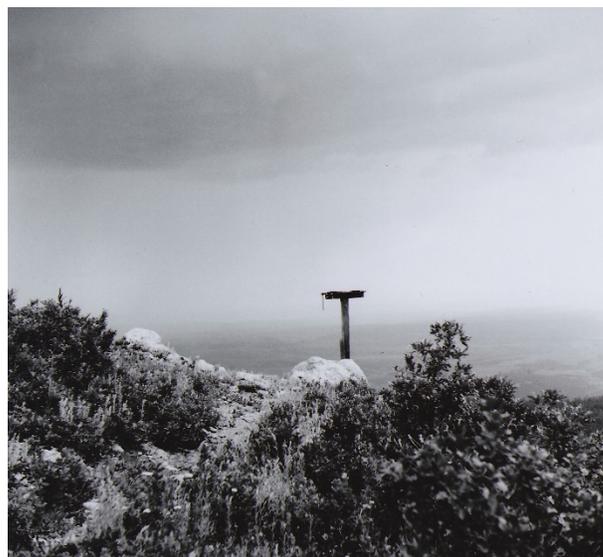
**Figure 79. Map board on the southeast point of Barillas Peak, one of three used after the old tower was condemned. (mid-1950s, archeology binder 53, negative no. 10082, SFNF SO)**

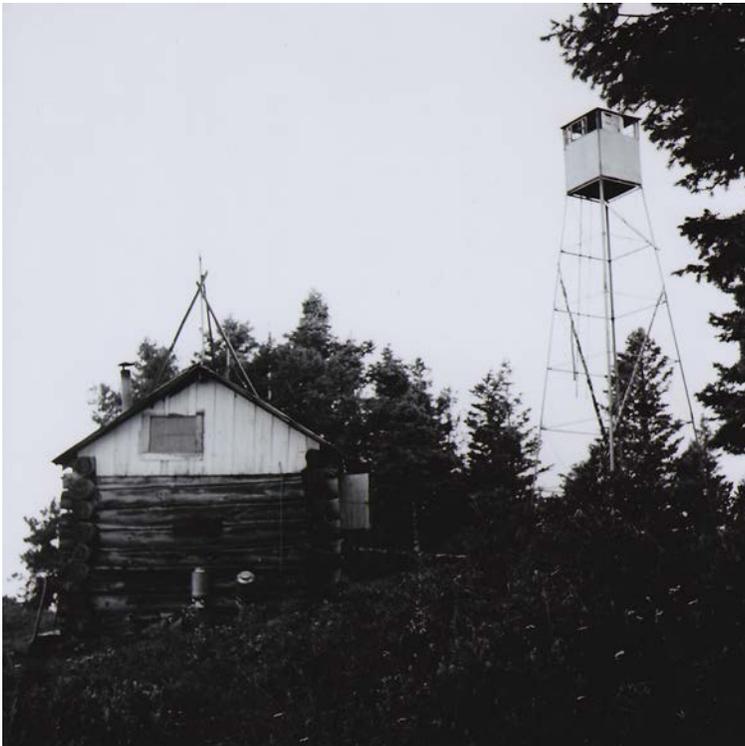
**Figure 80. Barillas Lookout tower and cabin in the mid-1950s. (mid-1950s, archeology binder 53, negative no. 10088, SFNF SO)**

Figure 16 a young man looks through the wooden Cerro Valdez alidade. Hermit Peak had a map board at each of its three patrol points, and Barillas had several outdoor map boards during the years its tower was condemned (Figures 93 and 80 respectively in the Pecos/Las Vegas District chapter). The metal map board at Los Griegos was in use through the 1960s. Outdoor map boards on wooden posts were also used at Cerro Pelado, Rowe Peak, Mud Spring, Cuba Mesa, Cerro Valdez, North Point and Tree 73. Although the Guaje Lookout cabin was partially glassed-in, a map board stood outside.

heating and cooking, table, chairs with insulators, Coleman lantern, battery box, map for determining legal locations of smokes, and metal cabinets to protect food and supplies from rodents. With no insulation under the metal roof, the cabin was very noisy in hailstorms. Figure 80 shows the cabin and old tower in the mid-1950s. The lookout used the radio in the cabin to make reports, as the telephones had been removed in the early 1950s. Some nights, Vigil chatted in Spanish over the radio with the lookouts at Clara Peak, Deadman and Red Top. There were no visitors as the roads were poor and the last mile and a half was trail. Although Vigil monitored his son’s activities at Barillas, Fred managed to climb the forbidden ladder up the old tower and looked into its cab. It was

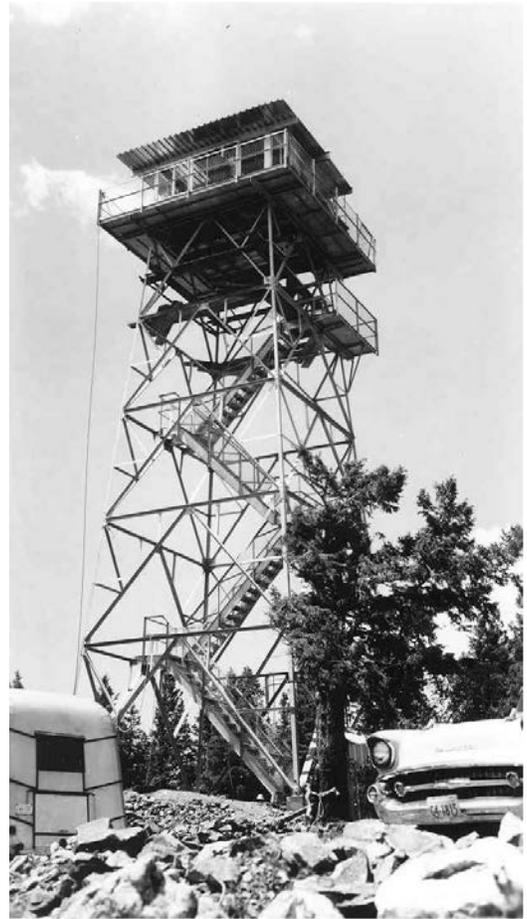
**Figure 81. Current Barillas Lookout tower built in 1959, a CL-100 (R6 flat), shown during construction. (June 26, 1959, negative no. BLO2, source FSMSW FS 1999.3.25, Digitized Photographs held by the Forest)**

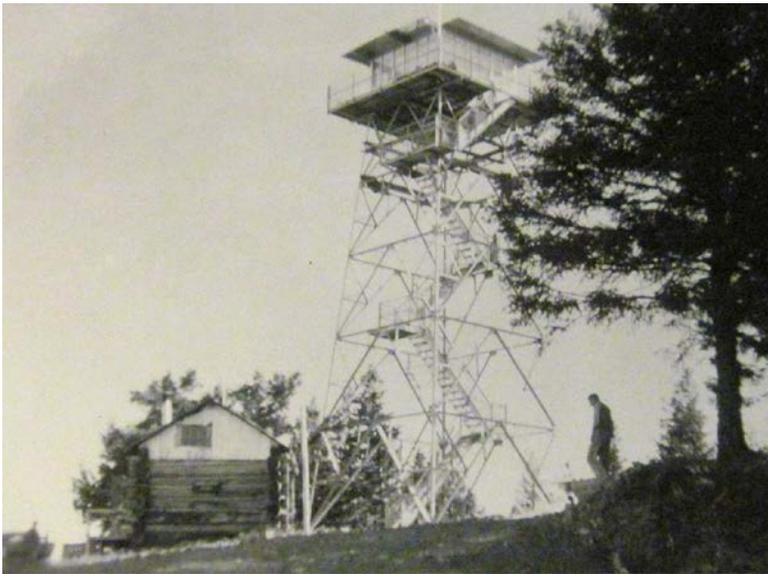
**Figure 82. Relationship of newly-completed Barillas Lookout tower to the old cabin (1959 Engineering Inspection, NARA, 5/237)**

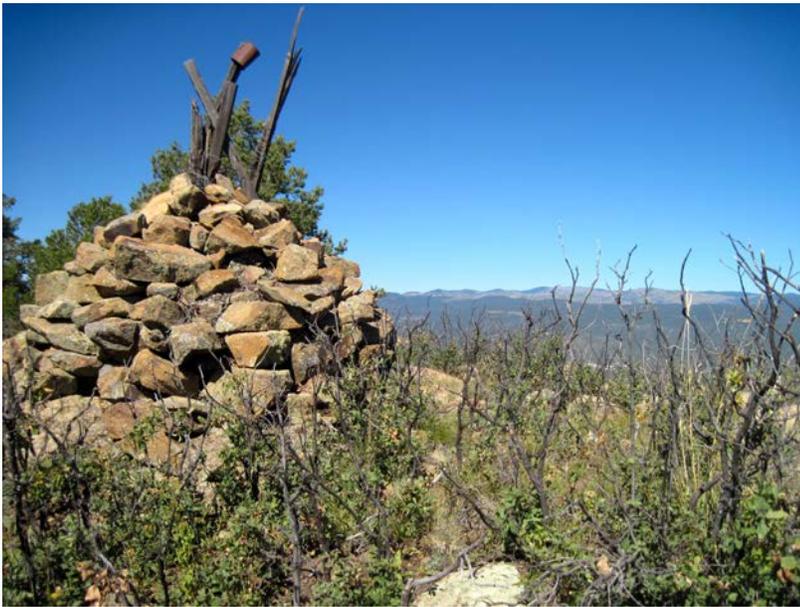
**Figure 84. Escobas summit cairn with view toward Pecos Wilderness (2014, author)**

Escobas was last shown on the 1933 Forest Map, although it was apparently retained as an emergency lookout. Proposed 1939 telephone improvements included running a line “from Pecos via Escoba Emergency Lookout point to Cow Springs... [to allow] emergency detection”. By 1953 only a cairn with a pole remained at the site and was still in place in 2014 (Figure 84),

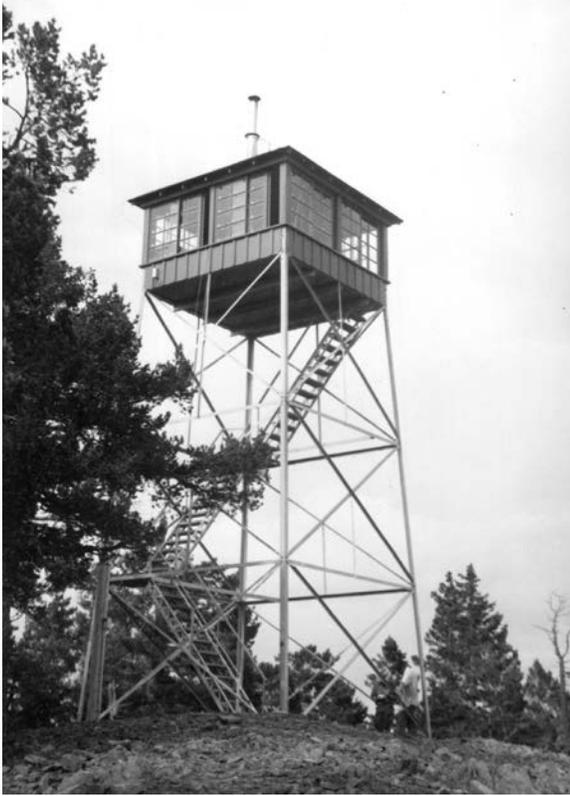
**Figure 86. Glorieta Baldy Lookout shortly after completion (1940, archeology binder 45, no. 9094, SFNF SO)**

Wester took over the lookout duties along with construction work. Figure 86 shows the lookout shortly after completion.<sup>51</sup>

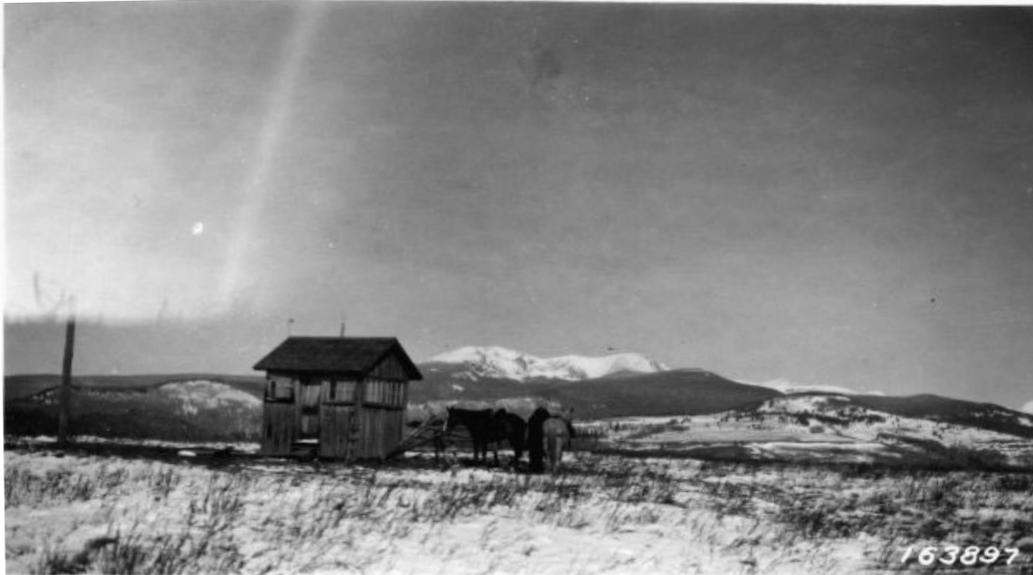
**Figure 89. “1921—The lookout on Grass Mountain. With no trees nearby to obstruct the view, this lookout did not need a tower.” (1921, J. D. Jones, USFS Southwest Region Historic Photos Online Collection)**

Spring of 1916 was also dry, and Grass Mountain was staffed when the primary high point lookouts, Lake Peak, Jicarilla Peak, and Elk Mountain, were inaccessible through snow. By that time there was “a very neat little cabin on Grass Mountain used as a shelter for the lookout man. It is a small frame building with shingle roof. There are windows on all 4 sides” (Figure 89). Its construction date is unknown.<sup>60</sup>

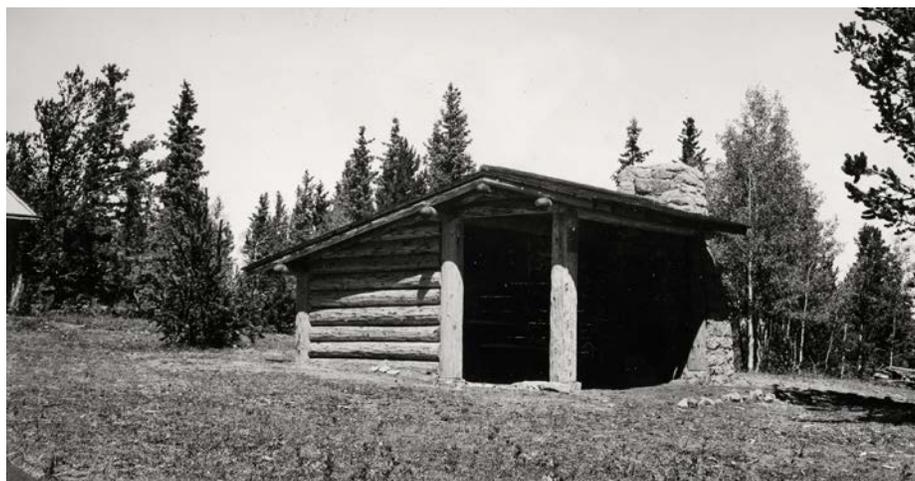
**Figure 90. Hermit Peak hiker shelter built by the CCC in 1936 (undated, Improvement and Construction Detail Pictures, SMC, RO coll bldg folio/91)**

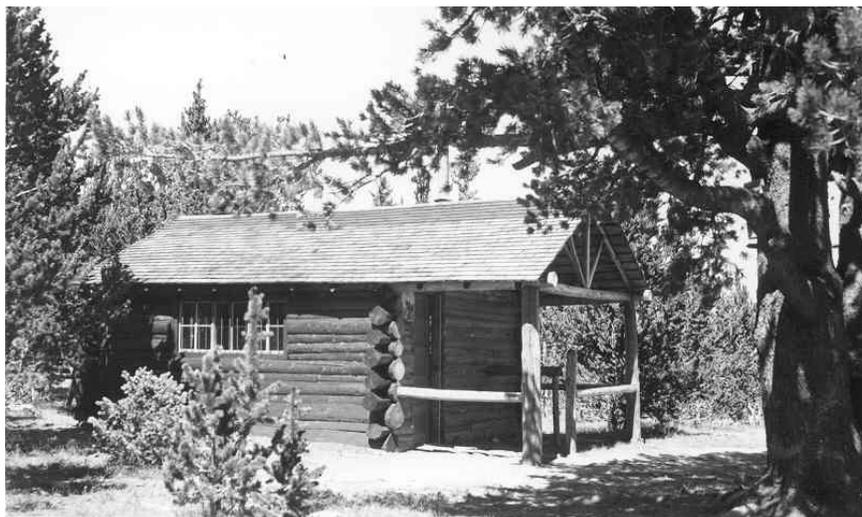
**Figure 91. Hermit Peak Lookout cabin built in 1944-1945 (October 1946, Improvement and Construction Detail Pictures, SMC, RO coll bldg folio/55)**

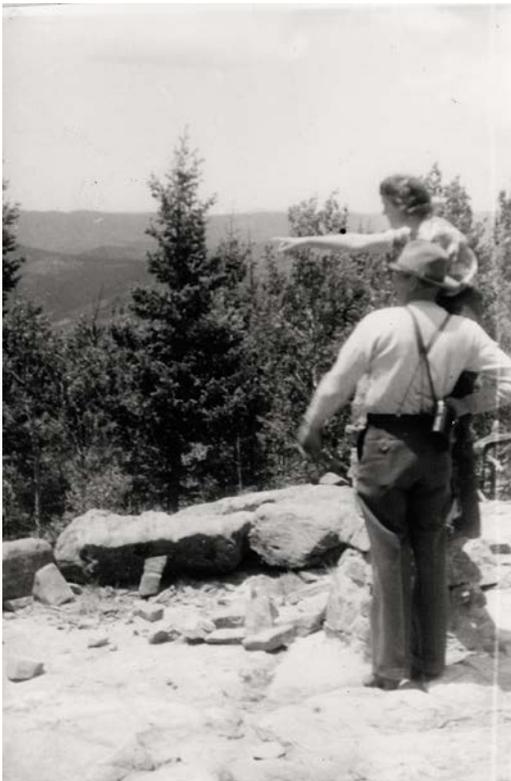
**Figure 92. Mrs. Springfels, Hermit Peak relief lookout, pointing towards Barillas from the west protractor point; the inspector is in front of the cement and rock protractor stand. (June 19, 1946, Edward Ancona, NARA, 1946fireinsp/10)**

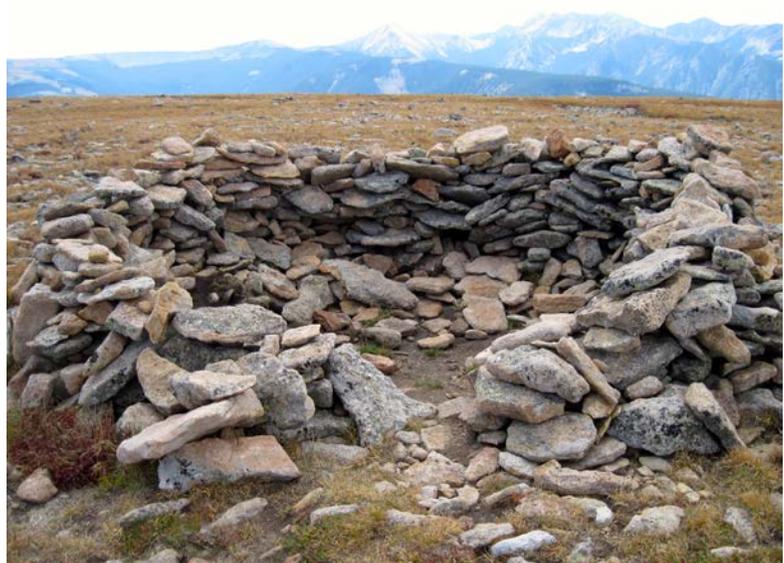
**Figure 93. Rock shelter on Jicarita Peak, very similar to the lookout structure on Penitente Peak (2016, author)**

and very similar to the lookout structure on Penitente Peak (Figure 93). No remains of telephone poles or lines were found. The lookout would have had to patrol across the broad summit to get full views, which are outstanding in all directions.

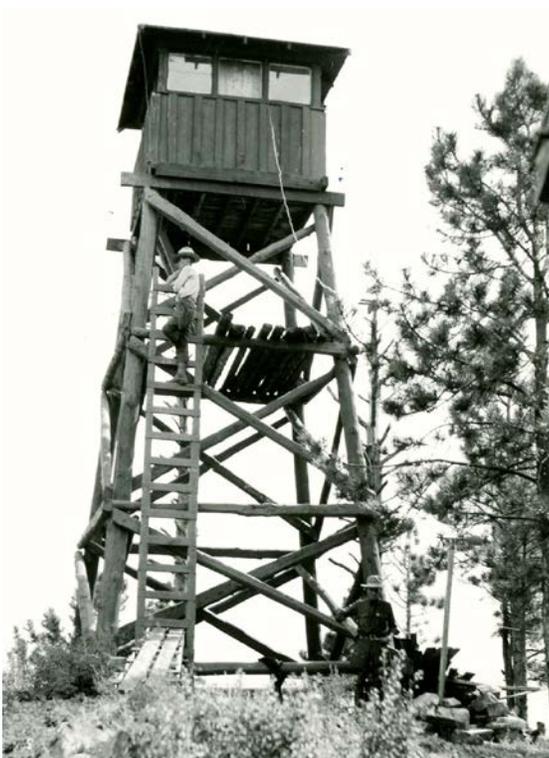
**Figure 94. Pole tower at Mt. Sedgewick Lookout on the Cibola National Forest, possibly similar to Pecos Peak Lookout (1932, SMC, RO scans old photos/10)**

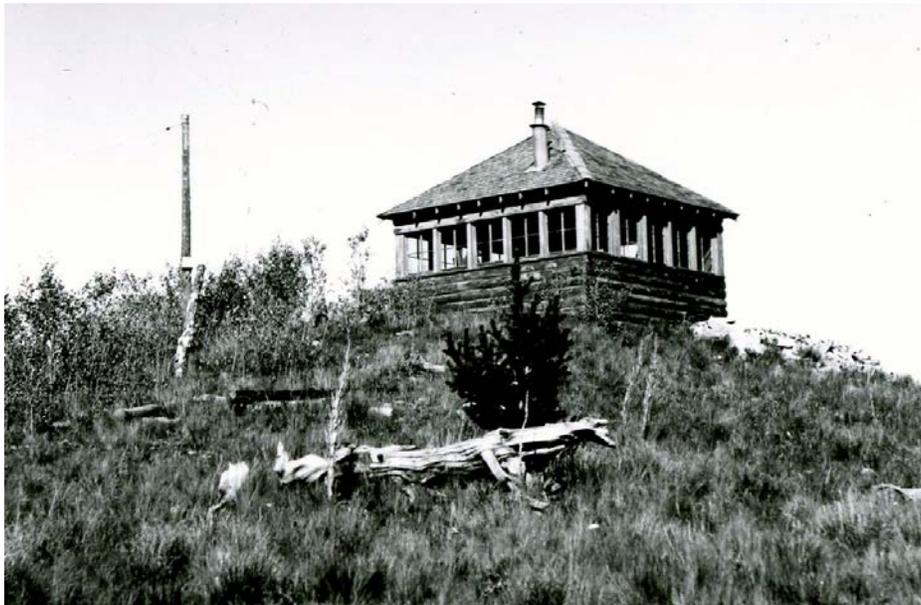
**Figure 95. Rosilla Lookout (1946, SMC, RO scans old photos/61)**

A 1946 inspector described Rosilla as a 14- by 14-foot ground house on skids, well built but incomplete inside (Figure 95). It was a frame building covered with Shevlin commercial siding, made to look like peeled pine logs, and it held a woodstove and two cots. In 1946 access was via a poor road and one mile of trail, but by 1956 a road reached all the way to the Lookout. A handwritten progress note said the cabin interior was completed in 1948. Rosilla was one of the few lookouts on the Forest that never had an Osborne firefinder, just a protractor and alidade.<sup>83</sup>

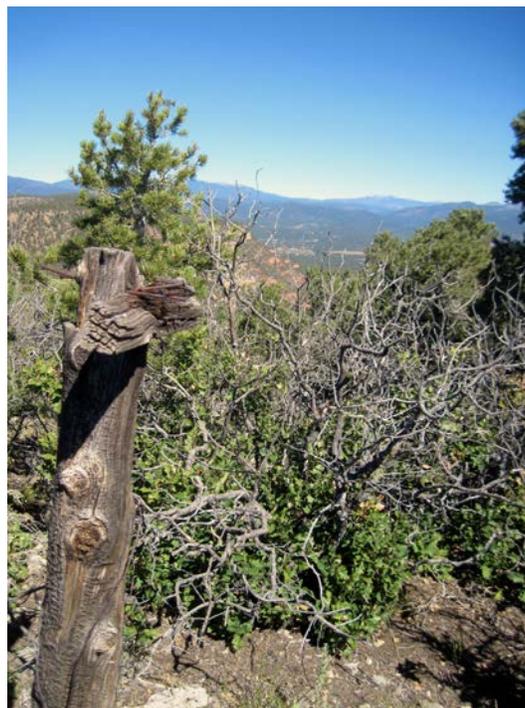
**Figure 96. Map board pedestal on Rowe Peak, with view to Pecos Wilderness (2014, author)**

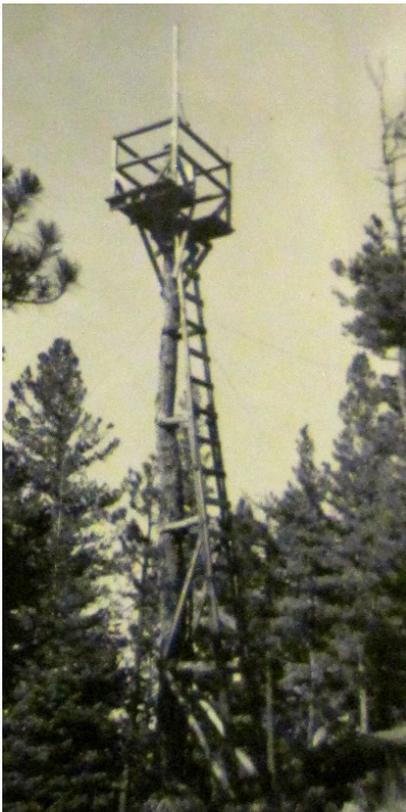
**Figure 97. Whites Peak tree lookout, built in the early 1920s. (June 1947, Substandard Improvements Folio, SMC, RO day2/78)**

This lookout site lies northeast of the Forest between Ocate and Cimarron, in an area of mixed State and private lands. Sometimes called White Peak or Black Lakes, it is shown on the second map at the beginning of this chapter. The first lookout was built in the early 1920s, a topped tree with ladder and platform (Figure 97). In 1926 the Carson National Forest and the State made a cooperative agreement to protect the Black Lakes area and staff Whites Peak Lookout. The area was heavily logged in the late 1940s, and the cooperative agreement was working well. In 1948 this tree lookout was one of the last two in use in the Region, but Region felt it was unsafe, having “already caused one permanent injury to a former lookout.”<sup>91</sup>

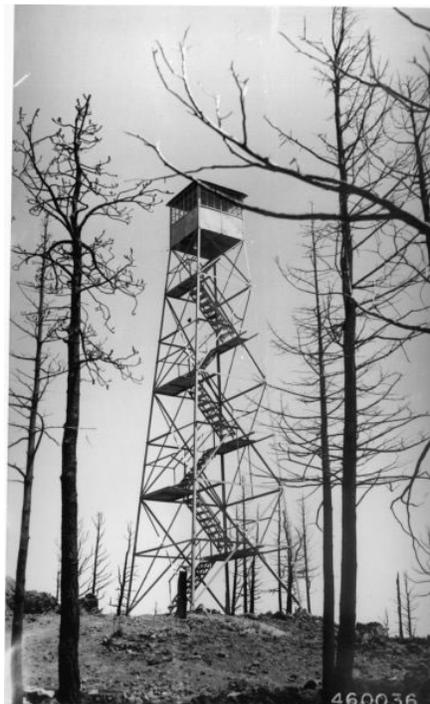
**Figure 98. Whites Peak Lookout, an Aermotor LS-40 built in 1949, shown after the 1950 Ocate Fire. (1950, R.H. Lewis, USFS Southwest Region Historic Photos Online Collection)**

lookout was quickly restored (Figure 98). The Fire obliterated the old tree lookout and the cabin, generally cleaning up the area just as recommended in the 1949 inspection. In 1951 the lookout stayed in a tent on a platform, though the State Land Commissioner was willing to finance a new cabin “if the State does not sell the land.” The site was also used as a work center by the New Mexico State Land Office in the early 1950s, with a crew living on site for timber cruising, fire patrol and suppression.<sup>93</sup>

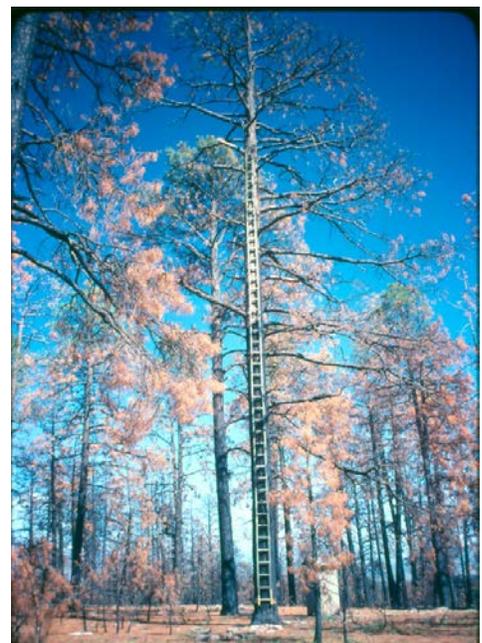
**Figure 100. Tree Lookout at the Y of Upper Crossing Trail, built and installed by the CCC in November 1936. Photograph taken after the La Mesa Fire. (1977, Chris Judson, National Park Service, Bandelier National Monument)**

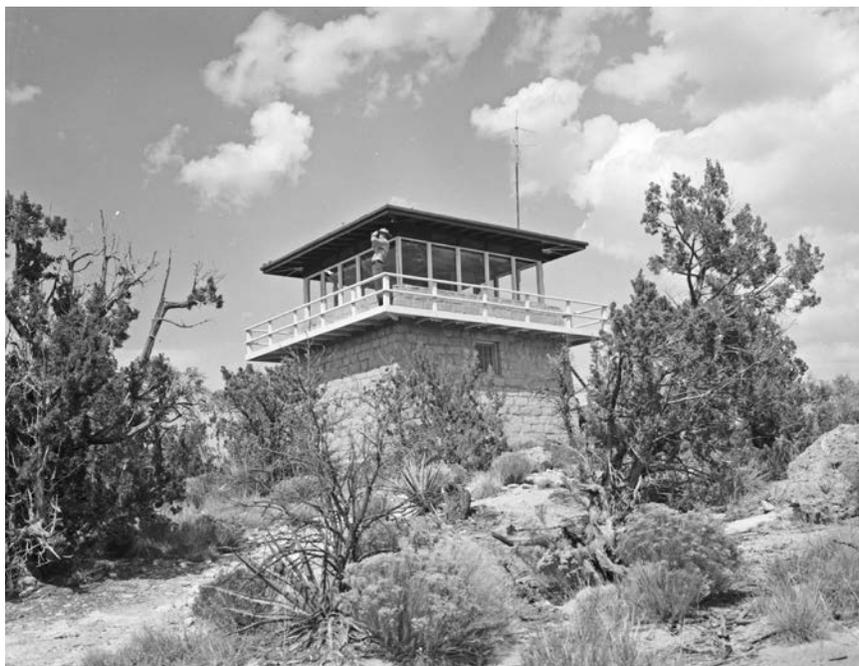
**Figure 101. Bandelier Lookout, built by the CCC in 1940-1941. (1964, BANC\_2387, NPS, Bandelier National Monument, Early 20th Century Photo Archives)**

In 1953, the AEC “conducted a series of tests in a technical area northeast of [Bandelier] headquarters, and as a result broke windows in the lookout...The AEC replaced the windows. The custodian wrote that he awaited the results of the seismograph reading to determine the strength of the tests. He never printed the results.” Bandelier added a slump block kitchen/bathroom addition to the first-floor living quarters in 1956. Sometime between 1965 and 1971, the windows were remodeled from vertical (Figure 101) to sloping.<sup>15</sup>

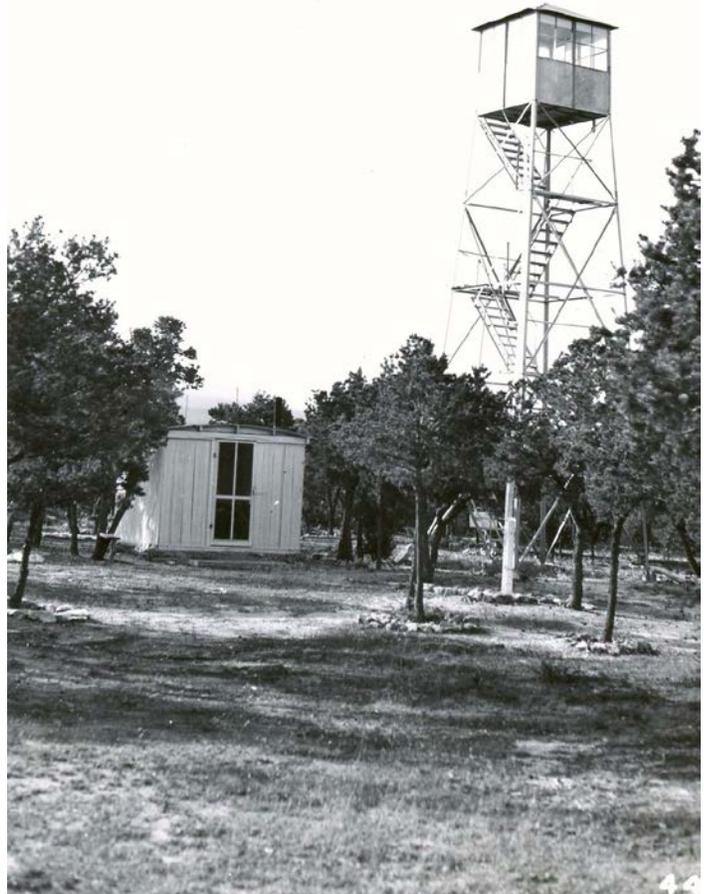
**Figure 102. Puye Lookout, an Aermotor LS-40 built by the Indian Service in 1931 or 1932. Scaler's cabin served as lookout quarters. (undated, SMC, RO scans old photos/54)**

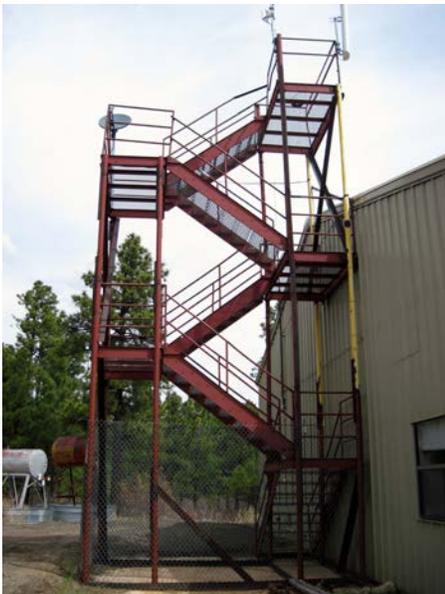
**Figure 104. Lookout structure at Cabo Lucero fire station, previously a fire escape on the Montezuma Hotel. (2016, author)**

This fire station for the Volunteer Fire Department was built northwest of Mineral Hill in 1992, with an attached steel tower and an open platform for detection (Figure 104). Its view includes areas blind to Barillas Lookout. The tower had previously been the fire escape on the Montezuma Hotel, and was obtained during its restoration. The firefinder came from Whites Peak Lookout after its closure by the State.<sup>32</sup>

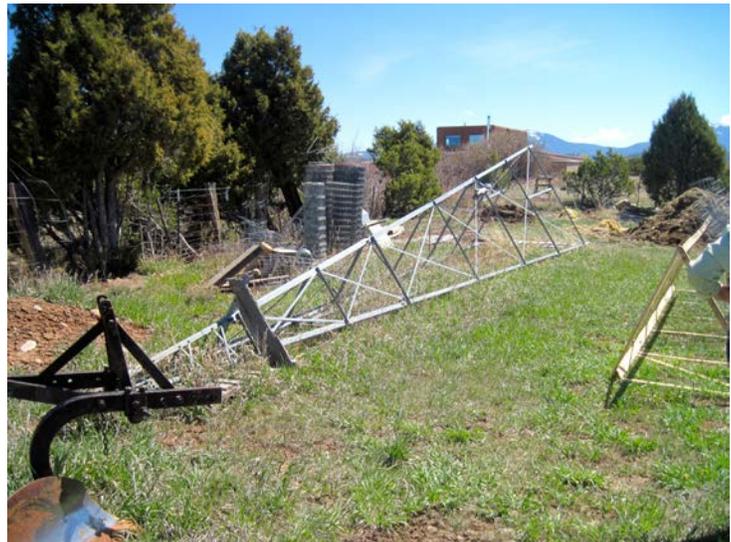
**Figure 106. The Truchas Lookout wind generator tower on the ground in Truchas (2015, author)**

Fire Plans of 1940 through 1955 list a per diem guard as Truchas lookout during high fire danger. Gilbert took over as storekeeper and Fire Warden in 1963. By the late 1960s, the tower was no longer used for spotting fires. In 2013 Gilbert’s son gave the tower to friends in Truchas, and in 2015 it was on the ground in their pasture (Figure 106).<sup>44</sup>
