## **Riparian Area Condition Item 22**

**OBJECTIVE:** Ensure compliance with Forest Plan standards for fisheries, water, and wildlife.

**REPORTING PERIOD:** 2014-2015

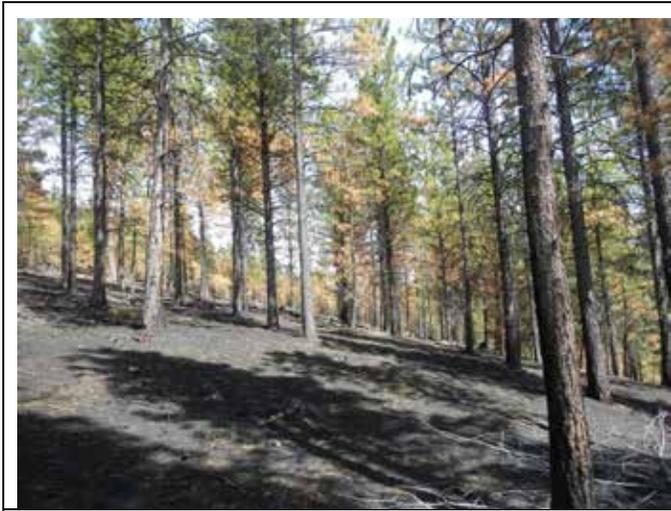
The only RHCA in Unit Bravo is the 100-foot wide RHCA surrounding Wheeler Creek. Fire was allowed to back down into the Wheeler Creek RHCA, but it made minimal inroads. In most places, the fire went out on its own along the outer half of the 100-foot RHCA. In a few locations, low severity fingers burned to within 10-15 feet of the waterline. Tree mortality in the RHCA is likely to be close to zero. There was no evidence of significant soil erosion and movement occurring. Hand line construction did not occur in the RHCA.

**Photo 1 – Typical Post-Burn Conditions in the Uplands in School Point Unit Bravo, Burn Blocks 1-3, May 2014**

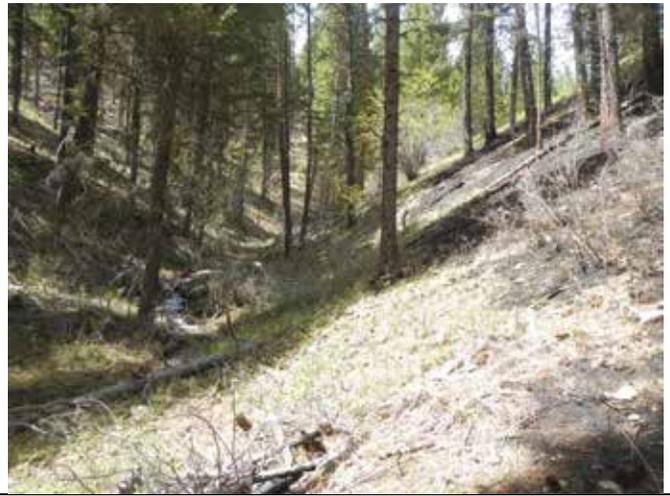
**Photo 2 – Typical Post-Burn Conditions in the RHCA along Wheeler Creek in School Point Unit Bravo, Burn Blocks 1-3, May 2014**

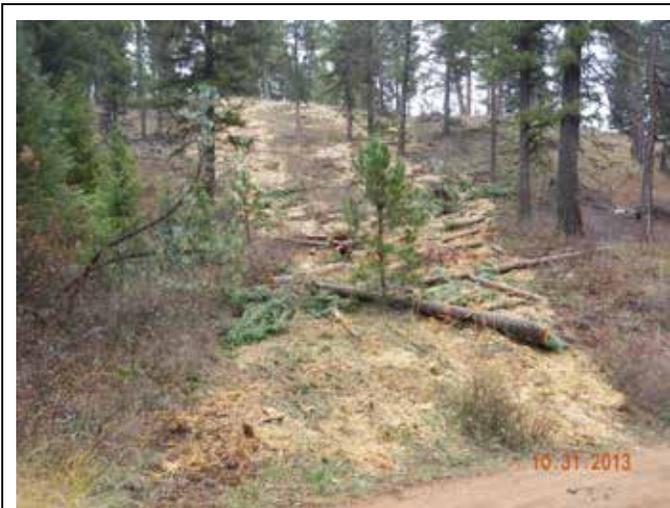
The recontoured machine lines and hand lines were monitored during the 2014 and 2015 field seasons. Significant erosion was not observed on the recontoured lines, and the recovery of grass cover was satisfactorily progressing in most areas. Nothing was observed that posed a threat to fish habitat quality or riparian integrity.

**Photo 3 – Recontoured Gold Pan Fire Feller Buncher Line in the Soda Springs Creek Drainage, October 2013**

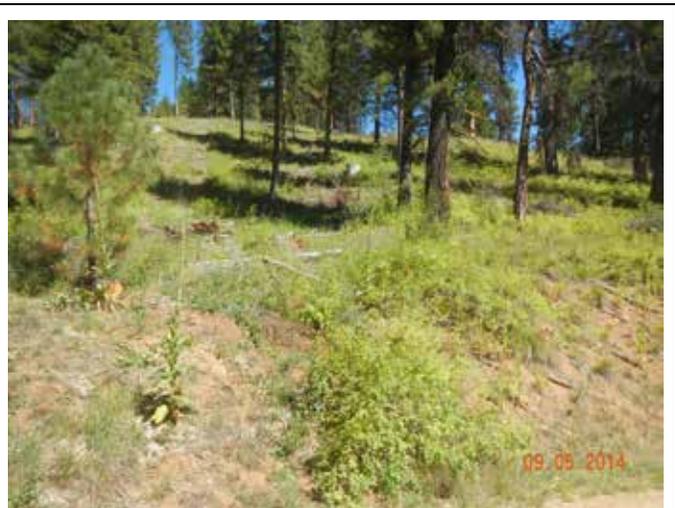
**Photo 4 - Same Line after One Growing Season, September 2014**

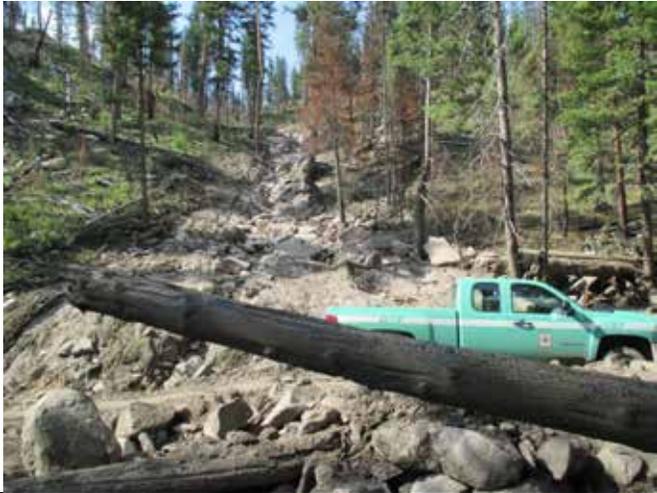
Intense thunderstorms on August 14, 2014 triggered six large debris flows in the Deep Creek drainage. The debris flows were centered around the Scimitar Creek drainage on the north side of Forest Road 468. A two mile long segment of Forest Road 468 was intermittently buried in about half a dozen spots with alluvial material to a depth of 3 to 10 feet. The Bitterroot NF road crew spent about a month removing the alluvial material from the road surface. They installed several new culverts in the ephemeral and intermittent draws that were scoured to bedrock and now contain surface flows, and also graveled the road stream crossings.

**Photo 5 – Gold Pan Fire Debris Flow in the Deep Creek Drainage, August 2014**

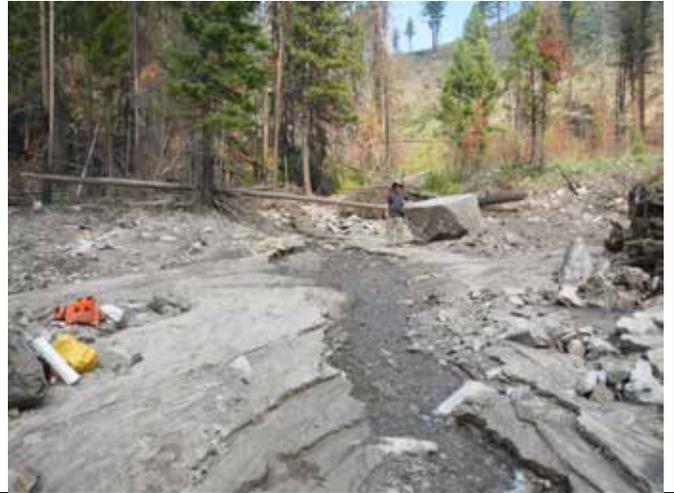
**Photo 6 - Forest Road 468 Crossing of Scimitar Creek after the Debris Flows. The 2013 Fish Culvert is Buried near the Large Boulder in the Photo, August 2014**

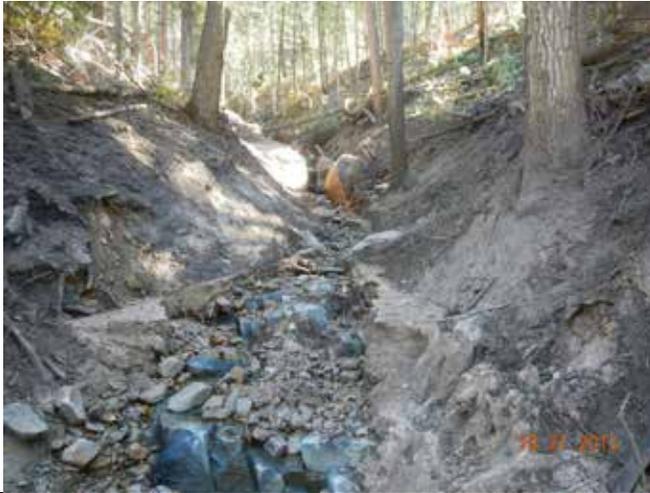
**Indian Ridge Wildfire (West Fork Ranger District):** The Indian Ridge wildfire burned the headwaters of Washout Creek at high severity in August and September, 2012. An August 29, 2013 thunderstorm on the burned areas triggered four small mudslides in Washout Creek and its nearby intermittent draws. The slides downcut the affected stream channels, overtopped Forest Road 6223 with a large blockage of mud and debris, and dumped a large quantity of sediment and wood into the Selway River just upstream of the Spire Rock pool. The pool was filled with sand and gravel substrates after the event, and the river ran turbid for several weeks. The Bitterroot NF road crew cleared the alluvial material from Forest Road 6223, and the downcut draws and new alluvial fans were seeded with grass, fertilized with an organic fertilizer, and mulched with weed-free straw.

**Photo 7 – Intermittent Draw near Washout Creek, October 2013**

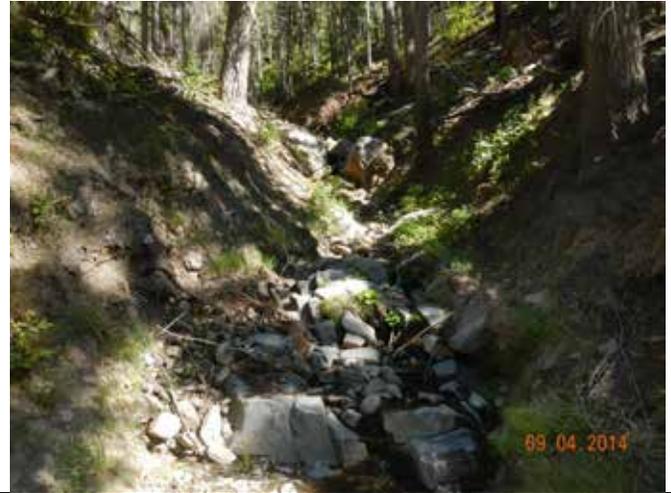
In summer 2014, the rehabbed alluvial fans were monitored. The sites healed considerably in just the first year. Much of the sediment and gravel that was deposited within the Selway River and its bankfull channel, and all of the large wood, was flushed from the area, including the majority of the sand and gravel that had filled the Spire Rock pool. Grass growth on the alluvial fans and downcut draws is progressing well.

**Photo 8 – Same Draw after One Growing Season, September 2014**

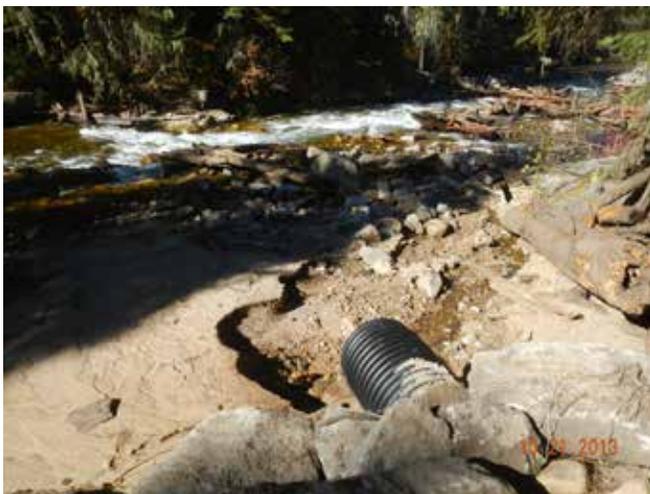
**Photo 9 – Alluvial Fan and Woody Debris from Debris Flows in the Selway River, October 2013**

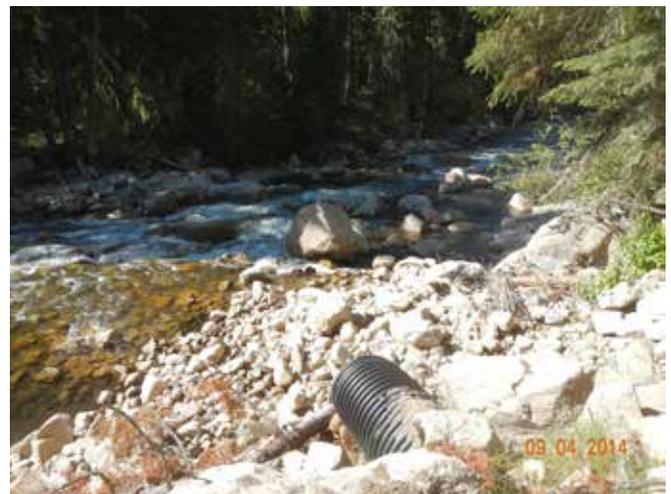
In summer 2015, vegetative recovery continued to progress well. The material that had previously filled the Spire Creek pool has largely been flushed out of the area. Vegetative recovery of the washed out draws has proceeded to the point that the casual forest visitor driving by on the road would not notice anything.

**Photo 10 – Same Spot nearly a Year Later, September 2014**

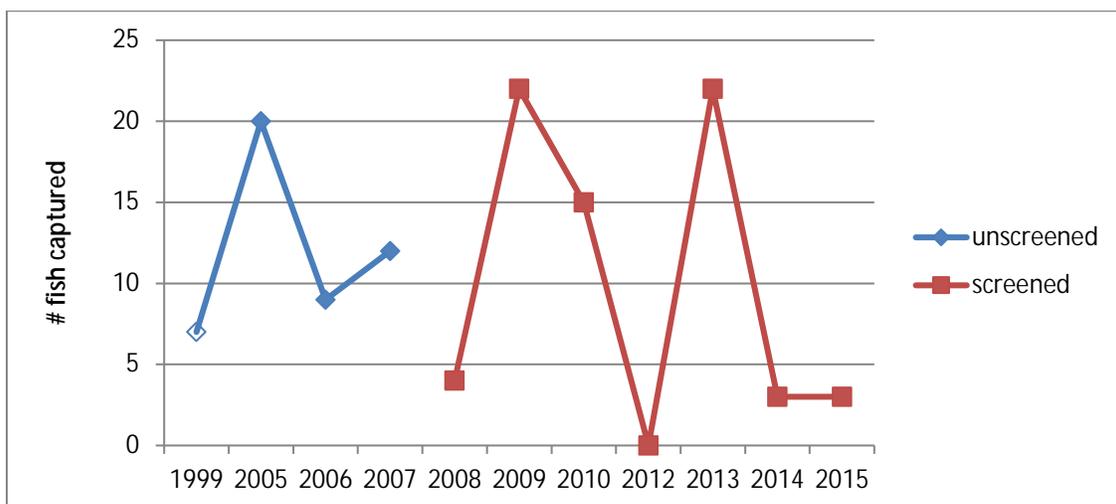
The Hawkes ditch has been electrofished in the months of June, July, or August for 11 years (1999, 2005-15 – see Figure 1 and Table 2). The ditch was unscreened in 1999, 2005, 2006, and 2007, and screened in all of the years since. The number of fish captured in the ditch has ranged from none to 22 (Figure 1).

**Figure 1 - Total Number of Fish Captured in the Hawkes Ditch**

Since screening, the number of fish captured in the Hawkes ditch has been highly variable (Figure 1). In four of the years (2008, 2012, 2014, and 2015), the screen appeared to be working successfully because only a few fish were found in the ditch (Figure 1). In three of the years (2009, 2010, and 2013), however, numbers were as high or higher than when the ditch was unscreened (Figure 1). The presence and extent of gaps along the bottom edge of screen may explain this variability. Water year does not appear to be playing a role. In the 2015 survey, only three small westslope cutthroat trout were captured in the Hawkes ditch (Table 1).

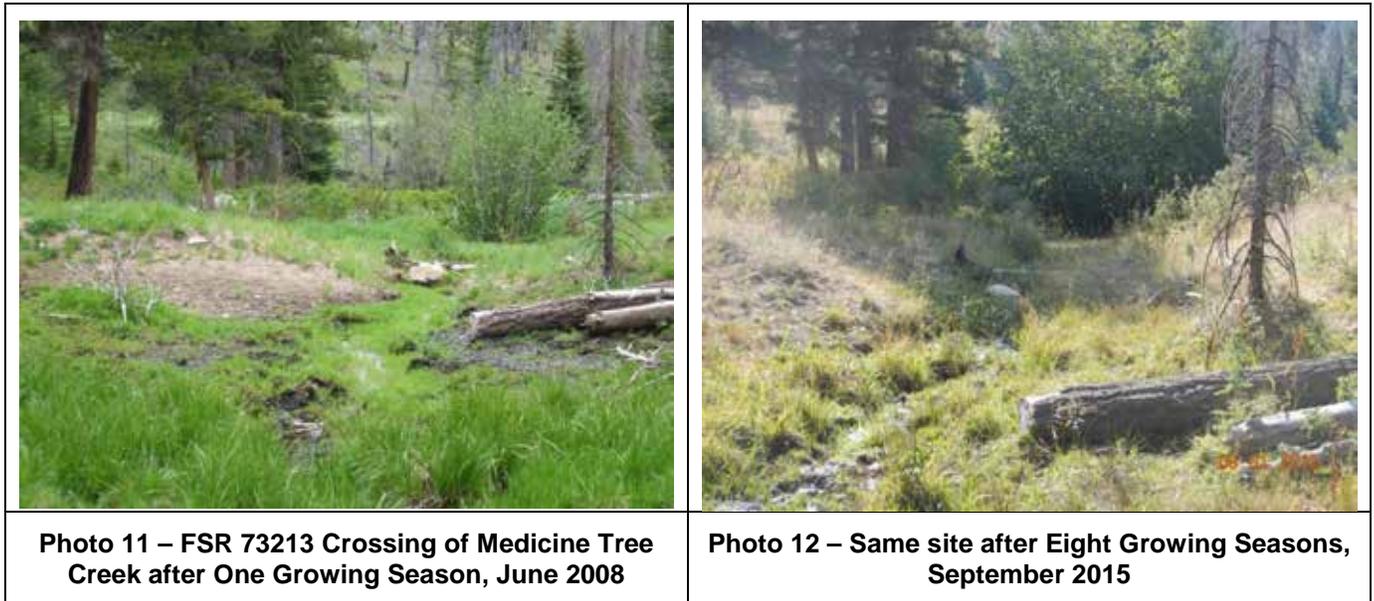
2010, 2013, 2014, and 2015. In 2015, riparian conditions at the crossing were very similar to what was observed in 2010, 2013, and 2014. Conditions do not appear to be improving much, nor do they appear to be getting much worse. The baseline condition appears to be a moderate amount of bank trampling.

There is a stock tank at the FSR 73213 crossing that is non-functional. This stock tank was also non-functional in 2014. Fixing the stock tank would help take some grazing pressure off of the nearby stream crossing.

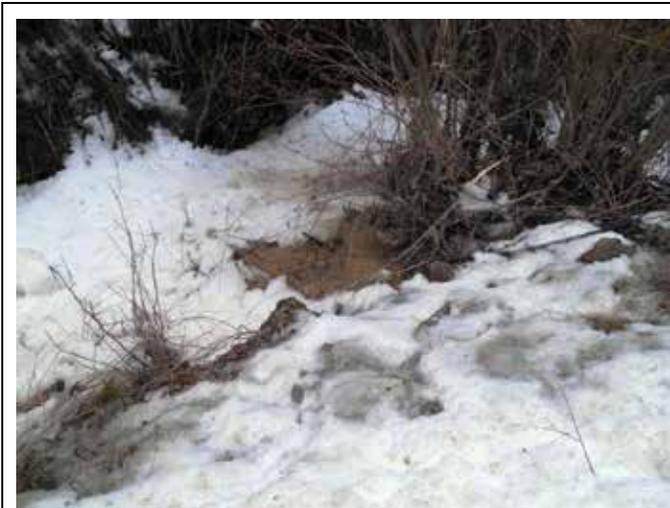
**Photo 13 – Outlet of FSR 428 Ditch Relief Culvert Carrying Water and Sediment into Ambrose Creek, February 2015**

In response to the accelerated runoff conditions observed on FSR 428, the Forest responded by stopping the log haul until colder temperatures returned and the road surface adequately refroze. Also, timber sale personnel used hand tools in an attempt to divert water off the road surface and spread salt on the road ice to try to melt a path for water to access the insloped ditch.

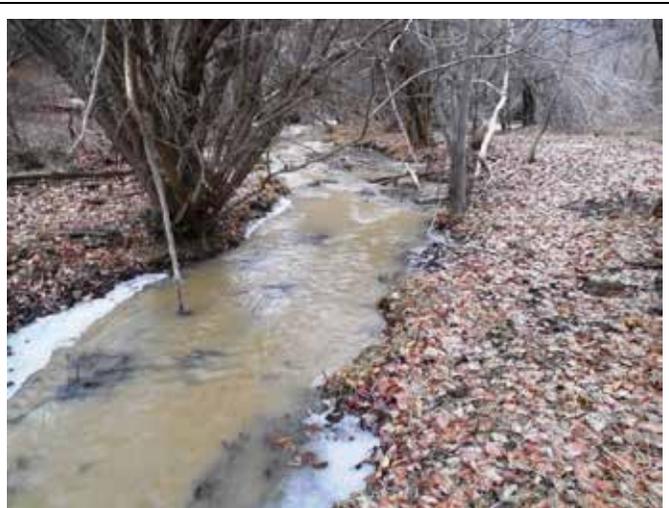
**Photo 14 – This is the Area where FSR 428 first Comes Close to Ambrose Creek. Estimated to be Milepost 1.2. Several Points Combine to Create the Turbid Water, February 2015**

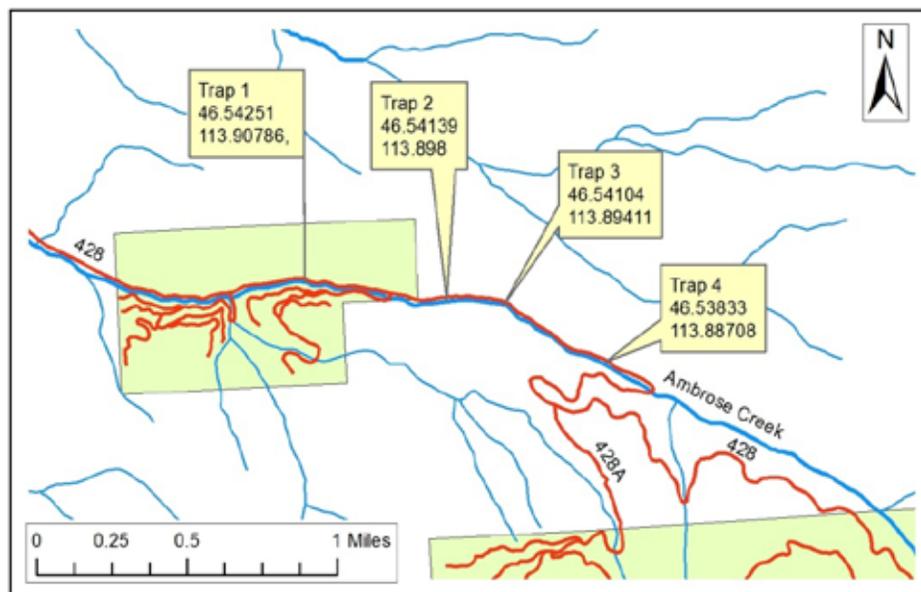
The four traps were checked periodically in 2010-14 and cleaned once or twice per year. Observations in March and sometimes April have shown that the boxes hold ice into the early to mid-spring. FSR 428 is also generally frozen at that time and not transporting much sediment. Observations in late April and May have shown low to moderate amounts of sediment in the traps as the temperature increases and the effects of vehicles increases. During late May and June snow melt, rain and road traffic combine to increase the amount of sediment moving from the road. Thundershowers in summer can also result in intense rain that moves sediment from the road and into the traps. Table 3 summarizes the observations that were made at the sediment traps is 2010-14.

Figure 2 – Location of Sediment Traps along FSR 428, Ambrose Creek Road
