## **Validation of Aquatic Habitat Quality and Fish Population Assumptions Used to Predict Effects of Activities And Cutthroat Trout Population in Relation to Habitat Changes Items 21 and 41**

**REPORTING PERIOD:** 2014-2015.

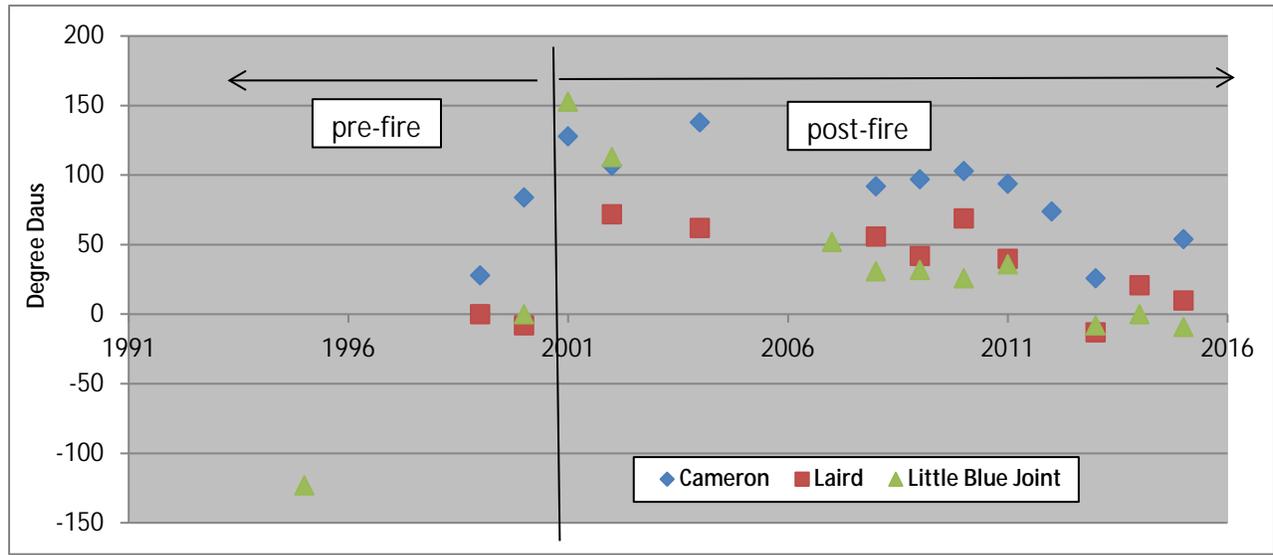
In Figure 18, the “0” line on the y-axis indicates that degree days at a burned site were identical to the degree days at its index site. Negative data points indicate the degree days at a burned site were less than (i.e. colder) than its index site. Positive data points indicate the degree days at a burned site were greater than (i.e. warmer)

than its index site. If temperatures are recovering in the burned streams, their data points should approach the “0” line over time.

**Figure 18 – Degree Day Differences between Laird Creek (milepost 1.5), Cameron Creek (milepost 10.1), and Little Blue Joint Creek (milepost 1.4) and Their Unburned Index Sites**

The data in Figure 18 suggests that recovery of temperatures is occurring, especially in Laird and Little Blue Joint creeks (i.e. the data points have moved very close to or even under the “0 degree day” line over time). In 2013, both the Laird Creek and Little Blue Joint Creek sites were cooler than their unburned index sites for the first time since the 2000 fires.

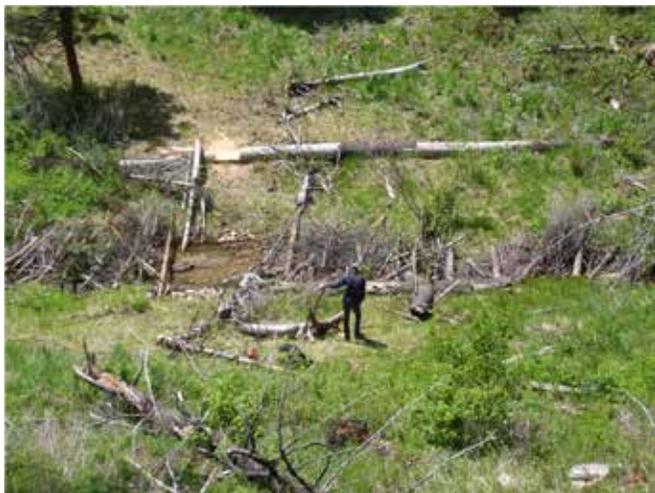
**Lyman Creek Road 13304 Stream Crossing Rehab Project (Sula Ranger District):** In 2009, the Forest fisheries crew placed slash and planted shrubs on three recontoured Road 13304 stream crossings on the North Fork of Lyman Creek. Road 13304 was decommissioned in the fall of 2008. The stream crossings were already overwidened prior to recontouring, and due to their lack of cover, were vulnerable to additional overwidening from livestock in the East Fork grazing allotment. Slash was placed by hand over the top of the stream crossings to discourage livestock entry. An opening was left in the slash to allow livestock a place to ford the stream and drink water. In 2015, after six growing seasons, the recovery of shrubs along the stream crossings was very encouraging as shown in the photos below.

**Photo 1 - Slash Placement on a Recontoured Road 13304 Stream Crossing, June 2009**

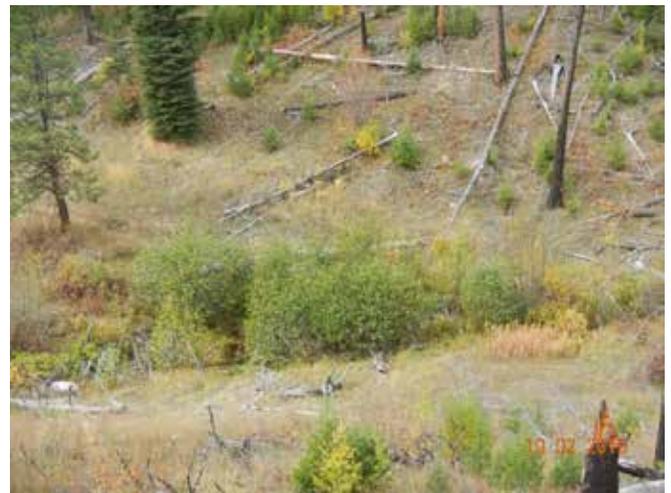
**Photo 2 – Same Site after Six Growing Seasons, October 2015**

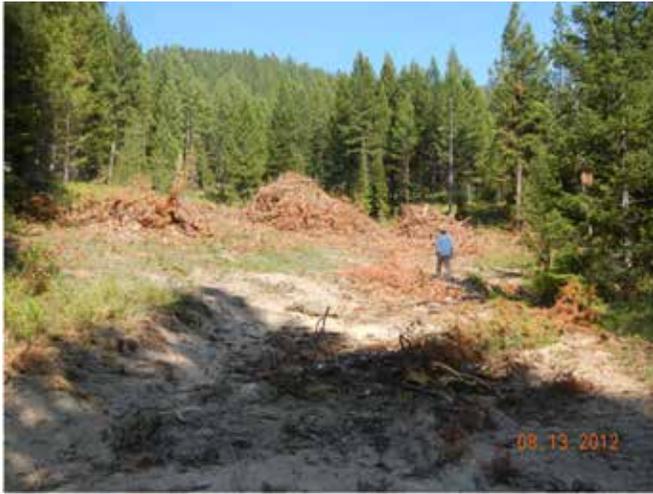
**Buck Creek Seed Production Area Timber Sale Helicopter Landing Rehabilitation Project (West Fork Ranger District):** In June 2012, a helicopter landing was constructed just outside of the 150-foot Riparian Habitat Conservation Area (RHCA) surrounding an upper reach of Buck Creek. About two acres of ponderosa pine and Douglas fir forest was clearcut to make room for the landing. When the logging was completed (July, 2012), the slash on the floor of the landing was piled with an excavator into three large burn piles. In June 2013, the landing was seeded with grass and fertilized with an organic fertilizer, but the piles were still not burned, so the rehab work could not be completely finished. The piles were burned in November, 2013. In June 2014, the burn pile scars were planted with grass seed and shrub seedlings (230 snowberry and 230 spirea), then fertilized with an organic fertilizer and covered with straw mulch. The purpose of this project is to restore native vegetation to the landing site and eliminate the risk for future erosion and sediment production. Monitoring conducted in

**Photo 3 – Looking up into the Helicopter Landing after Logging has been Completed and the Slash on the Floor of the Landing has been Piled, August 2012.**

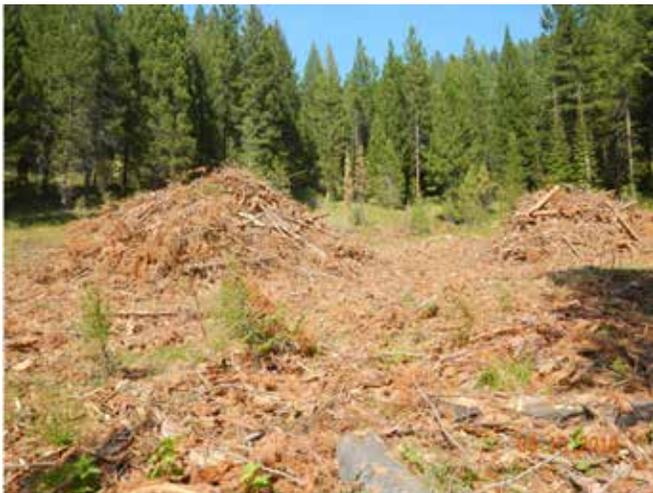
**Photo 5 – Slash Piles Prior to Burning, August 2012.**

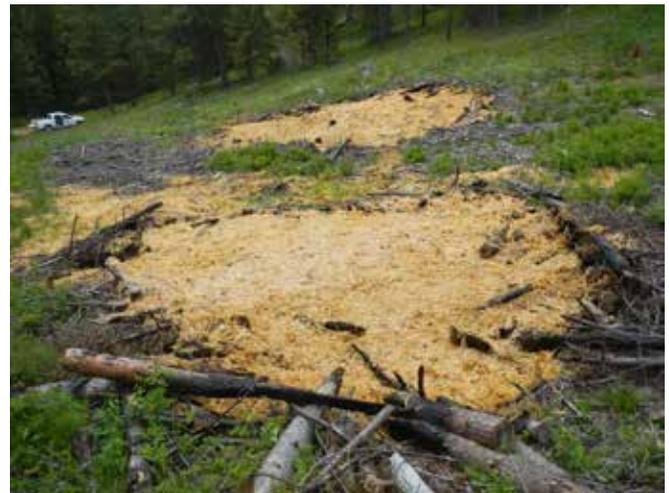
**Photo 6 – Slash Pile Burn Scars following Seeding, Planting Shrub Seedlings, and Mulching, June 2014.**

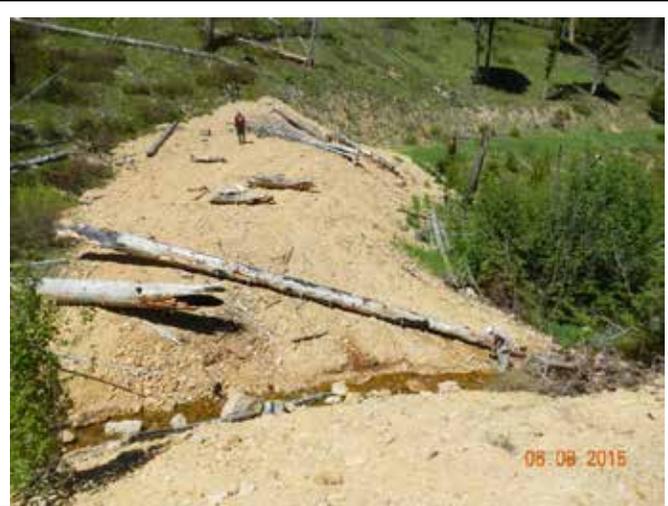
**Photo 8 – Road 13410 Crossing On West Creek Tributary 2.0 After Recontouring and Planting, June 2015**
