## **Road Construction, Mitigation, and Maintenance Item 24**

**OBJECTIVE:** To determine if Forest Plan Soil and Water Conservation Practices and State of Montana Best Management Practices are being implemented in project management activities.

**REPORTING PERIOD:** 2014-2015

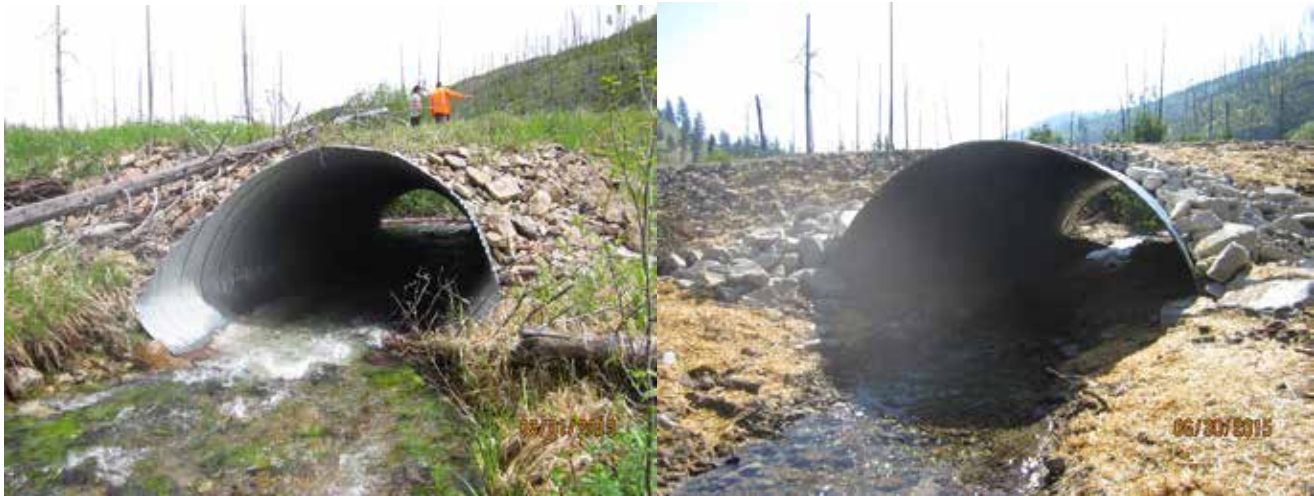
**Little Blue Joint Culvert Replacement (NFSR 5658 – MP 0.1):** Completed July 2015 – Replaced existing fish barrier culvert with 19'-span bottomless arch. Armored slopes and widened the curve at the pipe location. Installed an armored dip above crossing and graveled approx. 300' of roadway. All disturbed areas were seeded, fertilized, and mulched.

**Photos 1 - Little Blue Joint Culvert Repair before and after Photos**

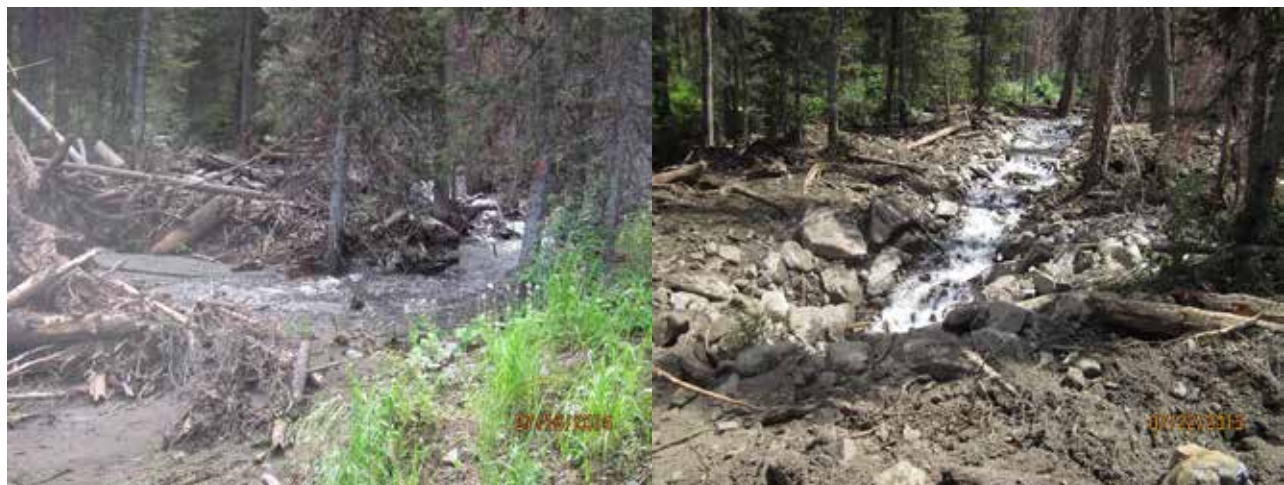
**Johnson Creek Washout Repair (NFSR 5685 – MP 1.0):** Completed Aug 2015 - Emergency Repair to upper Johnson Creek culvert washout. Cleared pipe, regraded stream above as required, and built or repaired the road to make passable after washout.

**Photos 2 - Johnson Creek before and after Photos Taken from the Edge of NFSR 91**

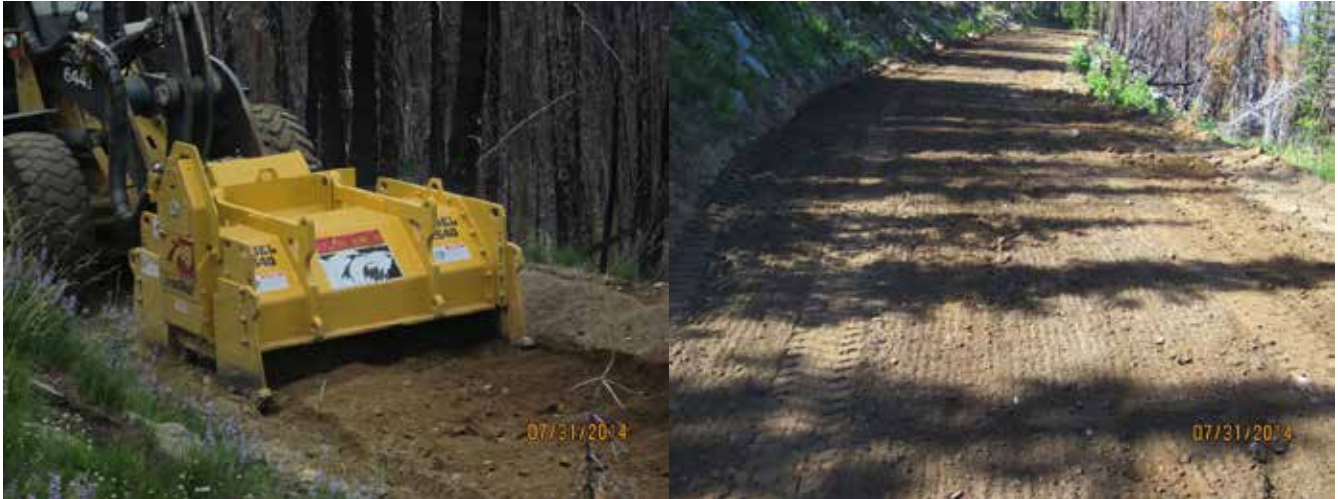
**Roadside Brushing and Drainage Maintenance (NFSR 468 – Gold Pan Overlook to Sabe Saddle):** Completed Aug 2014 – Forest Service Road Crew pulled brush and cleared snags where necessary throughout this 13 mile stretch. Ditches and catch basins were cleaned for all ditch relief pipes. Two ditch relief culverts that had been damaged and corroded were repaired by cutting out bad sections and patching with new sections.

**Photos 3 - Roadside Brushing and Drainage Maintenance NFSR 468 – Gold Pan Overlook to Sabe Saddle, Iron Wolf Pulverizing Road Subgrade, and Resulting Road Prism Prior to Roller Compaction.**

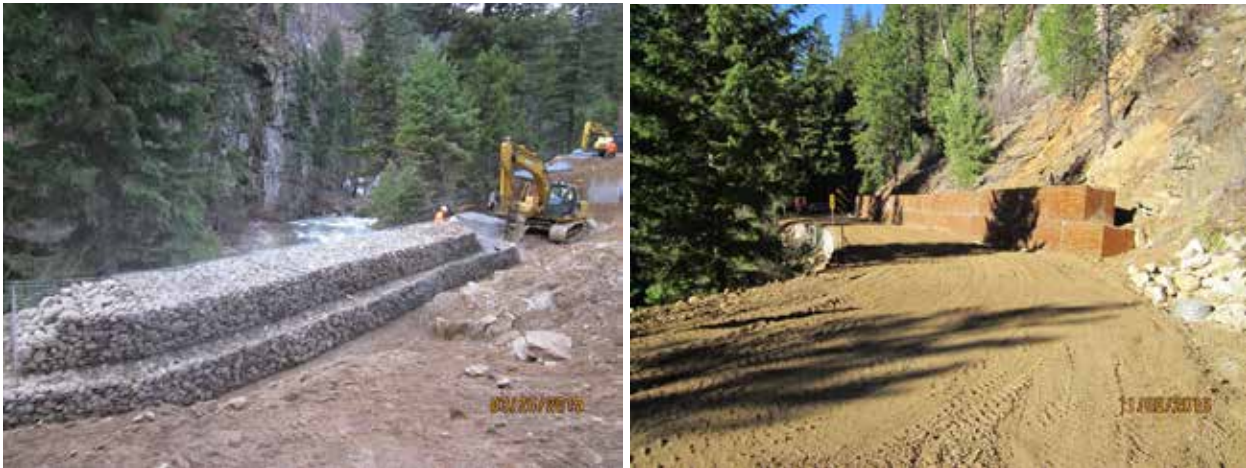
**Selway Road Stabilization (NFSR 468 – MP 34.4 & NFSR 6223 – MP 0.1):** Completed May 2015 – Installed 3 gabion basket retaining walls, 1 Geosynthetic Reinforced Soil retaining wall, and multiple rock buttress retaining walls to stabilize failed fill slopes along road 468 and 6223. Failing slopes had been identified throughout previous years and all were immediately adjacent to the Selway River. Appropriate treatments were discussed and decided on through collaboration with Regional geotechnical engineers and contracted A&E firm. This project is multi-phase and also includes the stabilization of cut slopes at various sites through the use of precast concrete retaining walls; this work started in fall of 2016 and will be complete by spring of 2017.

**Photos 4 – Gabion and Retaining Wall Installation and Finished Product NFSR 468**

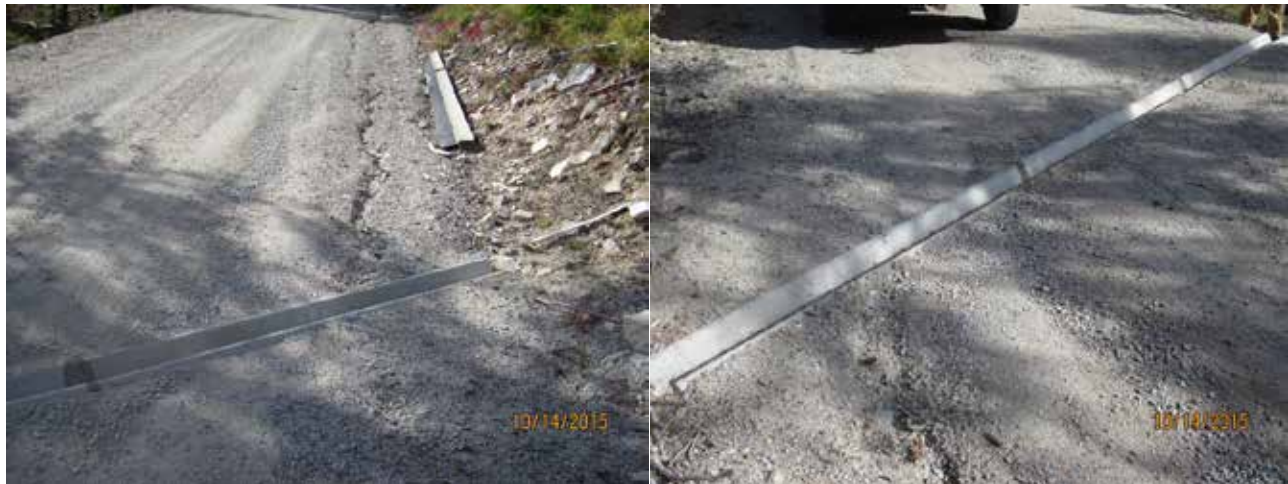
**Concrete Water Bar Installation (NFSR 468 – Magruder Crossing to Haystack Saddle):** Completed September 2015 – Installed concrete water bars at four different sites between Haystack and Magruder Crossing where water was obviously running down road and eroding roadway surface.

**Photos 5 – Concrete Water Bar Installation Lost Trail Ski Area NFSR 5734**

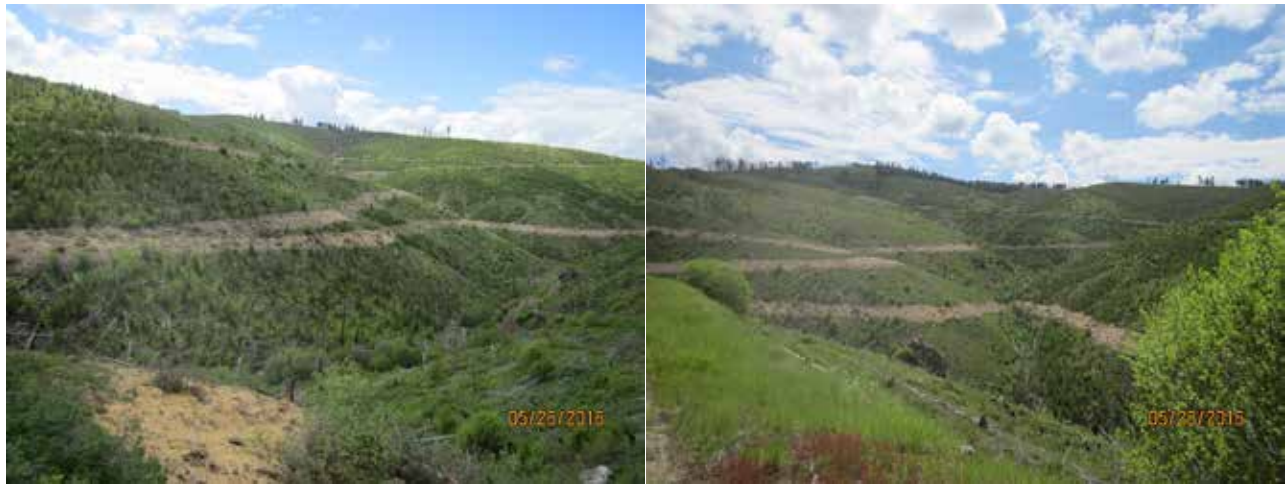
Road decommissioning work includes full or partial recontouring of the road prism, culvert removal, full recontouring of stream and drainage crossings, seeding, mulching, and fertilizing of disturbed areas. Road storage treatments include full recontouring of entrance, de-compaction of road prisms, culvert removal, full recontouring of drainages, surface drainage improvements, and seeding, mulching and fertilizing disturbed area.

**Photos 6 – Cathouse Creek Decommissioning Project**

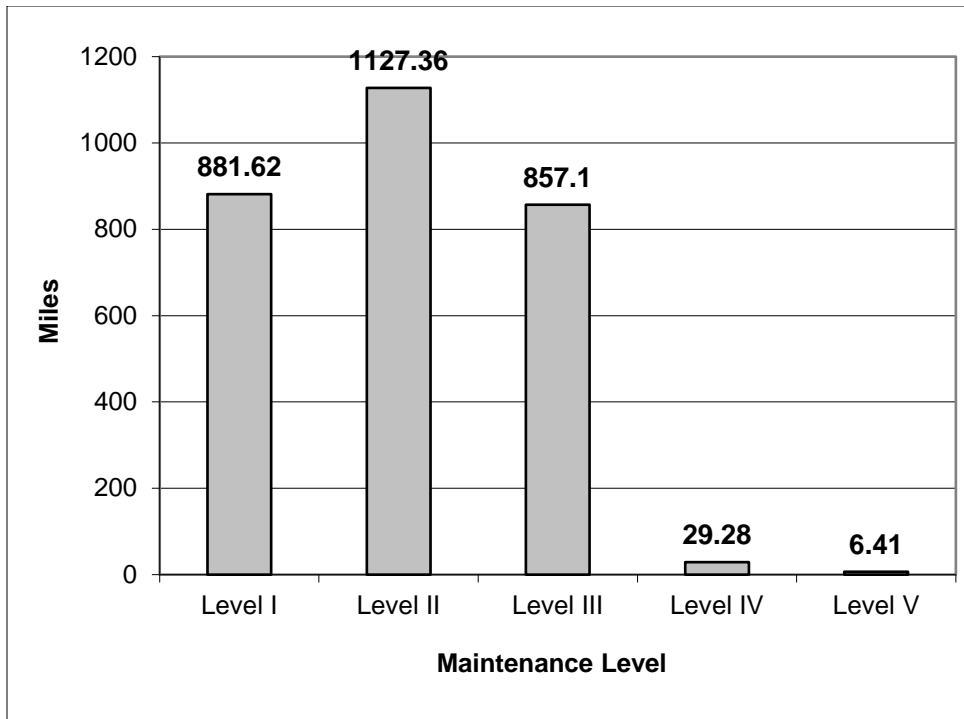
Maintenance Level	Management
Level I	Not maintained for public use. These are only maintained to preserve the road template. There are 881.62 miles of Level I roads on the Forest, these roads are closed yearlong to full size motorized vehicle traffic.
Level II	Managed for high clearance vehicles, maintenance mainly focused on erosion control. There are 1127.36 miles of Level II.
Level III	Native and gravel surface, low traffic volumes, maintained for template preservation and some user comfort. These roads are managed for use by standard highway vehicles. There are 857.10 miles of Level III.
Level IV	Higher traffic volumes, gravel surfaced arterial roads, maintenance at a higher standard. There are 29.28 miles of Level IV.
Level V	High traffic volumes, paved arterial roads. There are 6.41 miles of Level V roads.

**Figure 1 - Road Maintenance Status – Miles per Maintenance Level**
