## REPORT OF INVESTIGATION

Case #17-05-9478640

Helena Fire et.al.

USDA Forest Service

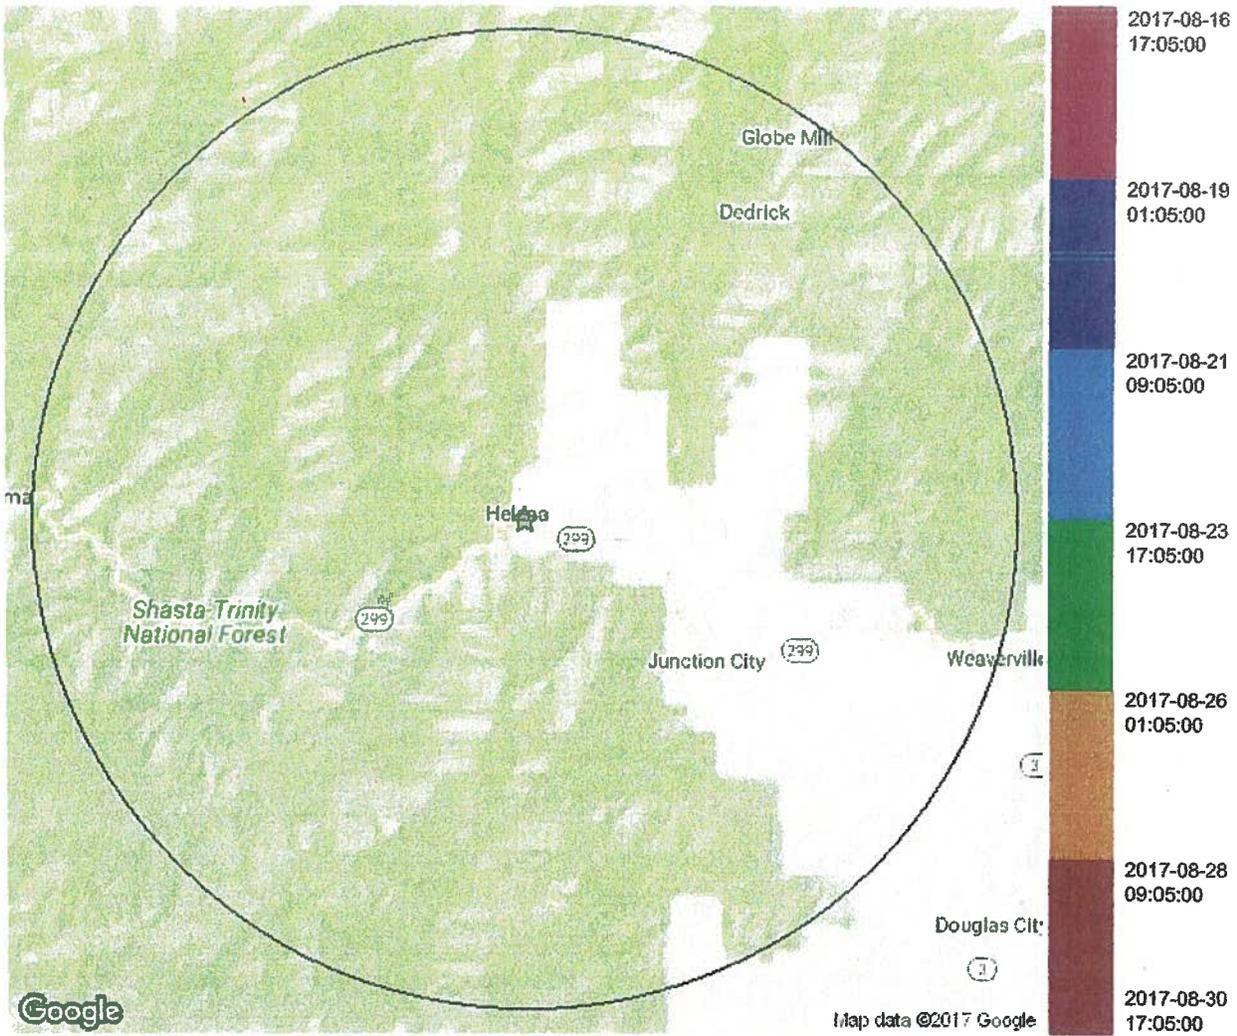
## Confidence Ellipses For Lightning Strokes

Lightning Confidence Ellipse Map indicates with 99% certainty that the recorded lightning event contacted the ground within the bounds of the ellipse.

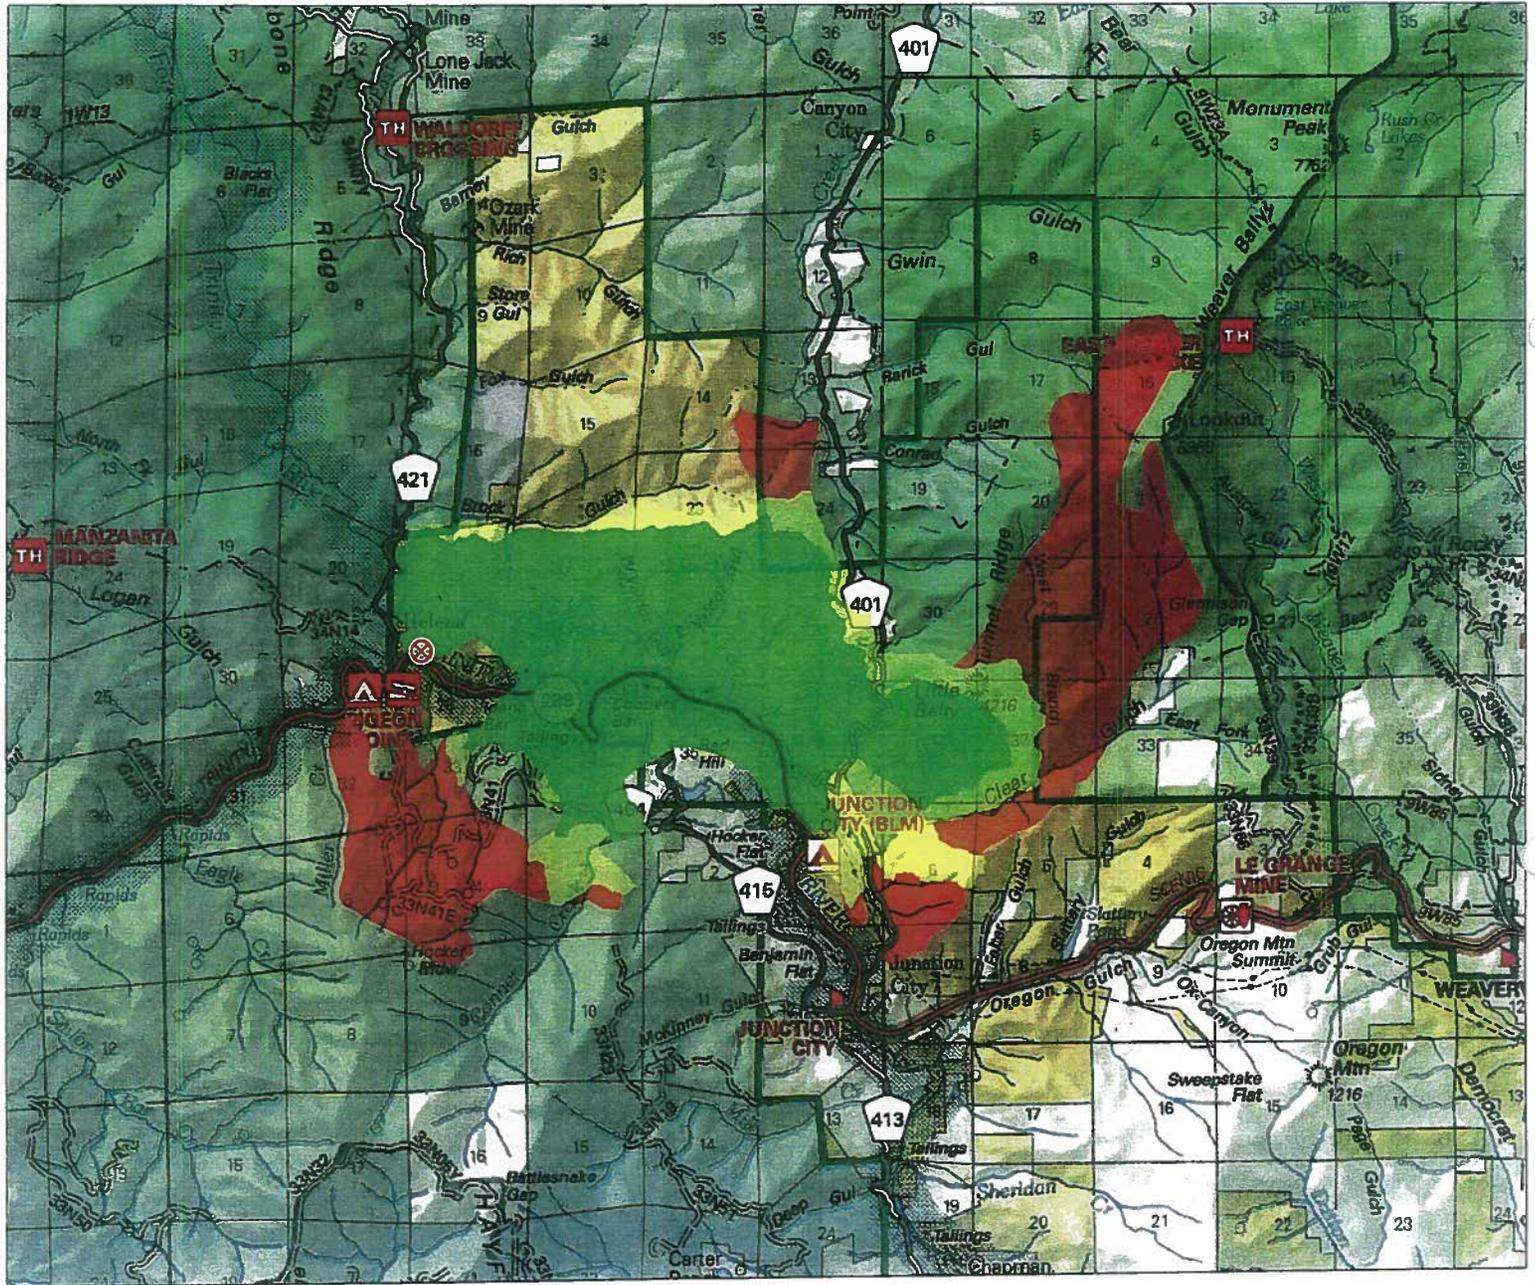
# Helena Fire Progression

- ⊗ Fire Origin
- Fire Progression
- Sept. 1
- Sept. 2
- Sept. 3
- Sept. 4

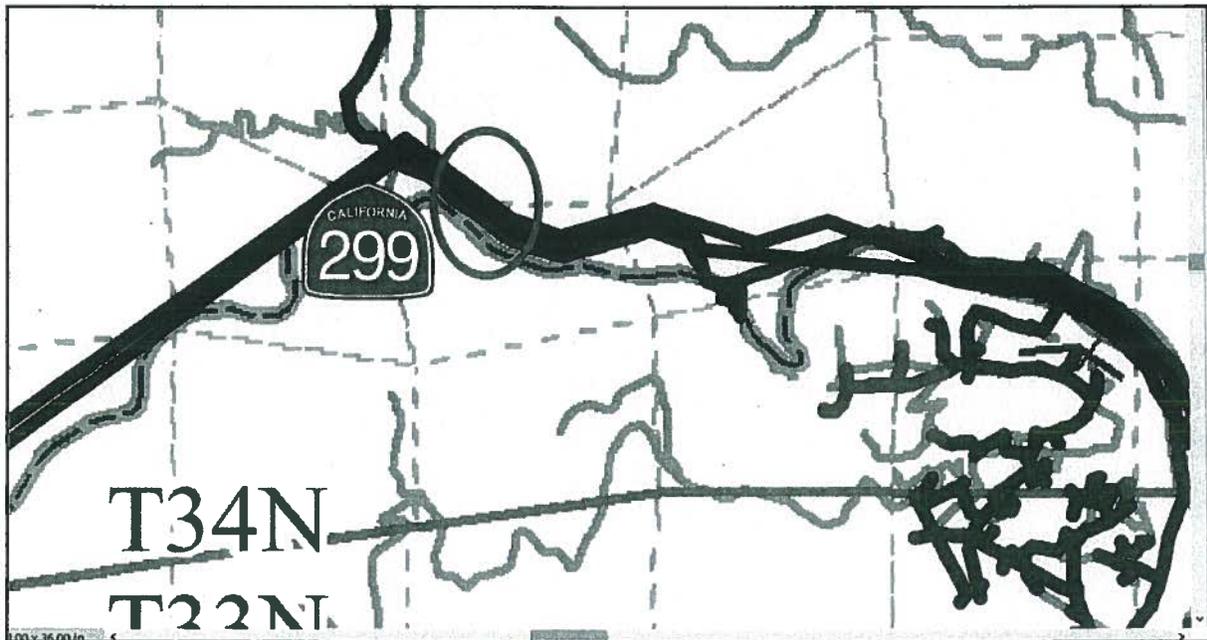
## Attachment 2

Location detail from Attachment 1 above  
The blue line represents the overhead line of interest.
