## Eagle Creek Fire Trail Assessment Herman Creek Trail 406 (Herman Creek Trailhead to Nick Eaton Trail 47)

Trail: Herman Creek 406 Miles: 1.5 (of 11.3) assessed Date Assessed: 11/29/2017

Overall Condition: Fair Wilderness: No

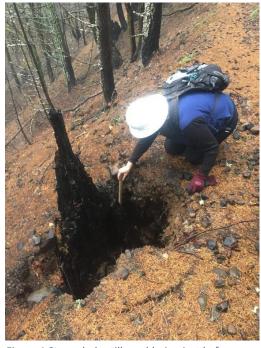
Figure 1 Stump hole still smoldering just before Herman Bridge junction

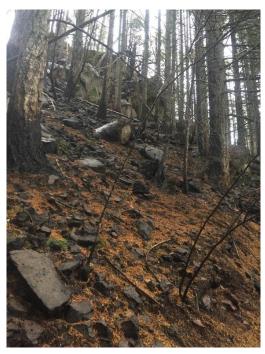
**Unique Safety Considerations**: Large boulders upslope of trail that could become loose due to lack of vegetation and effects of rain.

Figure 2 Upslope hazards along Herman Creek trail. Large boulders may loosen and fall onto trail

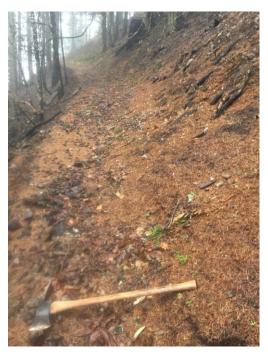
**Tread:** At this time, trail has been assessed between trailhead and junction with Nick Eaton and appears to be in fair condition (little work needed on segment assessed). Some sloughing on switchback and berms.

Figure 3 Moderate sloughing along sections of trail

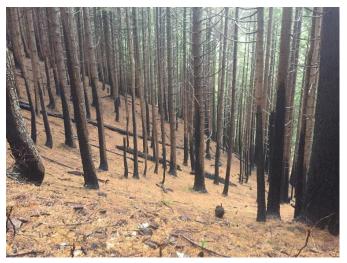
Figure 4 Primarily mosaic burn pattern with one area of high intensity burn along trail
