Holy Fire
Burned Area Emergency Response
Soil Resource Report

The Holy Fire BAER Team

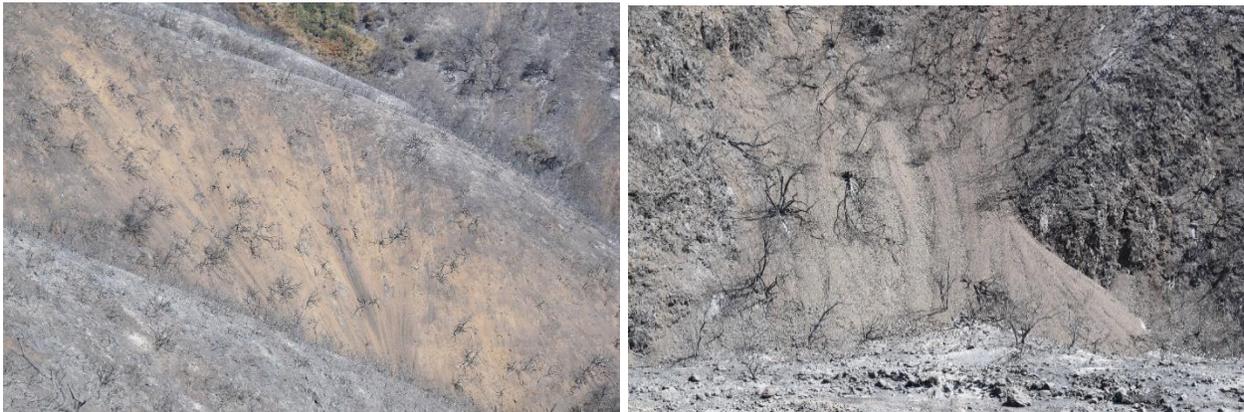
Figure 4- Dry Ravel on the Holy Fire; left photo –hillslope transport of material, right photo – resulting deposition.

Dry Ravel describes the movement of individual soil particles, by gravity, from steep slopes to valley bottoms during dry conditions. This process is a dominant erosional process in unburnt, steep chaparral environments and occurs predominantly on slopes greater than 65%. Prior to fire removing litter and live vegetation, natural soil creep is stored behind vegetation. Dry ravel is greatly increased through wildfire because fire burns the vegetation and instantly releases the stored soil behind that vegetation. Root mortality exacerbates the available sediment for dry ravel and may increase the amount of material moved. Material loads the channels, which increases flow bulking. This deposition also occurs on roads and trails, which contributes to unsafe and unpassable conditions. Examples of dry ravel from the Holy Fire can be seen in [Figure 4](#) below.

Dry ravel results – Dry ravel is not quantified or calculated on a BAER team. It is, however, something that is observed in order to understand the soil’s response to a wildfire. In the Holy Fire, dry ravel sites were abundant throughout the landscape (slopes >65%), such as can be seen in the picture above.

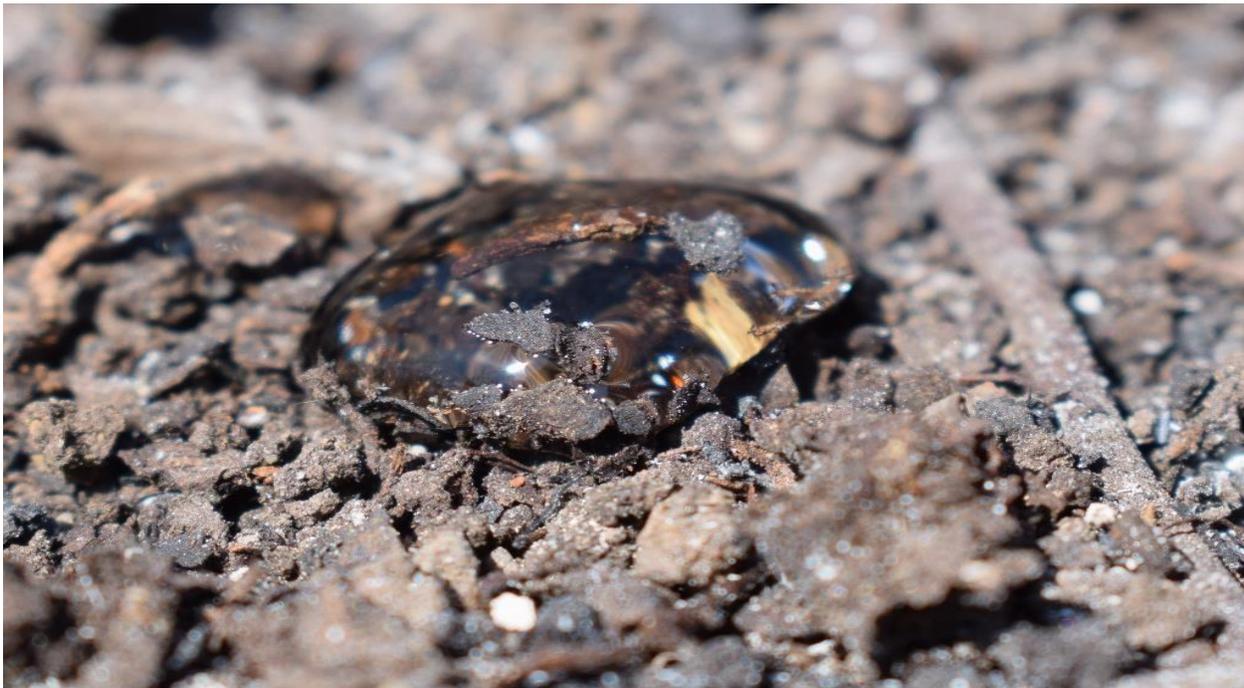
Figure 5- Hydrophobicity on soils within the Holy Fire

cover mitigates surface runoff and becomes reduced as the duff becomes wetted. Water repellent compounds volatilize with heat and concentrate lower in the soil as they condense on cooler soils. This increases strength and depth of water repellency. An example of water repellency can be found in the [Figure 5](#) below. The water is repelled from the hydrophobic soil surface, and unable to infiltrate, this water beads on the mineral soil.

Hydrophobicity Results - Water repellency was strong and thick in all burn severities and was prevalent throughout the fire area. Water repellency tends to strengthen with drought which may be exacerbating the strength of the water repellency. Thus repellency observed in the burned area was judged as greatly increased (in severity, extent, and continuity) by the fire, with a very significant effect on infiltration rates for watersheds as a whole. Increased water repellency can increase peak flow flooding and debris flow severity. Although water repellency may protect the soil from deep erosion, it allows for efficient removal of soil that is altered from fire. Fire-induced soil water repellency is often cited as a key factor controlling post-fire runoff and erosion.
