Figure 11. Extent of Metals-Impacted Soil in Cabins Area
 Supplemental Characterization Report for the Cabins Area at Mammoth Mill
 Inyo National Forest, Mono County, California

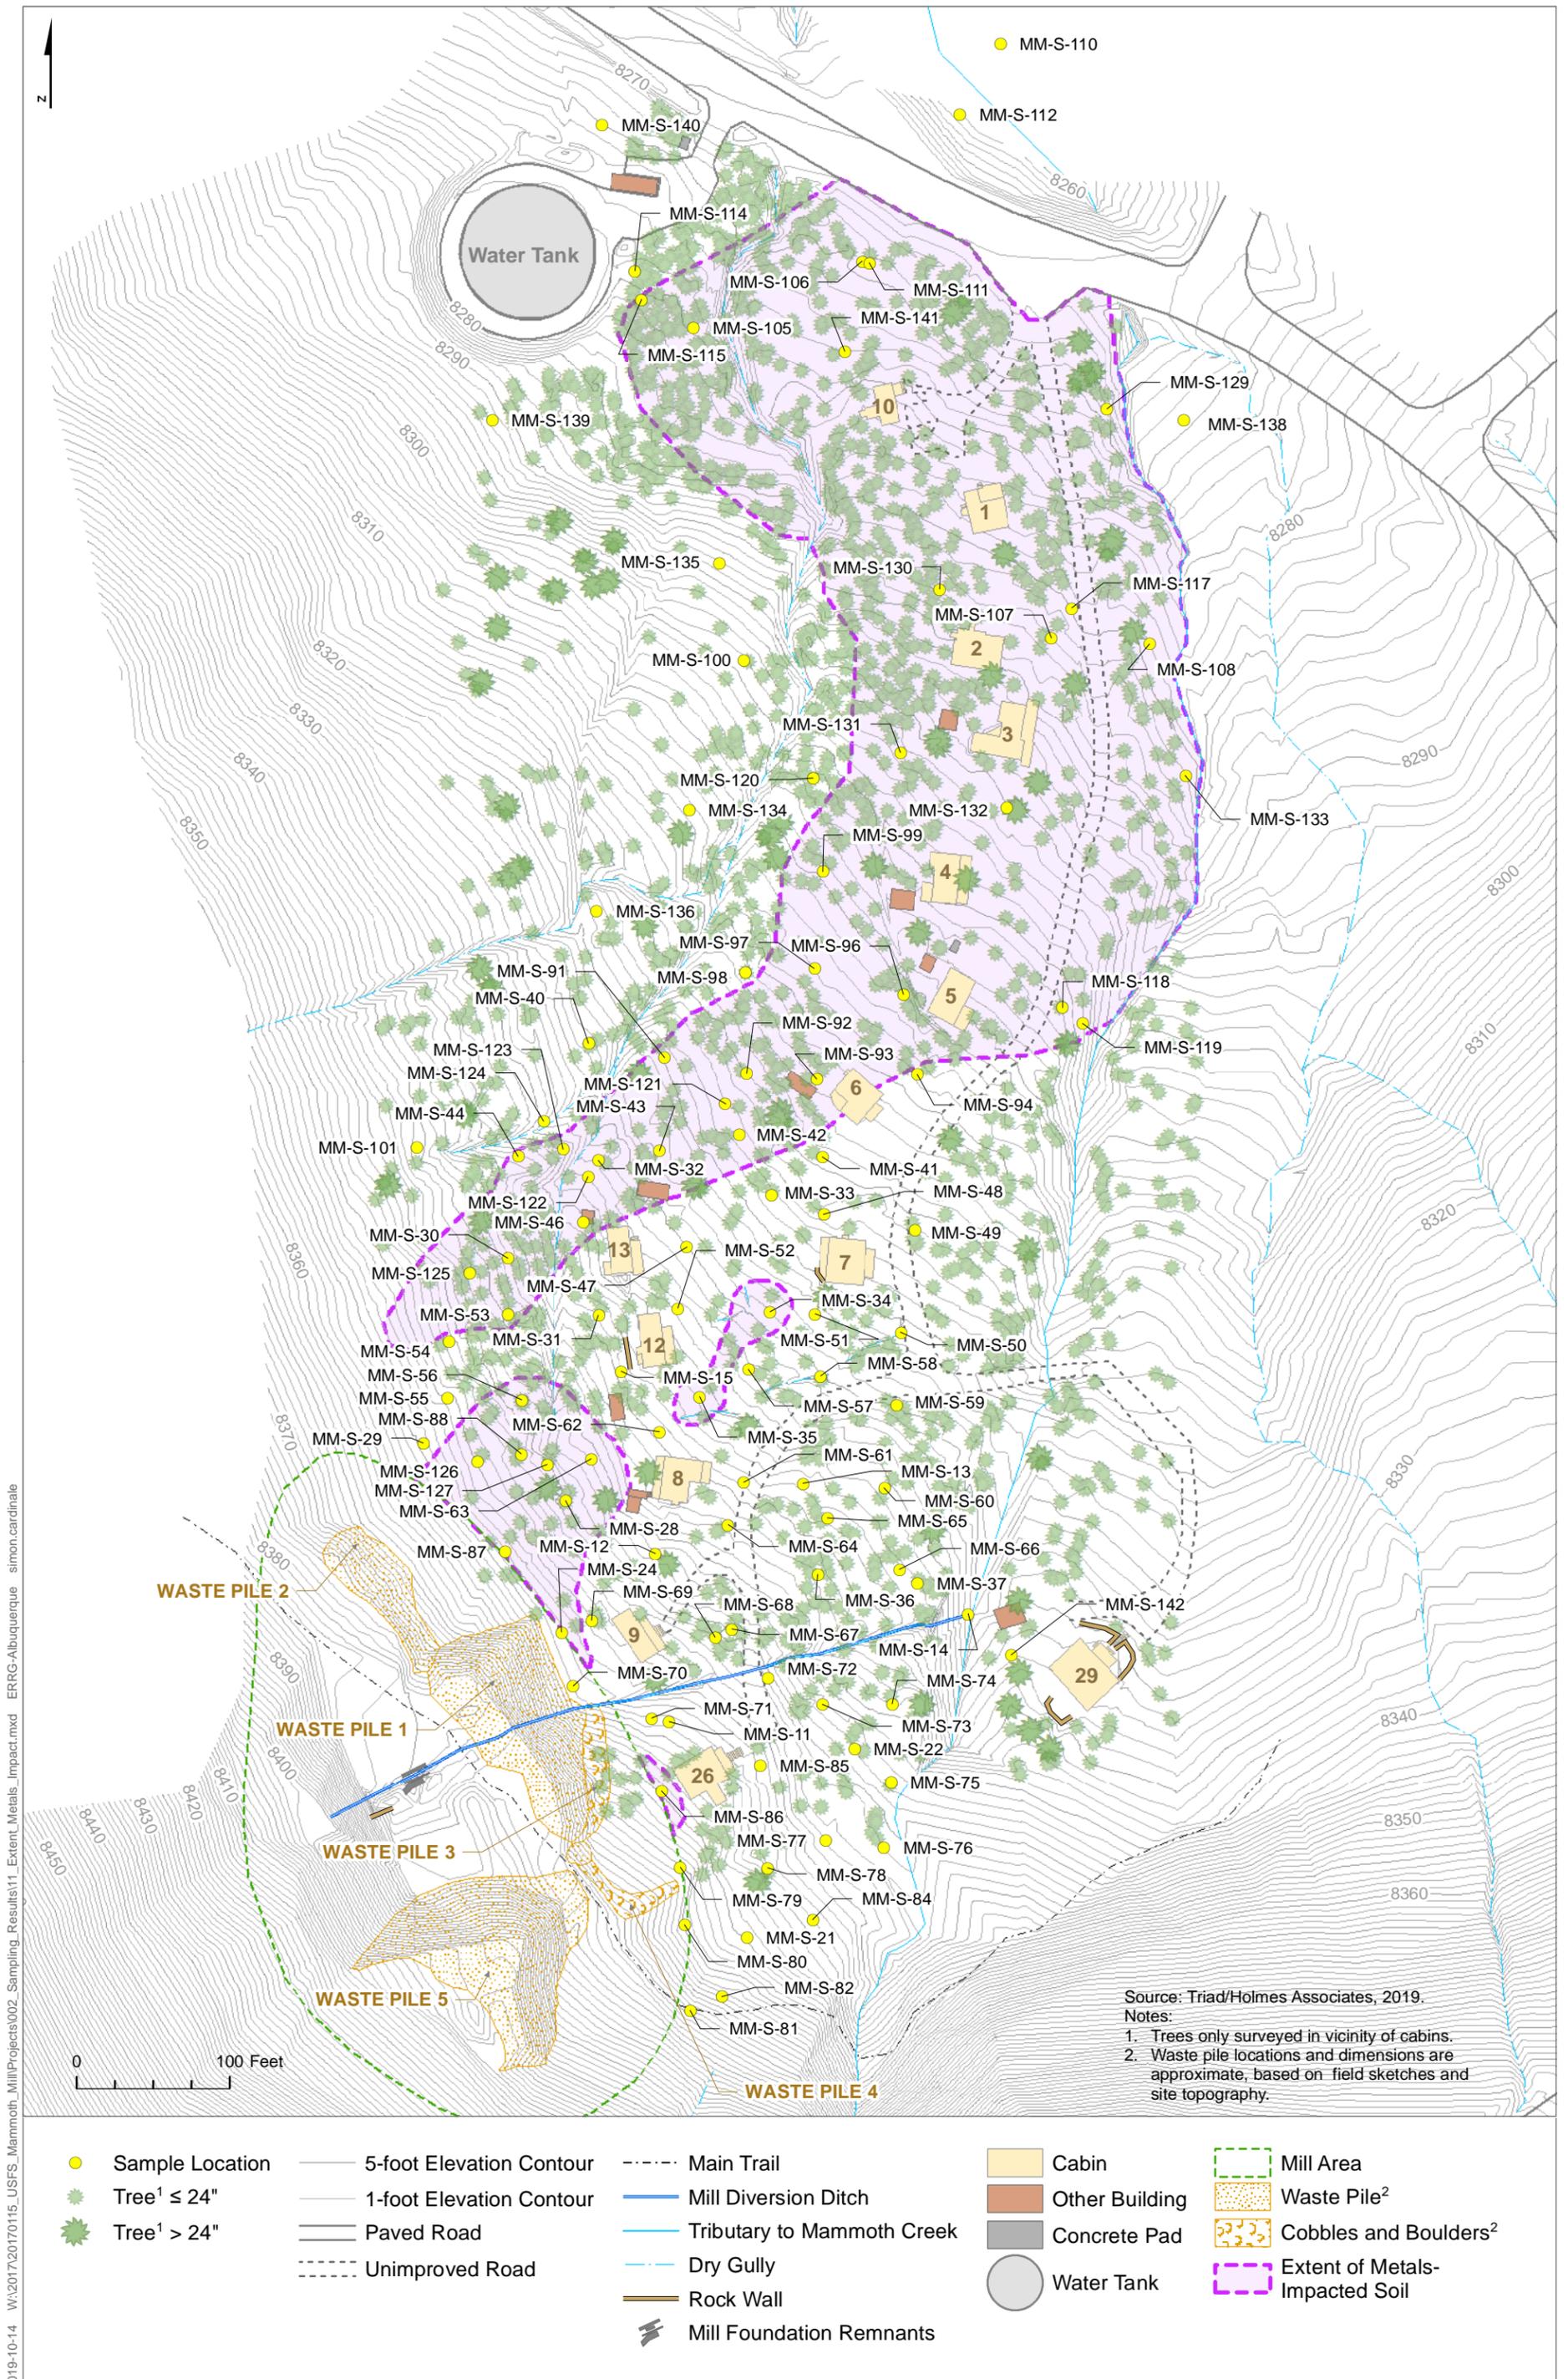
Source: Triad/Holmes Associates, 2019.
 Notes:
 1. Trees only surveyed in vicinity of cabins.
 2. Waste pile locations and dimensions are approximate, based on field sketches and site topography.
