# Burned Area Emergency Response

## CAPLES FIRE BAER ASSESSMENT

USDA Caples Fire CA-ENF-030945 BAER  
Pacific Southwest Region Eldorado National Forest

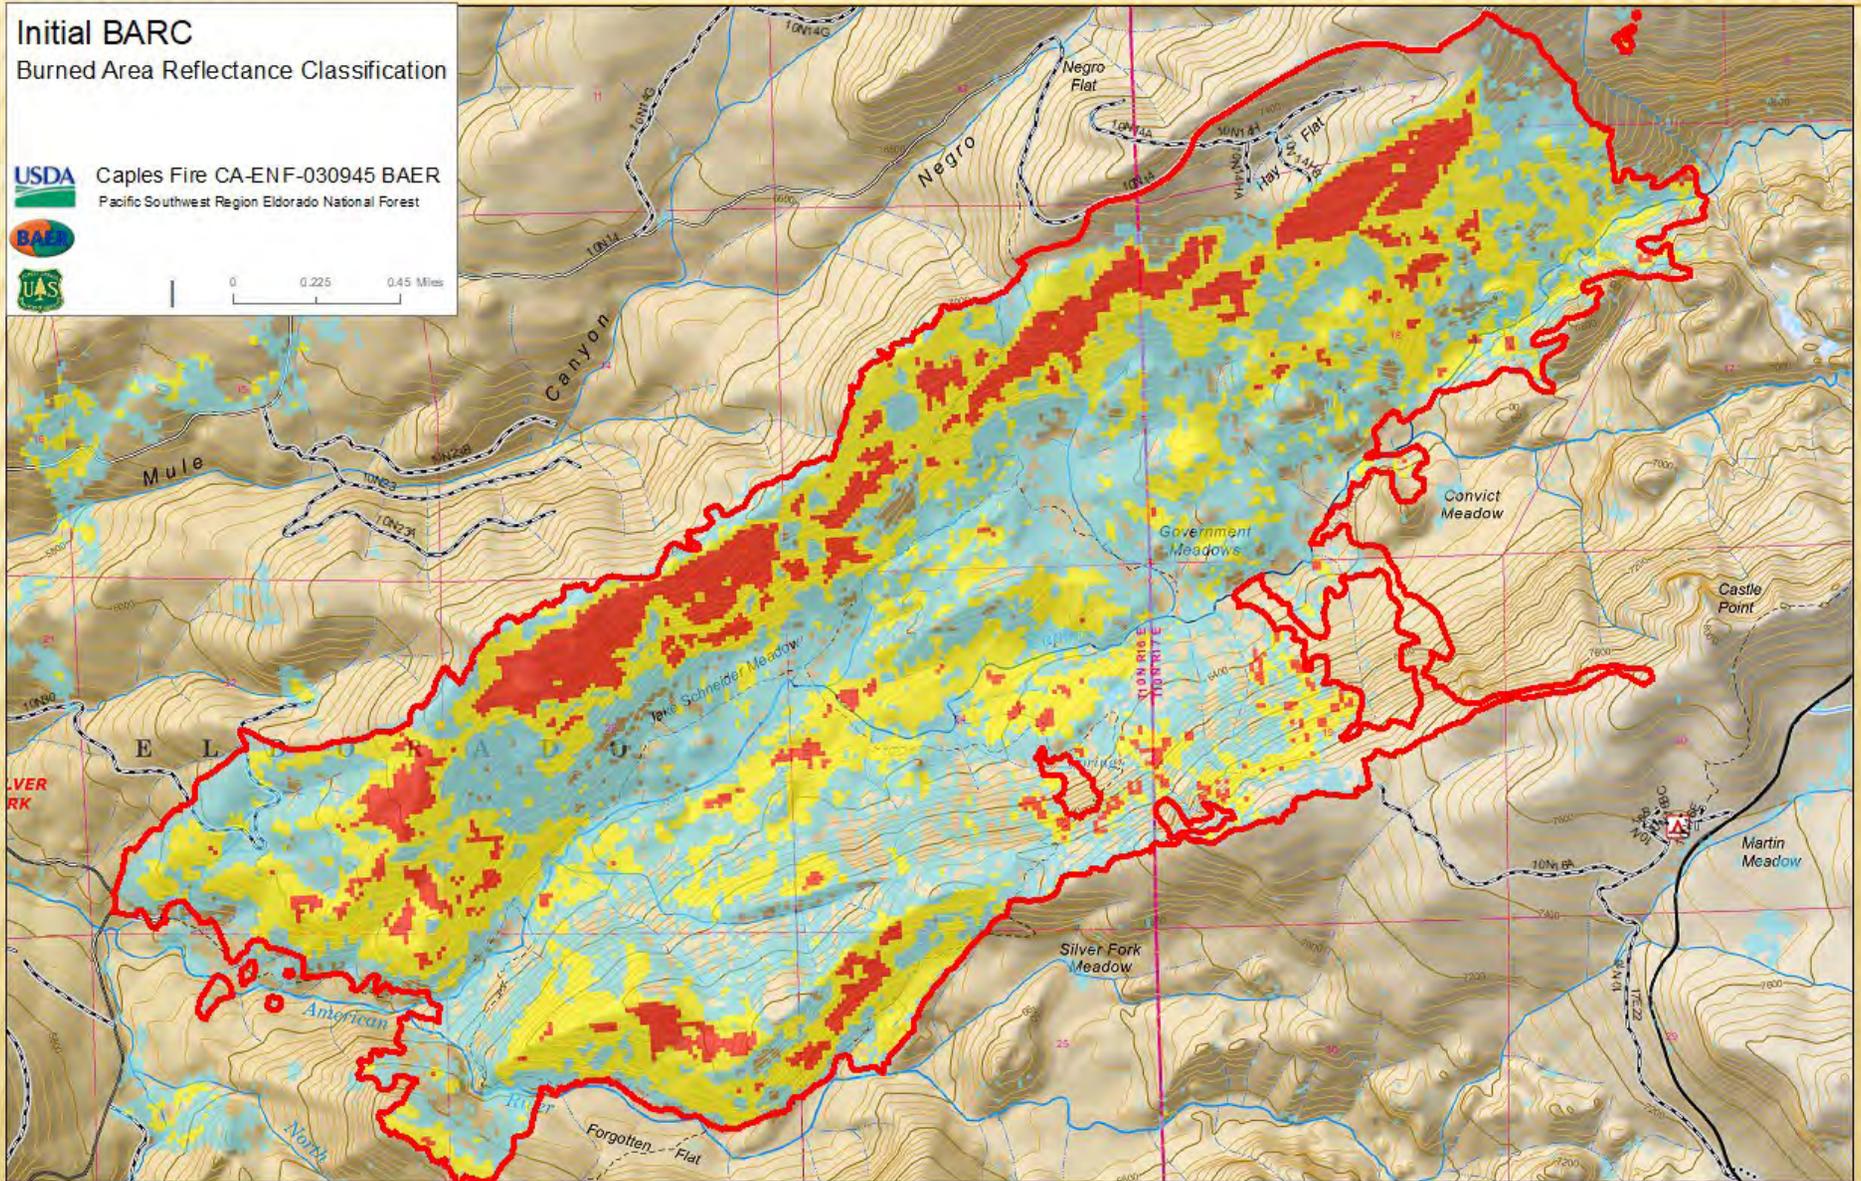
Burned Area Reflectance Classification

- BARC is the comparison between pre and post fire satellite imagery
- Processed by the Forest Service Geospatial Technology and Application Center
- BAER field verifies the BARC and makes adjustments for the final Soil Burn Severity Map (SBS)
- SOIL BURN SEVERITY IS NOT VEGETATION MORTALITY (but we have initial mortality data)

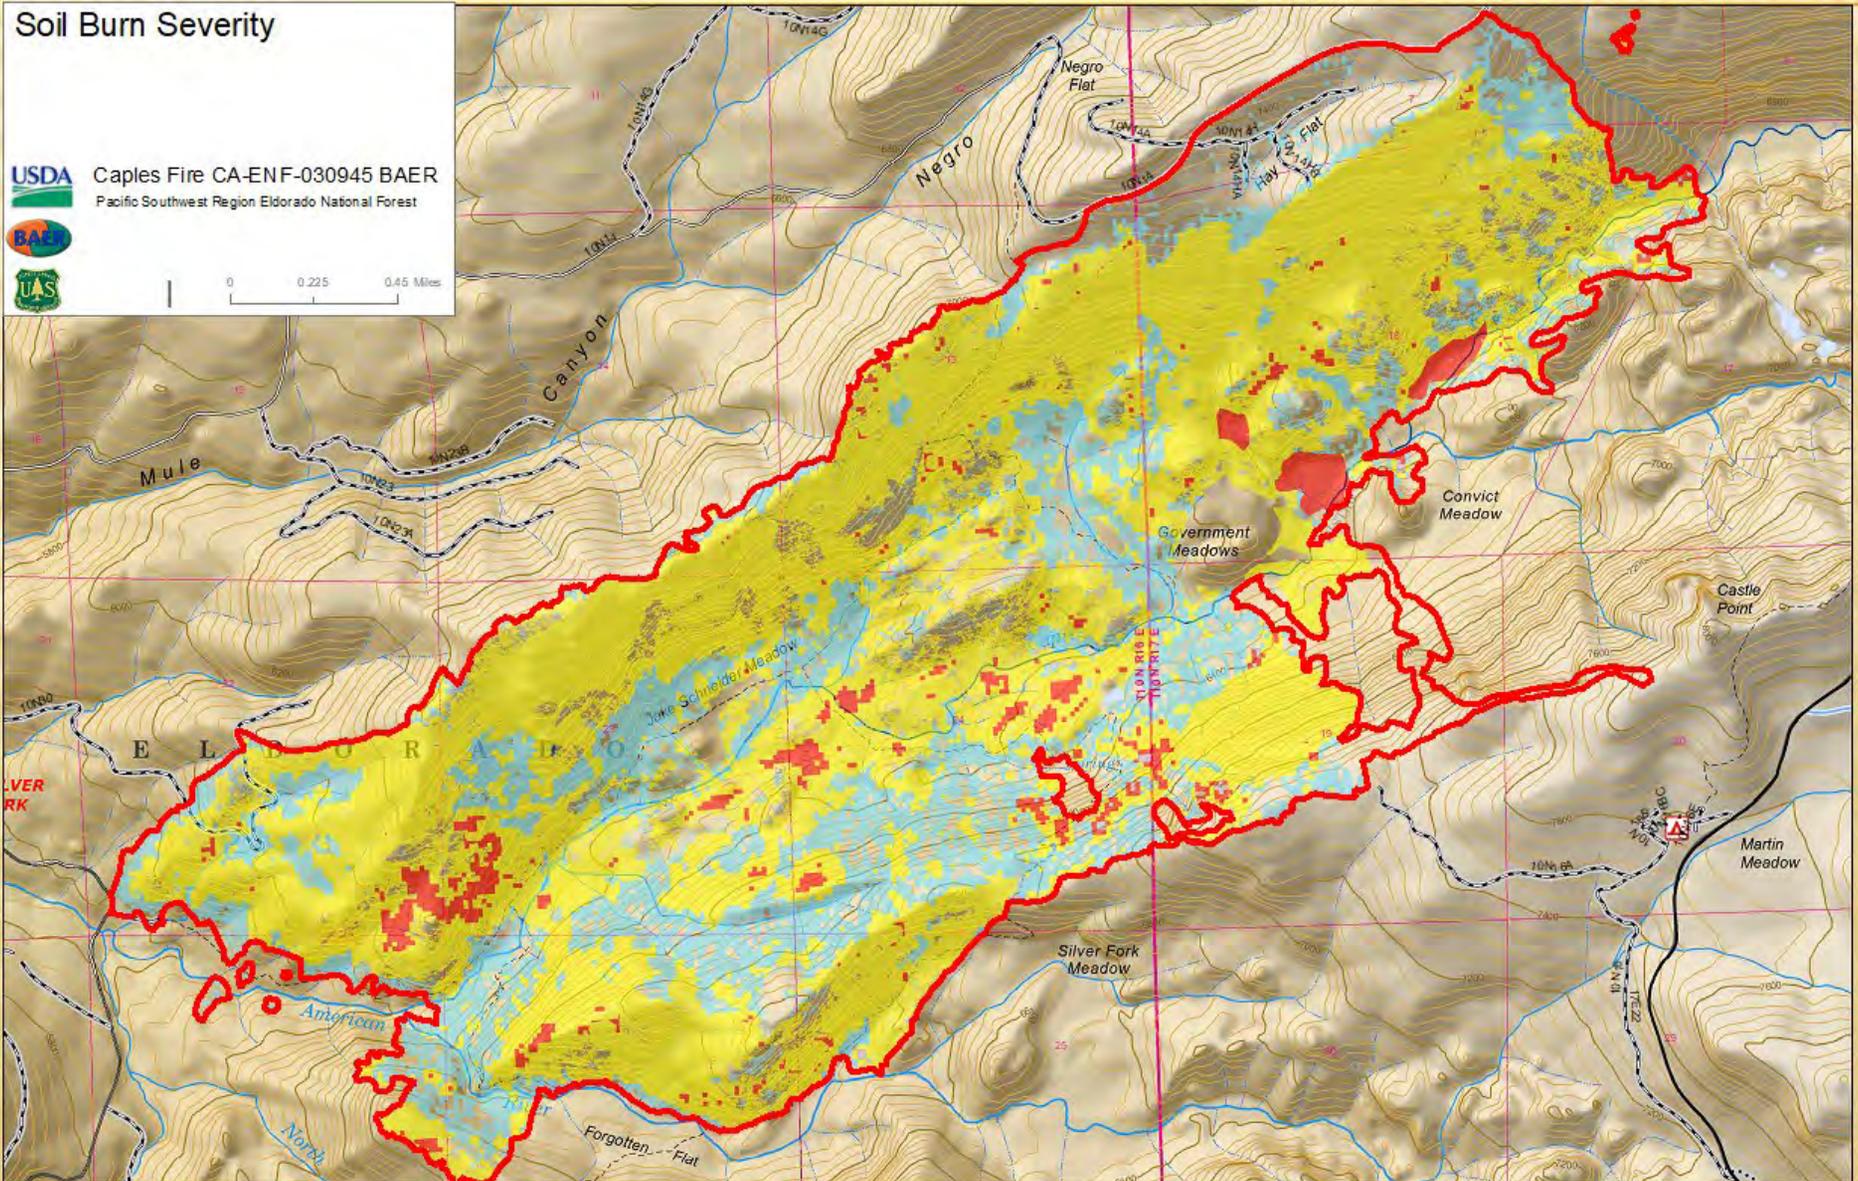
## Soil Burn Severity

Soil Burn Severity	Acres	Percentage
Unburned/Very Low	642	19
Low	760	22
Moderate	1884	55
High	116	3

- ✘ Fire actively burning affecting reflectance and extent
- ✘ Much of moderate severity SBS masked by green canopy introducing uncertainty
- ✘ Shrub canopy removal gives false SBS determination

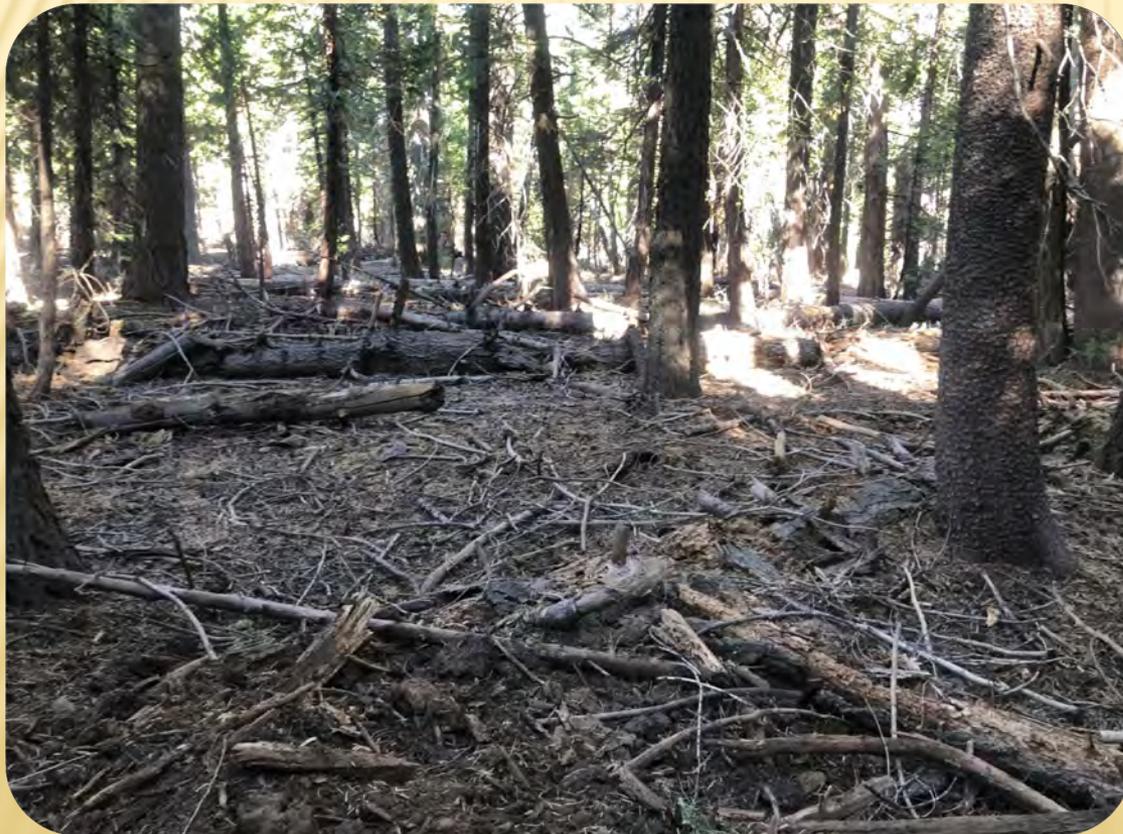
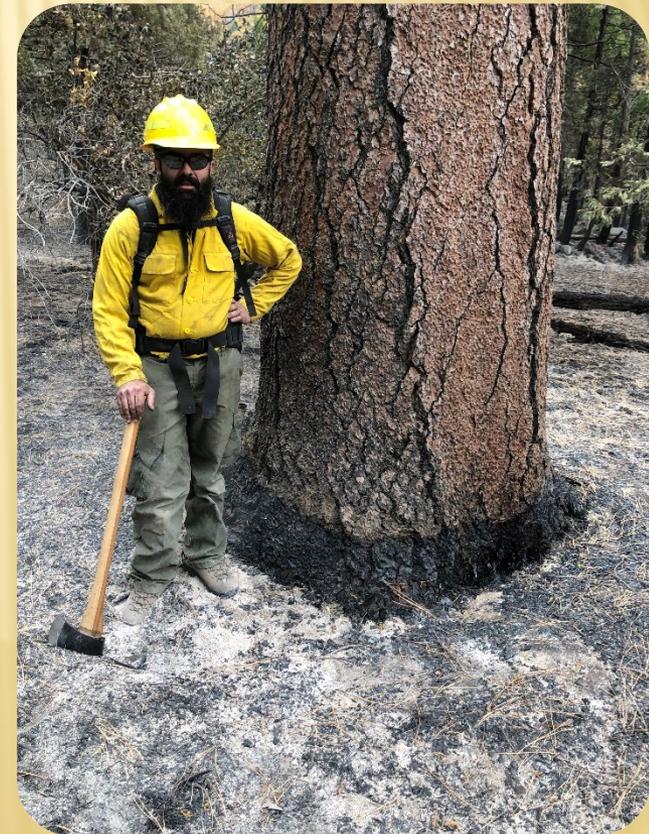
Successful fuel reduction in areas with high pre-fire fuel loads. However, unexpected mortality of some legacy trees and continuous tree stands. Areas with high ground heat and absent crown fire will show delayed mortality

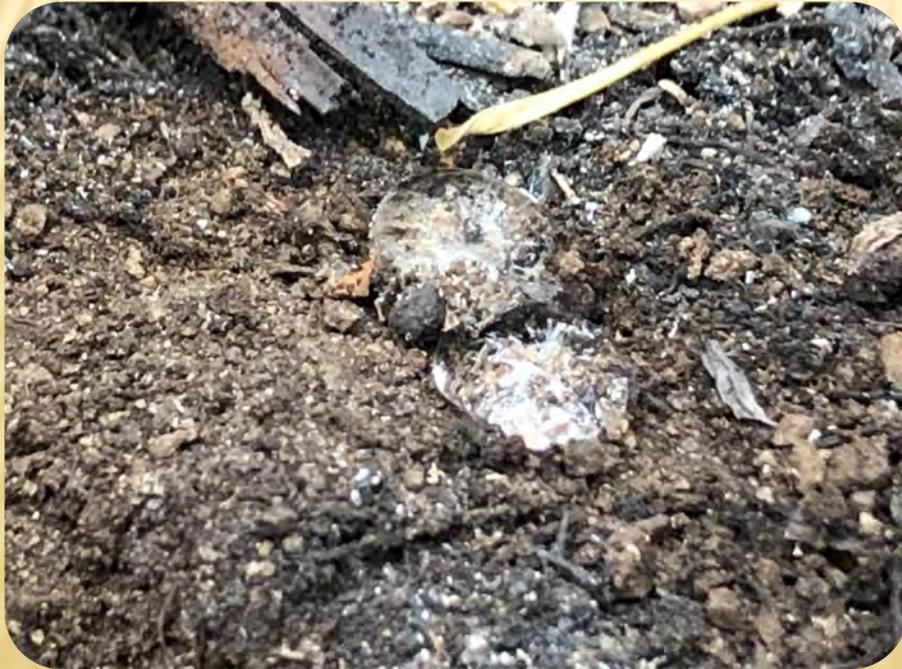
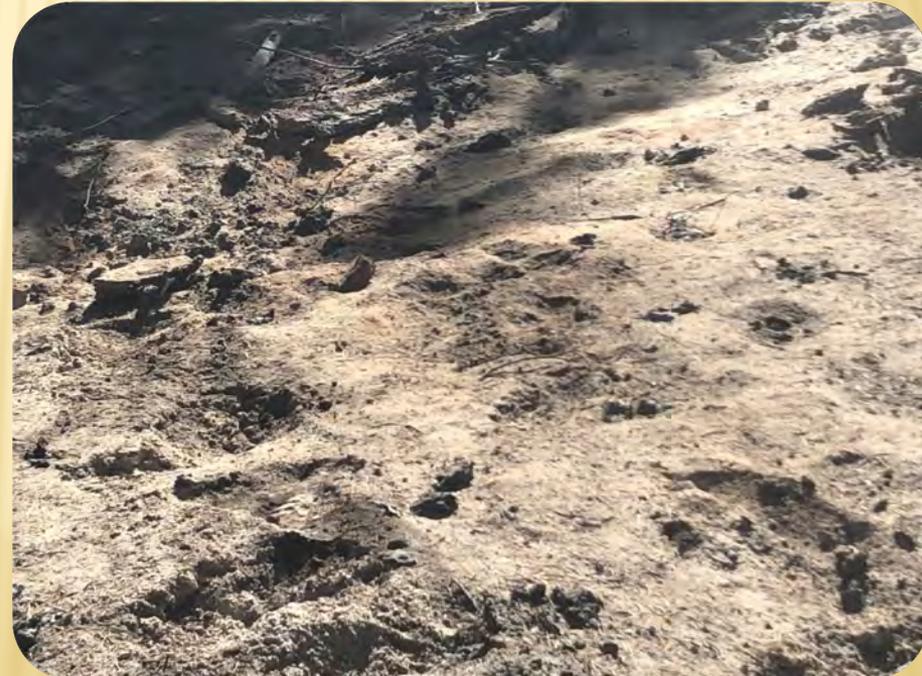
Severe water repellency, thick layers of organic ash, and burned riparian vegetation will result in significant localized deposits of ash and soil.

Amount of sediment delivery highly dependent on fall storm types  
Atmospheric River vs. early heavy snow fall

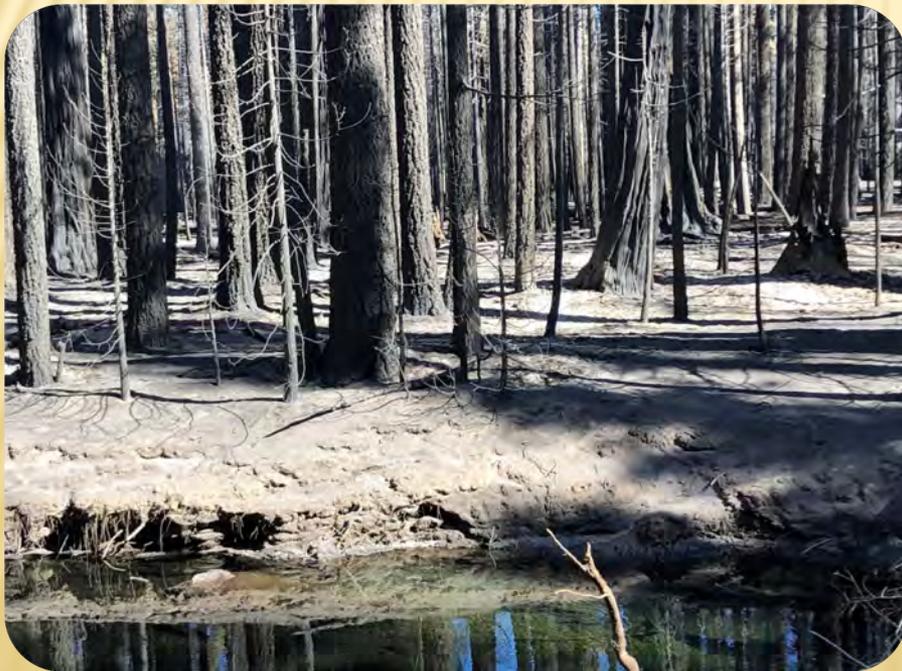
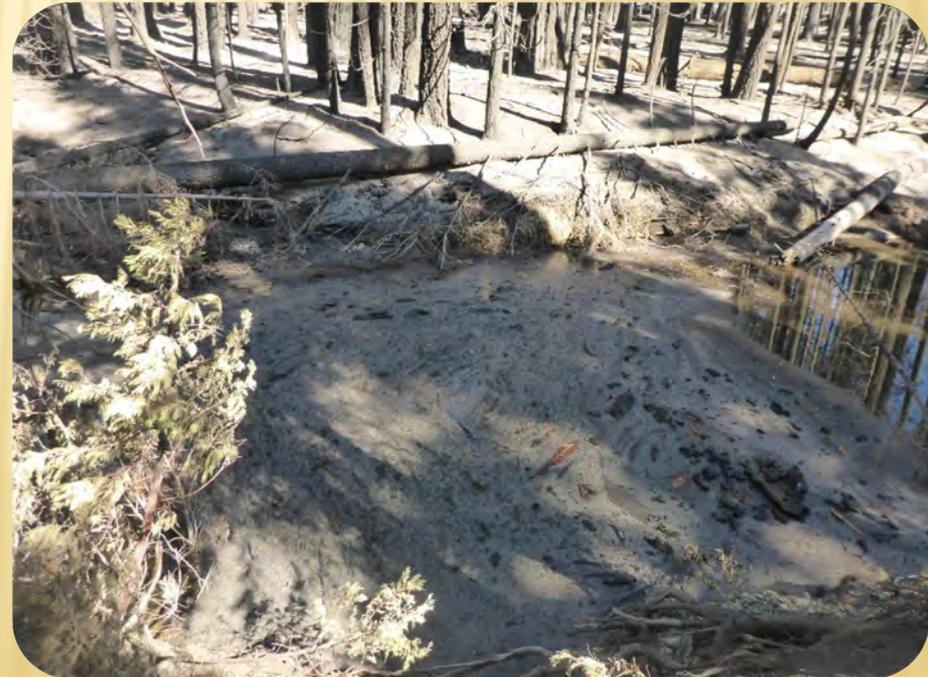
Negative effects to Caples Creek wild trout fisheries is likely. The severity is dependent on type and timing of fall and winter storms.

Ash deposits into the creek are currently evident without rain. The effects to aquatic organisms are still being assessed but no treatments are likely.

Burned bank stabilizing riparian vegetation on some reaches of Caples Creek.

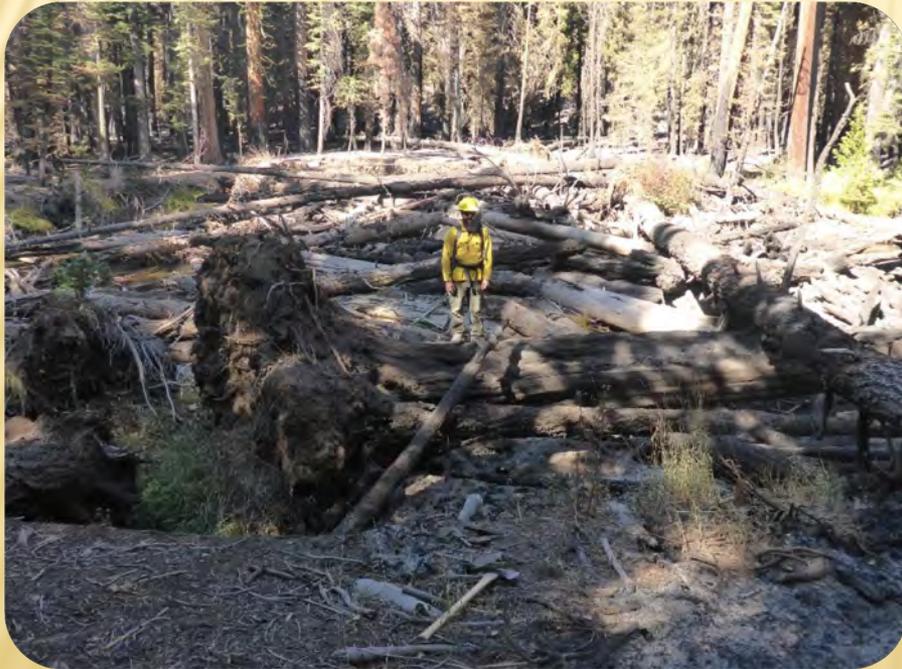
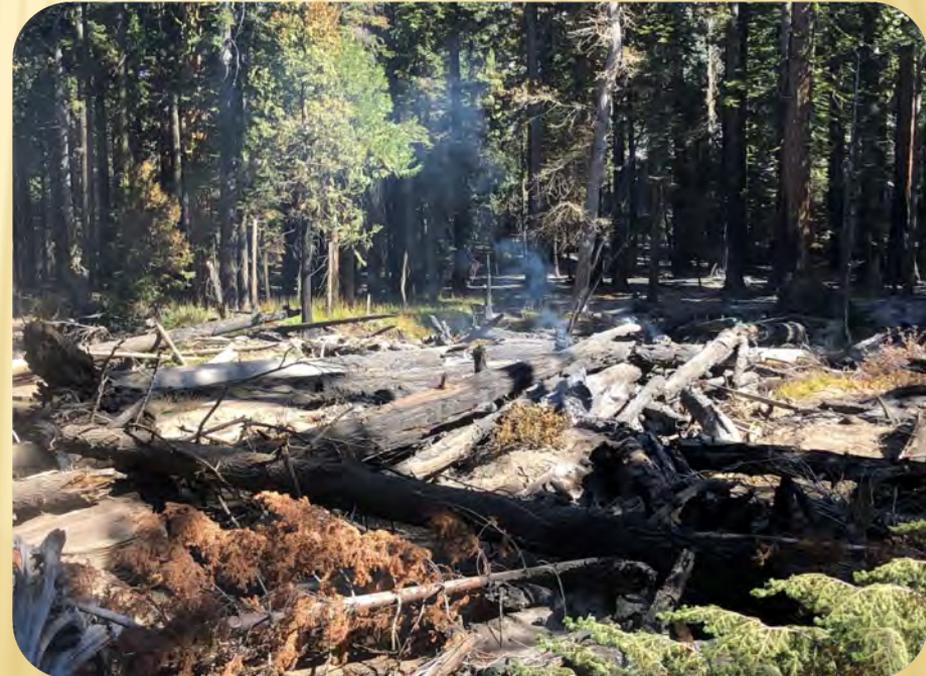
Large organic debris jams are common within both Caples Creek and Silver Fork American Creek. Heavy tree fall resulting from the fire will likely exacerbate these jams. In at least one instance, the jam is smoldering.

A liberated moving organic debris dam (MODD) could have a cascading effect impacting the Caples foot bridge, the Silver Fork bridge, and EID facilities.

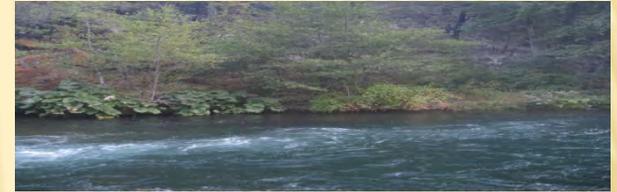
# WATERSHED CONDITION

✘ Increased watershed response

+ Q5 flows increase by 1-8%

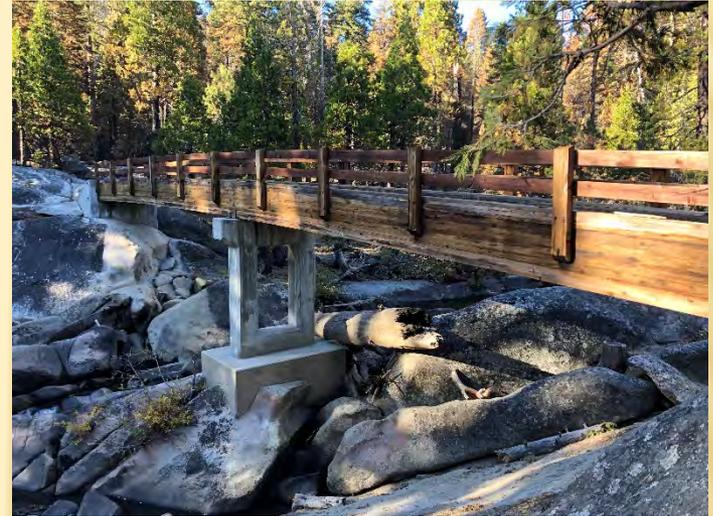
**Risk** - We evaluated the Silver Fork bridge and the Caples Trail Footbridge.

**Effects** – Both bridges are at risk of moving organic debris dams. The Caples Trail Footbridge is at particular risk of large woody material damaging the deck and supports

**Treatments** – Storm patrol, 10 person handcrew, and excavator to remove material

Type 2 excavator for 4 days

10 person handcrew for 2 days

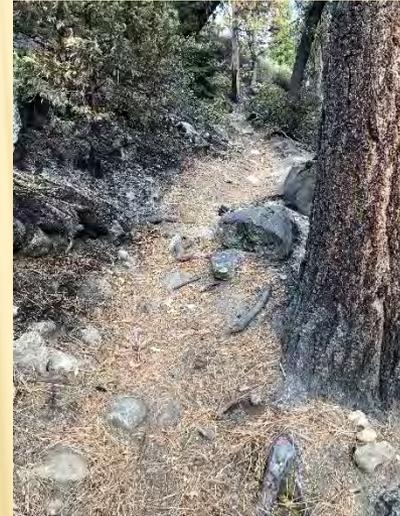
*Risk* – Two trails are at risk of erosion.

*Effects* – Approximately 1000 feet of trail in moderate and high soil burn severity with inadequate water controls. Trail damage and sedimentation is likely.

*Treatments* – Construct water dips with hand tools. The soil scientist and hydrologist will do the work concurrent with other monitoring work

2 GS-11 Watershed specialists for 1 day.

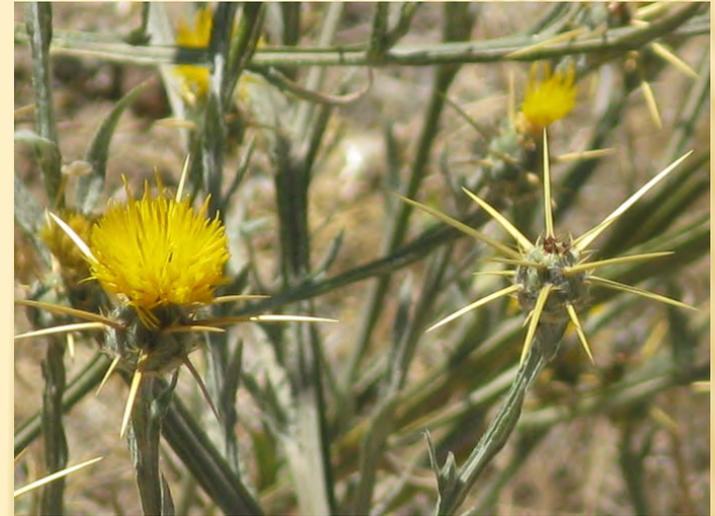
# VALUES-AT-RISK – NOXIOUS WEEDS

*Risk* – Spread of noxious weeds.

*Effects* – Potential infestations of noxious weeds in a proposed wilderness area without current infestations, and control of know populations

*Treatments* – GS 5,7,9 botany personnel + equipment and supplies for survey and treatments (EDRR). Funding can only be used for one year with a minimum of two surveys

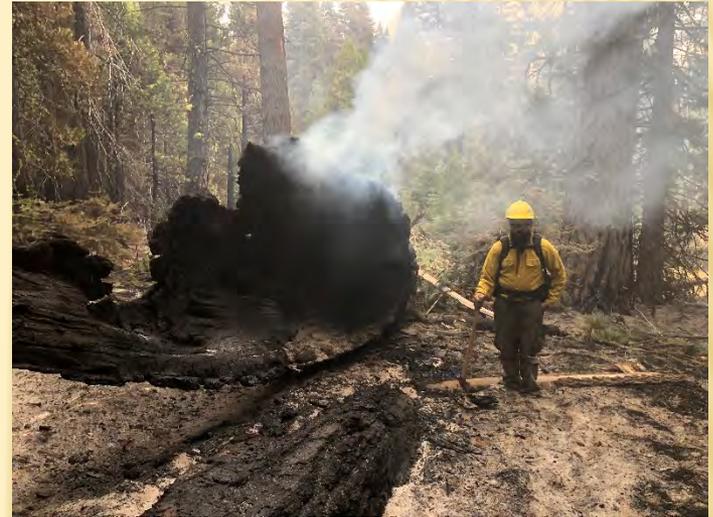
*Risk* – Potential injury/death from rock and snag fall in a high use recreational area

*Effects* – Trails are currently experiencing rock fall from destabilized slopes. Fire-killed and damaged trees are breaking and falling at significant rates and puts recreational users at risk. Legacy trees will likely burn into next spring creating more snag supply

*Treatments* – Recommendation to staff to evaluate snag danger after snow melt to determine opening date.

Signage - 6 signs
