Willamette National Forest
Burned Area Emergency Response Summary – Holiday Farm Fire
October 30, 2020

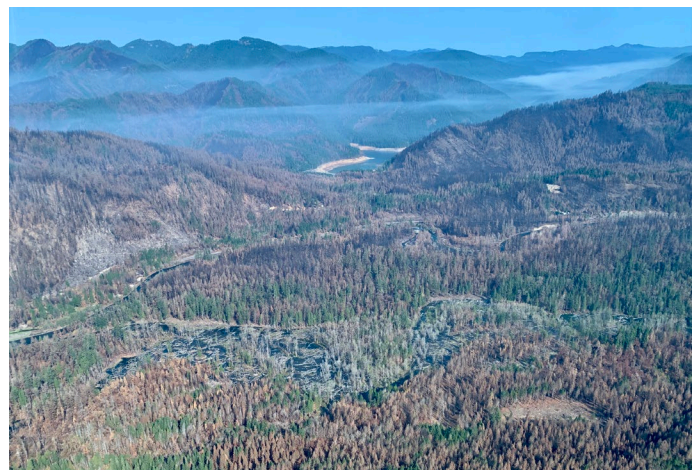
The most concentrated areas of high SBS are found in the Gate Creek, East Fork Deer Creek-McKenzie River,

Figure 1. Mosaic of low, moderate and high SBS – South Fork McKenzie River/Blue River area.

Lower Blue River, and Elk Creek-McKenzie River subwatersheds. Much of the high SBS overlaps with areas mapped with severe soil erosion hazard ratings. Modeled post-fire erosion potential for a ten-year storm event (10% probability of occurring in any year) ranges from 1 ton/acre to 90 tons/acre, averaging 26 tons/acre, in the most severely affected subwatersheds.

Long-term soil productivity was identified as a critical value with a high risk of damage or loss. However, no treatments are prescribed to mitigate impacts. Based on modeling across similar burned areas in western Oregon during the 2020 fire season, the reduction in soil loss achievable by techniques such as aerial mulching would be nominal, and treatments would not be cost-effective. Post-fire precipitation events early in the wet season have already accelerated soil loss on erosion-prone hillslopes, further reducing the prospective effectiveness of land treatments to reduce erodibility. Allowing for natural recovery is the recommended course of action.

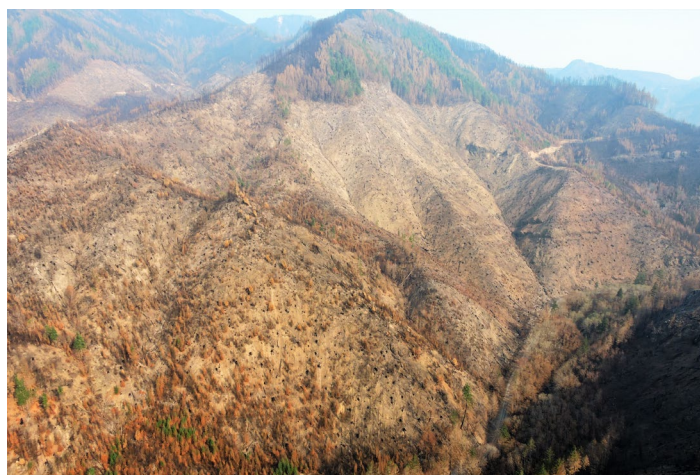
Figure 2. Debris-flow prone slopes in Quartz Creek drainage.

Our observations and analysis conclude that there is an elevated risk of instability in the form of rockfall and debris flows across much of the burned area. Specific areas with rockfall hazard were identified that in the Highway 126 corridor, on roads accessing Cougar and Blue River dams and reservoirs, and on a forest road accessing a communications site. Elevated debris flow hazard was identified on a number of steep canyon hillslopes where SBS is high and moderate, including in the Highway 126/McKenzie River corridor, in Gate Creek, Elk Creek, Cone Creek, Quartz Creek, and above Blue River Reservoir. The cumulative risk of various types of slope instability, sediment bulking, and channel flushing is high along many slopes and drainages in and below the burned area following the Holiday Farm Fire. Based on this, special attention and caution is recommended in areas where people are living, traveling through, working, or recreating in or below burned areas during and after storm events.

In order to reduce risk to life and safety, we recommend to coordinate warning notifications with the National Weather Service, post warning signs, and enforce administrative closures, especially if rainfall intensities would reach a threshold of 0.75-inch/hour in short duration storms. Cooperation and coordination with partner agencies such as Lane County and the Oregon Department of Transportation is recommended to help mitigate risk along the important transportation corridors in the burned area.

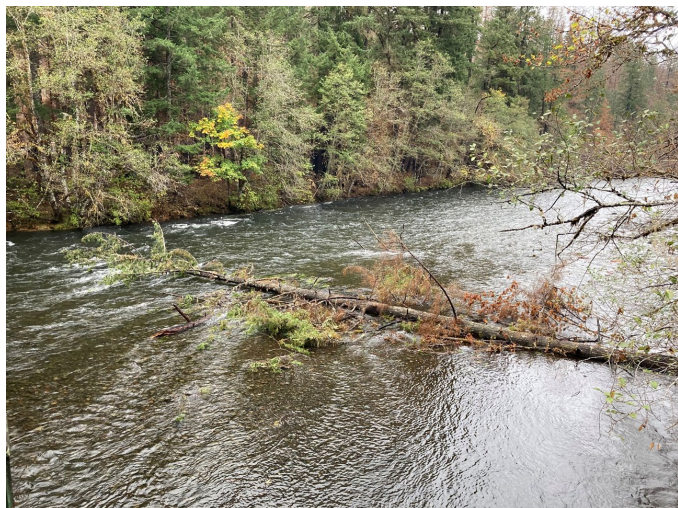
Figure 3. McKenzie River woody debris

Large woody debris available for recruitment into stream channels and valley bottom fish-bearing streams has increased greatly because of the Holiday Farm Fire. Increases in large channel wood will have a long-term benefit on wood loading, geomorphic complexity, and habitat quality in Critical Habitat. In the short term, increased wood delivery to the mainstem McKenzie River is likely to present challenges to recreational boating, a major driver of the local economy. Limited repositioning of channel wood is proposed as needed to protect boater safety while retaining habitat benefits that large wood provides.

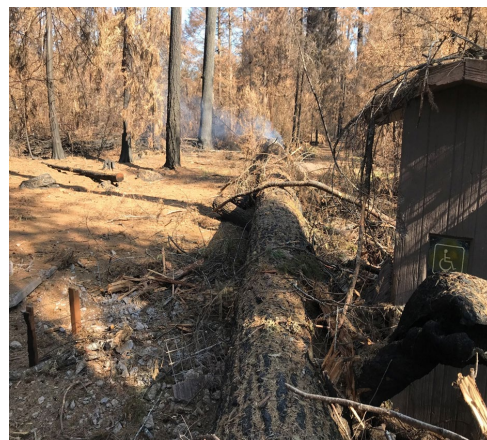
The Holiday Farm burned area and immediate vicinity include 3 campgrounds, 2 boat launches, 1 trail, 1 Wild and Scenic river, and 2 reservoirs, most of which experience year-round use. Of these, one campground, one trail and one boat launch were heavily damaged, with nearly total tree mortality and infrastructure loss. We recommend closure and decommissioning of the damaged campground and trail, hazard warning signage at the boat launch and other river access sites, and monitoring of conditions at one campground (storm inspection and response).

Figure 4. Delta Campground Vault Toilet
