## *George Washington and Jefferson National Forests*

# North Shenandoah Mountain Restoration and Management Project

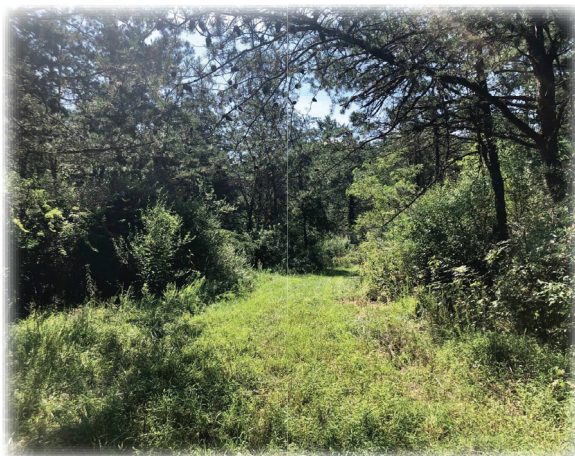
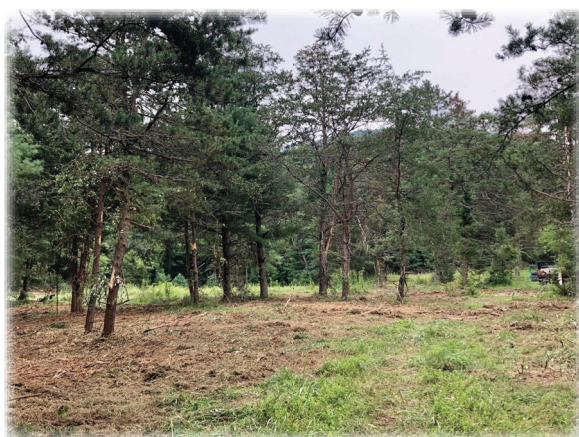
Figures 1 & 2: Before (top) and after (bottom) photos of the Camp Run Savannah Project located in Pendleton Co., WVa. This project removed non-native invasive species by mulching and then rehabbed the old field for pollinator habitat. Photo credit: Forest Service

**Camp Run Savannah** is a 12-acre, old pasture field in West Virginia. Over the past 25 years the field has become overgrown with Virginia pine trees, hardwood tree encroachment, and mature NNISs including autumn olive and bush honeysuckle. In August 2020 a three year management project was initiated focusing on both increasing native pollinator habitat and the treatment of NNISs. This year invasive shrubs and trees were felled reducing the basal area to around 15 square feet per acre. Native seed mixes for the area will be planted in the spring of 2021.

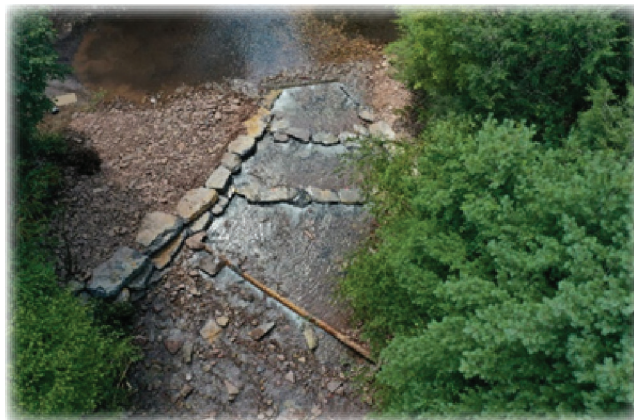
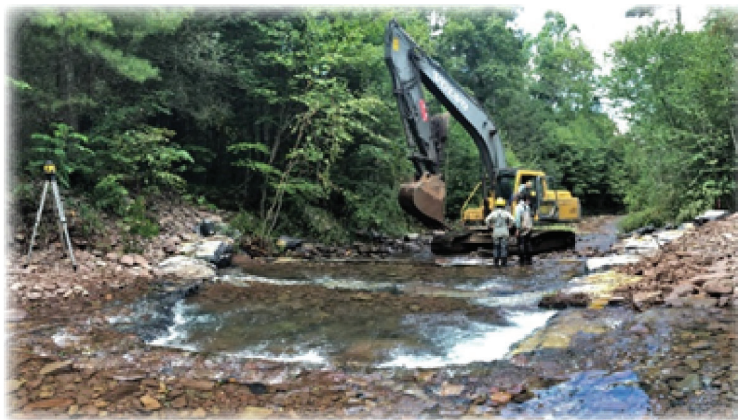
Figure 5: Overhead view of aquatic passageway on Forest Road 227A. Photo credit: Forest Service

Figure 6: Construction of aquatic passageway on Forest Road 227A. Photo credit: Forest Service

Forest Road 227A crosses Dunkle Hollow, a native brook trout stream. This crossing was held in place by a barrier with a two-foot drop height which was too tall for aquatic life to easily cross. To better facilitate trout upstream passage, a series of grade controls were constructed to allow fish to overcome the barrier. Four smaller steps of approximately 6 inches each were installed utilizing over 100 tons of rock.

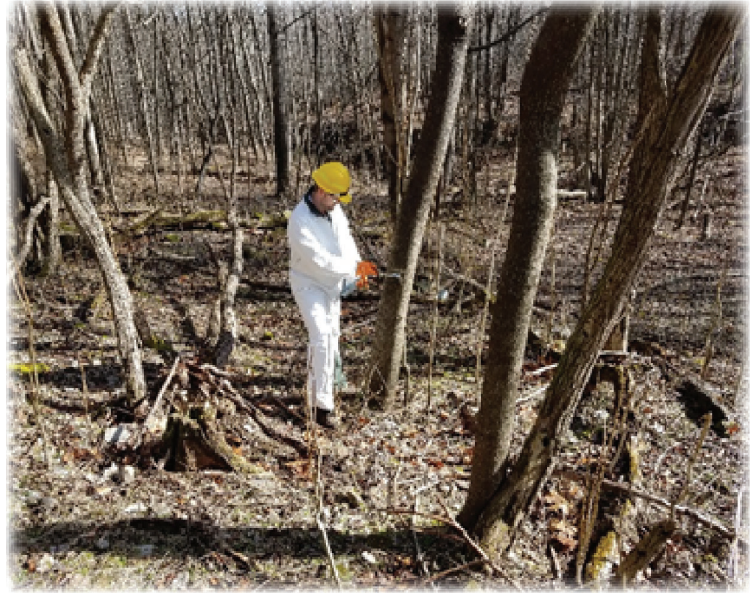
Figure 7: NNIS Hack and squirt treatment for Aileanthus. Photo credit: Forest Service

These treatments have included mechanical and chemical methods. Primarily mechanical control uses mulchers and chemical control uses spray wands to apply foliar treatments on targeted species and also hack-and-squirt method where a small cut is made into tree bark and applying chemical to the cut area, as shown in the picture.

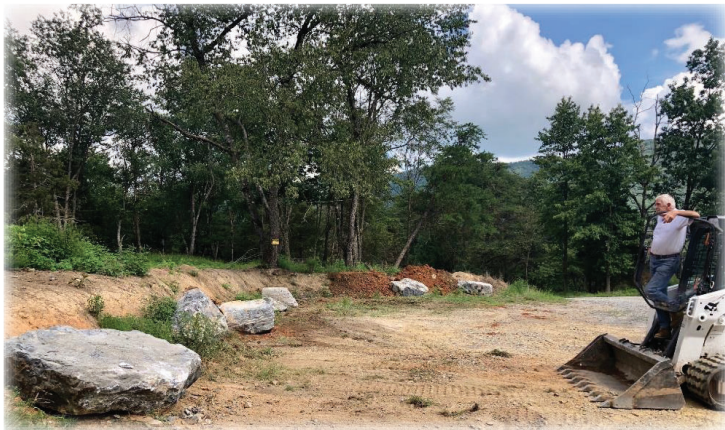
Figure 8: Working to reduce erosion and stream sedimentation. Photo credit: Forest Service

Stream corridors and riparian habitats provide shade and cover to help moderate water temperatures and keep a healthy microbial structure where native brook trout and other aquatic species live and forage. Large boulders were placed in several dispersed campsites to reduce impacts from vehicle traffic and allow vegetation to reestablish. Implementation of decommissioning of one road that is located in a riparian corridor has begun by removing trash, installing permanent waterbars and allowing the area to recover naturally.
