BEAR CREEK WATERSHED ANALYSIS

FISHERIES

**BEAR CREEK WATERSHED ANALYSIS
FISHERIES PHOTOS**

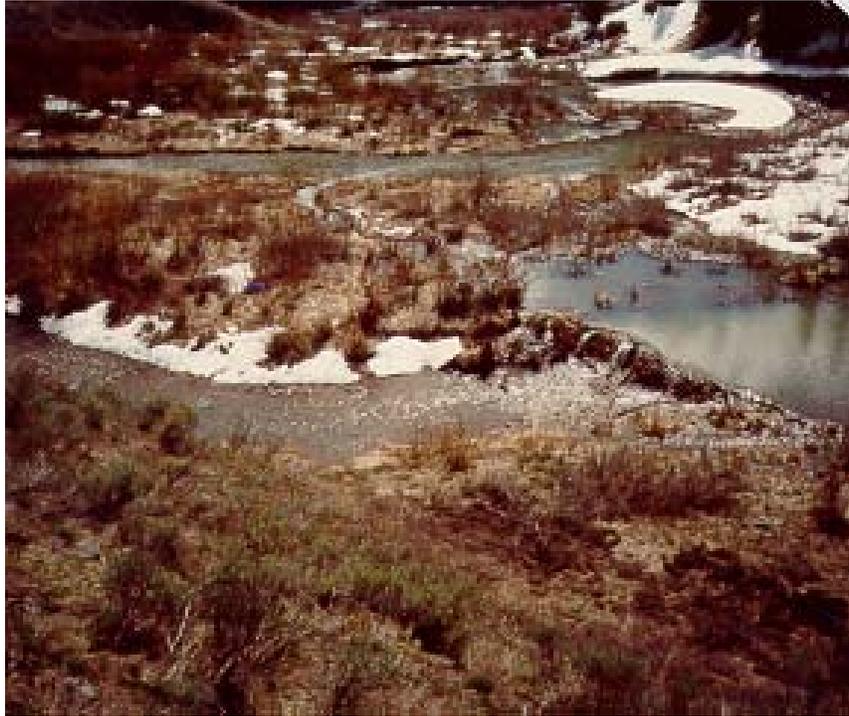
Snowmelt in lower Bear Creek, 1990.

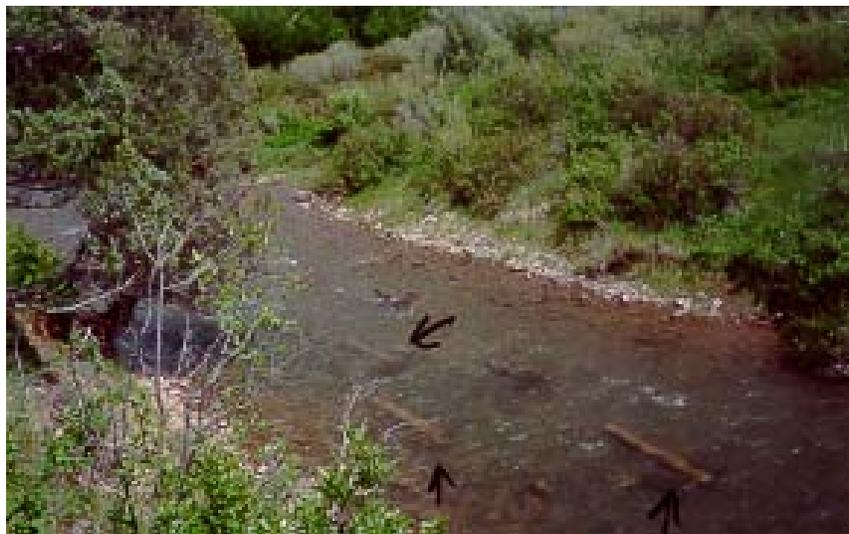
Habitat improvement logs in Bear Creek, photo taken 1990.

In August 1981, Palisades District Ranger Norm Huntsman signed a decision document to place habitat improvement structures in Bear and Elk Creeks to provide cover and develop pools. These were placed in the streams in 1982 and consisted of log structures. Most structures were half logs placed in the stream parallel with the flow.

The trend in Bear Creek appears to be stable. Considering the reduction of past livestock numbers that used the watershed, there may be a long term improving trend. Although slight impacts from livestock grazing and the trail were reported in current conditions, these impacts do not appear to have a serious impact upon aquatic or riparian habitat. Due to the high power nature of Bear and Elk Creek (high flows and high bedload), there are few signs of the habitat structures placed in Bear Creek in 1982. The most obvious structures that remain are the half logs that are now nearly buried in the substrate of Bear Creek.

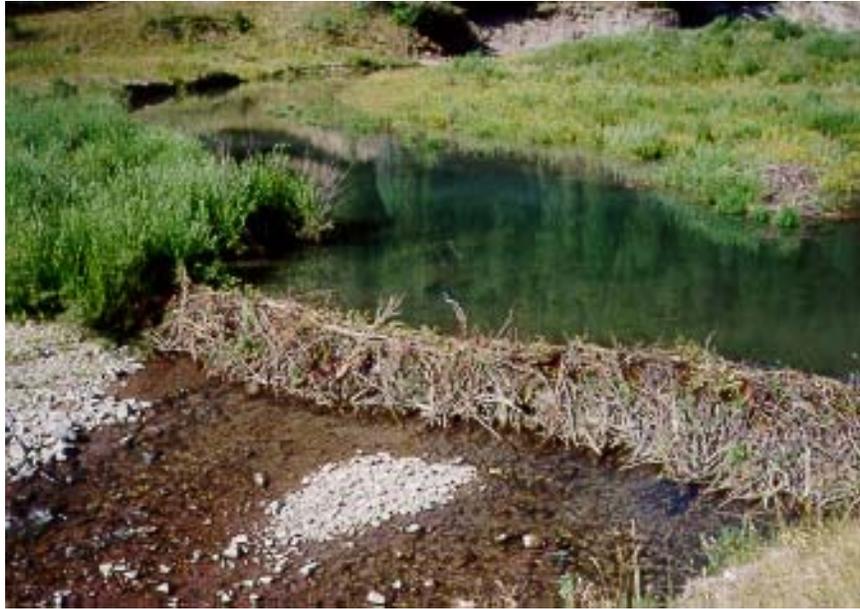
Beaver dam in Bear Creek, 2000.

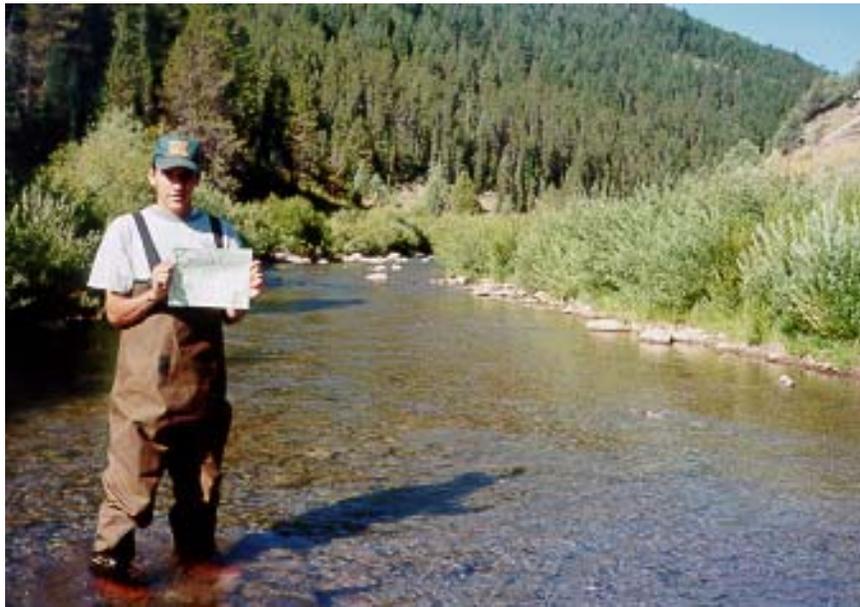
Typical habitat in lower Bear Creek, 2000.

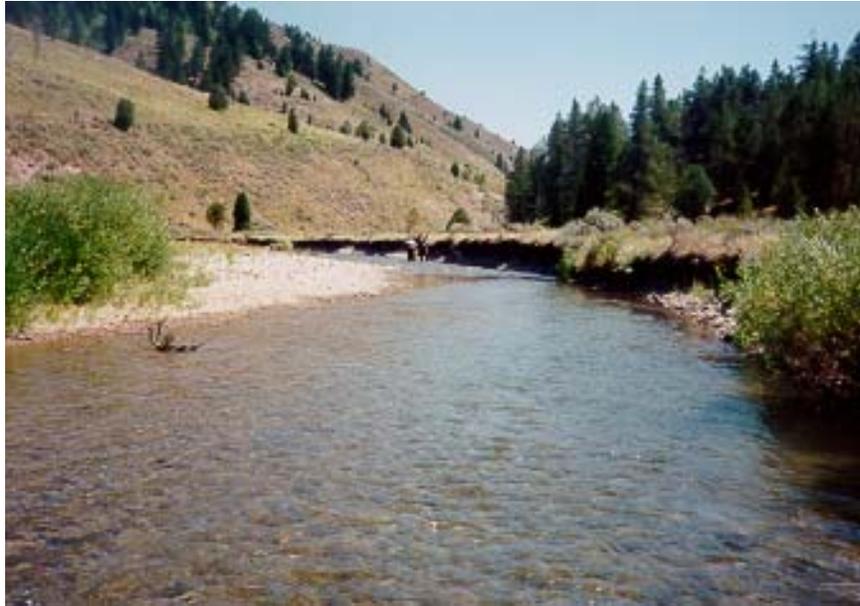
Section of raw stream bank in lower Bear Creek, 2000.

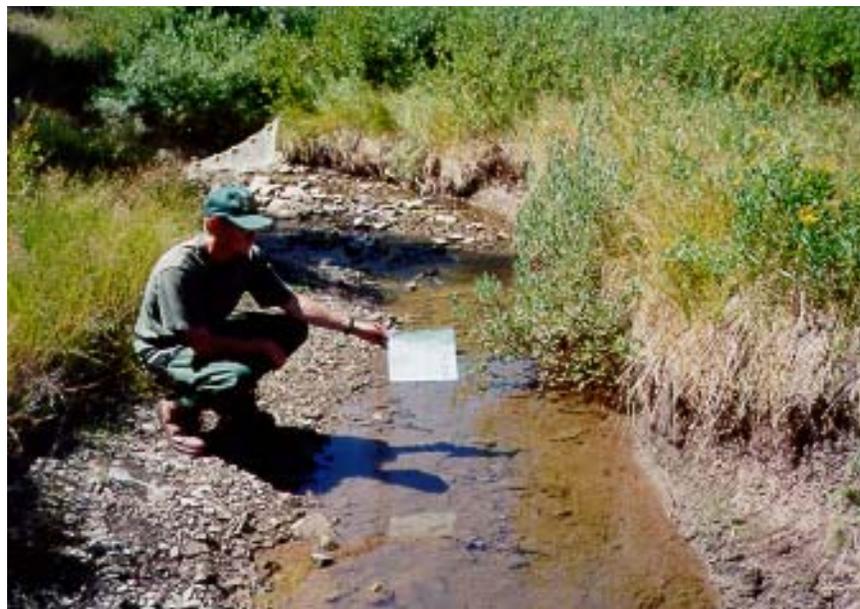
Upper Bear Creek, 2000.

The upper reach extended from the mouth of the South Fork of Bear Creek upstream approximately 2 miles. The riparian vegetation was dominated by a dense willow complex that paralleled the stream. Beaver activity was extremely frequent throughout the reach. Livestock grazing was more noticeable in this reach than the lower reach. Livestock trails were common in the riparian area and vegetation was heavily grazed upon. The stream substrate was dominated by cobble and gravel and surface fines were common. Stream channel stability was rated as poor (USDA Forest Service 2000).

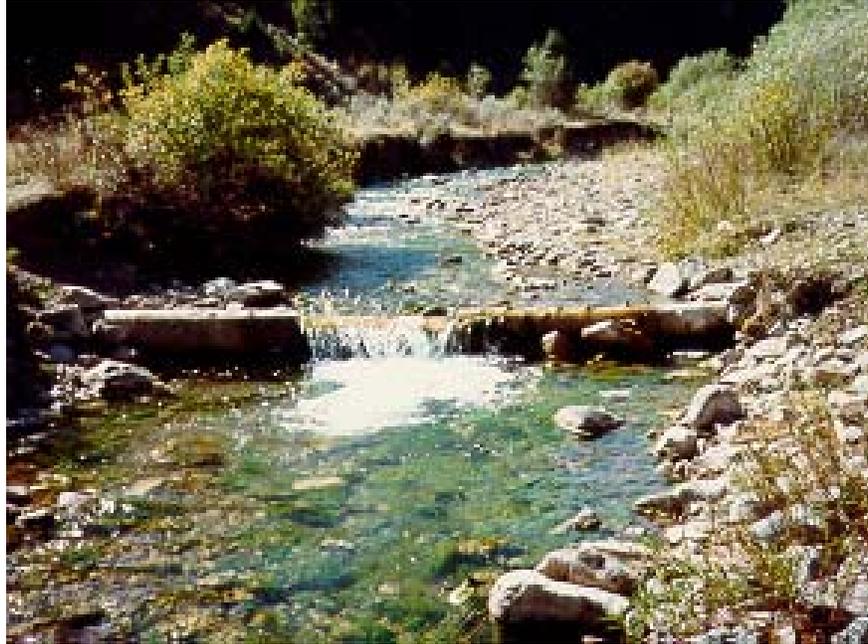
Habitat improvement logs in Elk Creek, photo taken 1987.

The trend in Elk Creek appears to be stable. Considering the reduction of past livestock numbers that used the watershed, there may be a long term improving trend. Due to the high power nature of Elk Creek (high flows and high bedload), there are few signs of the habitat structures placed in 1982. The road system up Elk and the West Fork of Elk is established and will not likely expand in the future. Although these roads affect the streams in the drainage, these impacts appear to be relatively slight (considering sedimentation) and have not increased since the construction of the roads. The culvert posing a barrier to upstream-migrating fish under FS Road 063 is a negative trend that occurred at road construction. However, this trend, a legacy of the construction of the road, is easily reversible.

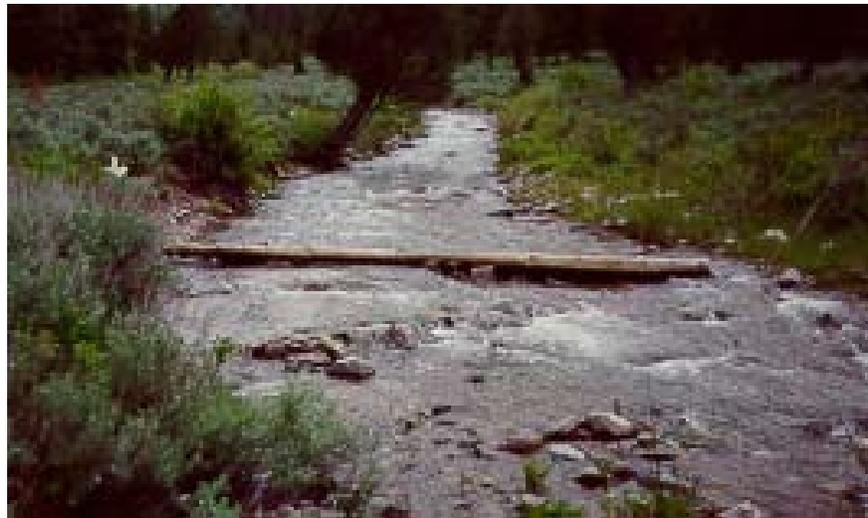
Habitat improvement log in Elk Creek, photo taken 1990.

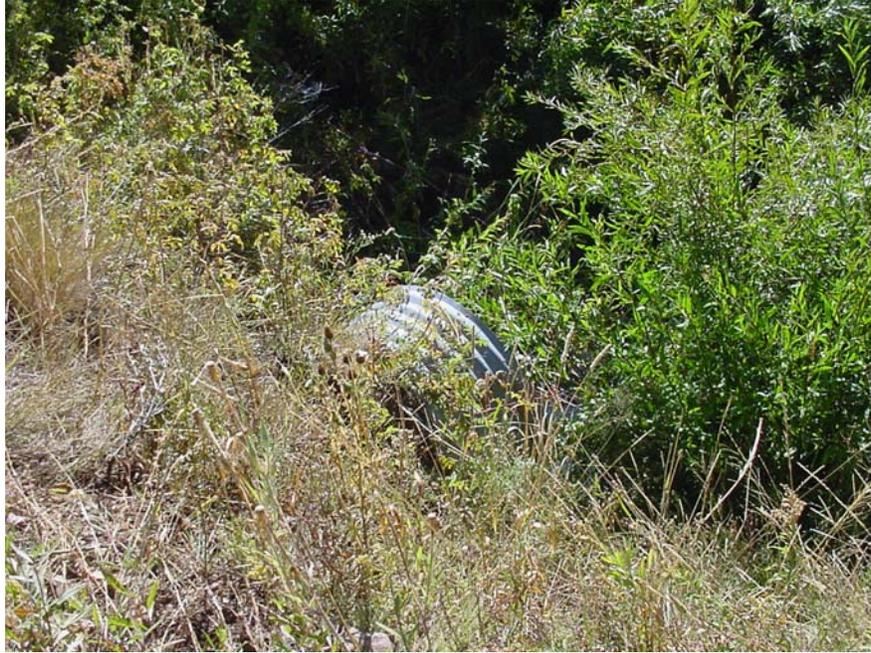
FS Road 063 culvert for tributary to West Fork Elk Creek. Barrier to upstream migration.

Remove the impassable culvert at FS Road 063 where it crosses an unnamed tributary to West Fork Elk. Create a trailhead at this location and construct a trail bridge over the tributary. The road beyond this point would be converted to a trail that would extend to the historic trailhead. This would open up an additional mile of habitat for Yellowstone cutthroat trout in West Fork Elk Creek and decrease road-related sedimentation from FS Road 063. If the additional 2 miles of road are needed beyond this crossing for some other resource reason, replace this culvert with a bridge or bottomless arch to insure upstream passage of fish. The slope of the stream at this crossing does not facilitate the placement of a culvert with the intent of successful fish passage.

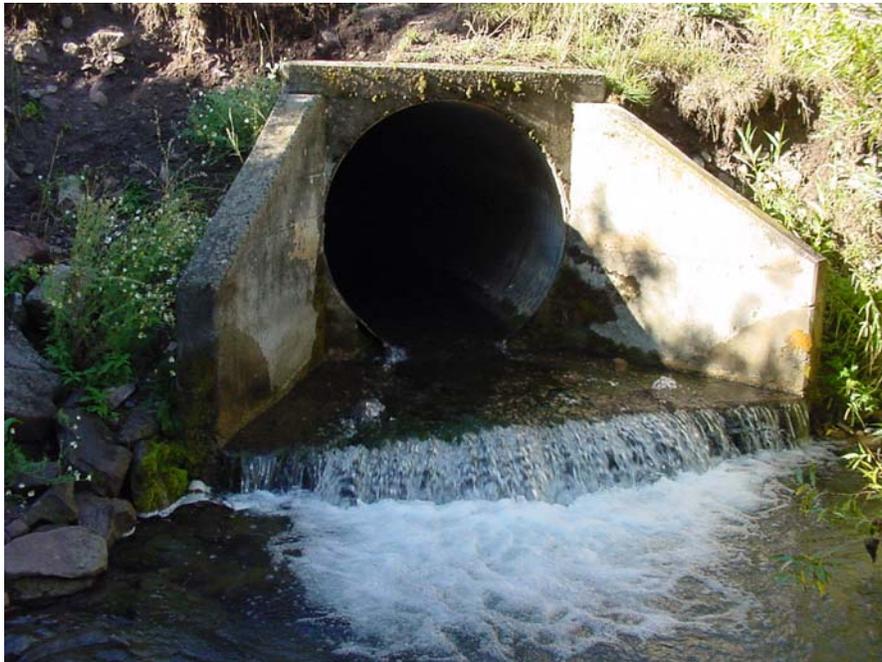
Forest Fisheries Biologist Capurso visited Elk Creek in September 2002. He noted FS Road 058 was laid out relatively well, keeping its distance from Elk Creek for the most part. There were a couple areas where the road encroached on the stream, but topography prohibits moving those road segments away from the stream. One of these places was heavily rip-rapped. A culvert under FS Road 058 (had a concrete apron) had a small plunge at its outlet, but appeared to be passable at any time of the year for fish. FS Road 063 was also responsibly placed along West Fork of Elk Creek. However, it had more impacts upon that stream through sediment delivery at encroachment locations and one fish passage barrier culvert at the crossing of an unnamed tributary to the West Fork of Elk Creek. This culvert is located 1.55 miles up from the intersection with FS Road 058. There appears to be approximately 1 mile of habitat upstream of this fish barrier.

FS Road 058 crossing over Elk Creek. Metal culvert with a concrete apron.
