Rangeland Resources & Best Management Practices Review - Targhee NF

Allotments: East Beaver C&S Allotment **Forest/District:** Caribou-Targhee NF, Dubois RD

Date: 8/31/2005

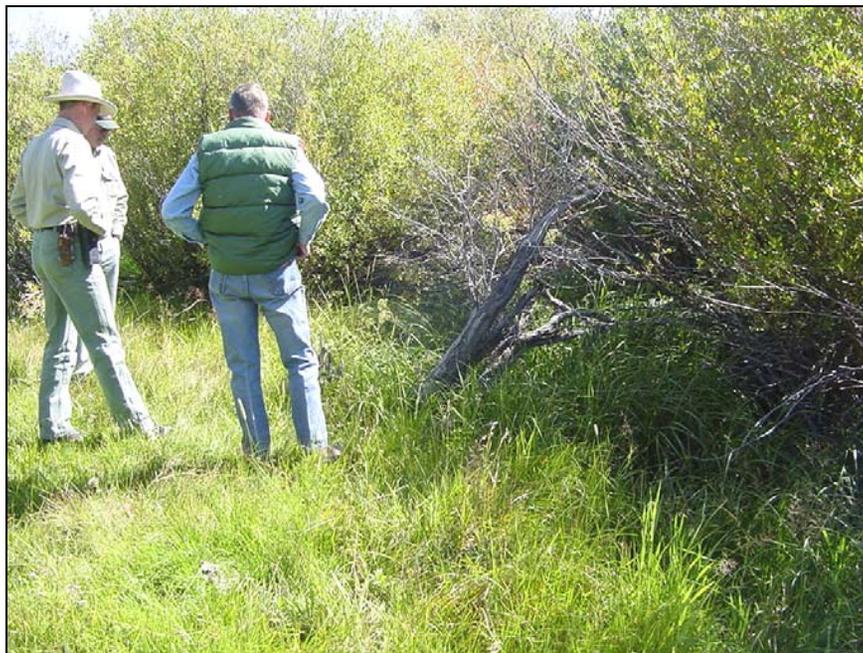
Photo 1. Dairy Creek in Unit 2 after grazing. Under the grazing system, this area should not be grazed again until next year. Some trespass did happen following the review however (Photo 2).

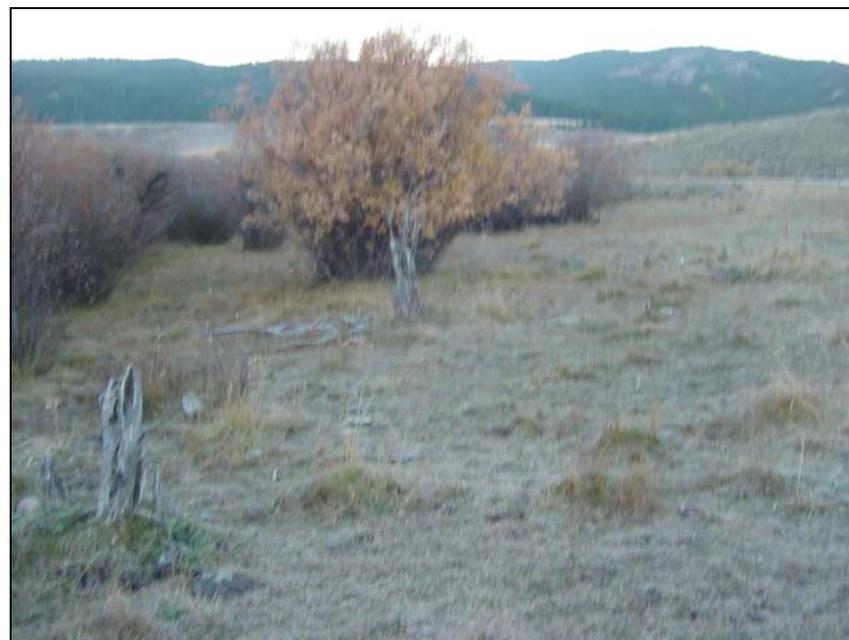
Photo 2. Dairy Creek (Unit 2) on 10/26/2005. Although photo is late in the fall, you can see that additional use did occur due to trespass cattle from Unit 1.

Post Review Activities. The team agreed that current management is greatly improving conditions. With the new grazing system however, adjustments will be necessary to minimize impacts. One such adjustment was identified later in the grazing season (following the review) after adverse impacts were identified in Unit 1 (upper Dairy, Left Fork, & Calf Creeks) and portions of Unit 2 (lower Dairy Creek). Following the review, the lower (downstream) end of Unit 1 received heavy use and Unit 2 received additional use (cattle had already grazed and left Unit 2 during the review). Under the previous “split herd” grazing system, half of the herd (750 head) grazed Unit 1 last approximately every other year prior to going home for the season. This year (2005) was the first time Unit 1 was grazed by the combined herd (1,500 head). That is, 750 head had never been in this unit late except to be gathered and head home (which had sometimes been mid-Sept). Scott McCoy observed that the majority of cattle that were hanging on the Unit 1-2 fence were those cattle that had never grazed Unit 1 in the past. Therefore, the animals were pushing the fence in anticipation of heading home. The problem was compounded by early snows that pushed cattle down near the fence as well. As a result, livestock hung in the lower portion of Unit 1, pushed and trespassed the fenced on Dairy Creek, and distribution was not adequate across the unit. District personnel informed and worked with permittees to fix the problem. Following the grazing season though, localized impacts were evident in Unit 1 and 2.

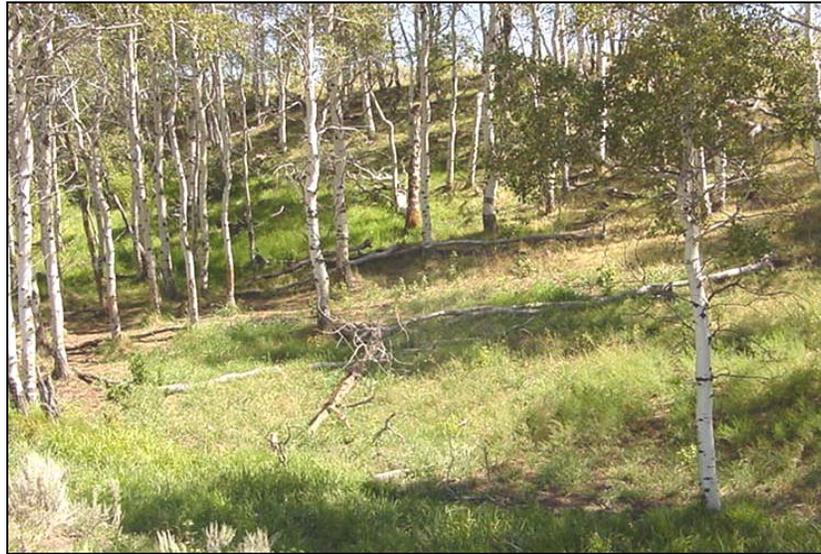
Photo 3. Telephone Creek area (Unit2). Improvement in a previously bare area (loafing zone). Aspen regeneration was observed in 2005; ground cover is increasing.

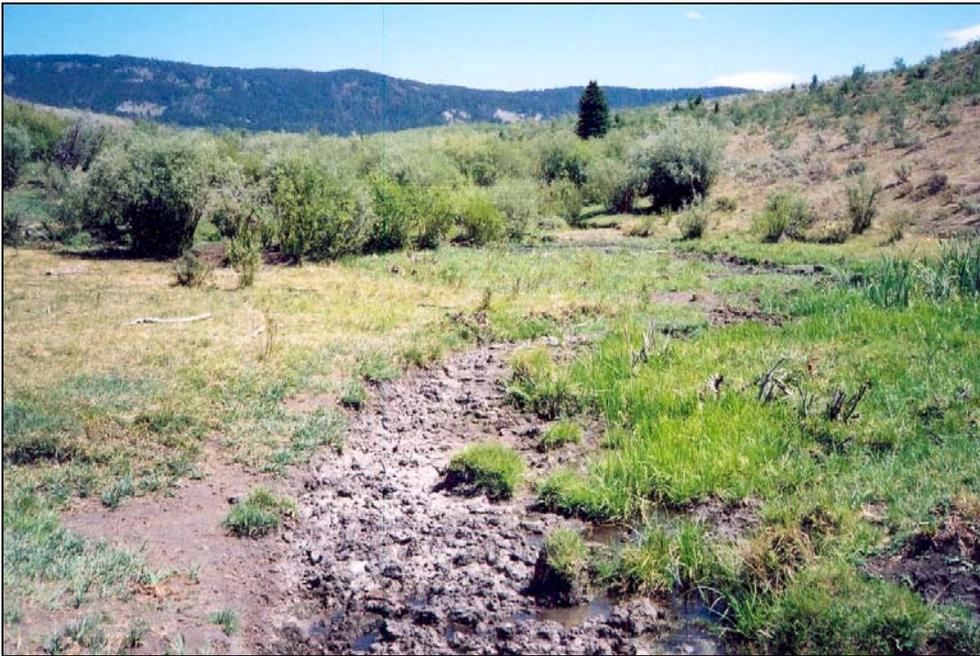
Photo 4. Telephone Creek in 2003. Note the excessive bank alteration along stream, the low stubble height along the stream, riparian utilization, and the lack of ground cover on the upland in the upper right hand side of photo.

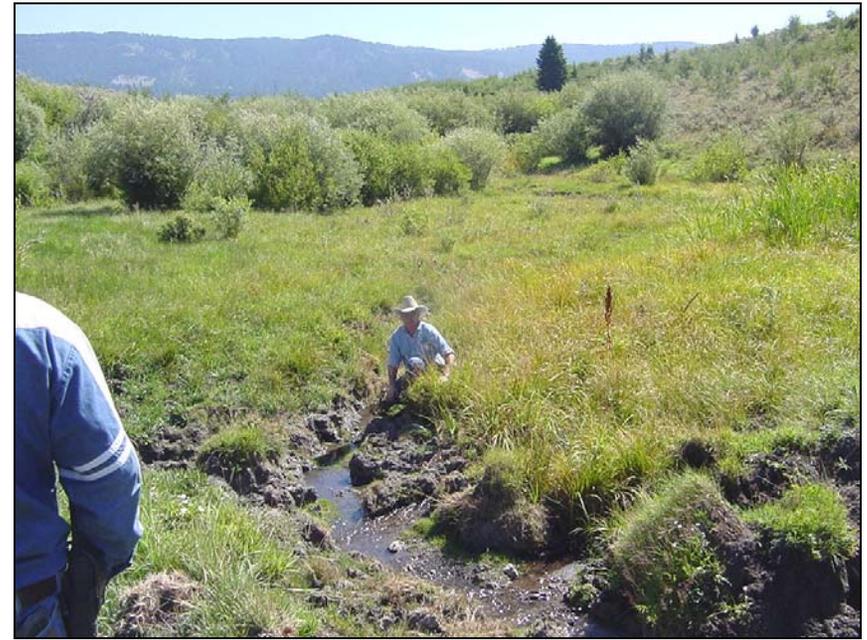
Photo 5. Same location as Photo 4 in 2005 (following the grazing season). Improvements in vegetated cover in both the riparian and upland areas. Improved stream bank stability. (person is kneeling, not standing).

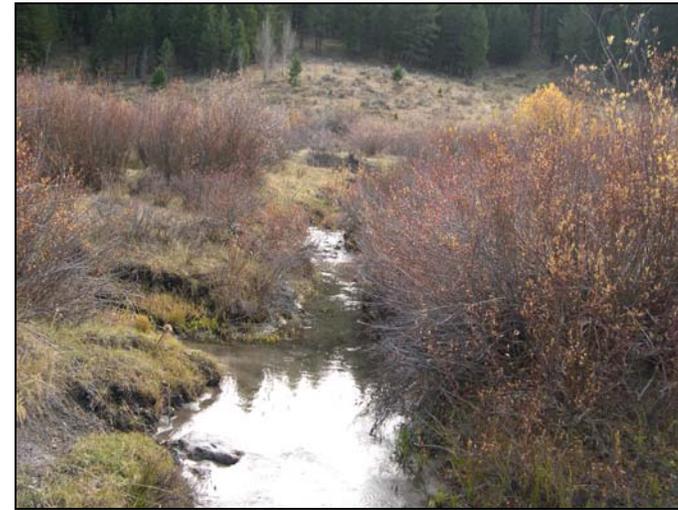
Photo 7. Miners Creek at confluence with Meadow Creek on 10/19/2005. Same general location as Photo 6, but not exact location.

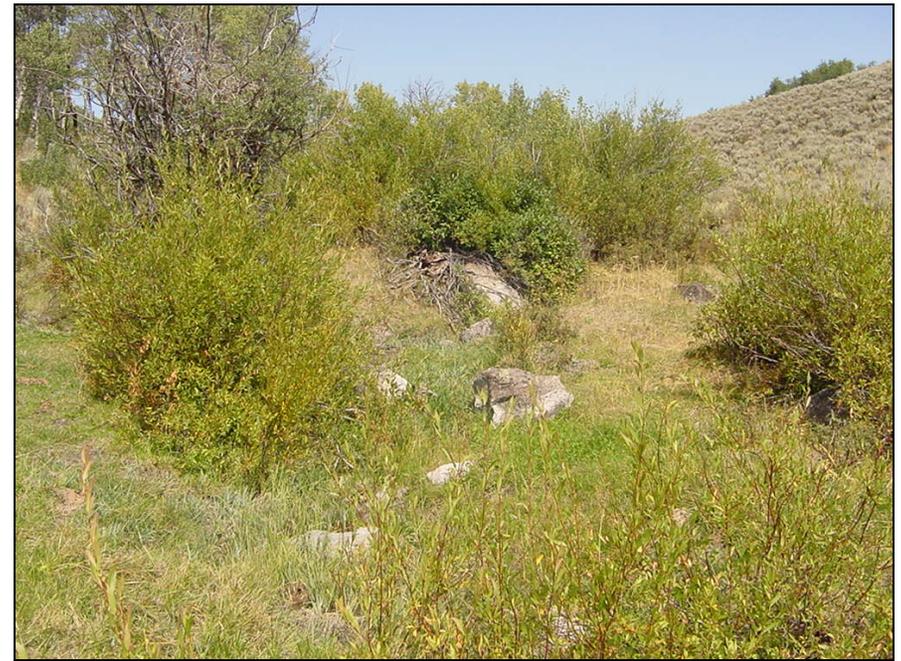
Photo 9. Owens Creek in 2005; Same general area as Photo 8, but not exact location. Improved cover and increased vigor on woody plants.

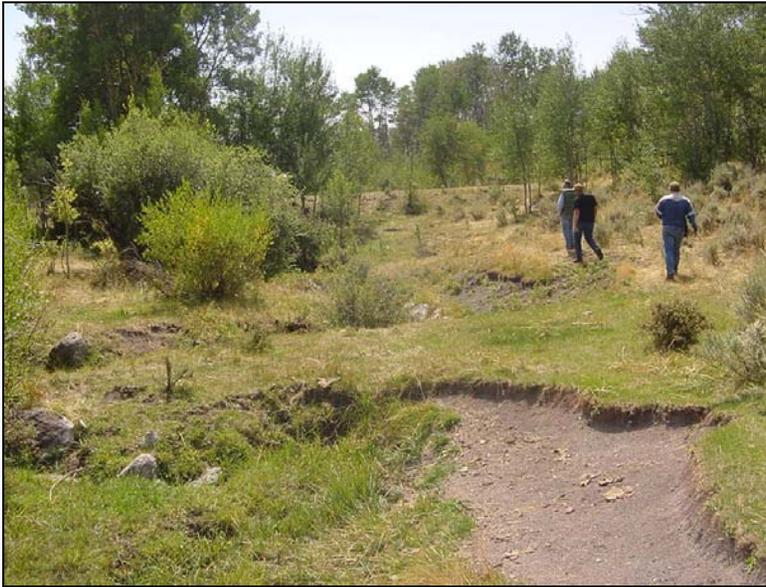
Photo 10. Owens Creek just upstream of FSR 325. Slower improvements in streamside conditions were noted here. Moderate bank alteration was noted along Owens Creek. Streambank stability along observed reaches of Owens Creek were estimated at less than 80% stable, but the trend appears to be improving.

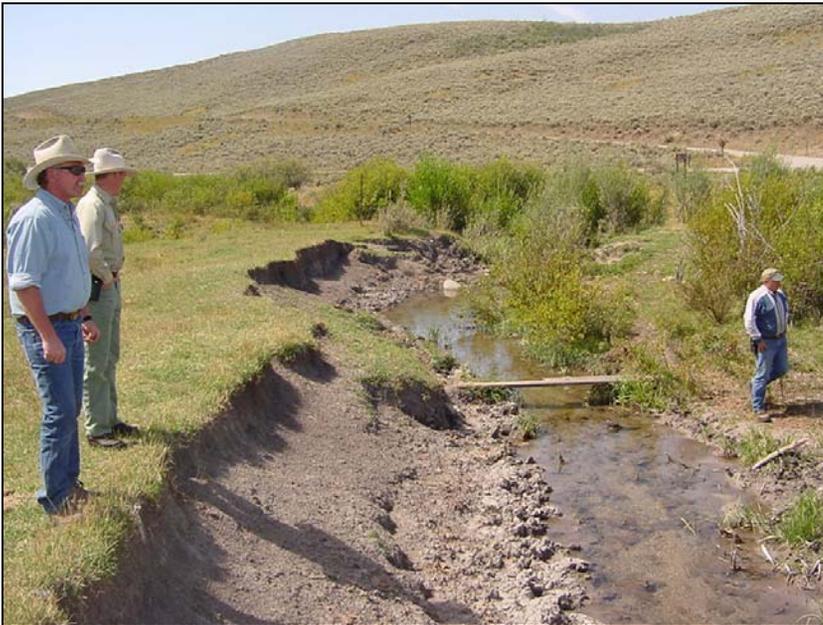
Photo 11. The group examined an identified watershed improvement need on Miners Creek located immediately upstream of the exclosure. A road/stream crossing (culvert) was removed in this area. The cattle crossed the stream on the road prior to removal of the pipe. The exclosure fence and habit of crossing at this location has resulted in excessive bank trampling in this localized area. The group discussed watershed improvement treatments to implement at this location. The District will add this location to its watershed improvement action plan. Willow planting and minor bank reshaping will be implemented to improve this area. Treatments should mimic the recovery that is taking place downstream of this location within the exclosure (see Photo 12). Willow planting with the District's tree spade was discussed.

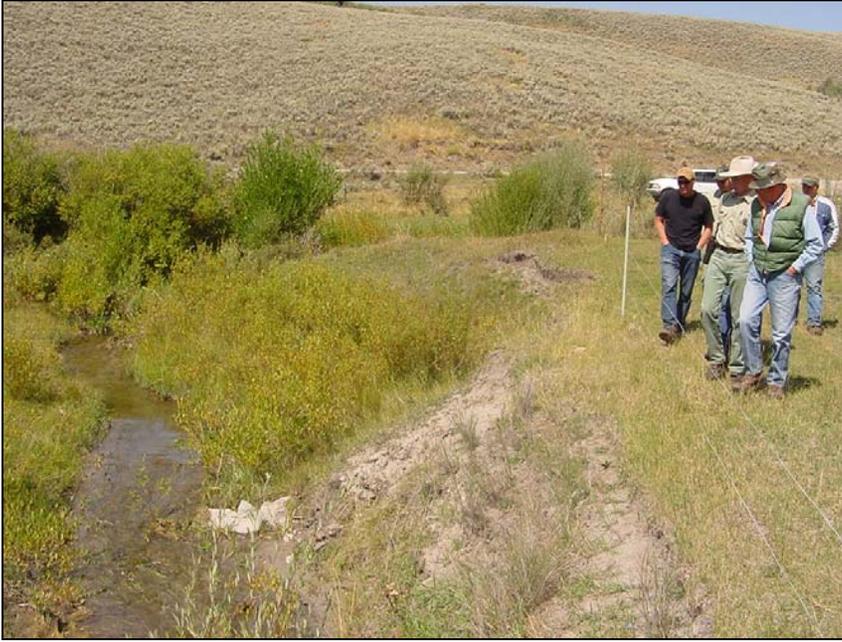
Photo 12. Miners Creek immediately downstream of Photo 11. Willow recovery is taking place within the exclosure. The stream is entrenched in some areas, but streambank stability is improving with increased vegetation cover.

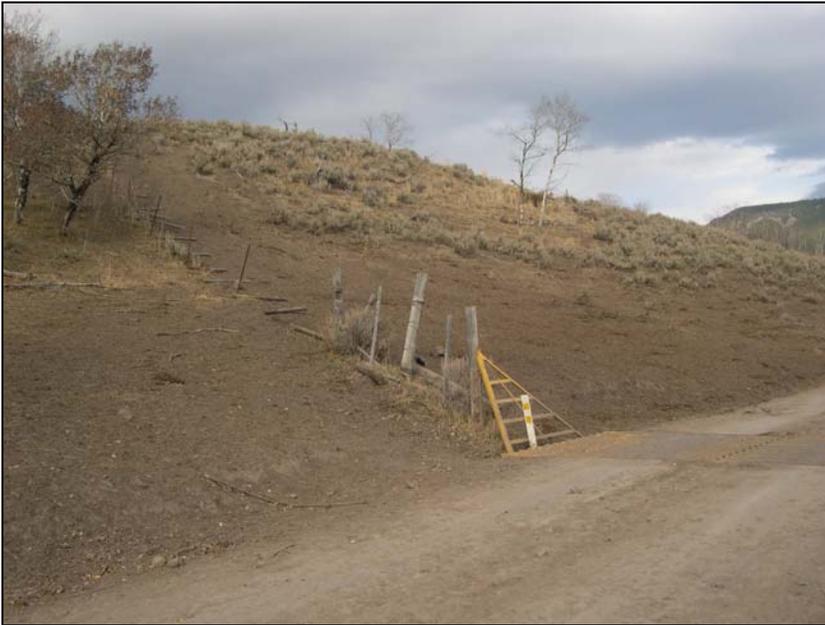
Photo 13. Fence between Unit 1 and 2. High trampling and lack of ground cover.

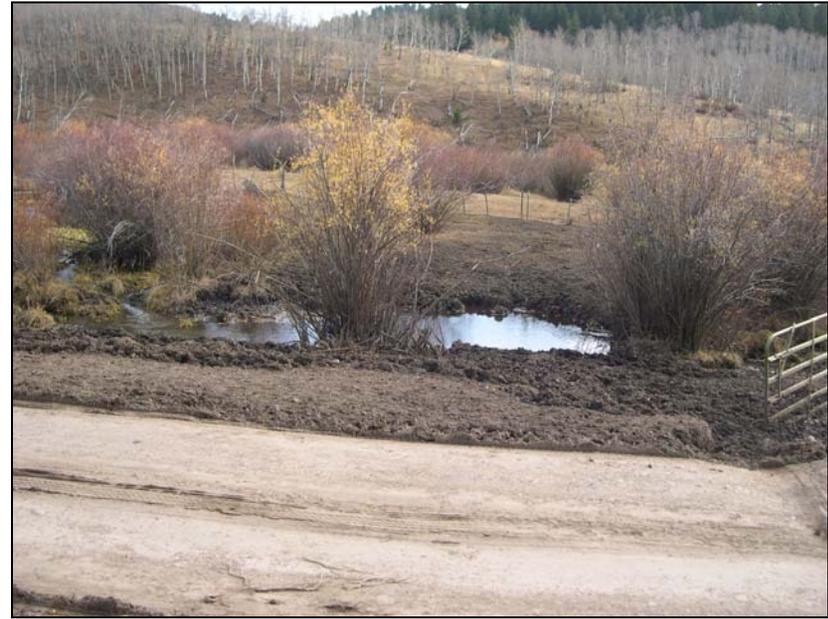
Photo 14. Dairy Creek on Unit 1/2 fence. High trampling in localized area.

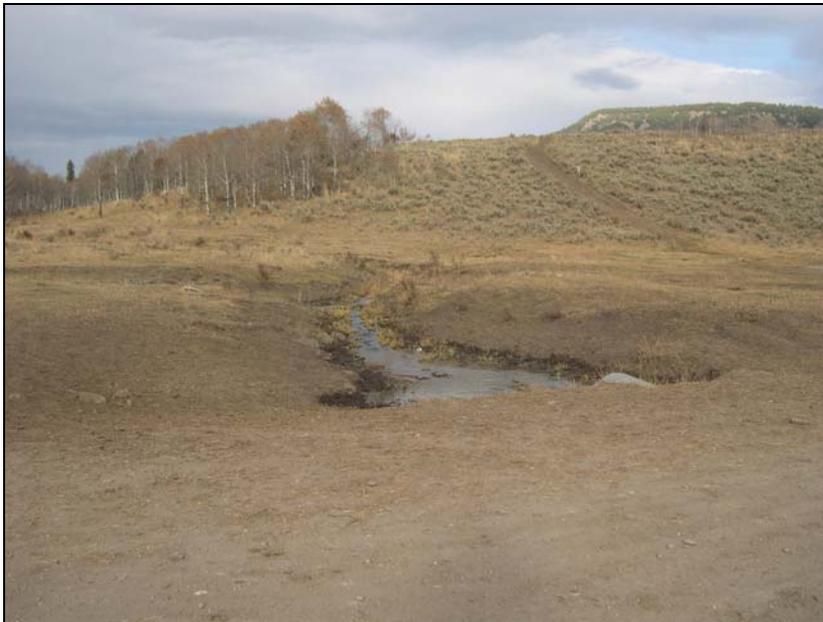
Photo 15. Left Fork (Unit 1). High localized trampling.

The mouth of Left Fork is a heavily used area (Photo 15); it is adjacent to the road, corrals, holding pasture (State lands) and it is very popular with recreationists and dispersed campers. Cattle are trailed across the area several times during the grazing season: 1) in the spring when some cattle are unloaded at the corral, 2) in the fall when the cattle are gathered into the holding pasture (the gate is just across road to south of where picture was taken), 3) when the cattle are moved from the holding pasture to the corral for sorting, and 4) when some of the cattle are trailed off the allotment. In addition, the area was used this year when sheep were shipped off the allotment in early September. So there is a lot of action at that site and if you would have went up stream a few hundred feet things look fine.

The impact shown in Photo 15 is very localized and the stream is in much better condition throughout its entire length. However, mitigation measures should be pursued as the opportunities arise.
