Monitoring Conducted

Exploration

Minerals & Geology Summary Points

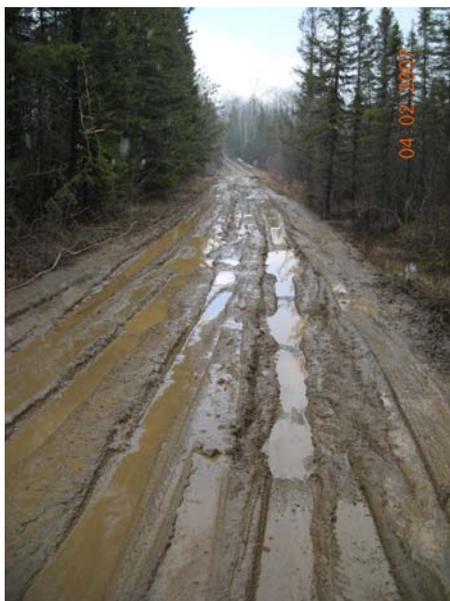
Private Minerals - The SNF received, approved, and monitored three private mineral exploration operating plans for compliance with approved project description and negotiated mitigation and reclamation requirements. Approximately 6 acres of new disturbance were permitted. One operation compliance issue relating to rutting

of a road occurred. When notified of the issue, the company stopped use of the road and completed repairs as required by the District Ranger (see below).

Figure 1. Road rutting.

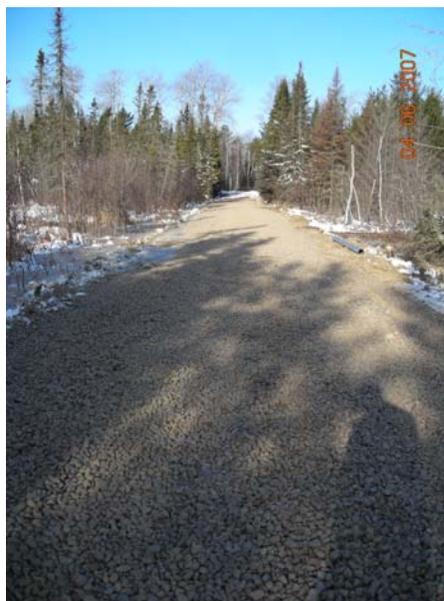
Figure 2. Road rutting repaired.

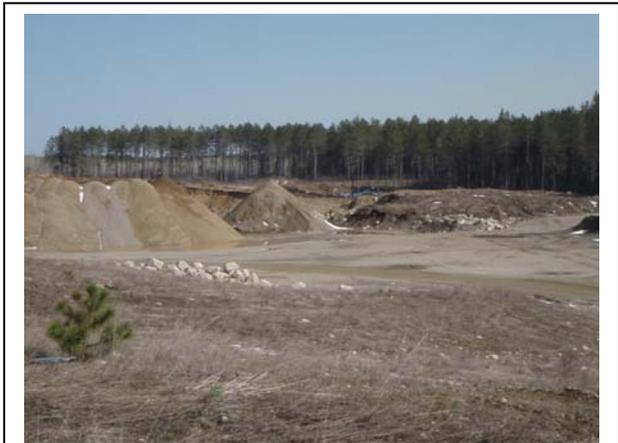
Sand and Gravel: The SNF continues to sell and provide sand and gravel to the public and companies. Seppi Brothers Concrete Products Corp. buys the most mineral materials and has a large active mineral material contract. Their operating plan was approved for 69 acres and the current disturbed area is approximately 31 acres. Free use is given to counties and other non-profit entities as requested. Small material sales are issued to the public. The SNF has an inventory of 397 gravel pits. The materials from these pits are used by the SNF for road maintenance, construction, timber sales, and other project administration. Production and sales are listed below.

Figure 4. Seppi Brothers Concrete Products – Jammer Lake Gravel Pit. (03/30/2007)

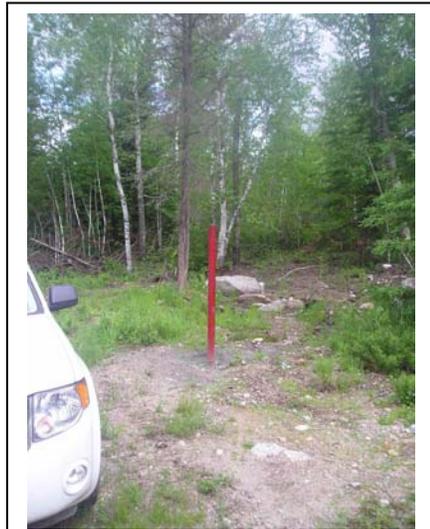
Reclamation of exploration projects is accomplished after the projects are completed and drill boreholes are permanently abandoned. No boreholes were permanently abandoned in 2007. Road closures appear to be effective at keeping motorized vehicles off of reclaimed/closed access routes. Drill sites, including closure of drill sumps, have successful reclamation and sites are stable. Reclamation appears to be successful and no issues developed.

Figure 5. Temporary Abandoned Drill Borehole

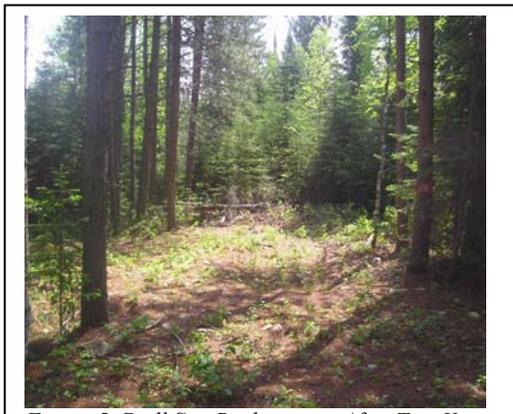
Figure 5. Drill Site Reclamation After Two Years
