## WHEN THE BAER HITS IN THE WOODS

Clay Johnson

Clay Johnson, Ashley National Forest, Vernal, Utah 84078

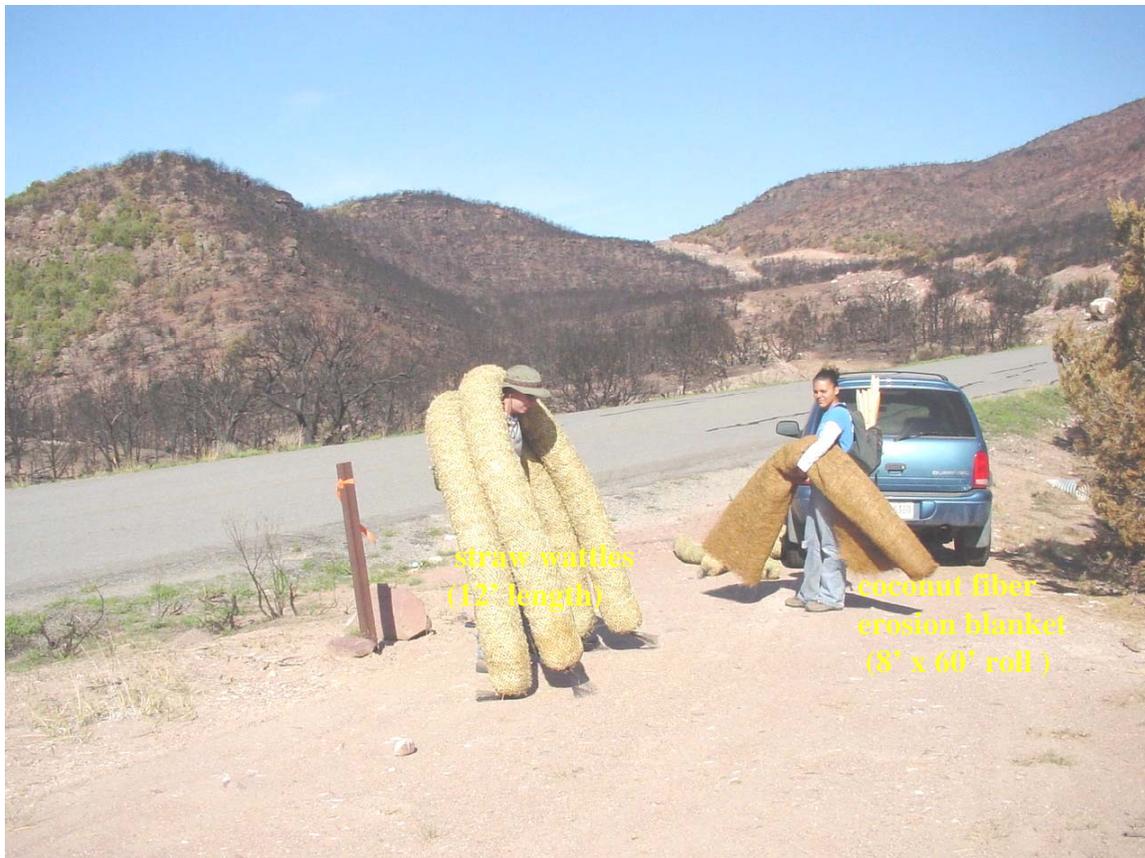
*Straw Wattles.* Wattles are biodegradable plastic mesh tubes about 9 inches in diameter (Figure 1) with a natural (coconut or straw) fiber fill, used as runoff barriers.

Figure 1. Derek Stertz and Sandy Duarte with treatment materials.

*Erosion Blanket.* Erosion blanket is a biodegradable plastic mesh envelope with natural fiber fill (Figure 1 above) used to stabilize ground surfaces and channel walls. Direct precipitation or minor sheet flows onto erosion blanket tend to slow and soak in. Erosion blanket in channels tends to armor the channel walls. Ground disturbance can be limited to the footprints of 6" (inch) long, U-shaped, wire anchor staples pushed into the ground at intervals of up to one meter. Erosion blanket is available in a range of fill materials and sizes. We chose CFO72RR coconut fiber in 8' by 67.5' rolls. For field transport, we typically carried up no more than half a roll (8' by 30') at a time, based on estimates of the material required at a site. The blanket can be cut with tin snips (or a pocketknife, in a pinch), but serrated tools like pinking shears may do a better job. It is impractical to blanket ground surfaces the size of typical archaeological sites. Erosion blanket was used to stabilize midden surfaces at the Hammond Fire. We used erosion blanket primarily to stabilize rockshelter floors and apron. At one site where five metates lay on the surface adjacent to a small drainage channel, we blanketed the surrounding surface and a portion of a channel.
