II. Resource Areas

A. Soils and Geology

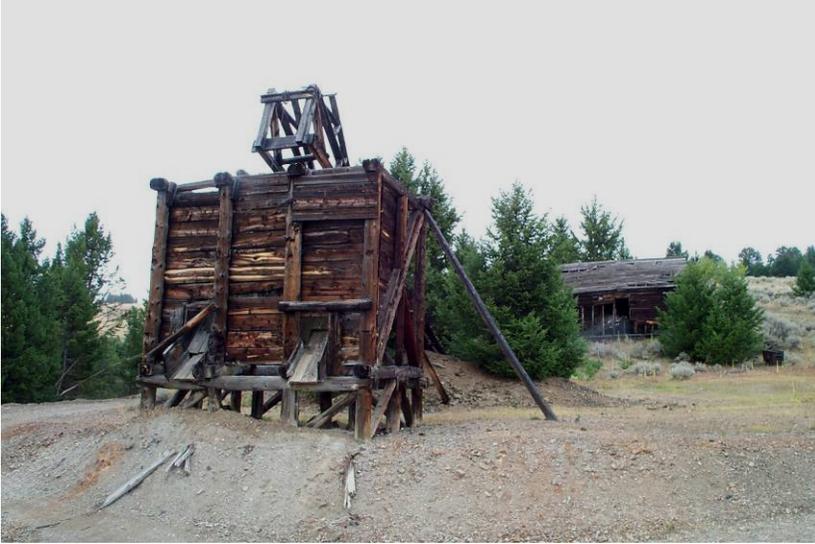
Photo: Abandoned mine, Middle Fork Cottonwood Creek.

There are 56 mapped mine-related features reported by the MBMG in the project area and numerous identified mineral locations (Figure IIA-2). A DEQ priority abandoned mine site exists on Orofino Creek (Champion Mine) and several in the middle reach of Cottonwood Creek (Emery Mining District). A survey of abandoned and inactive mines sites on land administered by the Deerlodge National Forest in the Upper Clark Fork River basin was completed by MBMG (Madison et al., 1998). Abandoned mines identified in the MBMG report as being an environmental hazard are shown in table IIA-1.

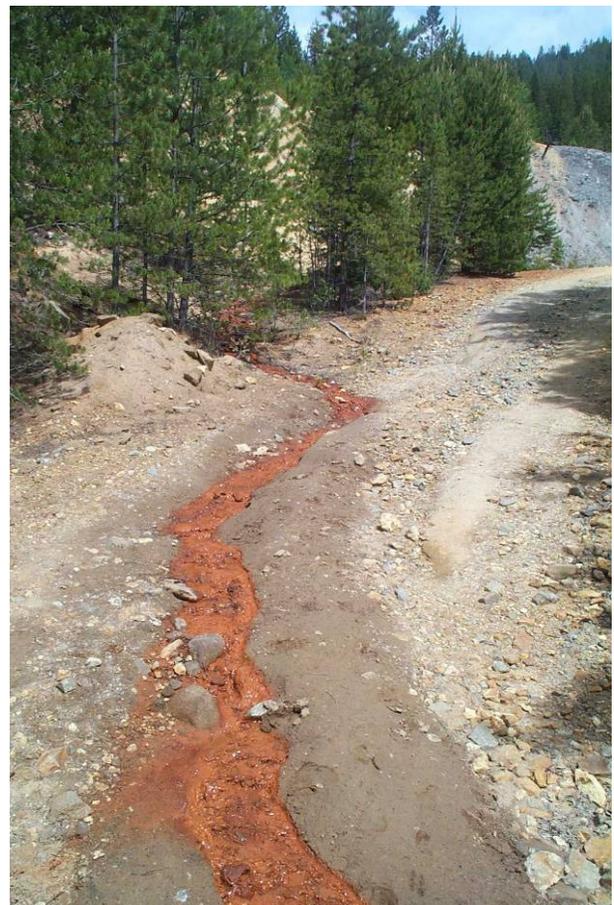
Photo: Acid mine drainage associated with the Champion Mine site, Orofino Gulch

Site Name	Town	Range	Sec	Problem
Champion Mine & Mill	6N	8W	33	Adit discharge, streamside tailings, water quality standards exceeded.
Ding Bat (Blue Eyed Maggie)	7N	8W	10	Discharge from waste dump, water quality standards exceeded.
Little Darling Mine	5N	8W	7	Adit discharge.
Lower Hidden Hand Mine	7N	8W	3	Caved adit discharge, water quality standards exceeded.
Rocker Gulch Mine	7N	8W	10	Streamside dump, water quality standards exceeded.
St. Mary Mine	7N	8W	11	Caved adit discharge, water quality standards exceeded (concentration is at detection limit).
Sterrit Mine	7N	8W	2	Caved adit discharge, water quality standards exceeded (concentration is at detection limit).
- Indicated water quality exceedences on BDNF lands.
