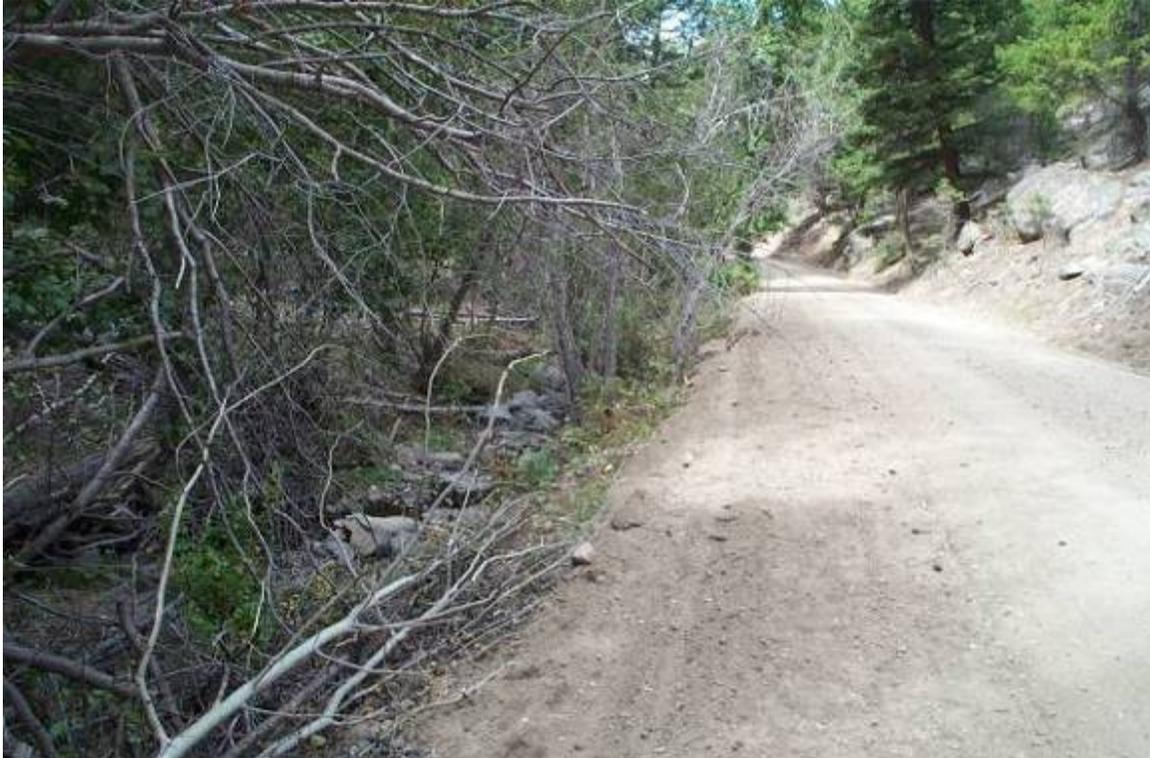
Photo: Road #85 encroaching on Dry Cottonwood Creek.

TSS sampling results presented in KirK Environmental (2003) did not capture periods when TSS was obviously higher than potential natural conditions. However, large runoff events caused by rapid snowmelt or flash-floods associated with thunder storms may cause short term TSS spikes of unknown magnitude. Streambed deposition in the landscape is usually a problem over short reaches where roads are near streams or where sources of fines from excessive hoof action exacerbates sloughing of streambank material into the streambed. The roads in Dry Cottonwood Creek and Perkins Gulch which parallel the stream are notable sources of excess stream sediment.

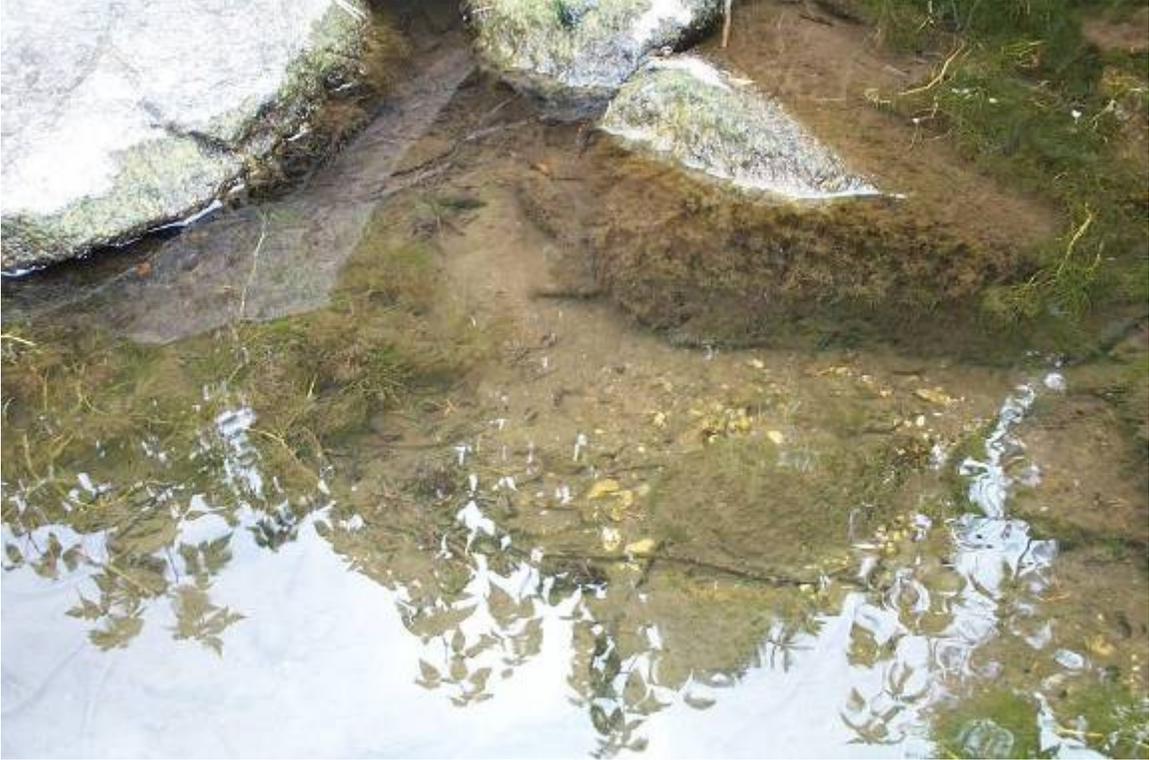
Photo: Sedimentation issues in Dry Cottonwood Creek.

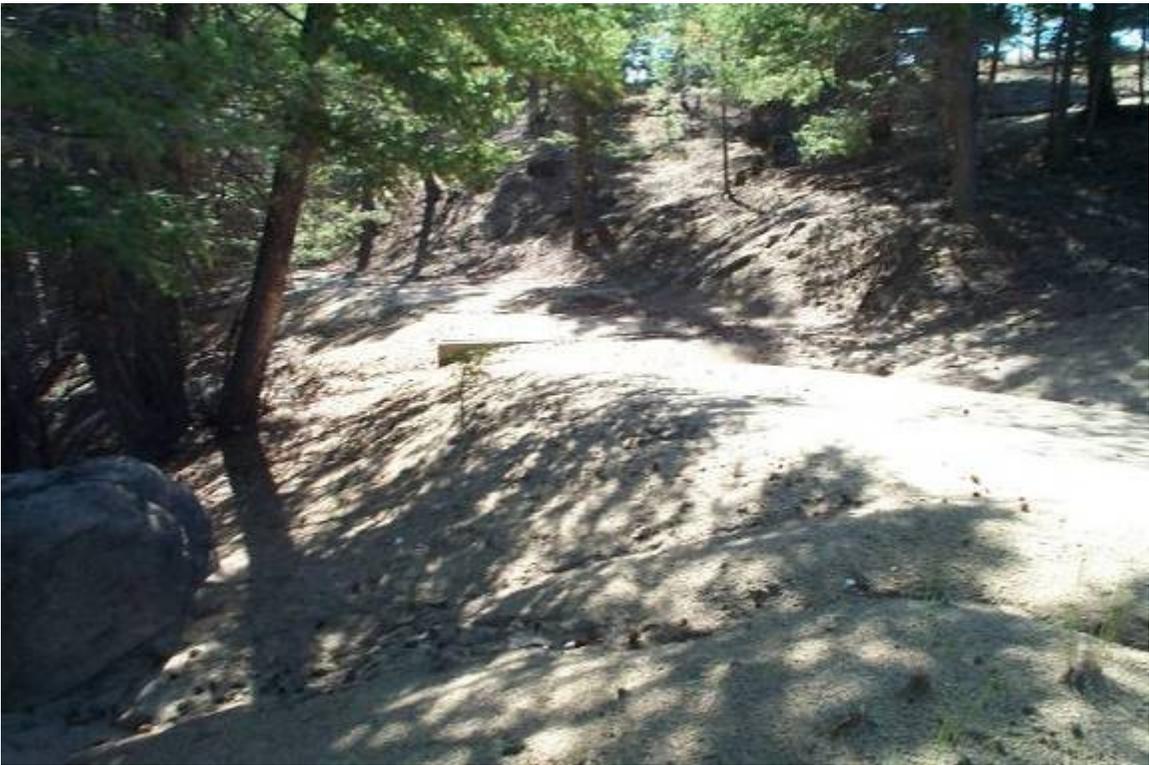
Photo: Sediment source in road surfaced with natural granitic soils in Perkins Gulch.

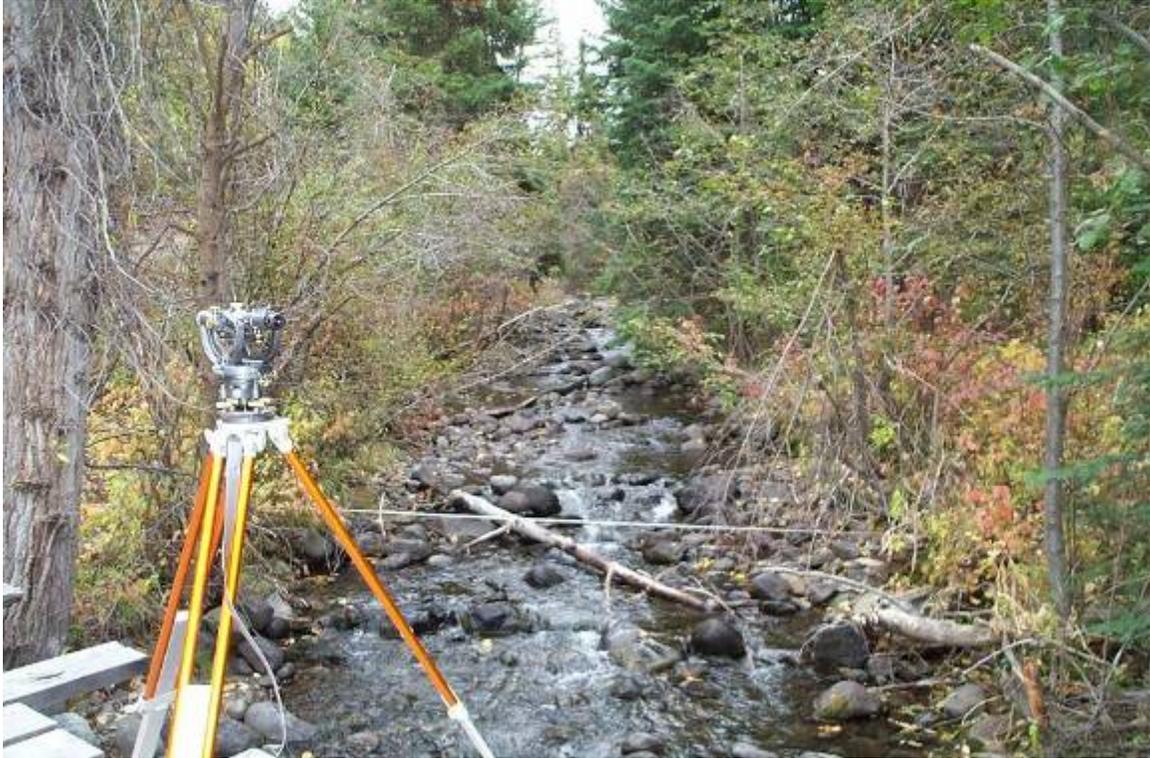
Photo: Rosgen stream channel survey on Cottonwood Creek.

Rosgen Classification cross-sections performed by the USFS and KirK Environmental (2003) are shown in figure IIB-2 and table IIB-1. Additionally, Rosgen stream type information for stream reaches assessed as part of USFS fish habitat surveys are shown in table IIB-8. Streams in the project area include A2, A3, B2 through B5, C3 through C5 including subtypes of these channel

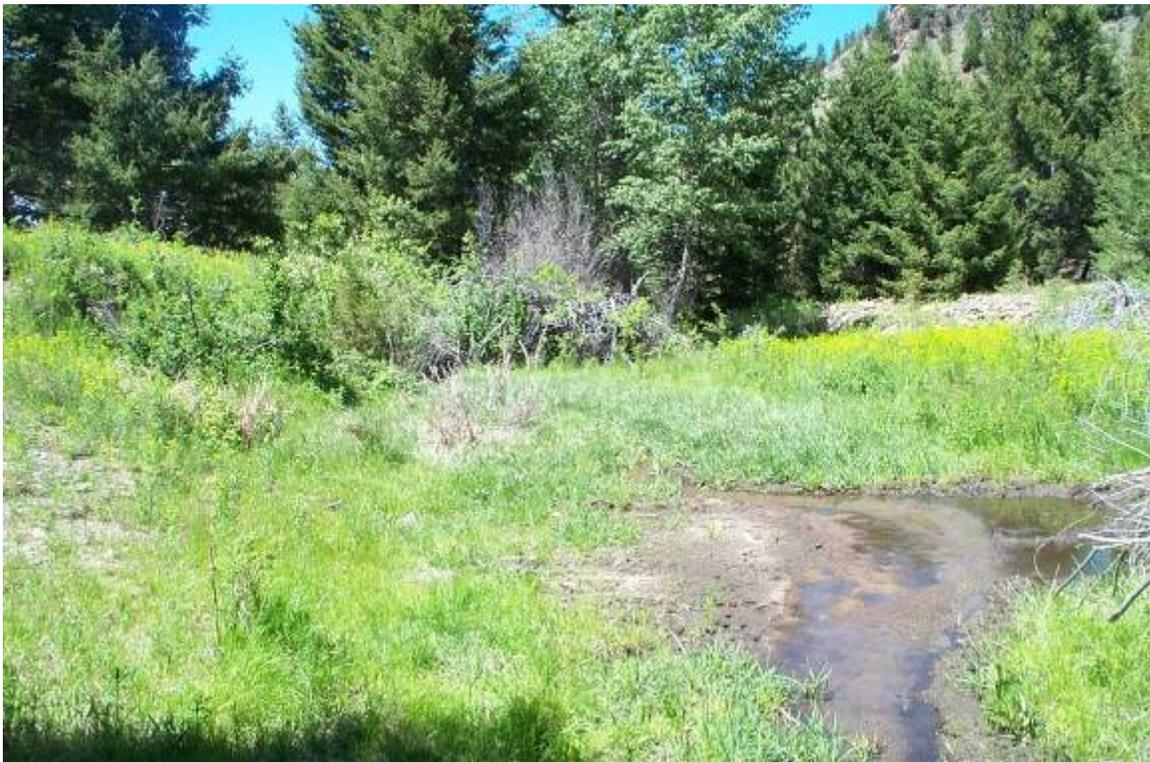
Photo: Stream channel morphology resulting from grazing impacts on private lands, middle Orofino Creek.

Evaluation of stream channel morphology allows the comparison of stream channel and substrate characteristics between different locations. Where reference conditions are available, the stream channel and substrate characteristics can be compared against conditions typical of the range of natural variability. Bank alteration by trampling can be an important source of stream channel and riparian degradation (e.g., Clary and Webster, 1989, 1990; Belsky, et al., 1999). Of the Rosgen Level II criteria, the width to depth ratio is the most sensitive and positive indicator of trends in channel instability. Where width to depth ratios are high, increases in the sediment supply to the channel develop from bank erosion, which by virtue of becoming an over widened channel gradually loses its capability to transport sediment. Deposition occurs which further accelerates bank erosion. Impacts from bank trampling may also include a loss of ability of flood flows to access floodplains and a loss of riparian vegetation which then makes banks more vulnerable to further erosion. Where downcutting occurs localized lowering of water tables in riparian areas further exacerbates loss of riparian vegetation.
