Soil Resource

1986 FOREST PLAN MONITORING ITEMS FOR THE SOIL RESOURCE

Monitoring Item 1. Soil Chemistry Work Done in Red Spruce and Hogback Areas

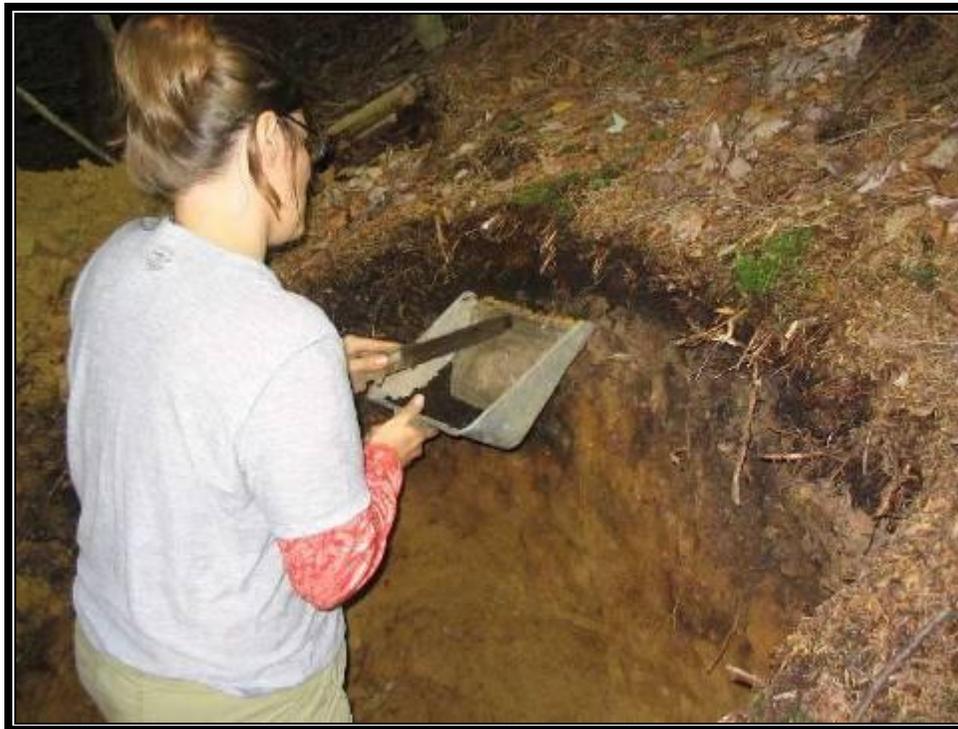
Figure SL-1. Stephanie Connolly Collecting Soil Sample in Red Spruce Soil Pit

- Characterize soil types under red spruce habitats.
- Assess soil productivity levels and soil quality with respect to acid deposition effects.
- Determine whether mycorrhizae can be an indicator of red spruce health.
- Assess foliar nutrition levels to determine if red spruce are under stress or malnourished.

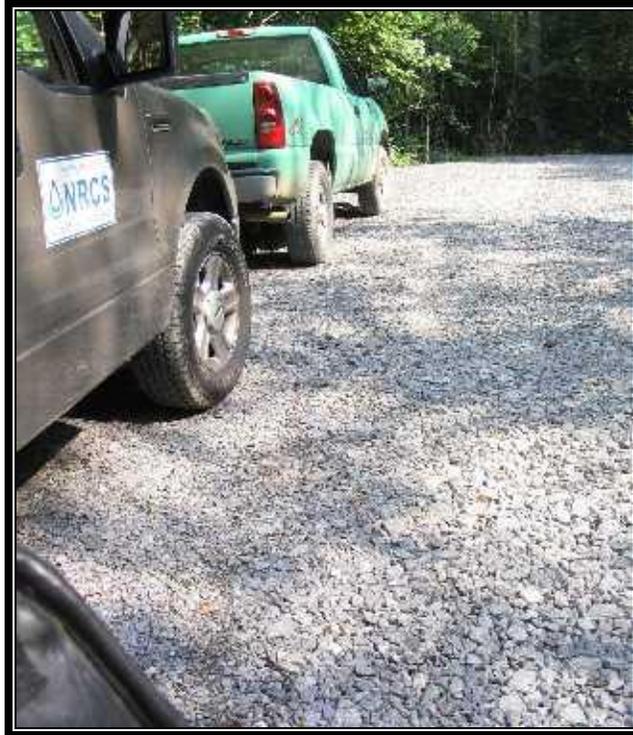
Figure SL-7. New Road Surfacing on Forest Road 946

The new road surfacing for the main hauling road in the Desert Branch Timber Sale looked excellent in most areas (Fig. SL-7). The TSA says that 4 to 5 inches of stone was applied prior to hauling. Engineering and soil scientist recommend an application of 8 to 12 inches of stone in the EA. In places, the road bed was failing and becoming soft. There was little sign of existing or new stone in place in some of these areas. The recommendation was to spot stone those areas immediately to prevent any further damage of the subgrade. This may have occurred because the additional stone (up to 12 inches) was not added as dictated by pre-sampling and during road design. Given that some areas of the road looked good and were holding up to current levels of logging traffic and other spot areas were not holding up to use, a range of soil conditions were determined to be present in the road prism. The Specialist checked with Engineering as to why the full amount of stone was not added, and the response was that the amount dictated in the EA should have been in the contract. Follow-up is needed to see if contract called for 4 to 5 inches of stone or more as the design indicated.

The Specialist will return for additional monitoring when pioneering of new road construction is completed and additional units are open for harvest. More rock will be need to be added to main road to support the hauling for helicopter harvesting.

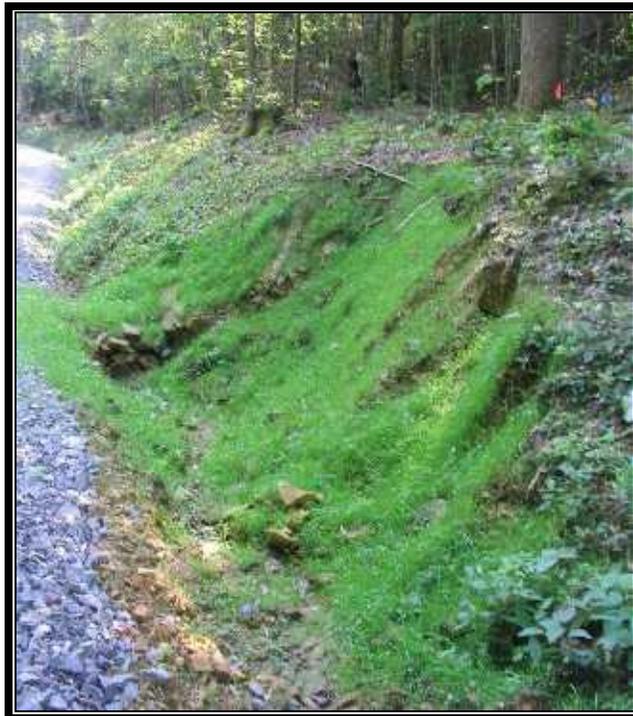
Figure SL-8. Seeded and Stabilized Cutbank in Desert Branch Sale Area

Seeding of disturbed soils looked excellent throughout the project area. Most all of the disturbed soil was seeded. No mulch was required because the seeding was so efficient in establishment (Fig. SL-8). Even extreme sloping cutbanks looked stable. The Contractor used a hydro seeder. There was a good bit of precipitation prior to the monitoring trip, which allowed for good seeding establishment.

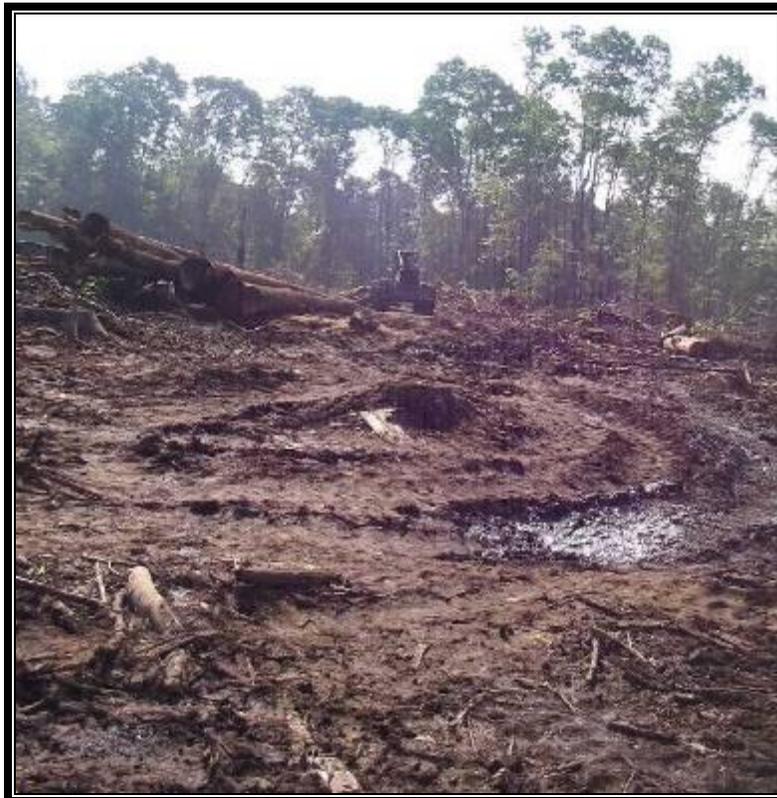
Figure SL-9. Soil Disturbance in Unit 25 Landing

Unit 25 and Associated Landing – The landing area (Fig. SL-9) looks highly disturbed into the O and A horizons and surface of the subsoil; however this is to be expected. The main skid road into the landing from the harvest area show signs of some compaction and will need to be ripped in order to restore hydrologic flow (conductivity). The entrance to the landing was heavily stoned and holding well. Logs were not muddy indicating that, although showing some signs of wetness, the soil was not saturated.

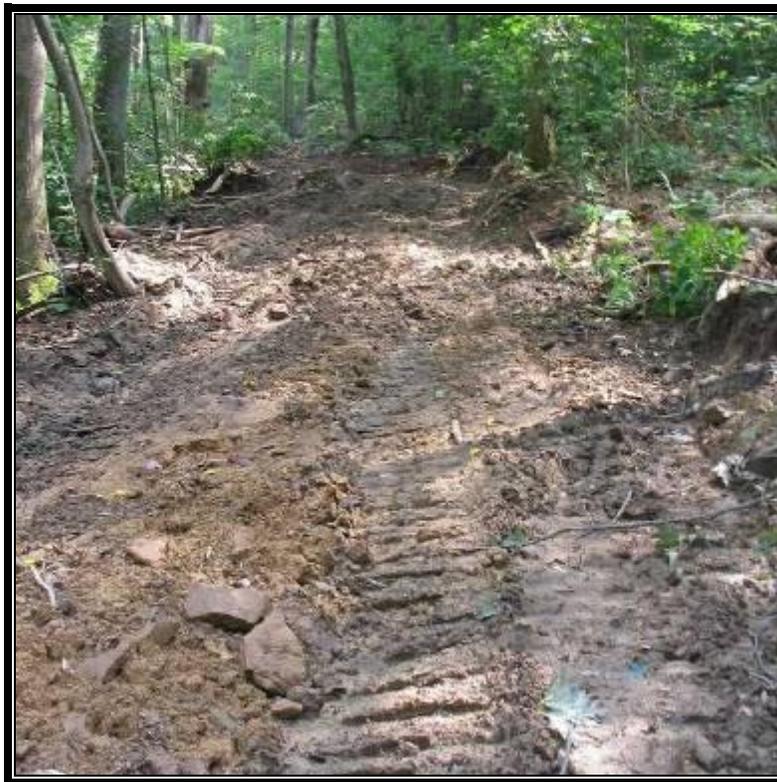
Figure SL-10. Surface Rock in Unit 15 Skid Trail

drainage in the ditch line. The landing looked stable and although there was quite a bit of disturbance, soil did not seem to be moving off site and deep rutting was not evident. The Specialist observed main haul road into landing from harvest unit. Operator was not working this day due to what he perceived to be wet conditions. The Specialist recommended that the operator put in more temporary water bars and open the ends to allow for drainage. Native surface rock was apparent in the skid trail and was acting to stabilize the surface and prevent compaction and rutting (Fig. SL-10). There were several temporary water bars present, but the skid road needed more and in closer spacing to deal with surface water problems. This excessive ponding may have been due to the presence of layers in the soil perching the water and bringing to the surface subsurface water from the bladed skid trail.
