Slope Limitations for Tractor Operations, BMP 13.02

Re-vegetation of Surface Disturbed Areas, BMP 13.04

Timber Harvest Unit Design, BMP 14.02

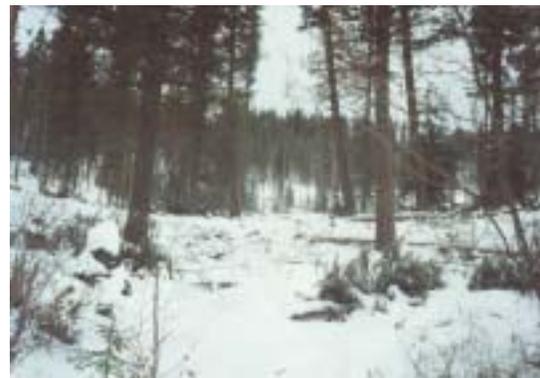
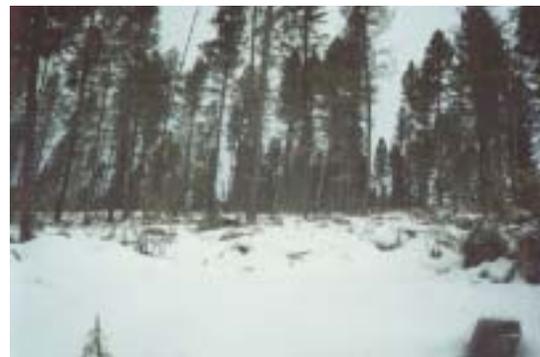
Photo 1

The slope of a timber unit plays a significant role in determining the type of logging practice to be used on a site. Tractor logging is only permitted on slopes of 35 percent or less (photos 1&2). Slopes greater than 35 percent should be tractor logged only on a case-by-case basis after a review by the soil scientist and where erosion and soil impacts can be controlled.

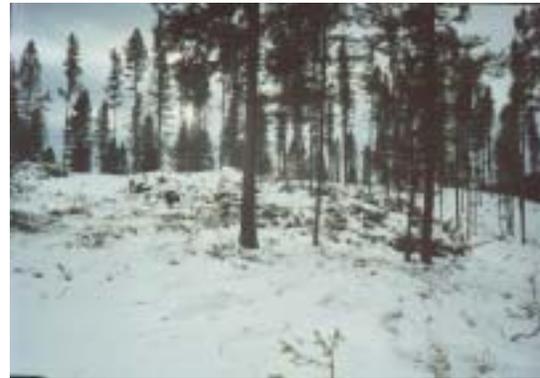
Photo 3

Specifying that timber can only be tractor-harvested if the slope is 35 percent or less, greatly reduces the risk of sediment production. The logs on the site were skidded to two landings. The landings were located adjacent to Road 4245 (photo 3). No signs of erosion, such as ruts or gullies, were present. Soil displacement was minimized, with no sign of soil movement off site. Drainage structures were not needed due to the winter harvest method. During periods of overland flows, natural drainage features will be sufficient to direct runoff and filter sediment off site.

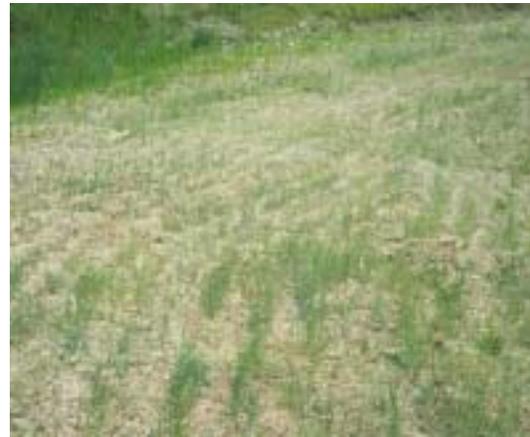
Photo 1

Soil was scarified 2 to 3 inches deep and approximately 8 inches apart by a dozer equipped with ripper teeth. During the observation the grass seeded was roughly 3 to 4 inches tall on the travelway, and 3 to 5 inches tall on the cut and fillslopes (photo 1).

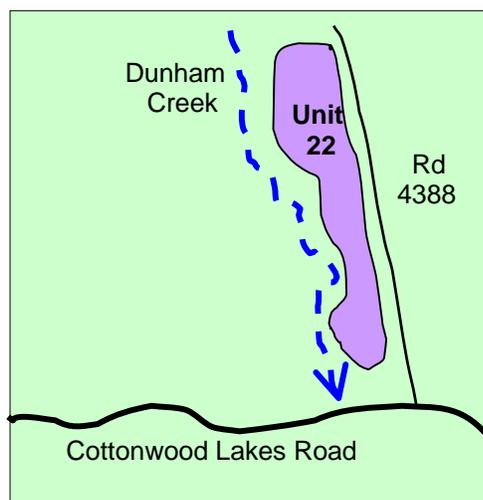
Figure 1

Unit 22 is a 42-acre tractor harvest unit designed to maximize the use of existing roads, and allow access to skid trails and landings with minimal disturbance to the soil, stream and riparian area. Unit boundaries are aligned between Road 4388 and Dunham Creek (figure 1). The western boundary is flagged more than 50

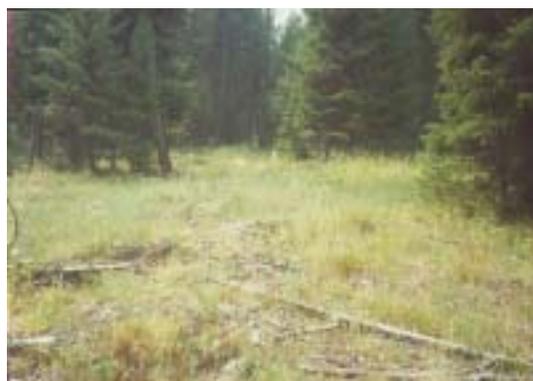
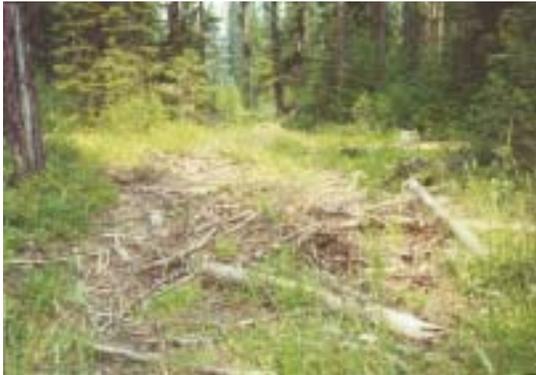
Photo 1

The slope of the trails is less than 5 percent, and they drain east, away from the stream. The area was seeded, and large woody debris was placed over the skid trails, providing long-term filtration and nutrient enhancement. Average slash diameter left on site is from 1 to 4 inches, with the majority ranging from 2 to 3 inches. A few large diameter logs, greater than 4 inches, are present, but comprise roughly 5 percent of the skid trails (photos 1 & 3).

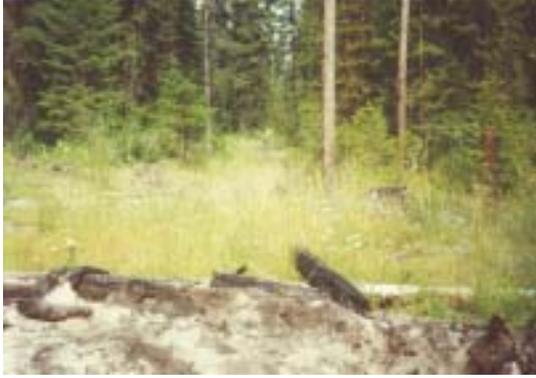
Photo 2

The western boundary of the unit met SMZ qualifications, being 50 feet or more from the stream channel. Designing the unit with two main skid trails leading in either direction decreased the overall impact and still provided access to a large area.

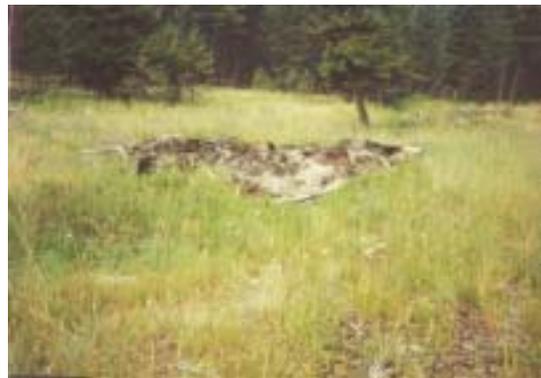
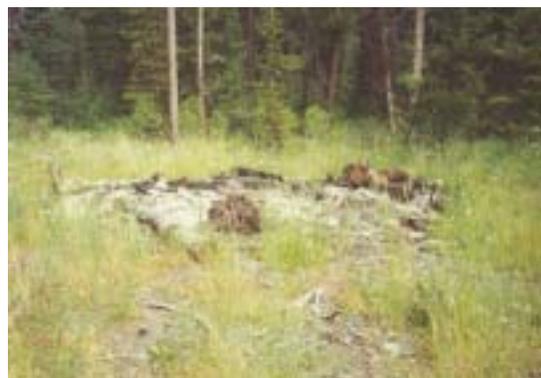
Photo 4

Skid trails were located to maximize the accessibility to harvest areas while minimizing their numbers. Skid trails and landings were built far enough from Dunham Creek to satisfy Montana SMZ requirements and protect water quality. Two main landings were located in natural openings to minimize impacts, each built with two skid trails leading from them (photos 1, 2 & 3). Landing 1 is close to Cottonwood Lakes Road on the south end of the unit, and Landing 2 is in the middle of the unit (photos 4 & 5, and figure 2). Another smaller landing on the north end also provides access there (figure 2).
