Timber Harvest Unit Design, BMP 14.02

Log Landing Location and Design, BMP 14.10

Using Sale Area Maps to Designate Soil and Water Protection Needs, BMP 14.03

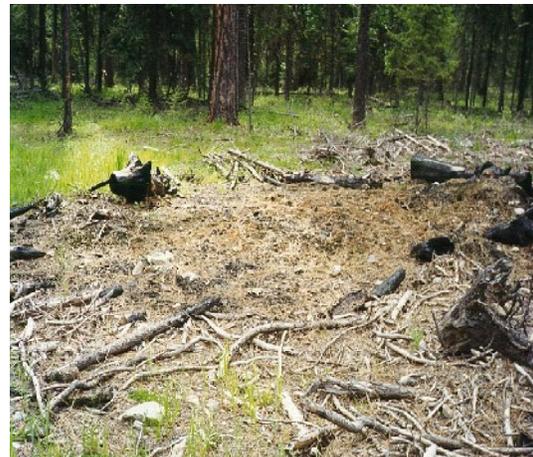
Photo 1

Harvest machinery did not enter or cross the riparian area. Logs near the riparian area were winched out and slash was brought to the landing from two adjacent skid trails. After harvest was done, most of the landing slash was burned and then scattered. Scattering slash adds organic nutrients to the soil, enhancing soil productivity and protecting disturbed soil (photos 1 & 2).

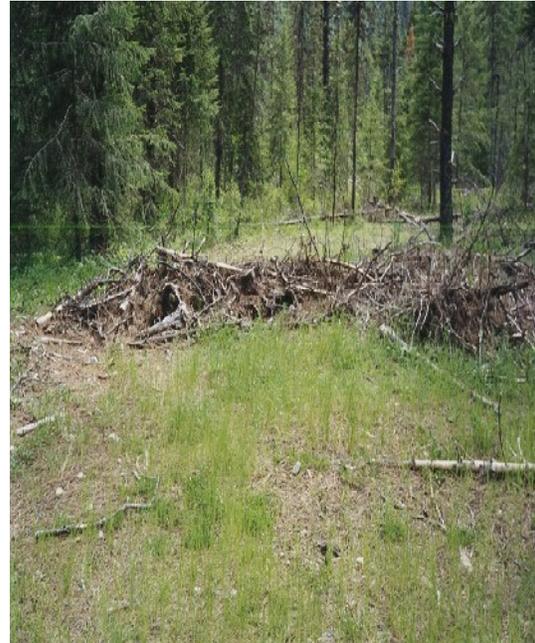
Photo 3

The log landing was 98 feet wide x 82 feet long, and is 78 feet away from the road. The average size of the retained slash is approximately 2 to 5 inches in diameter. Vegetation is reestablishing, but the heavily burned areas have not yet vegetated. One slash pile on the main skid trail has not yet been burned. Currently, it is acting as an access barrier to one of the main skid trails (photo 3).
