Proposed Action for the Ward Creek Watershed Ecosystem Restoration

USDA Forest Service Pacific Southwest Region
Lake Tahoe Basin Management Unit
El Dorado Co., California

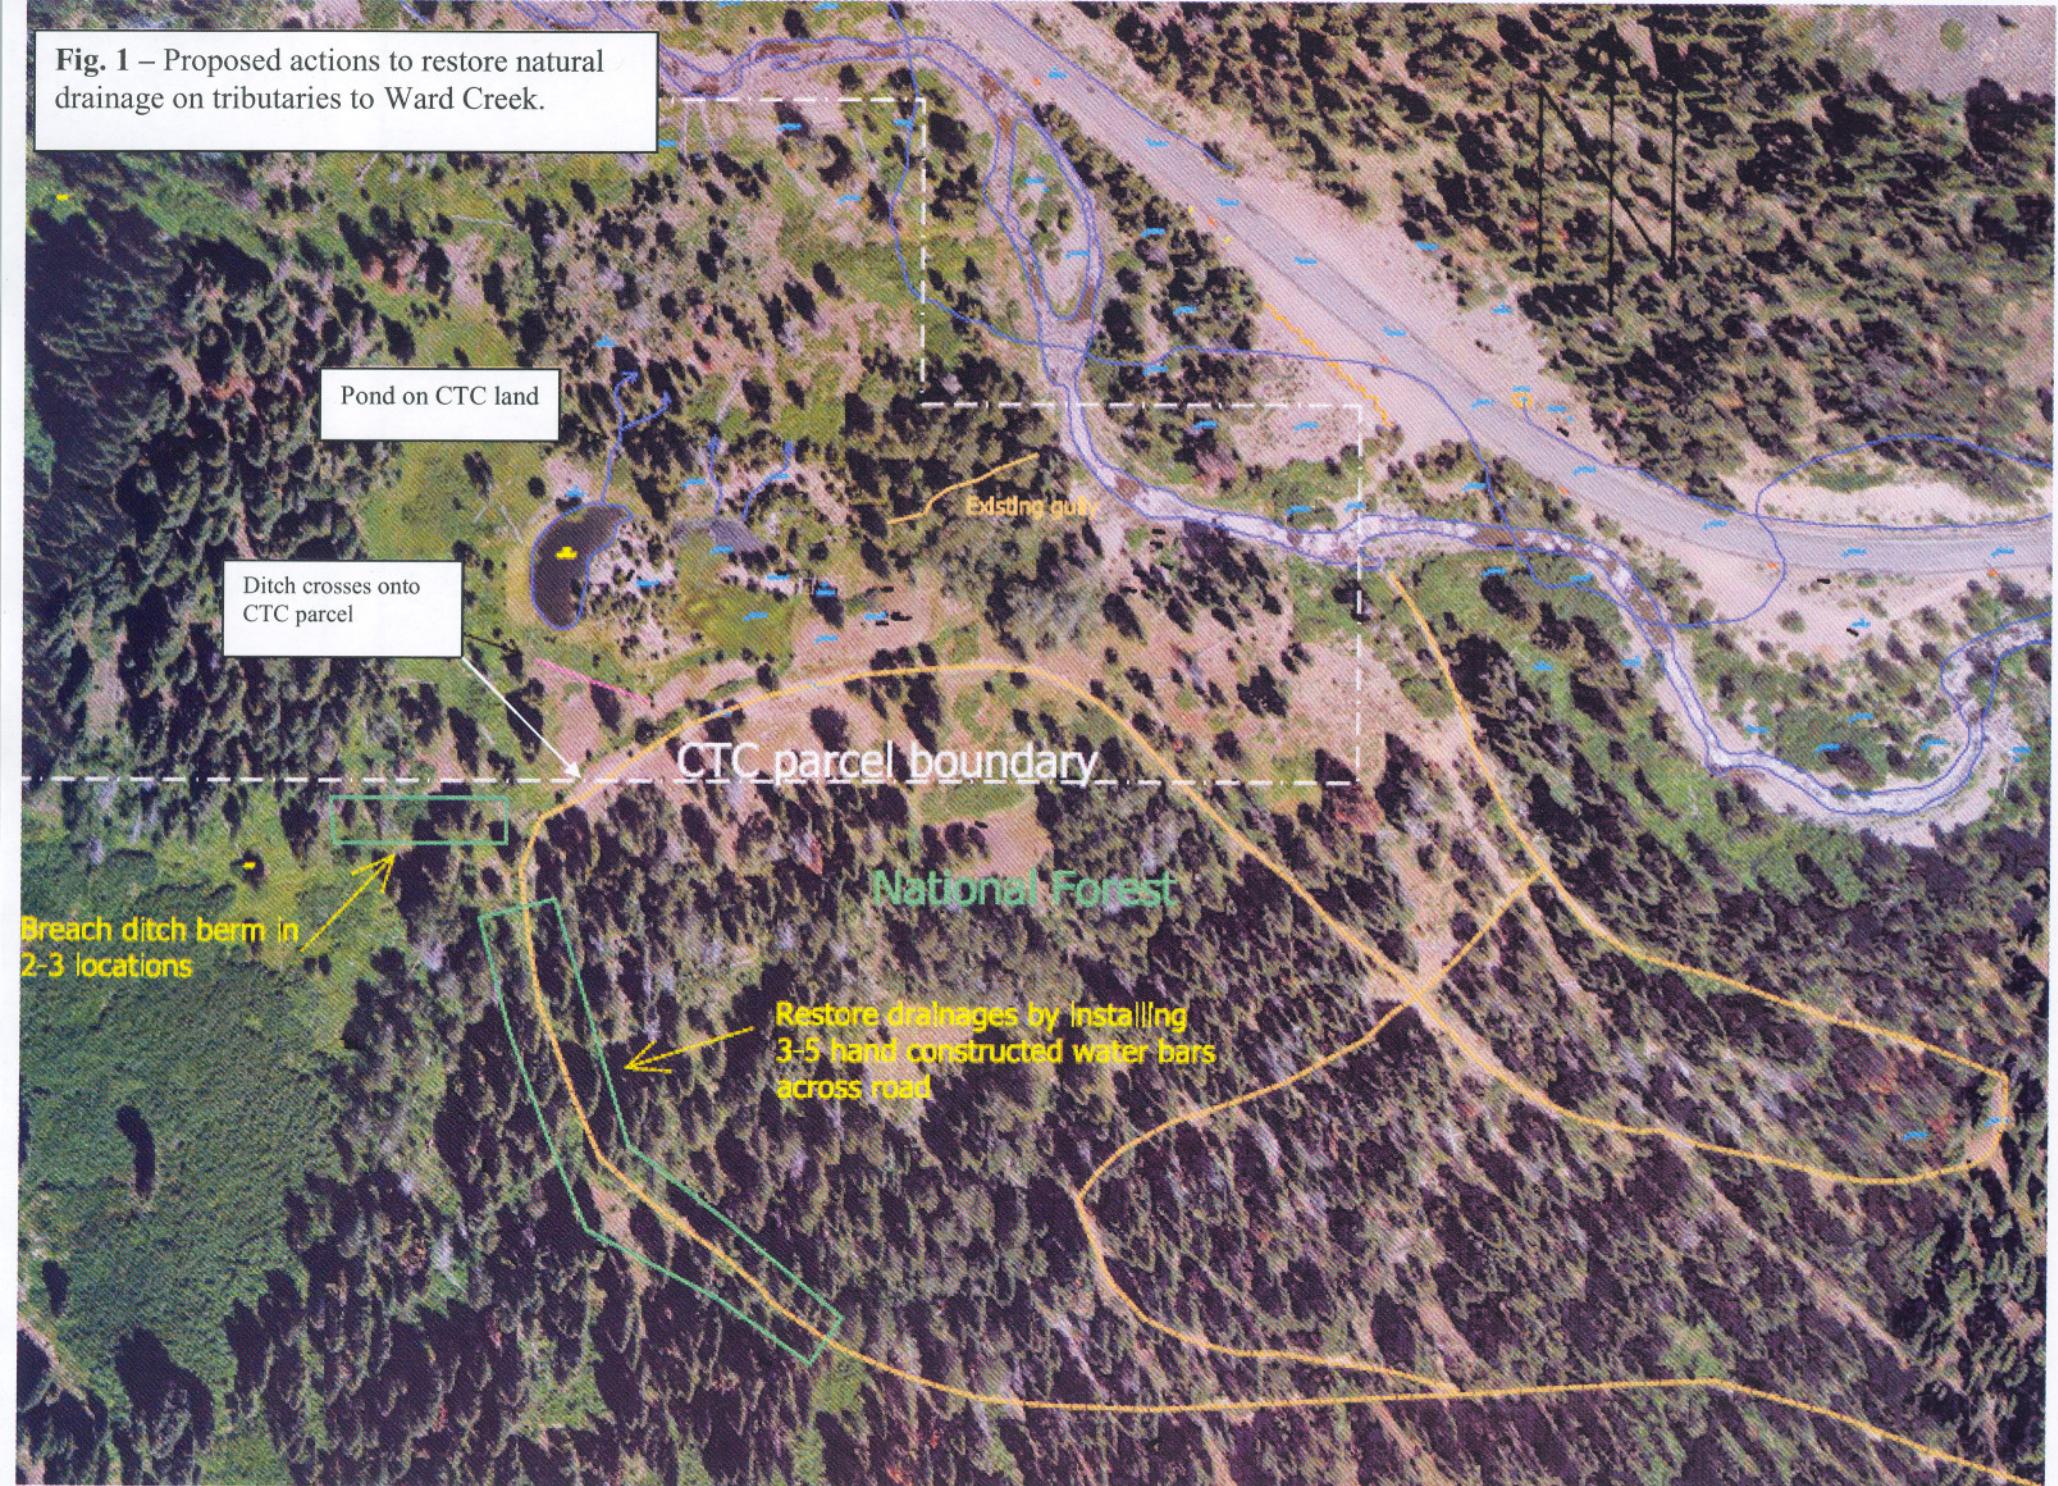
Fig. 1 – Proposed actions to restore natural drainage on tributaries to Ward Creek.

Pond on CTC land

Ditch crosses onto CTC parcel

Existing gully

CTC parcel boundary

National Forest

Breach ditch berm in 2-3 locations

Restore drainages by installing 3-5 hand constructed water bars across road

The USFS proposes to partially reestablish drainage patterns at a five acre site on the south side of Ward Creek, near the abandoned Stanford Rock Road Crossing (Fig. 1). All work would be accomplished using hand labor.

- Breach the ditch berm in 2 to 3 locations, within a reach of approximately 70 feet. The channels created through the ditch berm would be revegetated.
- Construct 3 to 5 waterbars on the abandoned logging road, to restore the original drainage paths across the roadbed. Waterbars would be reinforced with available rock on site.
