On July 1, 2014 Sue Crowder and myself complete a field review of the 1168427 road. The main purpose of the site visit was to inspect the road and a decommissioned stream crossing to determine if this section of road could be utilized for the removal of special forest products (fir boughs). This section of road has been decommissioned by decompacting, installing water bars and placing slash and root wads on the first 100 feet of the road surface to prevent vehicular access. A portion of this road segment will be re-constructed and used for the Buck Tule timber sale.

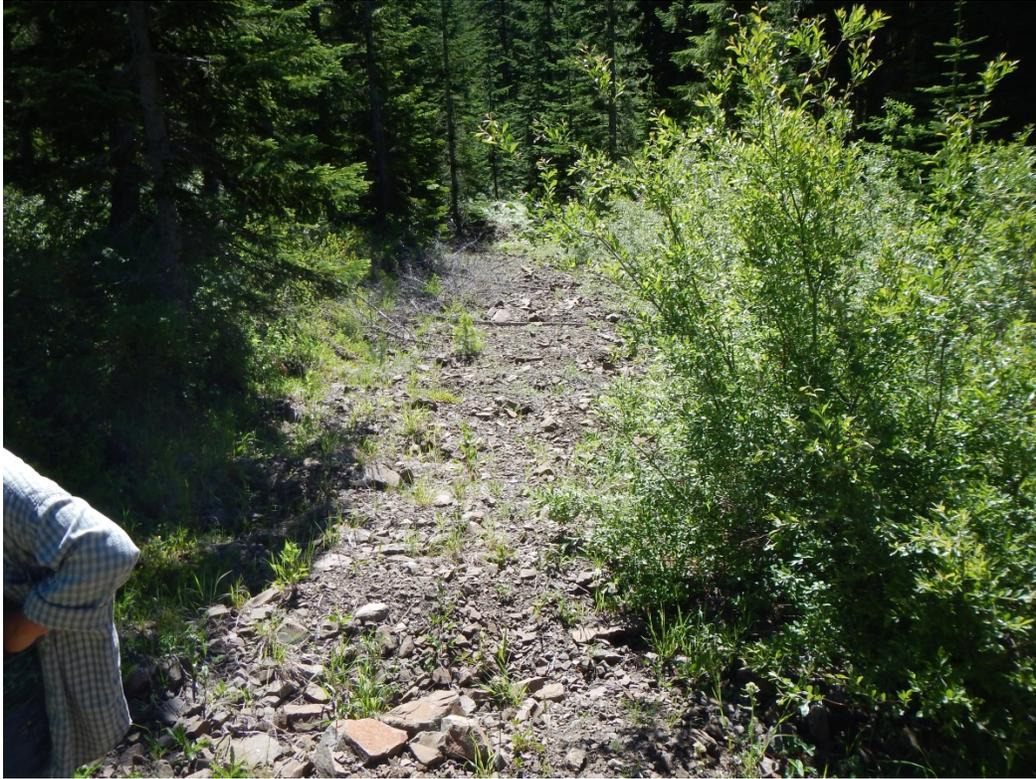
It is proposed to allow ATV access on this segment of road for removing special forest products; this would include crossing one perennial stream. The road surface contains a high percentage of rock fragments (see photos 1 and 2) and is hummocky from the decommissioning work. Due to the high percentage of rock fragments and the light weight and low ground pressure of ATV vehicles there will be no measurable increase of soil compaction on the decommissioned road surface.

Photo 1. Rock fragment road surface at stream crossing

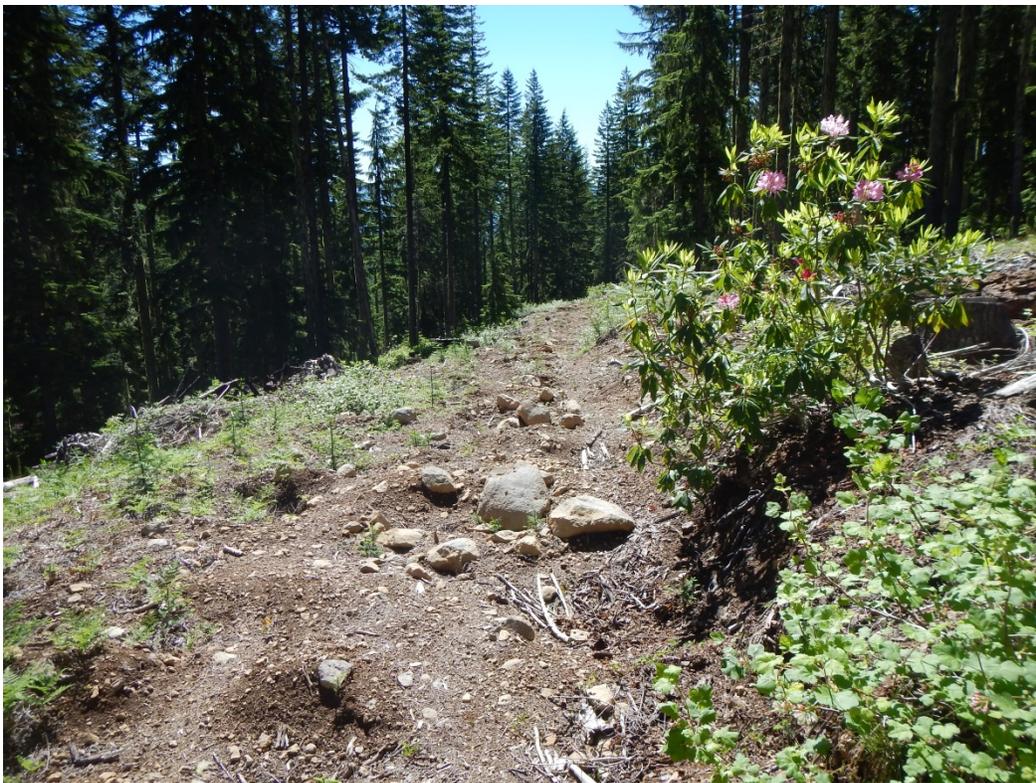
Photo 2. Large and small rock fragments and hummocky decommissioned road surface

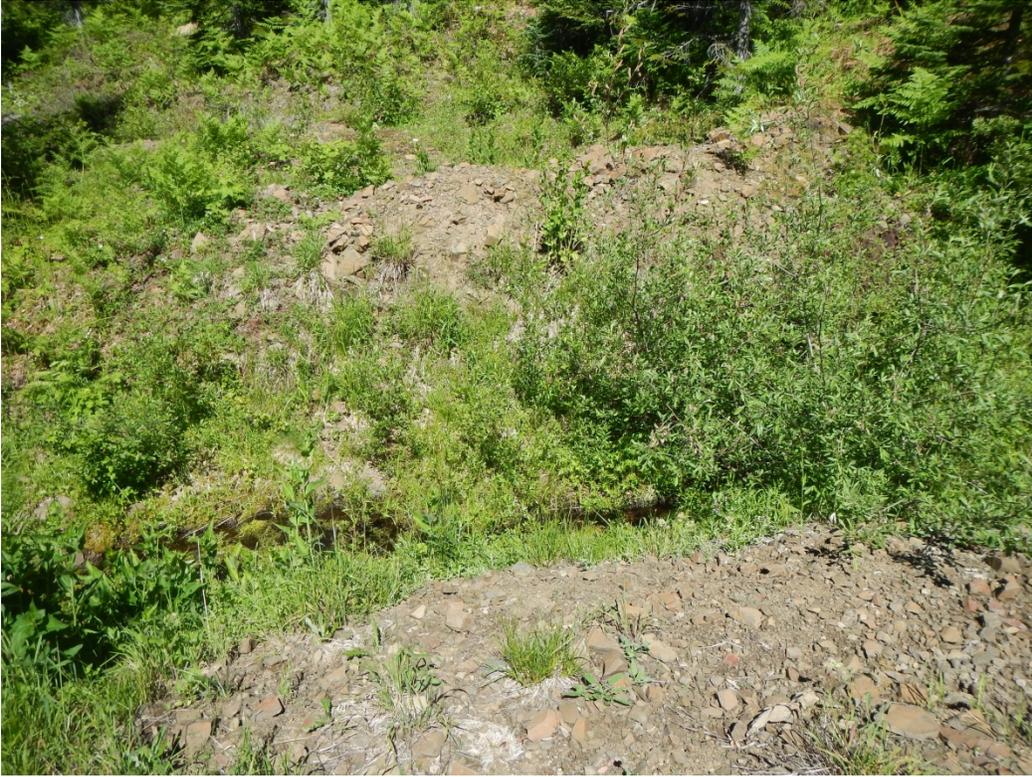
The decommissioned stream crossing had the culvert and fill material removed leaving 1:1 side slopes and creating about a 20 to 25 foot span across the stream. The perennial stream is about 18 to 24 inches across and less than six inches deep (see photo 3). In order to protect water quality it is recommended that a small temporary log stringer bridge be installed by the purchaser to facilitate ATV access to this portion of the unit. The log stringer bridge should be a minimum 30 feet in length and wide enough to safely allow for ATV access. The log stringer bridge can be placed and anchored on the existing road approaches with minimal hand earth work required. The log stringer material can be cut from the small diameter noble fir plantation present on both side of the stream crossing (photo 4). There will be a 50 foot no cut buffer on both sides of the crossing measured from the top of the stream bank and extending out 50 feet on both sides of the stream. Material cut for the log stringers will be gathered outside the no cut buffer and felled to the road for processing, skidding and stringer placement. After all special forest products activities have been completed the temporary log stringer bridge should be removed, disassembled with the stinger logs being placed in the stream channel above, below and in the decommissioned stream crossing.

Photo 3. Decommissioned perennial stream crossing and approaches.

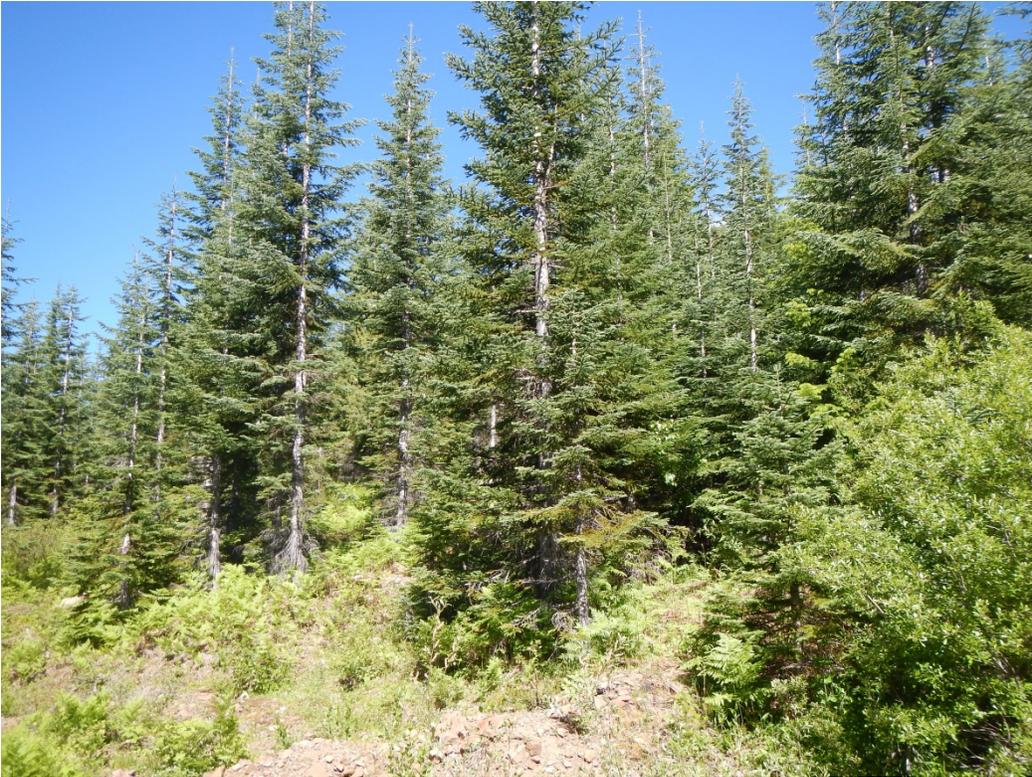
Photo 4. Small diameter Noble fir for log stringer material
