## SKY BASIN (UPPER CA-1 WATERSHED) EROSION ASSESSMENT

**August 2014**

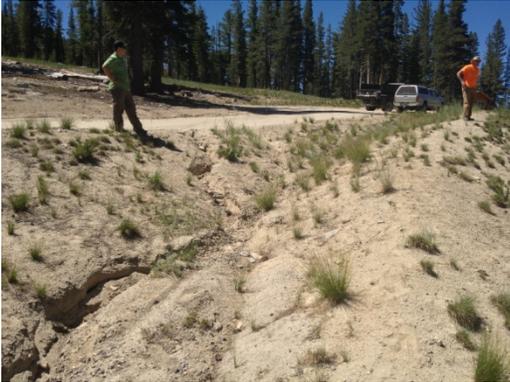
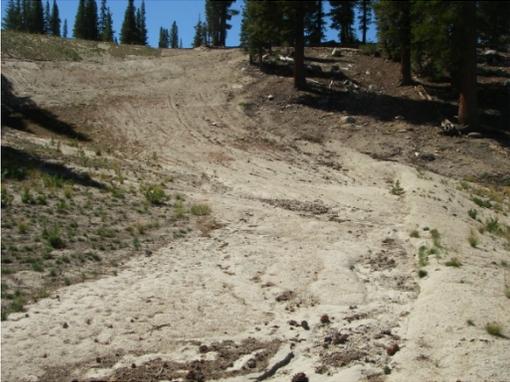
<b>Hot Spot #</b>	<b>Photo 1</b>	<b>Photo 2</b>
6

Hot Spot #	Type	Erosion Risk	Active Erosion	Active Deposition	Proximity to Stream/SEZ	Connectivity to Stream/SEZ	Overall Priority	Problem Description	Treatment Recommendation(s)
6	Water Bar	H	Y	Y	L	L	L	Giant sediment plume and incising WBs downslope of road, all caused by concentrated road runoff	re-direct road runoff away from slope, then remove WBs on slope and stabilize with full restoration treatment (~15,000sf)
7	Gully	M	Y	Y	L	L	L	Road drainage to breached WB formed gully down fir-covered ski run.	maintain drainage to WB on ski run; rake out gully; apply thick mulch to lower ski run above road (~2500sf)
13	Water Bar	H	Y	Y	M	H	H	water bar draining to reservoir	install PN wattles as sediment forebay; create small infiltration swale at WB outlet (~500sf)
30	Disturbed area	L	N	Y	H	H	M	bare and poorly vegetated area under Sky Deck (~3000sf)	restoration and planting shade-tolerant meadow/riparian species

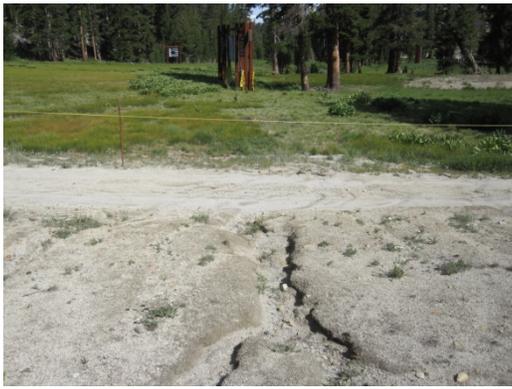
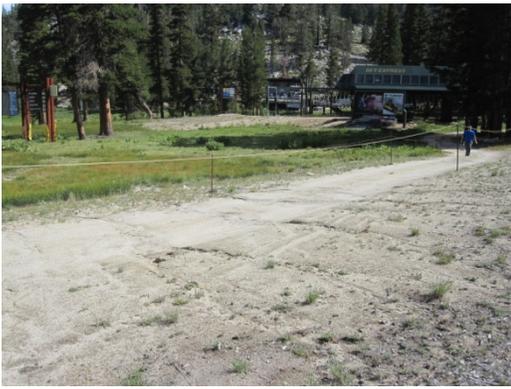
<p><b>31</b></p>

31	ski run	M	Y	Y	H	H	H	erosion from bare ski run area above road (and on road) directly to meadow below	full restoration treatment (~2500sf)
32	swale	M	Y	Y	H	H	H	rock-lined swale around Canyon base filled with sediment; sediment plume into meadow	remove sediment and rebuild rock-lined swale; install several mulch filter berms in swale; remulch lift loading areas as needed to maintain surface mulch (~500sf)
33	ski run	H	Y	Y	H	M	H	steep ski run (lower double down) with low surface cover and sparse trees; water bar near bottom of run filled with sediment and overtopped	rehab water bar and convert to infiltration swale; install several mulch berms on ski run OR cover lower portion of ski run with mulch (1500-15,000sf, depending on treatment)
34	ski run	H	Y	Y	H	H	H	steep ski run (lower ridge run/sky chute) with little surface cover and widespread erosion; several v-shaped water bars direct water to a culvert system that leads to meadow and several water bars have overtopped (causing erosion below)	rehab water bars and convert to infiltration swales; install several mulch berms on ski run OR cover ski run with mulch (2500-15,000sf, depending on treatment)

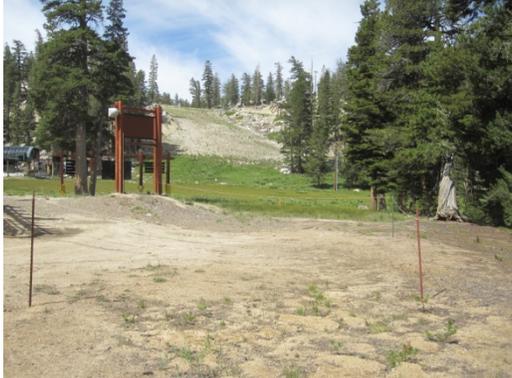
<p>35</p>

35	road	M	N	N	H	H	H	bare, compacted vehicle turnaround and access to Sky lift	maintain wood chip mulch cover on turnaround area near creek (~500sf)

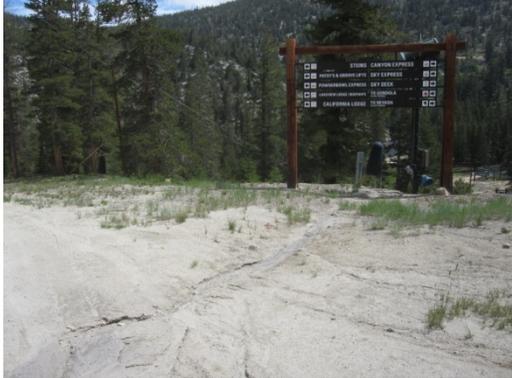
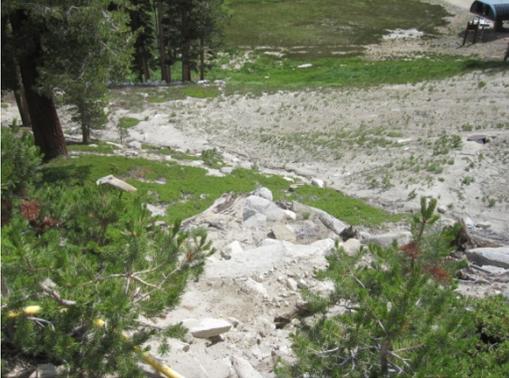
<p>36</p>

Hot Spot #	Type	Erosion Risk	Active Erosion	Active Deposition	Proximity to Stream/SEZ	Connectivity to Stream/SEZ	Overall Priority	Problem Description	Treatment Recommendation(s)
								base, which is ~20ft from creek channel	
36	water bar	H	Y	Y	M	H	H	water bar draining road is causing erosion under large ski run sign, compromising power box, and contributing runoff and sediment to ski run below (lower ridge run - hot spot 34)	create spreading/infiltration area at water bar outlet and add pine needle filter berms to trap sediment (~500sf)
37	water bar	H	Y	Y	L	H	H	road drainage collects at V-shaped water bar with culvert direct to meadow; erosion along water bar (head cutting); water bar overtopped at culvert inlet, causing erosion downslope	rehab water bars and convert to infiltration swales; rake out and mulch rills (~1000sf)
38	water bar	H	Y	Y	L	H	H	road drainage directed along water bar on ski run; erosion along water bar and downslope where water bar overtopped	rehab water bars and convert to infiltration swales; also rebuild water bar on roadway; ; rake out and mulch rills on ski run (~1000sf)

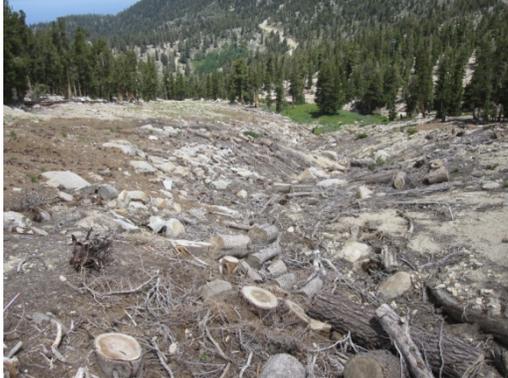
<p>39</p>

39	ephemeral drainage	H	Y	Y	L	H	L	large ephemeral drainage; lots of woody debris in flow line and moderate mulch cover in surrounding areas	no action recommended
40	water bar	H	Y	Y	L	M	L	many water bars on high roller ski run above and below summer road; many have failures where they have overtopped, causing erosion downslope	rehab water bars at failure points and convert into infiltration swales through soil loosening, wood chip incorporation (~10,000-15,000sf)
41	water bar	H	Y	Y	L	H	M	ski run (upper ridge run) with ~6 eroding water bars that direct runoff into large drainage that eventually outlets at the Canyon lift base and connects to Sky Meadow; many water bars have failures.	rehab water bars at failure points and convert into infiltration swales through soil loosening, wood chip incorporation (~10,000-15,000sf)

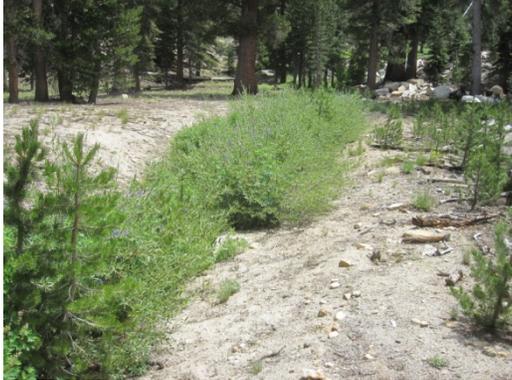
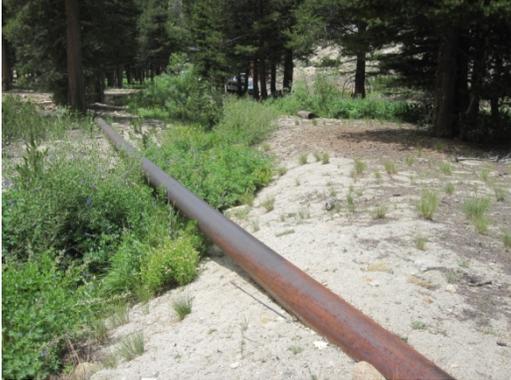
<p>42</p>

Hot Spot #	Type	Erosion Risk	Active Erosion	Active Deposition	Proximity to Stream/SEZ	Connectivity to Stream/SEZ	Overall Priority	Problem Description	Treatment Recommendation(s)
42	stream channel	M	N	N	H	H	M	south fork of SEZ channel above Sky Meadow culvert with mostly bare soil and moderately steep slopes on both sides of channel; old decomposed jute and plastic netting observed from previous USFS erosion control efforts; generally no visible erosion from banks; channel is somewhat straight and incised but no significant head cuts or bank erosion observed	definitely potential for restoration/stabilization of banks (loosening/seeding/mulch - no fabric); approx ~5000sf of bare soil along channel
43	stream channel	M	Y	Y	H	H	M	bank erosion and sediment plume in south fork of SEZ channel above Sky Meadows culvert	bank stabilization/restoration treatment (loosening/seeding/mulch - no fabric); ~300sf

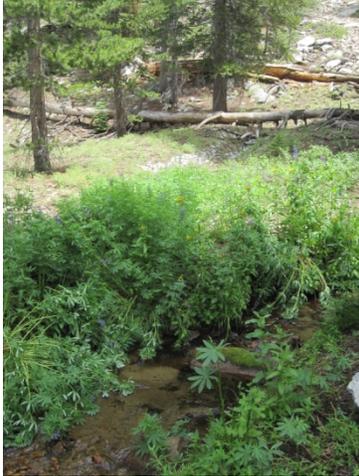
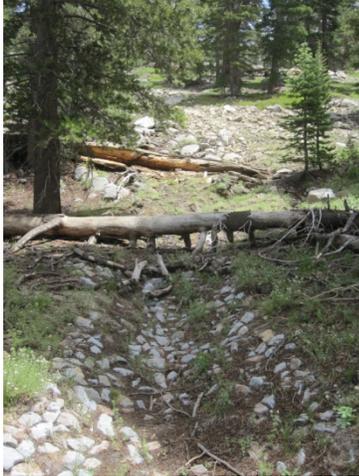
<p>44</p>

44	stream channel	M	Y	Y	H	H	M	sediment plume in south fork of SEZ channel above Sky Meadows culvert; sediment appears to have come from short section of rock-lined swale upslope of creek; no obvious bank erosion	decommission rock-lined swale, which appears to unnecessarily collect dispersed runoff from rocky slope above it (~1000sf)
45	water bar	H	Y	Y	H	H	H	very steep section of road (Hellwinkle's) is delivering sediment downslope into a fingered section of the north fork of the SEZ channel above Sky Meadows culvert; rills and gullies formed on hillside below road and above channel	stabilize rills/gullies on hillside, and address road runoff. Road options: 1) surface and/or pave road; 2) decommission road and use only for emergency access; 3) improve infiltration capacity and conduct very frequent maintenance at sediment basins along road (~1000-5000sf)
46	water bar	H	Y	Y	H	H	H	very steep section of road (Hellwinkle's) is delivering sediment downslope into a fingered section of the north fork of the SEZ channel above Sky Meadows culvert; minor rilling on hillside below road and above channel	options: 1) surface and/or pave road; 2) decommission road and use only for emergency access; 3) improve infiltration capacity and conduct very frequent maintenance at sediment basins along road (~1000-5000sf)

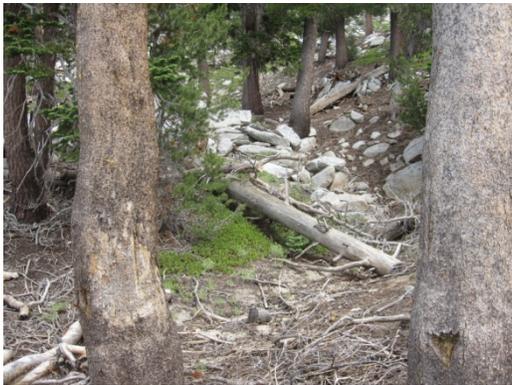
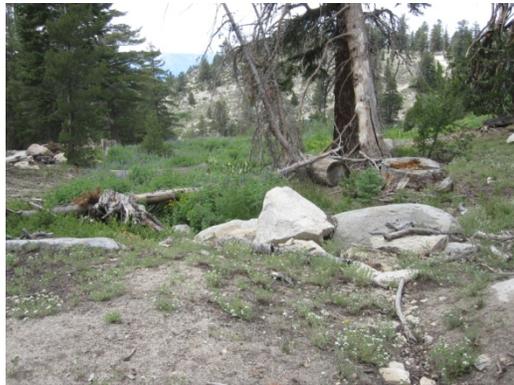
<p>47</p>

Hot Spot #	Type	Erosion Risk	Active Erosion	Active Deposition	Proximity to Stream/SEZ	Connectivity to Stream/SEZ	Overall Priority	Problem Description	Treatment Recommendation(s)
47	ephemeral drainage	M	Y	Y	L	H	L	large ephemeral drainage at crossing with lower Cal trail; relatively stable and well vegetated with small meadow below road crossing; evidence of flow during recent rain events but no obvious sediment transport	no action recommended
48	gully	M	Y	Y	L	M	L	well-established gully formed at downslope end of lower Cal trail; collects water from large drainage area; moderate amount of erosion and deposition observed from recent rain storm	full restoration treatment along gully (maintain general swale-like shape) to slow and infiltrate surface runoff during spring snowmelt and rain storms; installation of mulch filter berms would provide short-term benefits (~1500sf)
49	ski run	H	Y	Y	H	M	H	steep ski run (lower Ellie's) with compacted soil, moderate veg cover, and visible rilling; water bar near bottom of run filled with sediment and overtopped in several locations	rehab water bar and convert to infiltration swale; install several mulch berms on ski run OR cover lower portion of ski run with mulch (1500-15,000sf, depending on treatment)

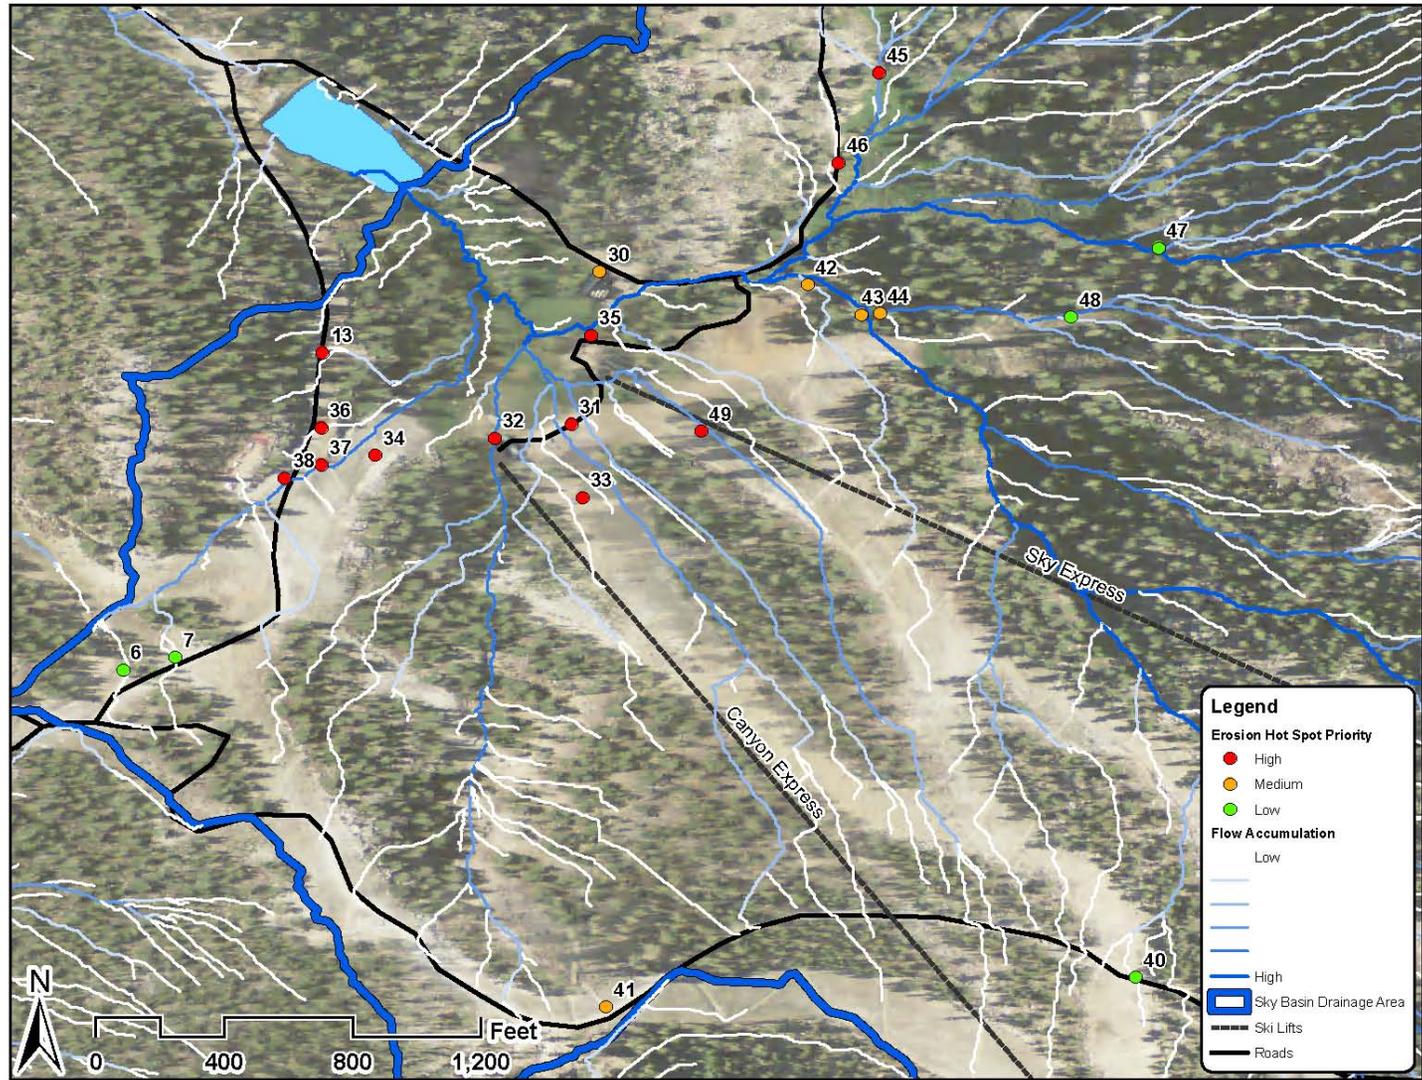
Figure 1. Efra Summary Map showing hot spots in Sky Basin (CA-1).

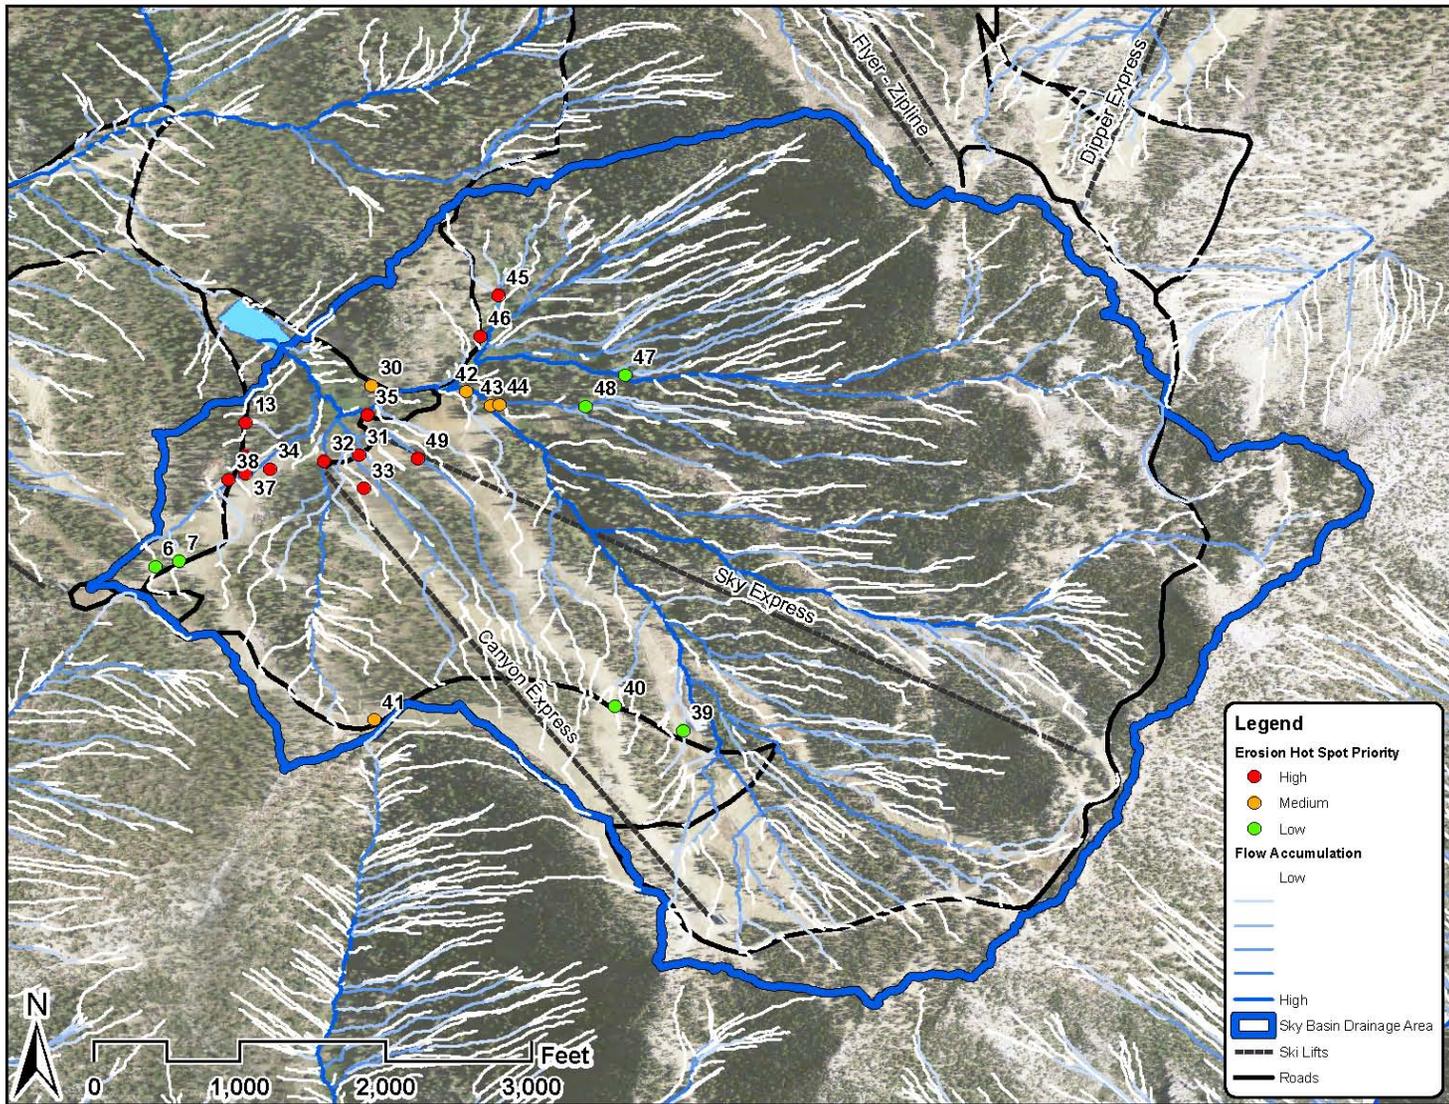
Figure 2. Summary Map showing hot spots in Sky Basin (CA-1), zoomed out to show entire Sky Basin drainage area.
