Jökulhlaup in the Wind River Mountains, Shoshone National Forest, Wyoming

A jökulhlaup burst from an ice-dammed lake at the head of Grasshopper Glacier in the Fitzpatrick Wilderness of Wyoming's Wind River Range during early September 2003. The 12-hectare lake drained an estimated 3.2 million cubic meters of water, down slope, underneath the glacier, and down tributary valleys into the Wind River valley. The outburst flood was recorded at a USGS gage (06221400; drainage area 245 km²) on the Dinwoody River approximately 33 km downstream from the ice-dammed lake. Jökulhlaups can be triggered by volcanic, seismic, and meteorologic events, and perhaps by climatic warming. Satellite images of the Wind River Mountains show dramatic recession of the glaciers since 1986. Work by Naftz et al. (2002) on the Upper Fremont Glacier (10.5 km south of Grasshopper Glacier on the Continental Divide) shows a warming trend and temperature increase of 3.5°C at high elevations over the past fifty years. It is likely that the Grasshopper Glacier jökulhlaup was triggered by local conditions within the glacier and the outburst lake created by this climatic warming trend. Reconnaissance surveys in the sum

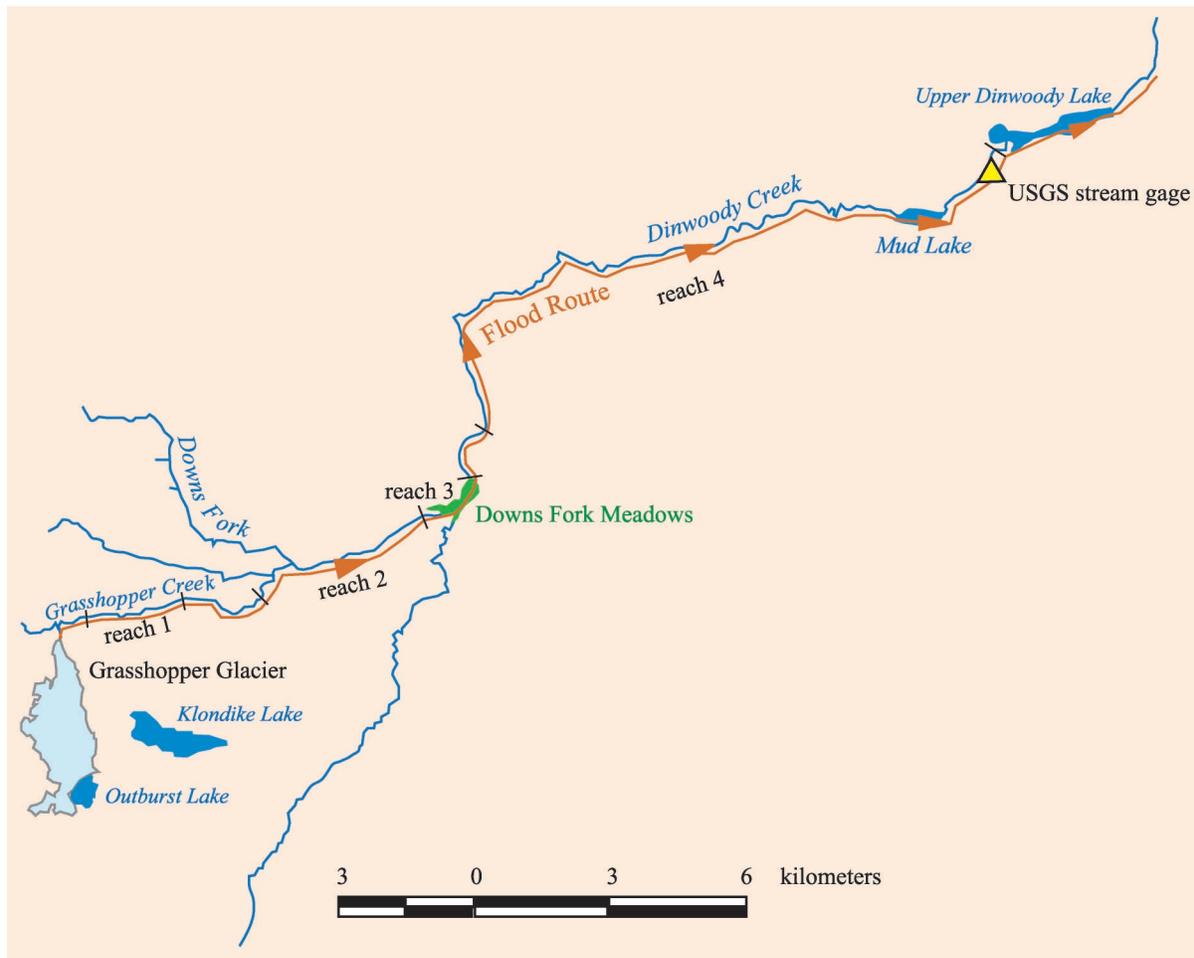
Figure 1. Grasshopper Glacier is located in the Fitzpatrick Wilderness, on the Shoshone National Forest, in the Wind River Range about 30.5 km south of Dubois, Wyoming. The USGS stream gage site on Dinwoody Creek is located at the eastern margin of the watershed on the Wind River Indian Reservation. Dinwoody Creek crosses Wyoming Hwy. 287 downstream of the gage site, and is tributary to the Wind River. Map base is USGS topographic series Thermopolis Sheet 1:250,000.

A jökulhlaup, or glacial outburst flood, burst from an ice-dammed lake at the head of Grasshopper Glacier in Wyoming's Wind River Range during early September 2003. The 12-hectare lake drained an estimated 3.2 million cubic meters of water downslope, underneath the glacier, and down tributary valleys into the Wind River valley. The outburst flood was recorded at a USGS stream gage (06221400; drainage area 245 km²) approximately 33 km downstream from the ice-dammed lake. During the period 1956-2001, annual peak snowmelt flow at the gage averaged 23 cubic meters per second (range 14-42 cubic meters per second). On 9 September 2003, the gage recorded a peak of 36.5 cubic meters per second, which rose from a base flow of 7 cubic meters per second on 6 September (Figure1).

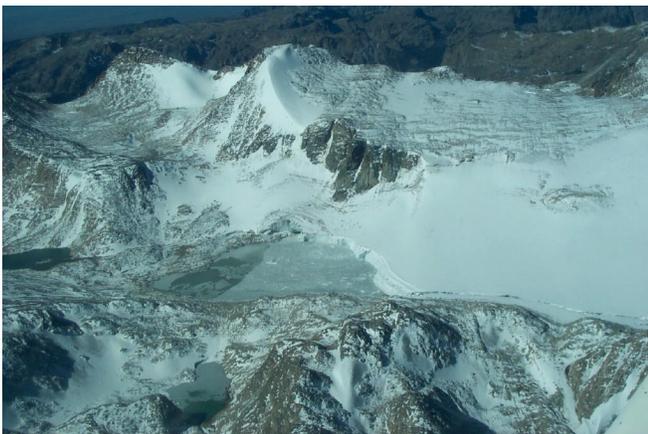
Figure 2. Ice-dammed lake that drained from head of Grasshopper Glacier. The view is to west. The lake drained beneath glacier to the north, and flooded to the north then east down the drainage of Grasshopper Creek, to Downs Fork Creek, and to Dinwoody Creek.

facing cirque walls of the mountain front. The glacier, which flows from south to north, drops 2.8 km from approximately 3647 m down a slope of 0.11 to its snout at 3435 m elevation. Grasshopper Glacier is presently about 2.5 km wide and covers approximately 364 hectares. The catchment of the outburst lake is at most 2.8 km², and only a small remnant of the glacier remains in the cirque above the lake. Ice at the margin of the lake is 18-21 m thick. (Figure 2)

Field reconnaissance surveys conducted in summer 2004 recorded the geomorphic effects of the jökulhlaup as the flood eroded, transported, and deposited sediment and shaped the river and its valley along the flood route. From the draining of the ice-dammed lake (Figure 2) and subglacial entrainment of sediment, five distinct

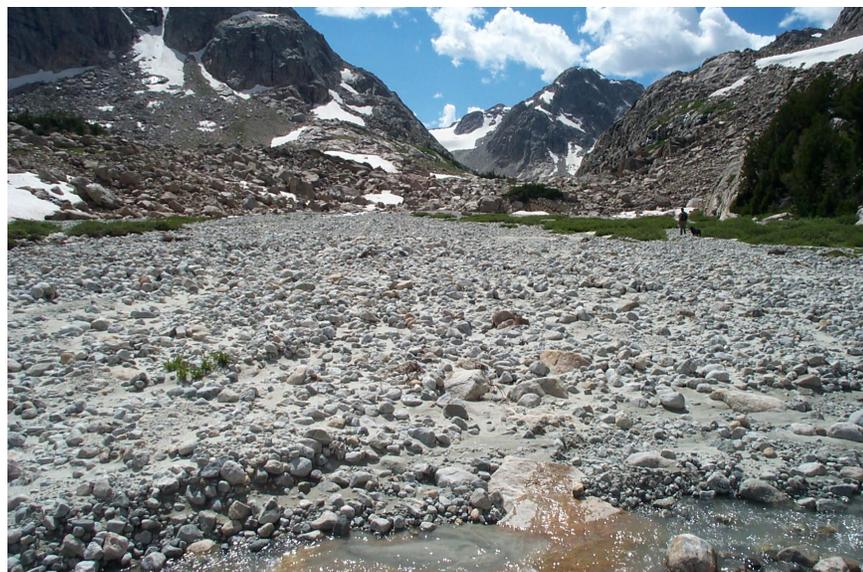
Figure 3. Expansion bars deposited by flood in upper reaches of Grasshopper Creek. The view is upstream.

Outwash deposition of expansion bars occurred in the most upstream reaches (Table 1) of Grasshopper Creek (Figure 3; Reach One: 4.2 km to 6.1 km; distance measured from outlet of outburst lake at head of the glacier). Valley slope averages about 0.045. Bar deposition spread out across the entire valley bottom, up to 0.2 km wide and 1.4 m high. Log jams, stream bed aggradation, and overbank deposition occurred in a lower-gradient reach with 0.025 average slope (Reach Two: 8.2 km to 13.2 km distant from the outburst lake). Sixteen log jams were recorded that persisted in the valley at the time of the survey. The largest

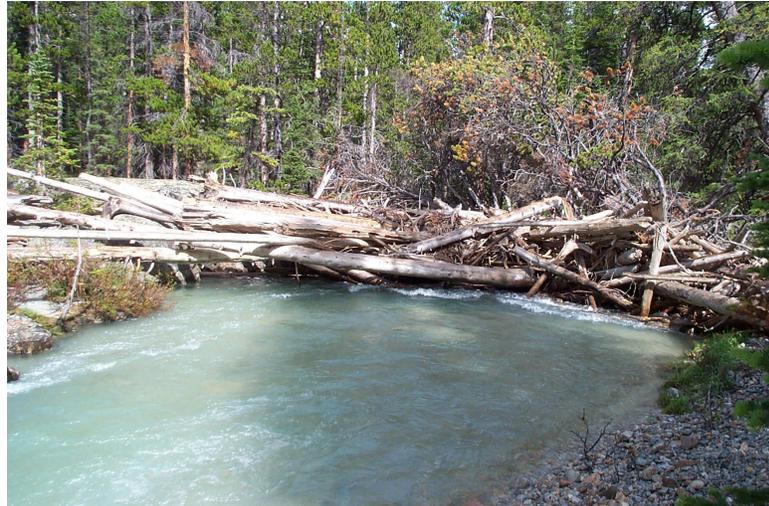
Figure 4. One of the many log jams on the Downs Fork. The view is downstream

log jam was at a maximum up to 12 m wide down the length of channel, 35 m across the width of channel, and up to 3.5 m high from the channel bed (Figure 4). At the Downs Fork bridge, large woody debris had been removed in order to “save the bridge”. Channel avulsion and aggradation, log jams, and deposition of suspended load in an ephemeral lake occurred in the Downs Fork meadow area, with 0.013 average slope (Reach Three: 13.2 km to 15.3 km) (Figure 5). In-channel depositional filling of riffles and pools occurred below Dinwoody Falls, to below Shangri-La Meadows, and on to the lower reaches of the Dinwoody valley (Reach Four: 16.7 km to 21.2 km and beyond). Slopes averaged 0.025 at depositional areas of these reaches. Silt and clay deposition in lakes and irrigation systems occurred in the lower reaches of the Dinwoody valley at Mud Lake, the Dinwoody Lakes (Reach Five: 32 km to 38.6 km), and irrigation canals and ditches that traverse the lower Dinwoody River to the Wind River floodplain.

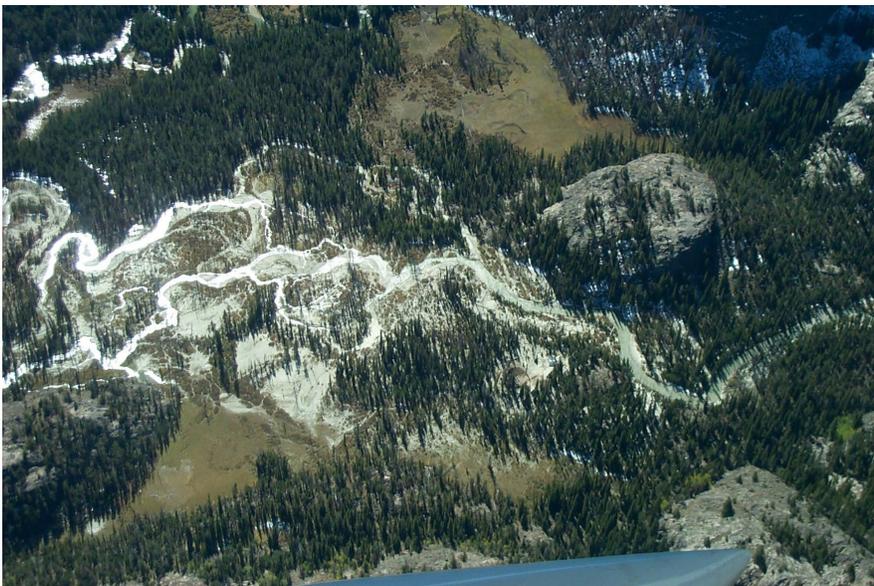
Figure 5. Aerial view of Downs Fork Meadows in late September 2003, showing extent of flood deposition in ephemeral lake, channel avulsion, and overbank flows. Left is downstream.
