Taylor, Tallac, and Spring Creek Watershed EAR  
U.S. Forest Service  
P 3T058.01 05/04

### Wetland System

Taylor, Tallac, and Spring Creek Watershed EAR

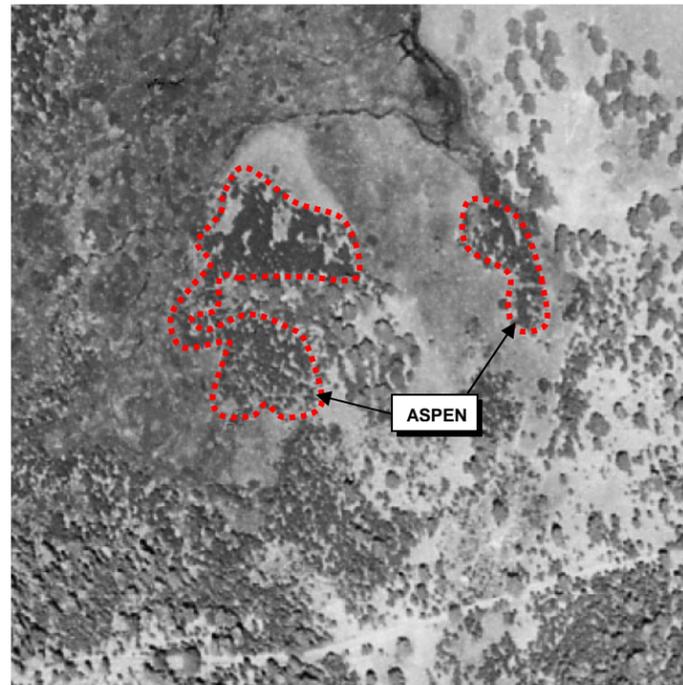
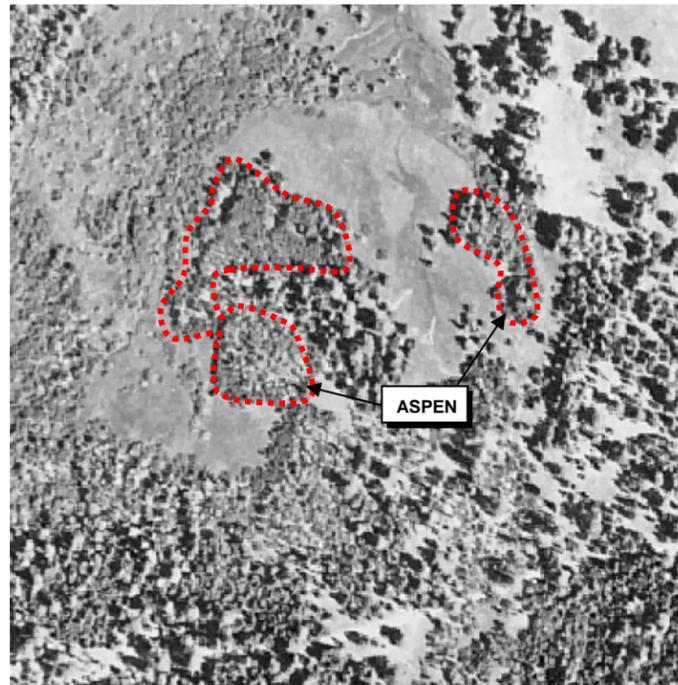
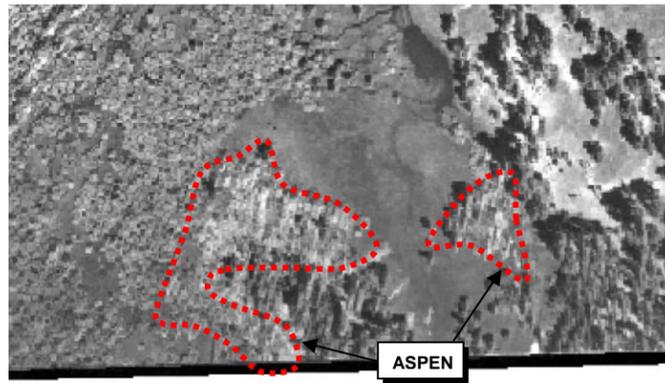
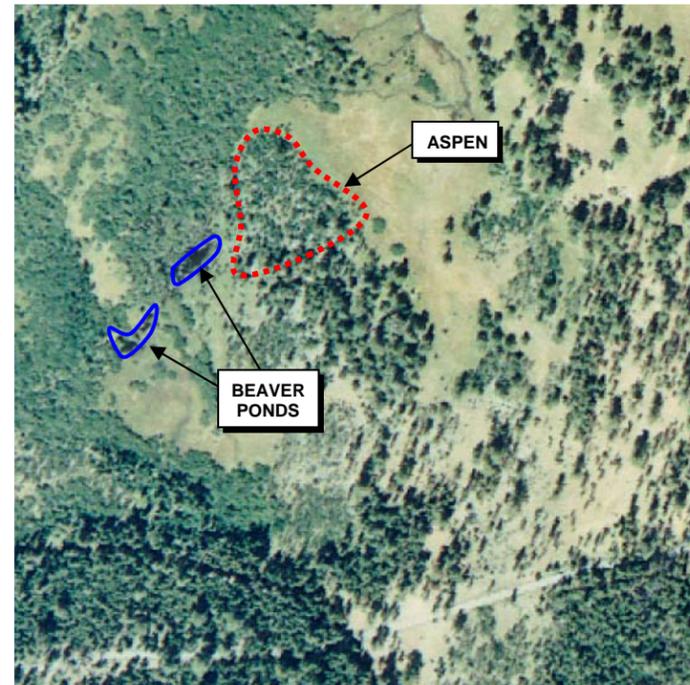
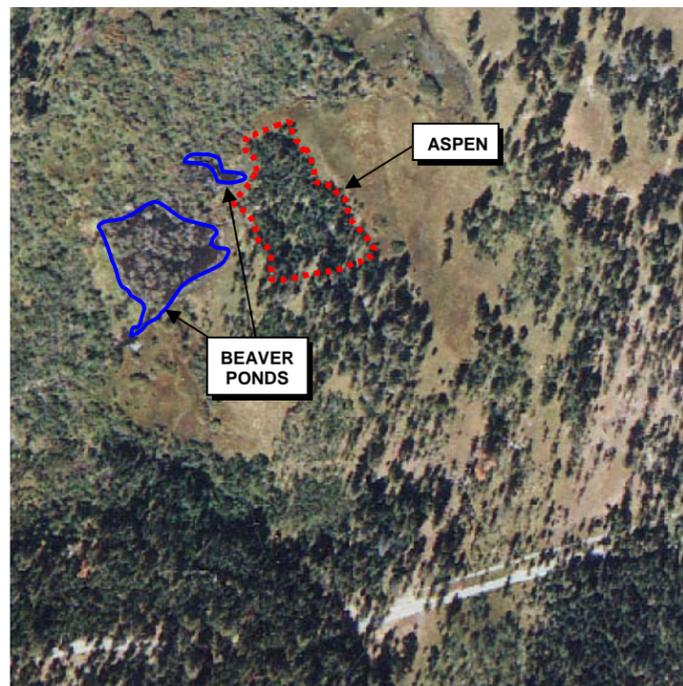
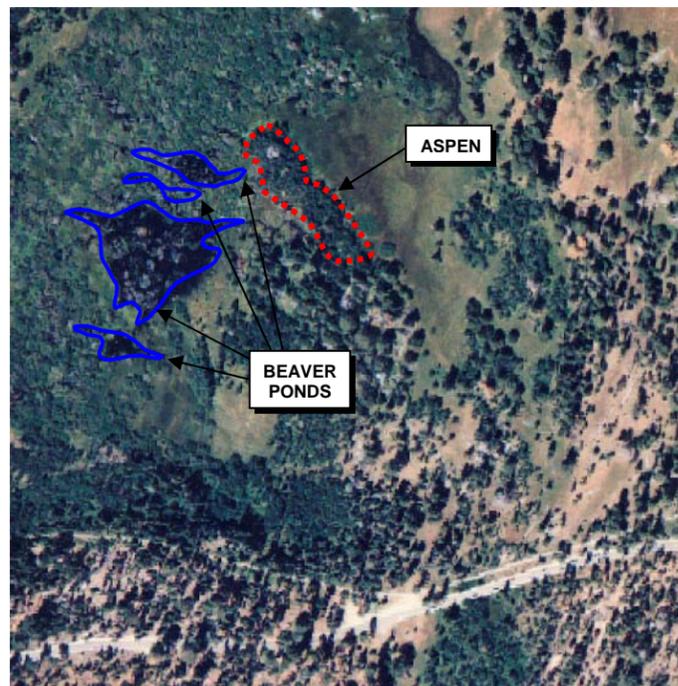
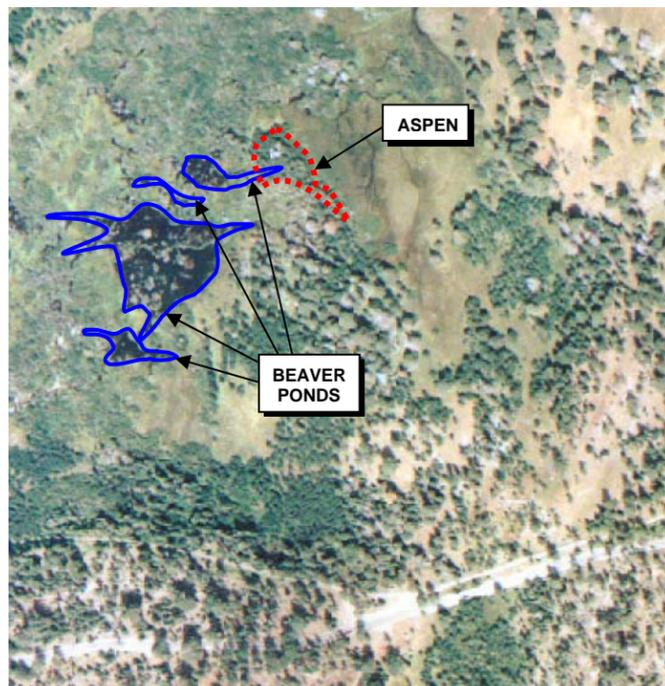
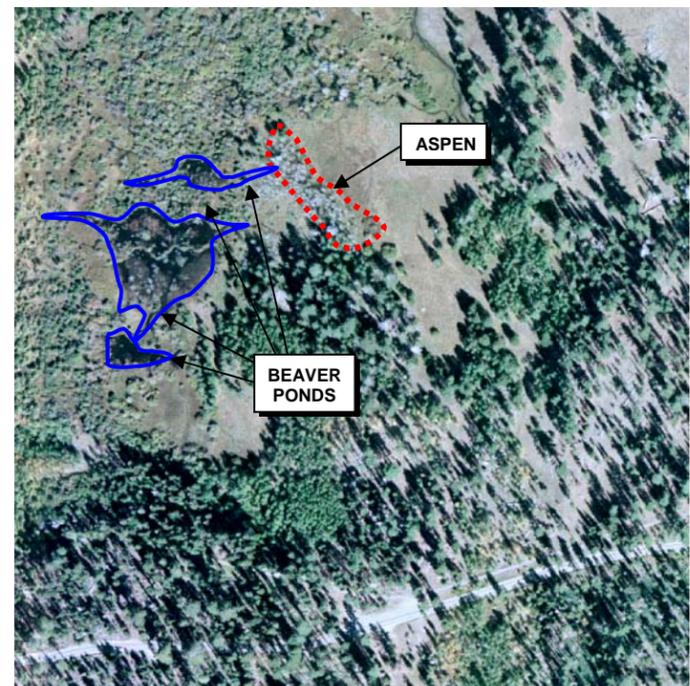
### Aspen and Beaver

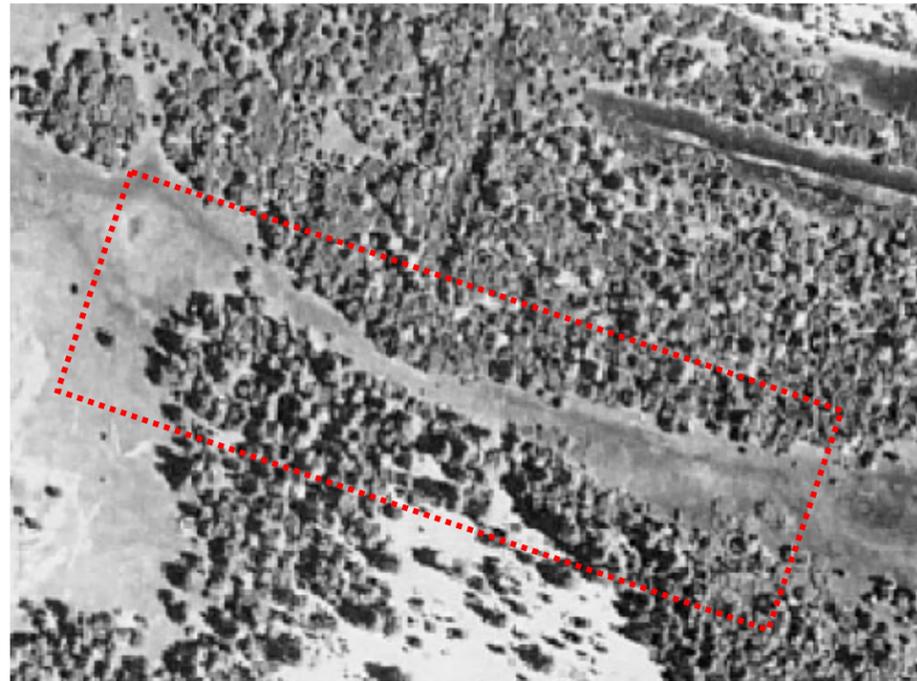
(a) Meadow swale 8/14/52

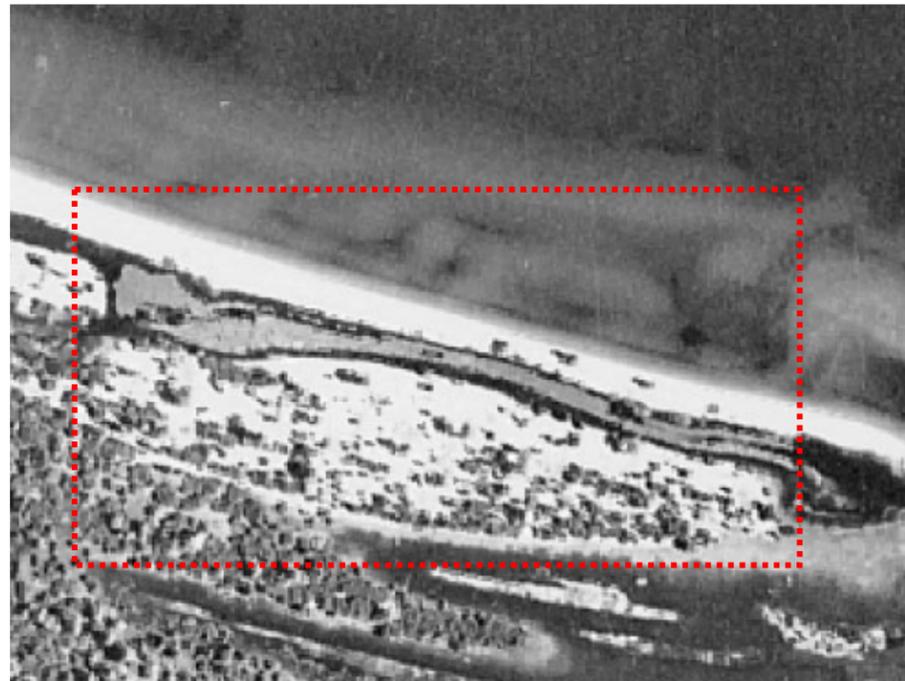
(c) Near shore wet swale 8/14/52

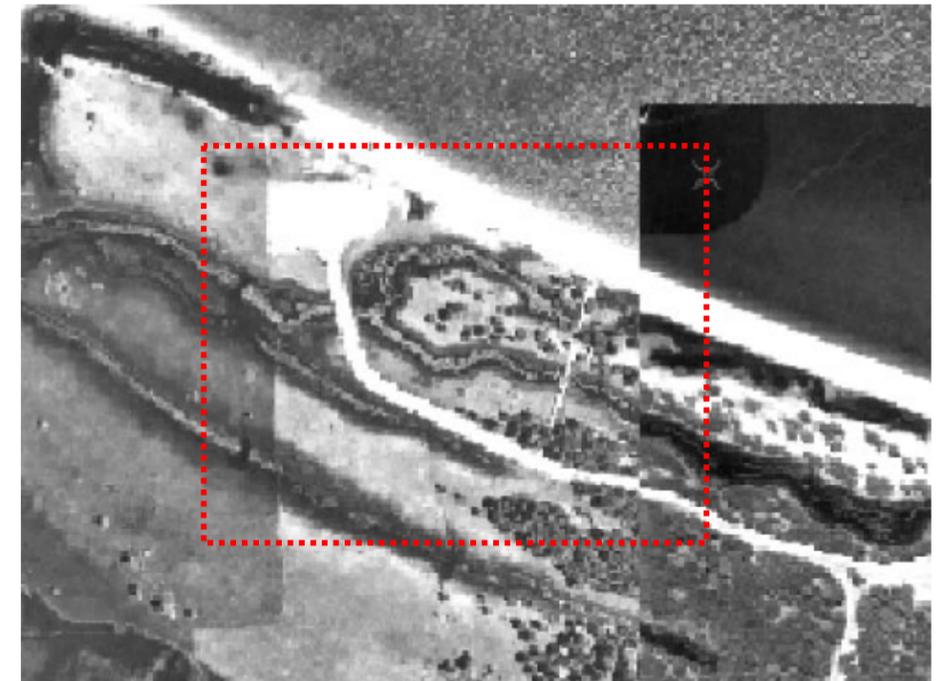
(e) Path across meadow 5/2/67

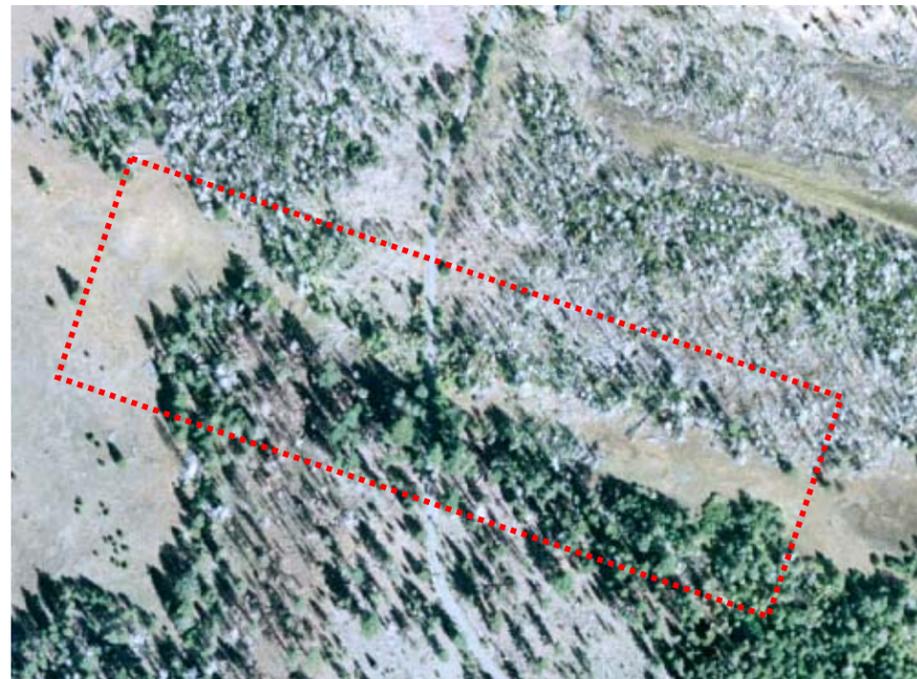
(b) Meadow swale 9/10/03

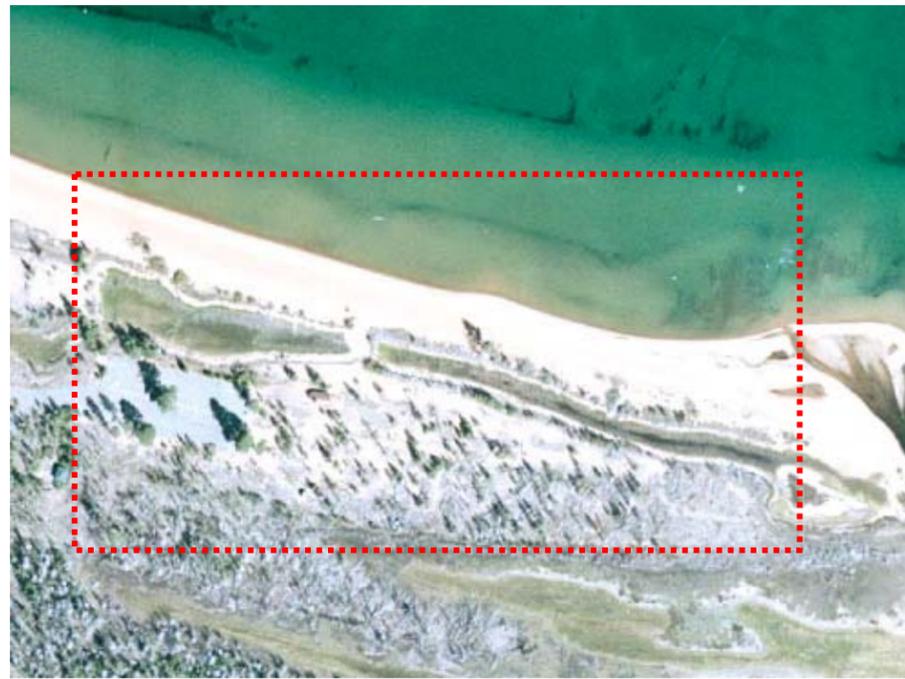
(d) Near shore wet swale 9/10/03

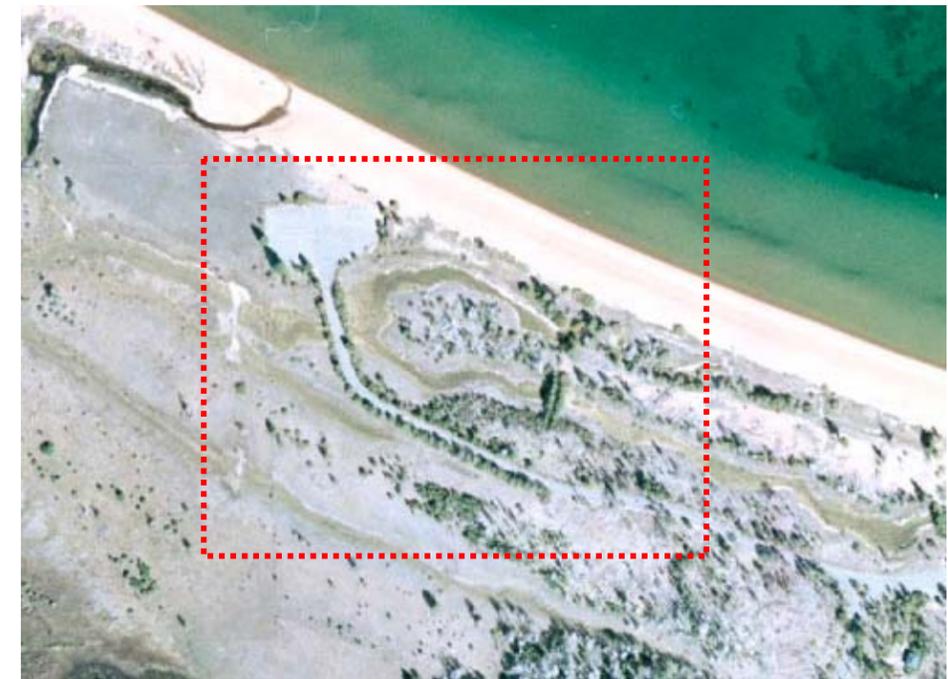
(f) Path across meadow 9/10/03

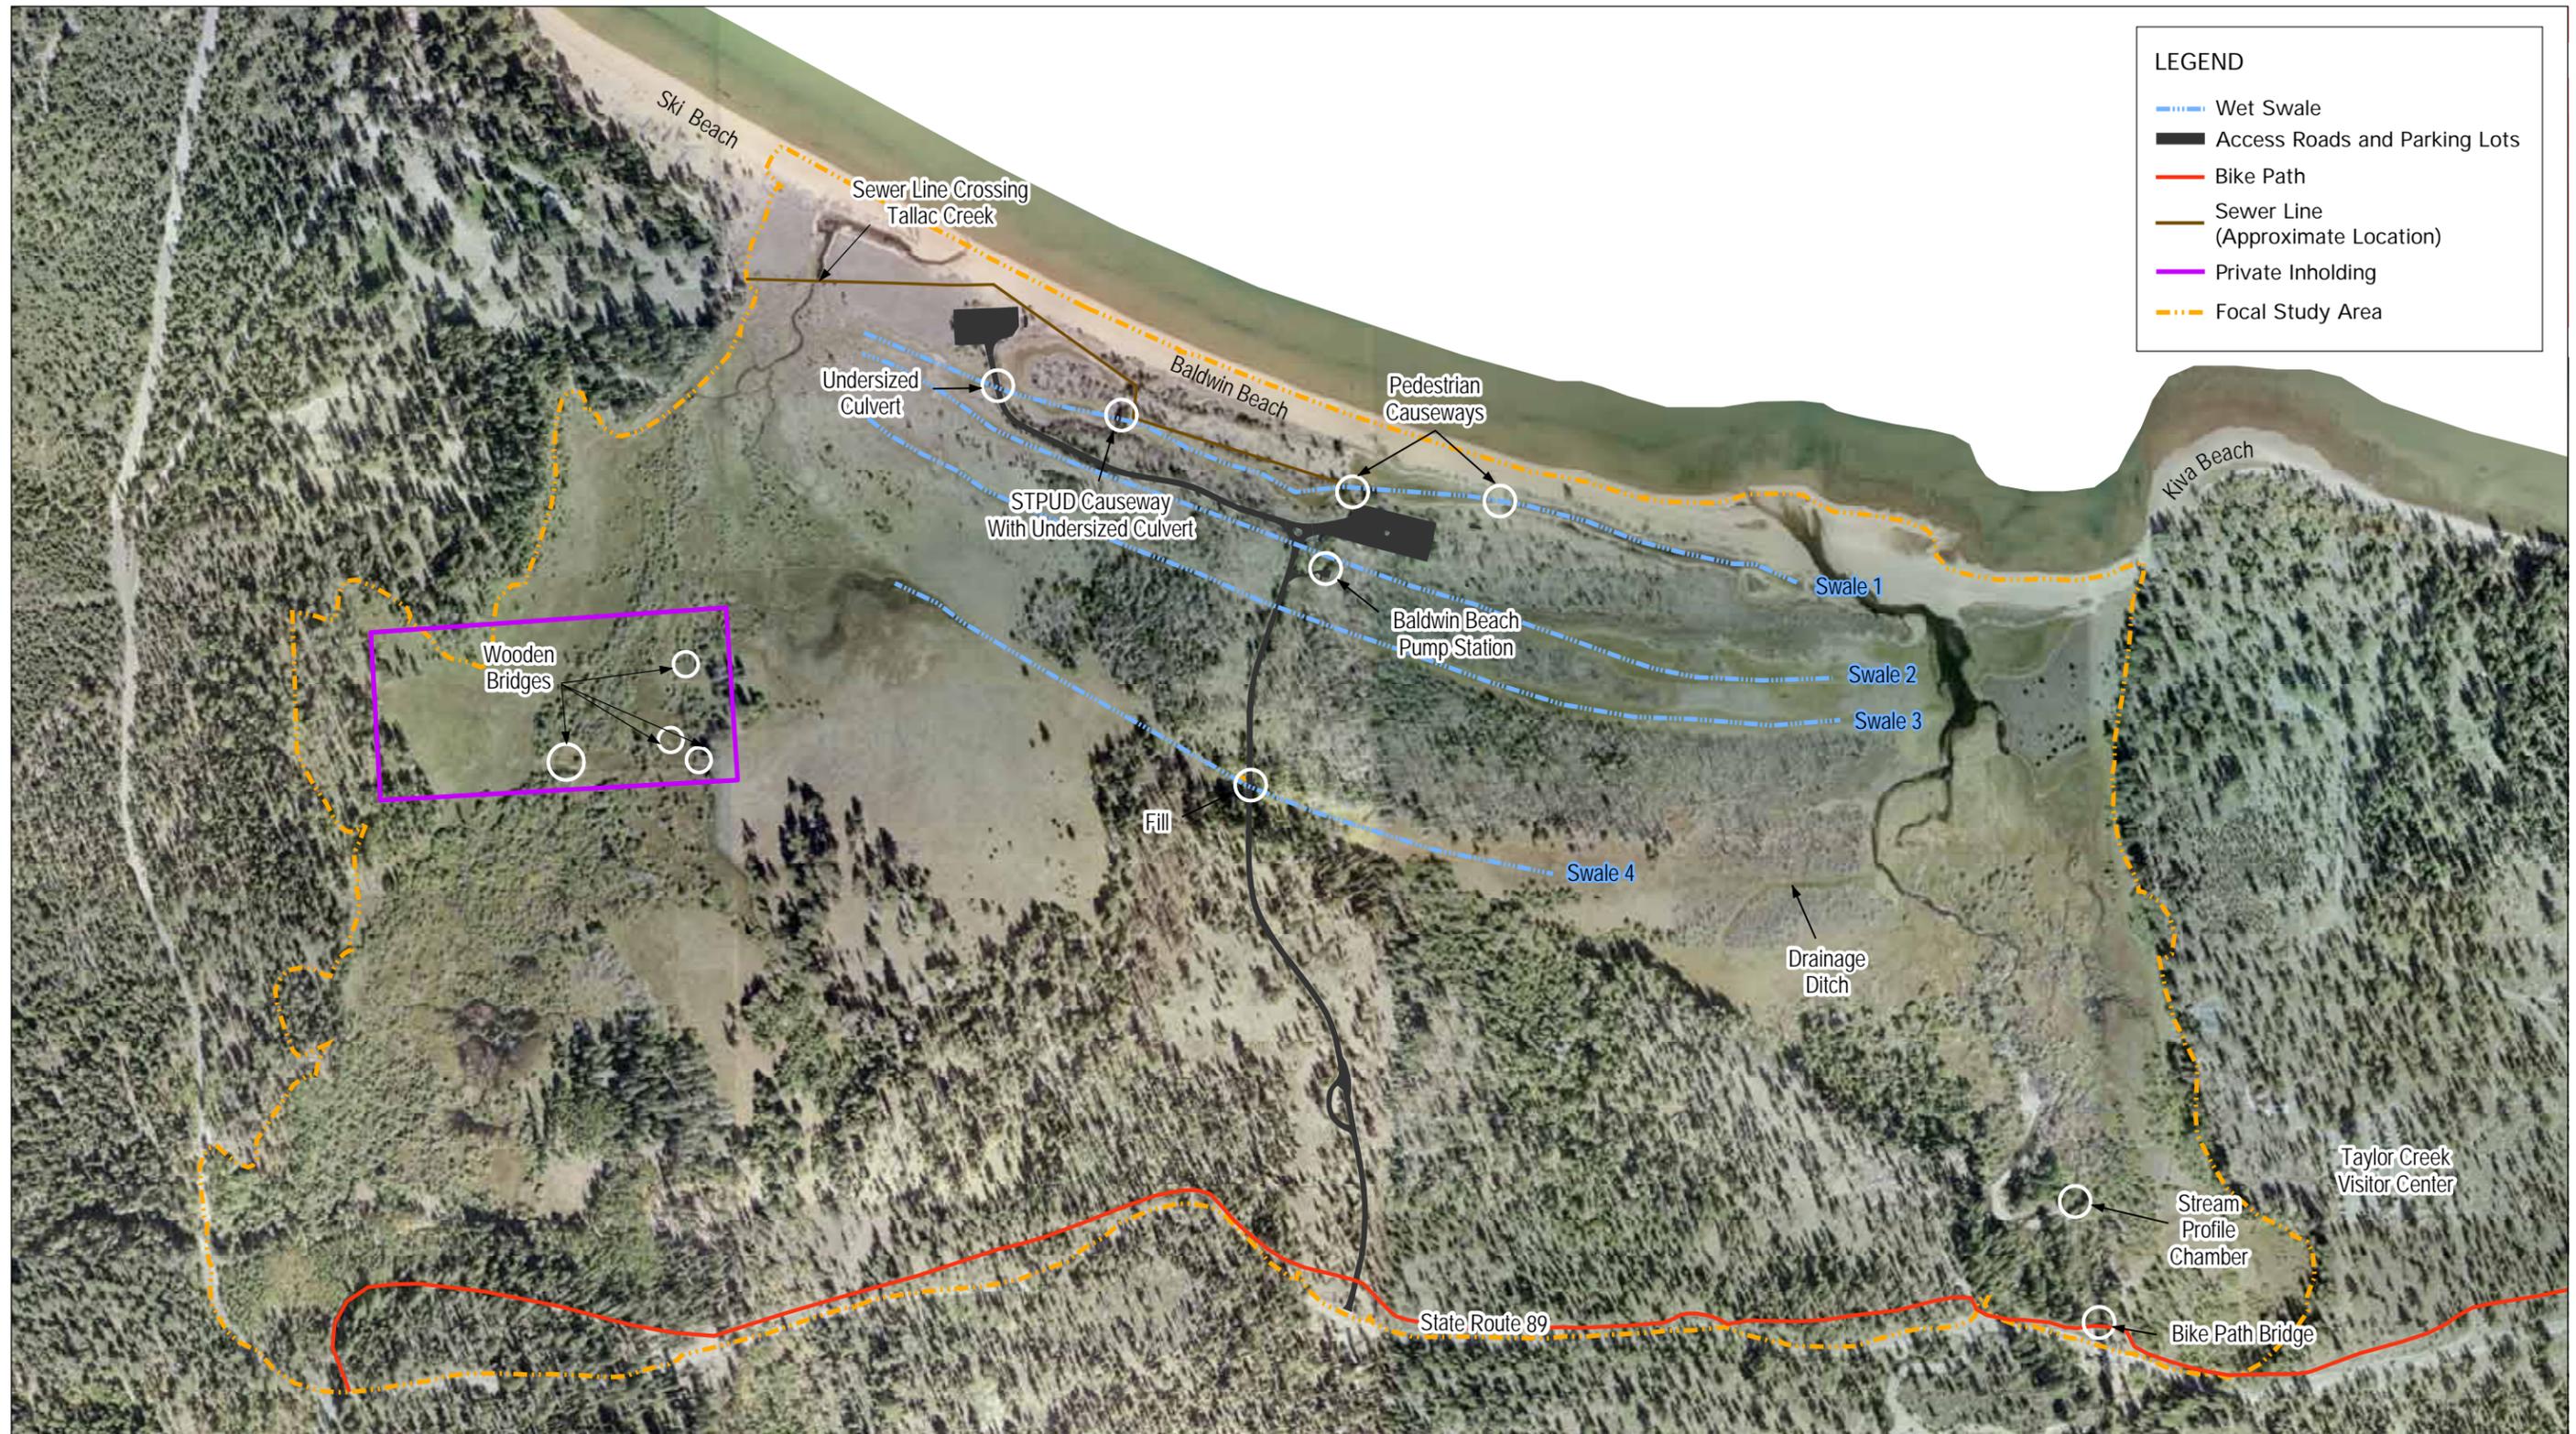
EXHIBIT 4.3-1

Infrastructure

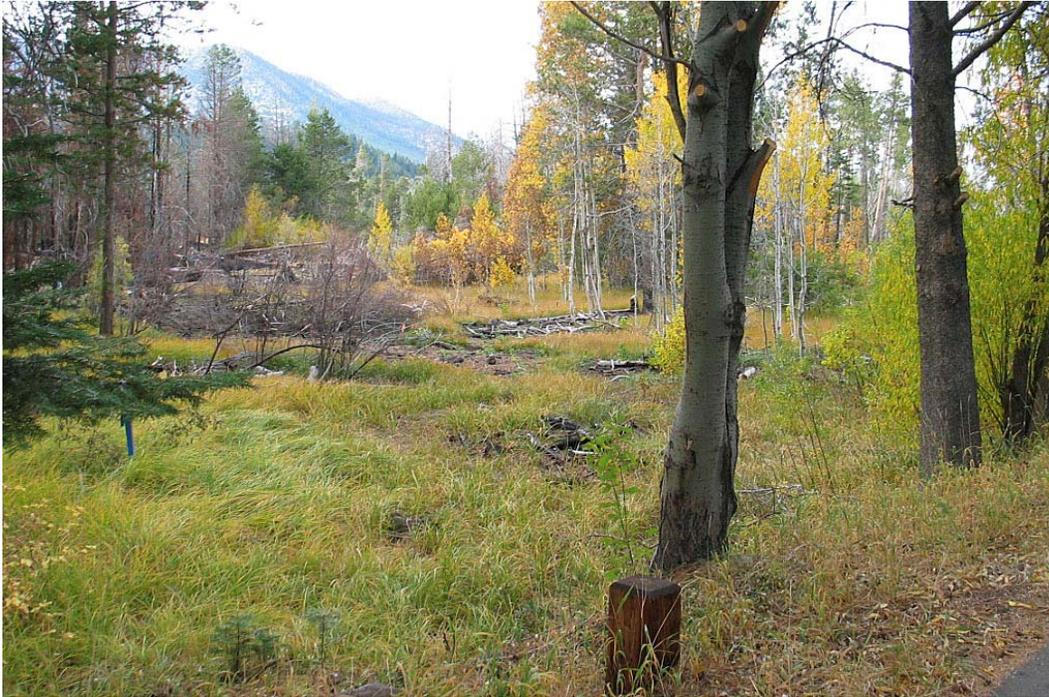
EXHIBIT 4.3-2

Southernmost wet swale looking west from the Baldwin Beach access road (October 2003).

## Tree and Shrub Encroachment of Wet Swale

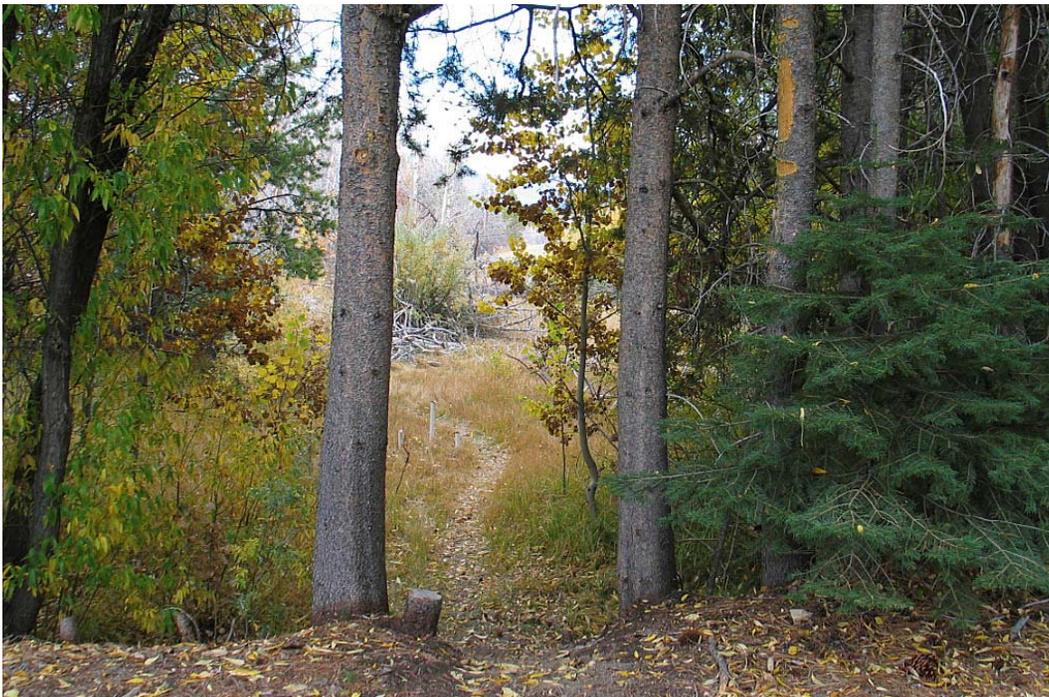
Southernmost wet swale looking east from the Baldwin Beach access road (October 2003).

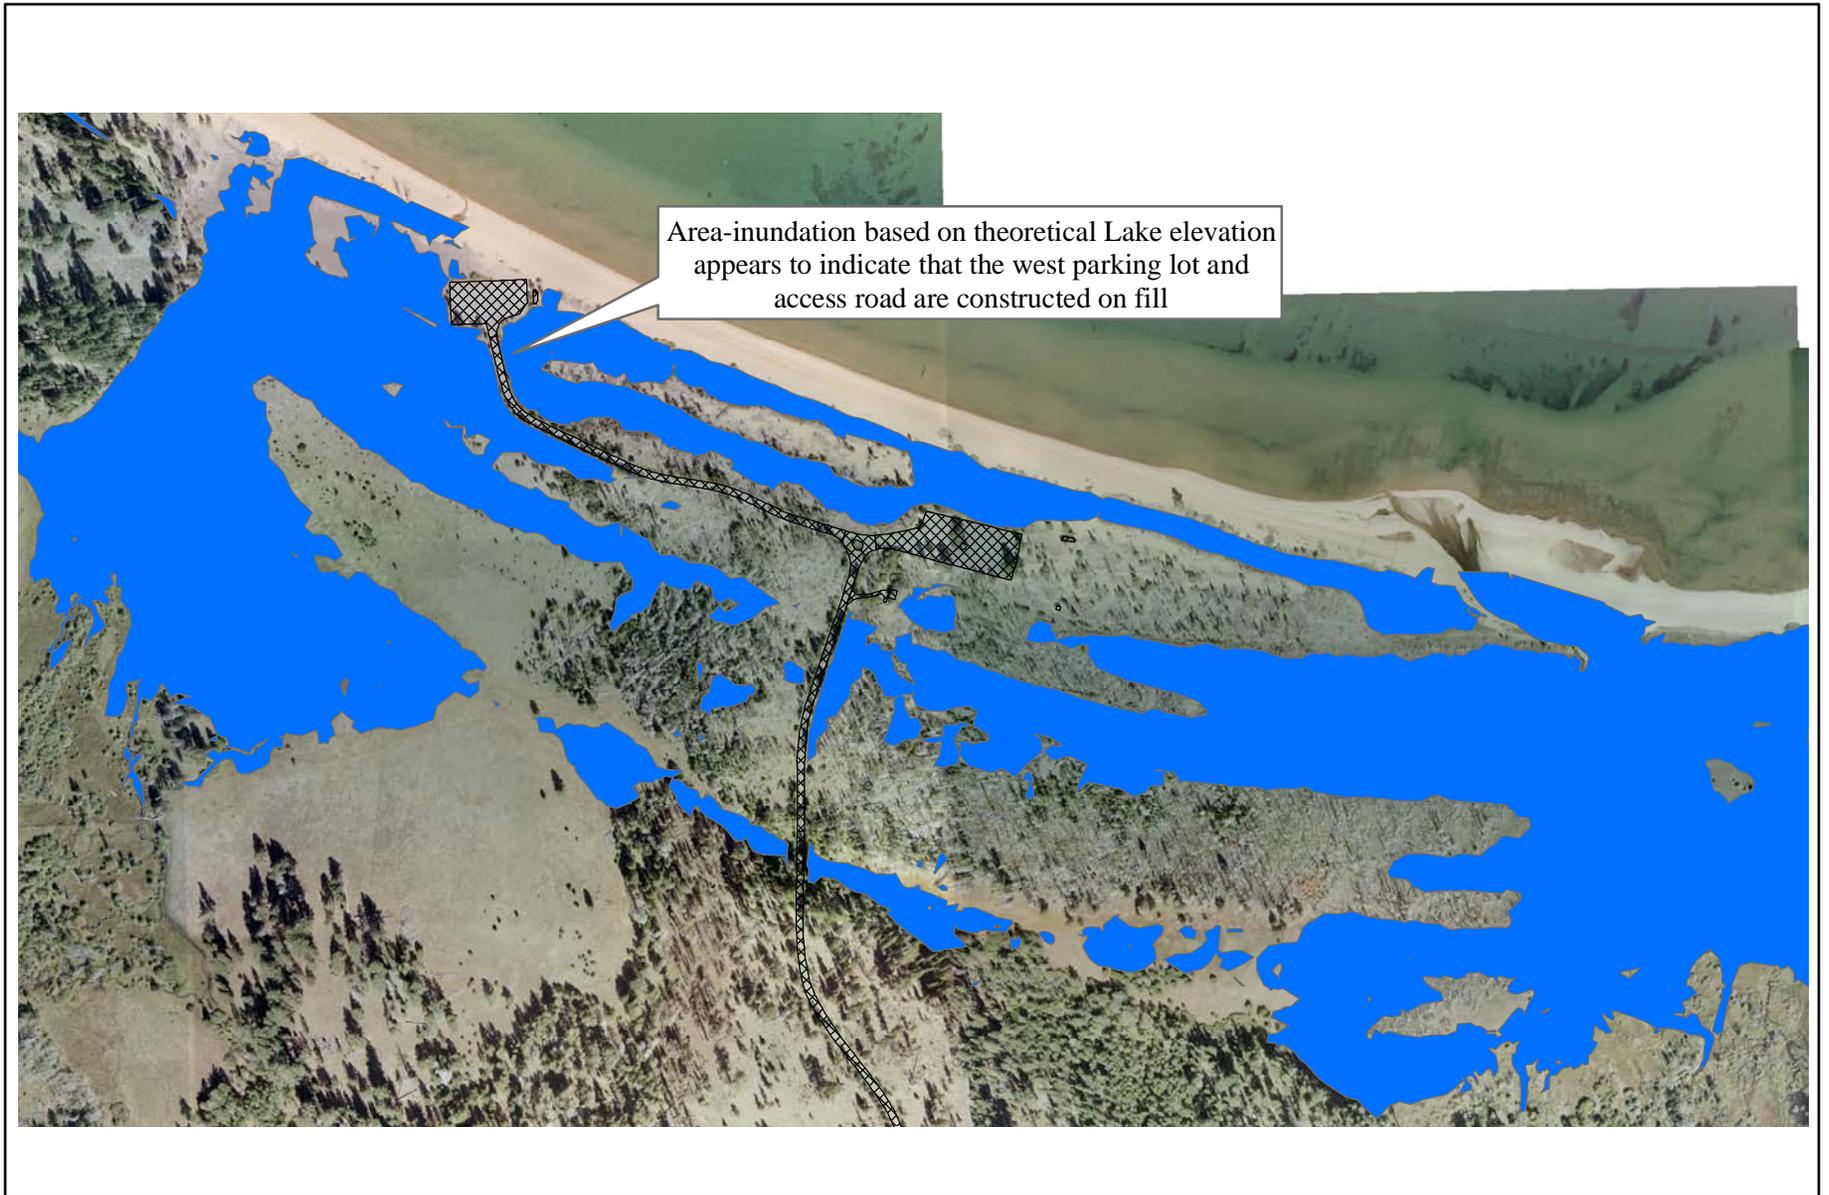
EXHIBIT 4.3-3

### Theoretical Inundation at Legal Maximum Level

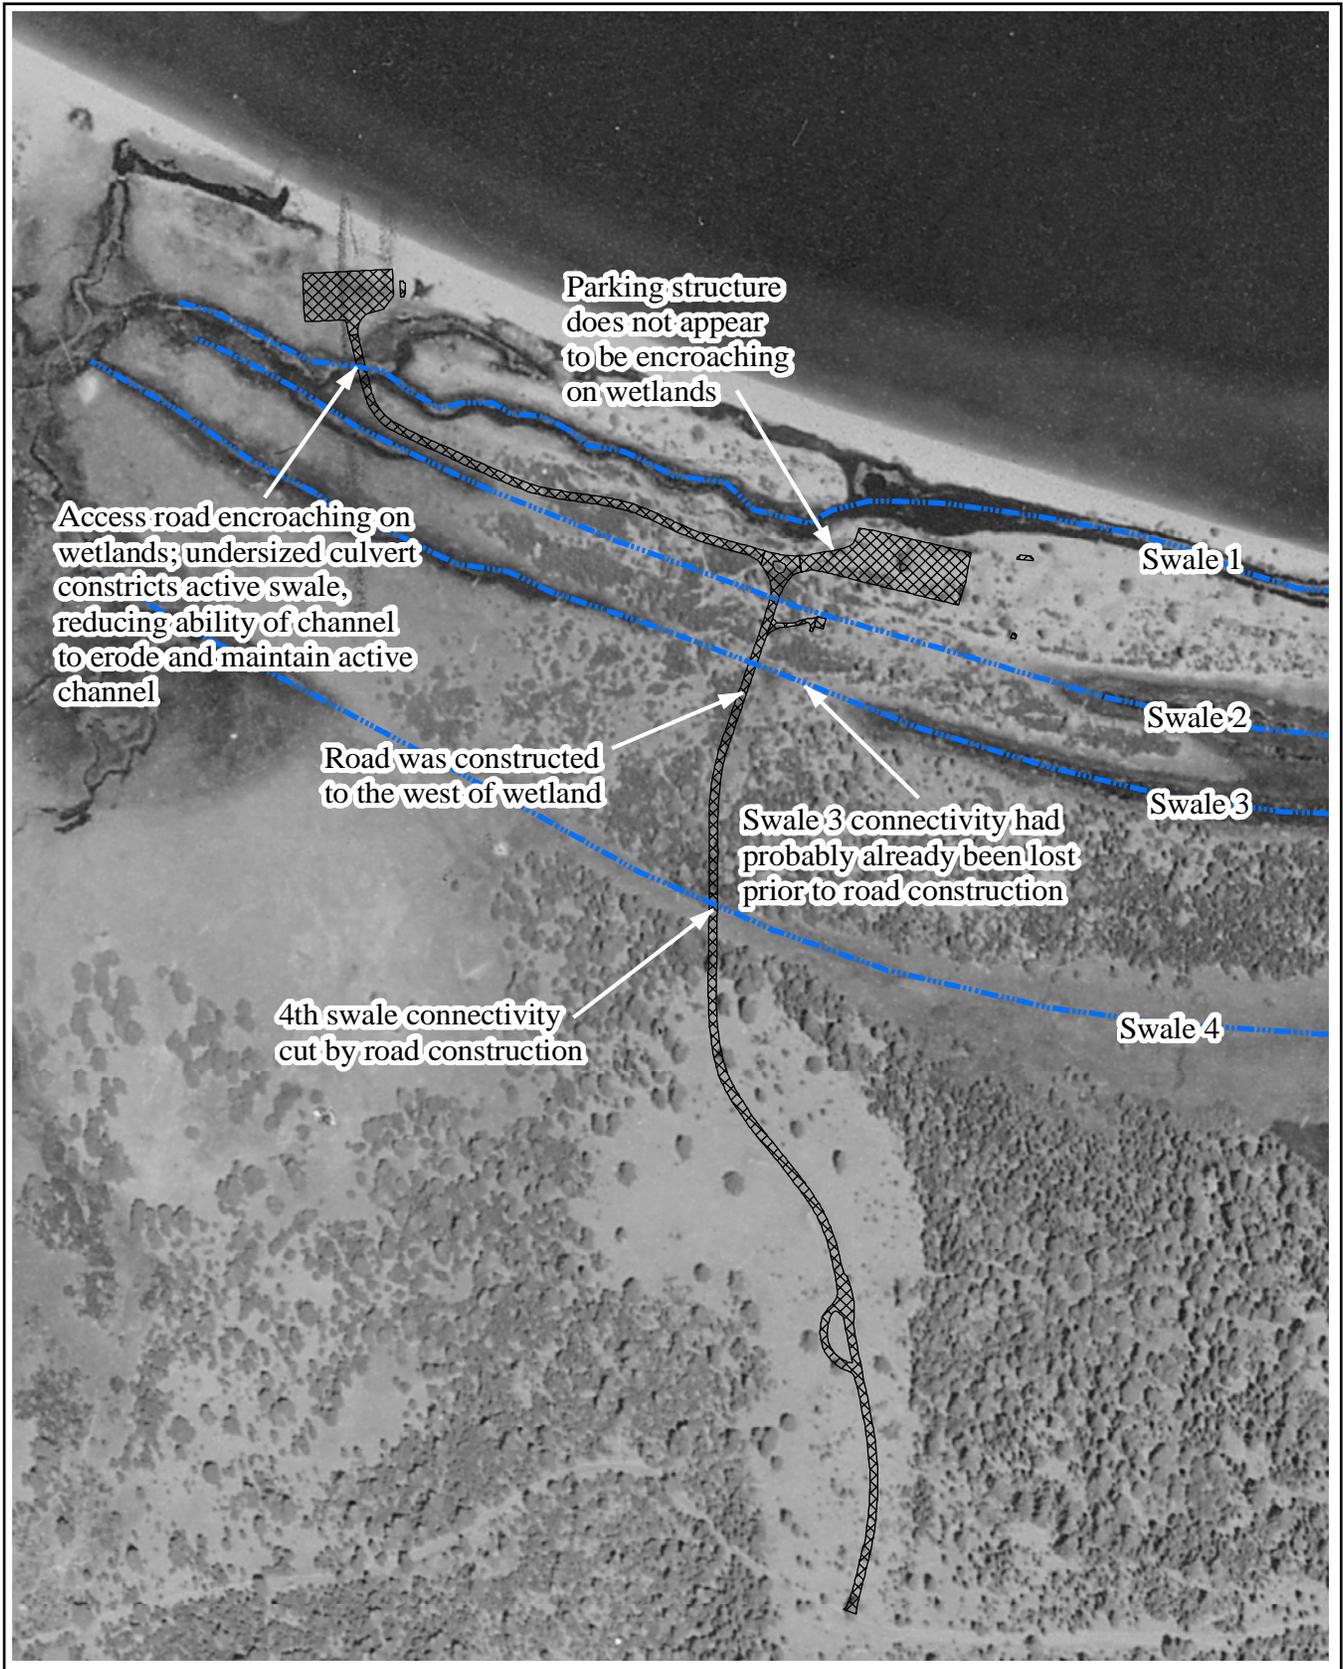
Exhibit 4.3-4

Existing Parking Lots and Roads on 1940 Orthophoto

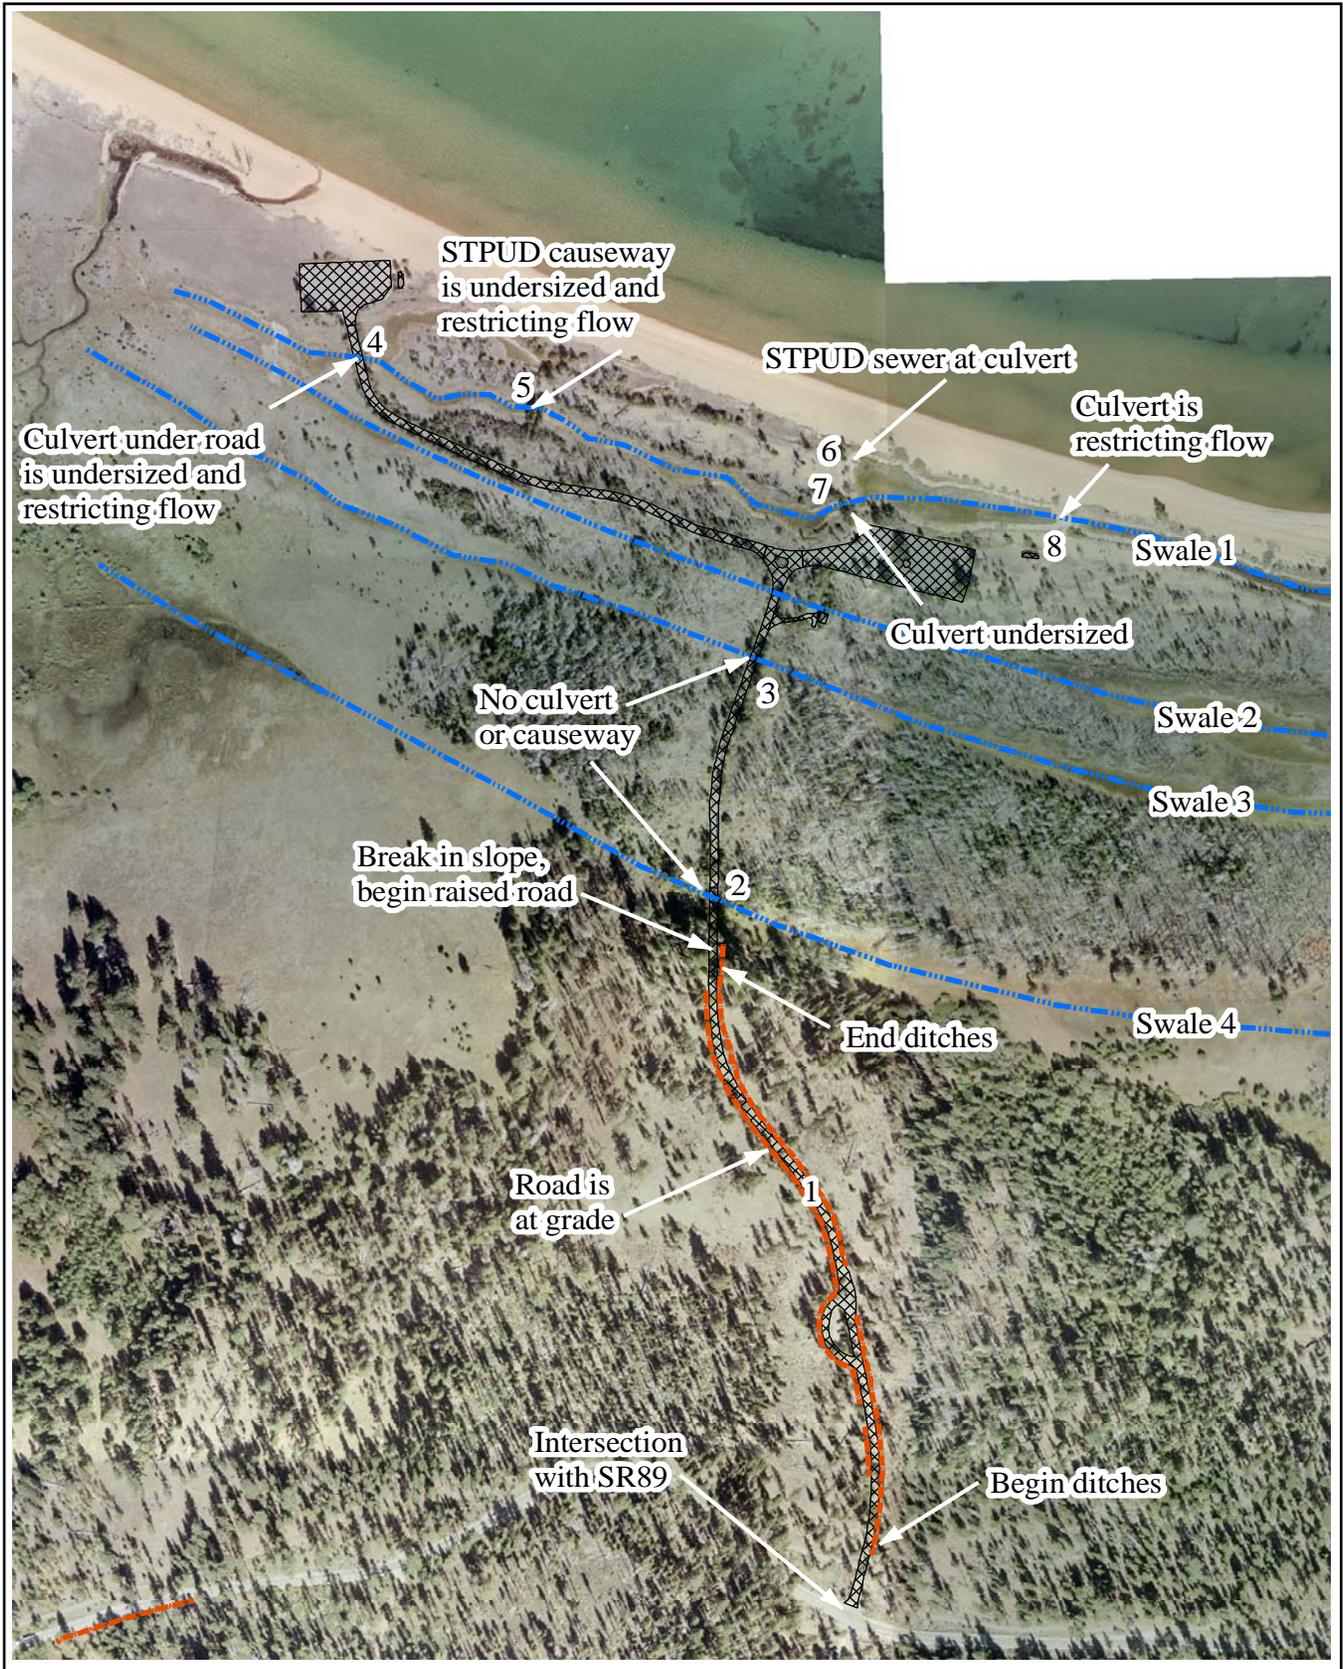
Exhibit 4.3-5

Existing Parking Lots and Roads on 2003 Orthophoto

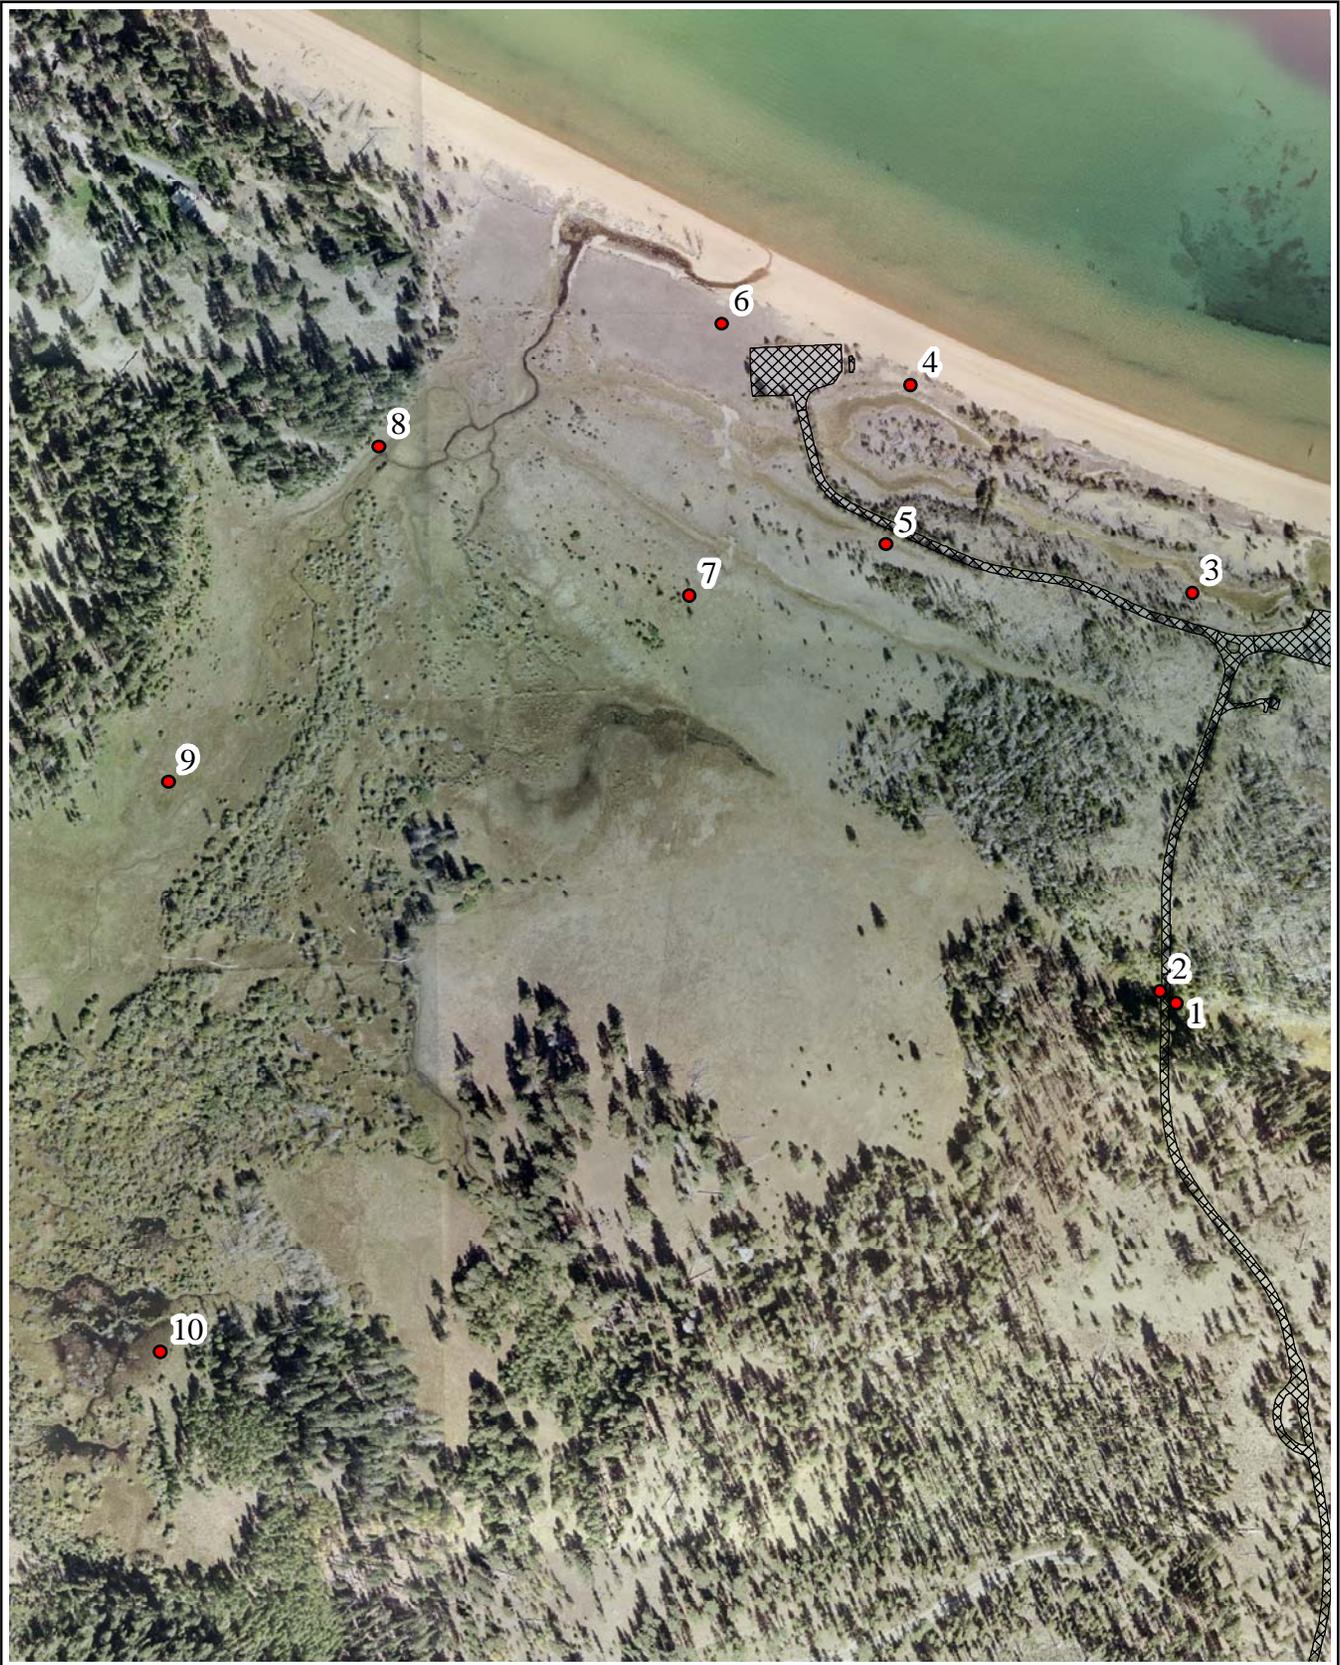
Exhibit 4.3-6

## Piezometer Locations
