7 GEOMORPHIC, HYDRAULIC, AND BIOTIC BASIS OF ENGINEERING DESIGN

7.1 NATURAL PROCESSES AND PROCESS ALTERATIONS

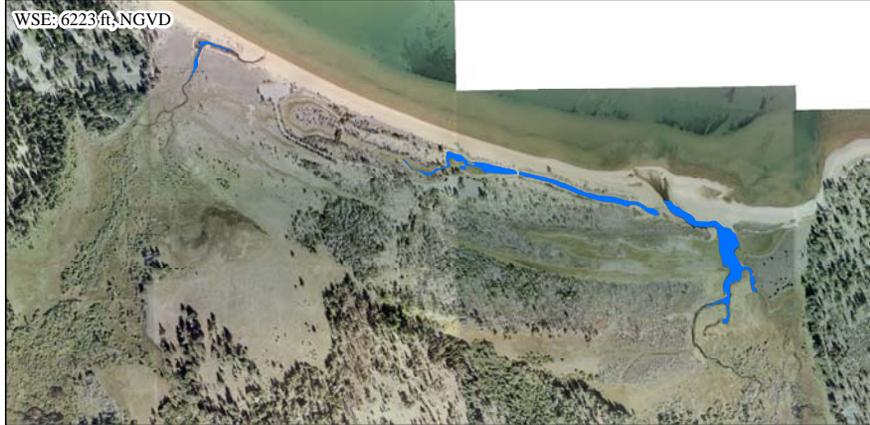
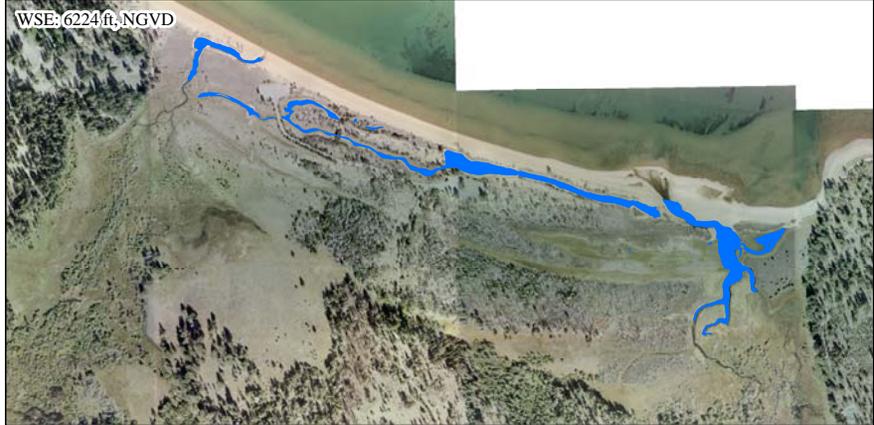
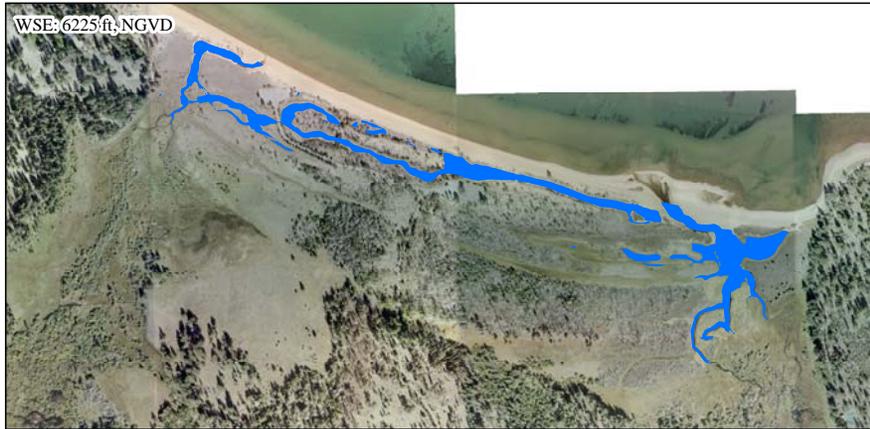
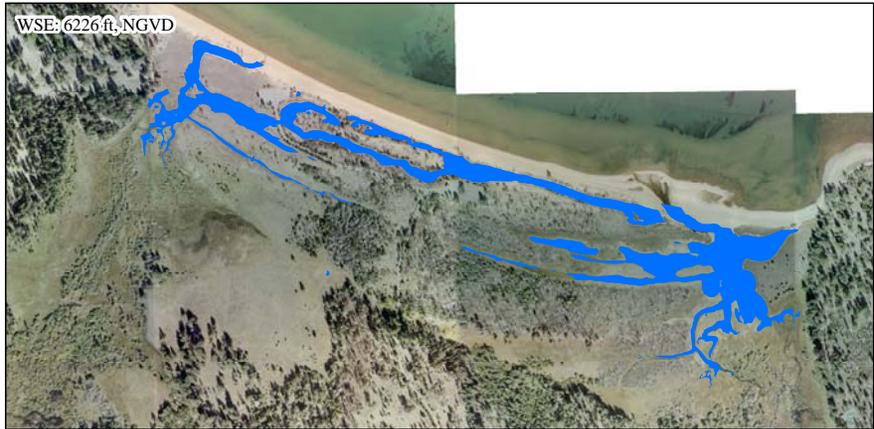
EXHIBIT 7.5-1

Theoretical Inundation due to Lake Level with Swale 1 Excavated

The theoretical inundation area of the wetlands was calculated for existing conditions and the modified conditions, which assume 1 foot of excavation in Swale 1. The theoretical inundation area for a range of lake elevations is shown in Exhibits 7.5-1 and 7.5-2 and tabulated in Table 7.5-1. Table 7.5-1 shows that the hypothetical excavation of Swale 1 generates the greatest relative increase in wetland area when the lake level is relatively low, at approximately 6224 feet NGVD 29.

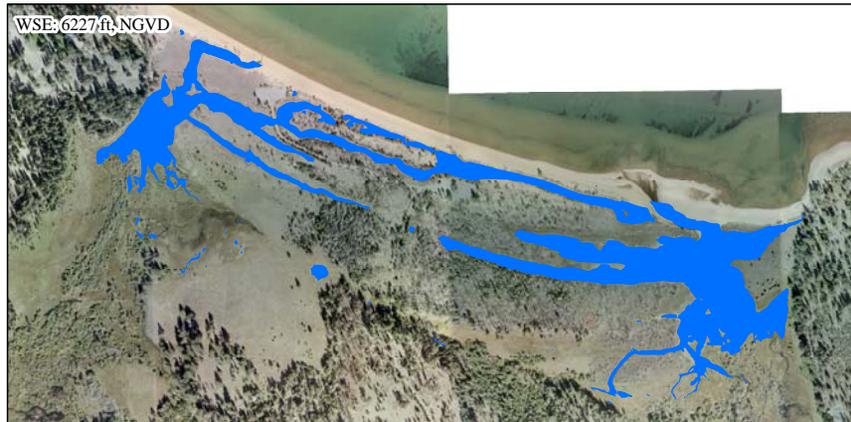
EXHIBIT 7.5-2

Theoretical Inundation due to Lake Level with Swale 1 Excavated
