Saddle Fire BAER Report

Hydrology

28 June 2014

Zack Mondry, Hydrologist (PH), ACT2 Enterprise Unit

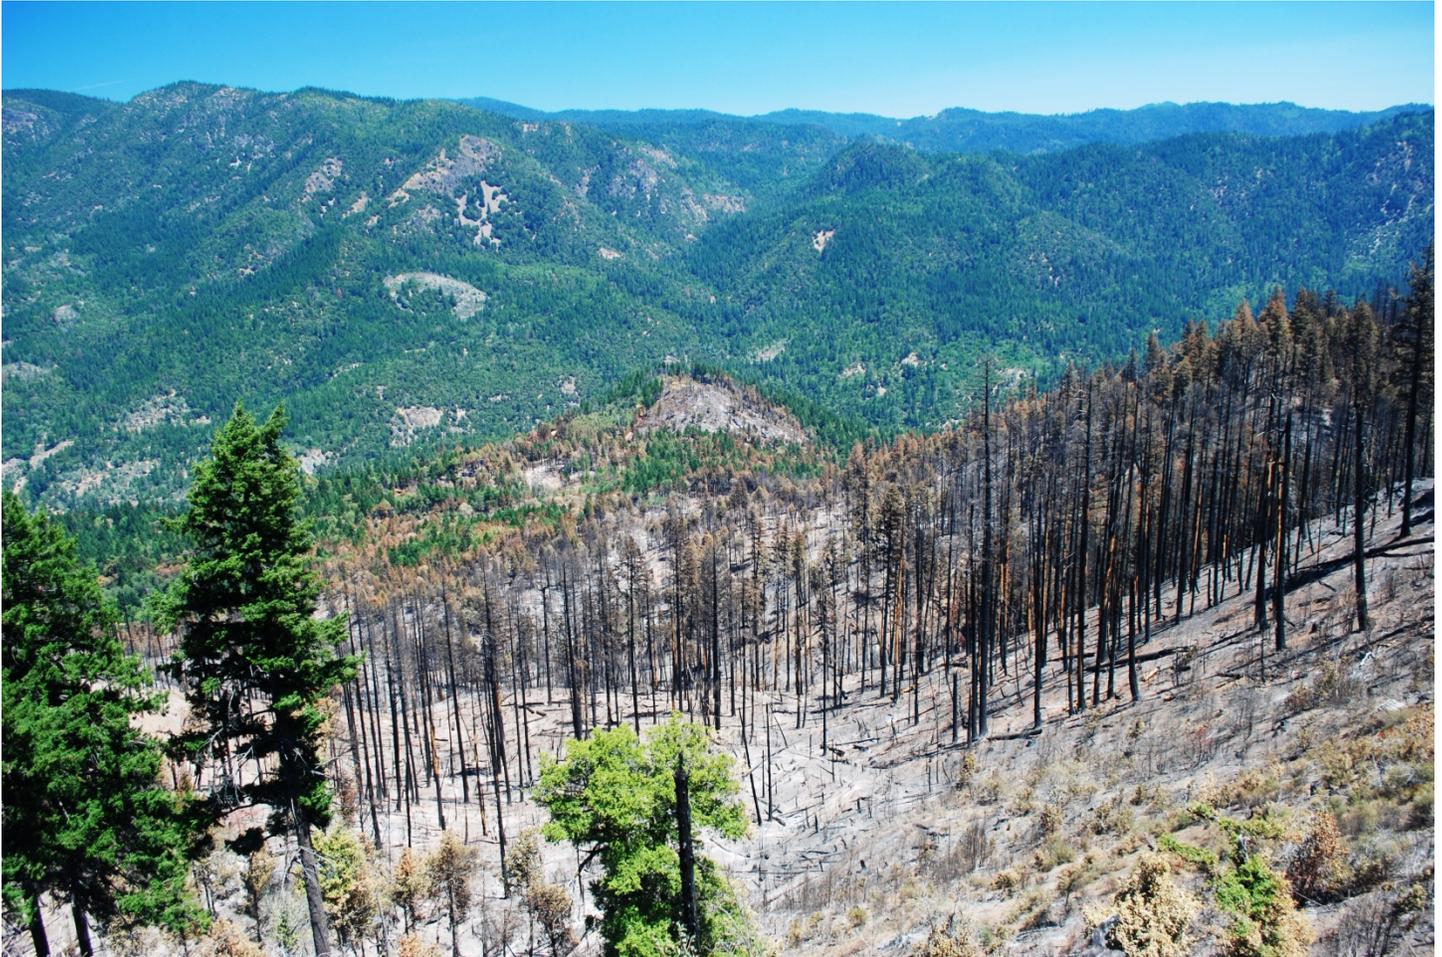
Figure 1 View east of the Saddle Fire in the headwaters of Saddle Gulch on 6/25/15.

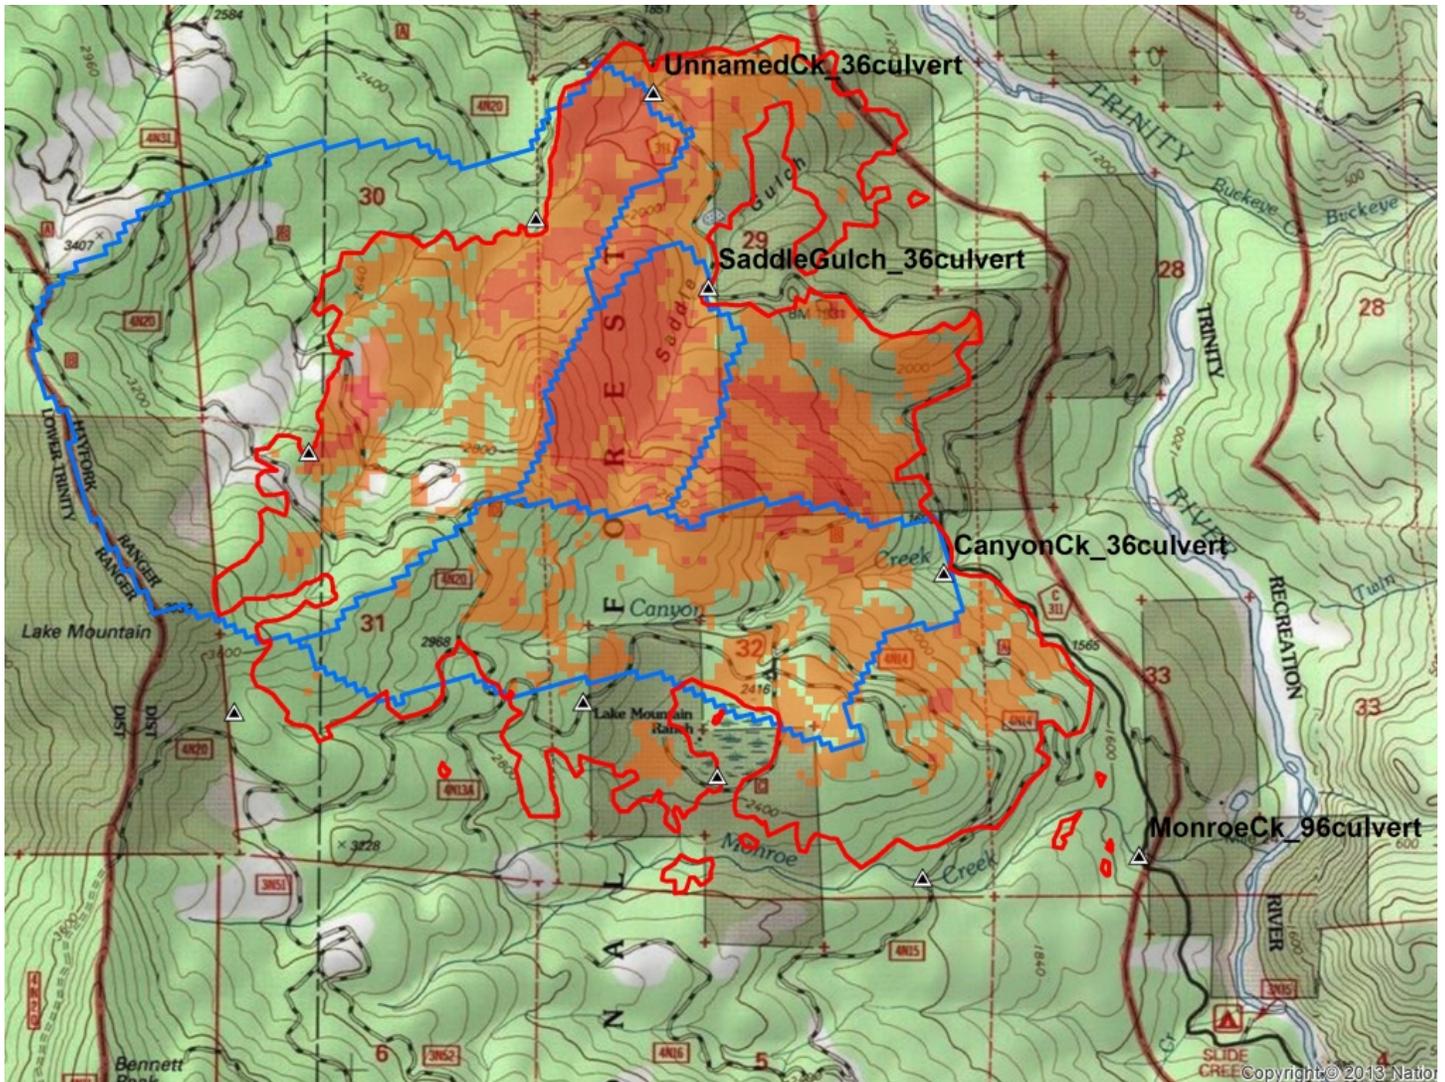
The unnamed creek, Saddle Gulch, and Canyon Creek drain directly to the South Fork Trinity River which is critical habitat for Coho Salmon (Figure 2).

Figure 2 Saddle Fire area map showing fire perimeter (red outline), high and moderate soil burn severity areas (red and orange shading), and pour points and catchments (blue outline) used in the hydrology analysis. Map scale is 1:24,000.

The unnamed creek (Figure 2) drains to a 36" culvert beneath a large fill at TC311. This culvert was determined to be undersized to convey even the pre-fire 2-year return flow estimated at 95 cubic feet per second (cfs). While post-fire discharge is expected to increase (Table 1), this crossing does not appear vulnerable to diversion and may be able to trap sediment during increased peak flows or perhaps a debris flow.

Similar to the unnamed creek Canyon Creek (Figure 2) also drains to a 36" culvert beneath an appreciable fill at TC311. Given the relatively limited areas of moderate and high soil burn severity (Figure 2) an erosive flood event and/or debris flow is not expected in Canyon Creek due to fire effects on hydrologic function. Similar to Saddle Gulch streamside trees above the TC311 crossing over Canyon Creek are too old to have become established after the 1997 flood and may date to the 1964 flood.

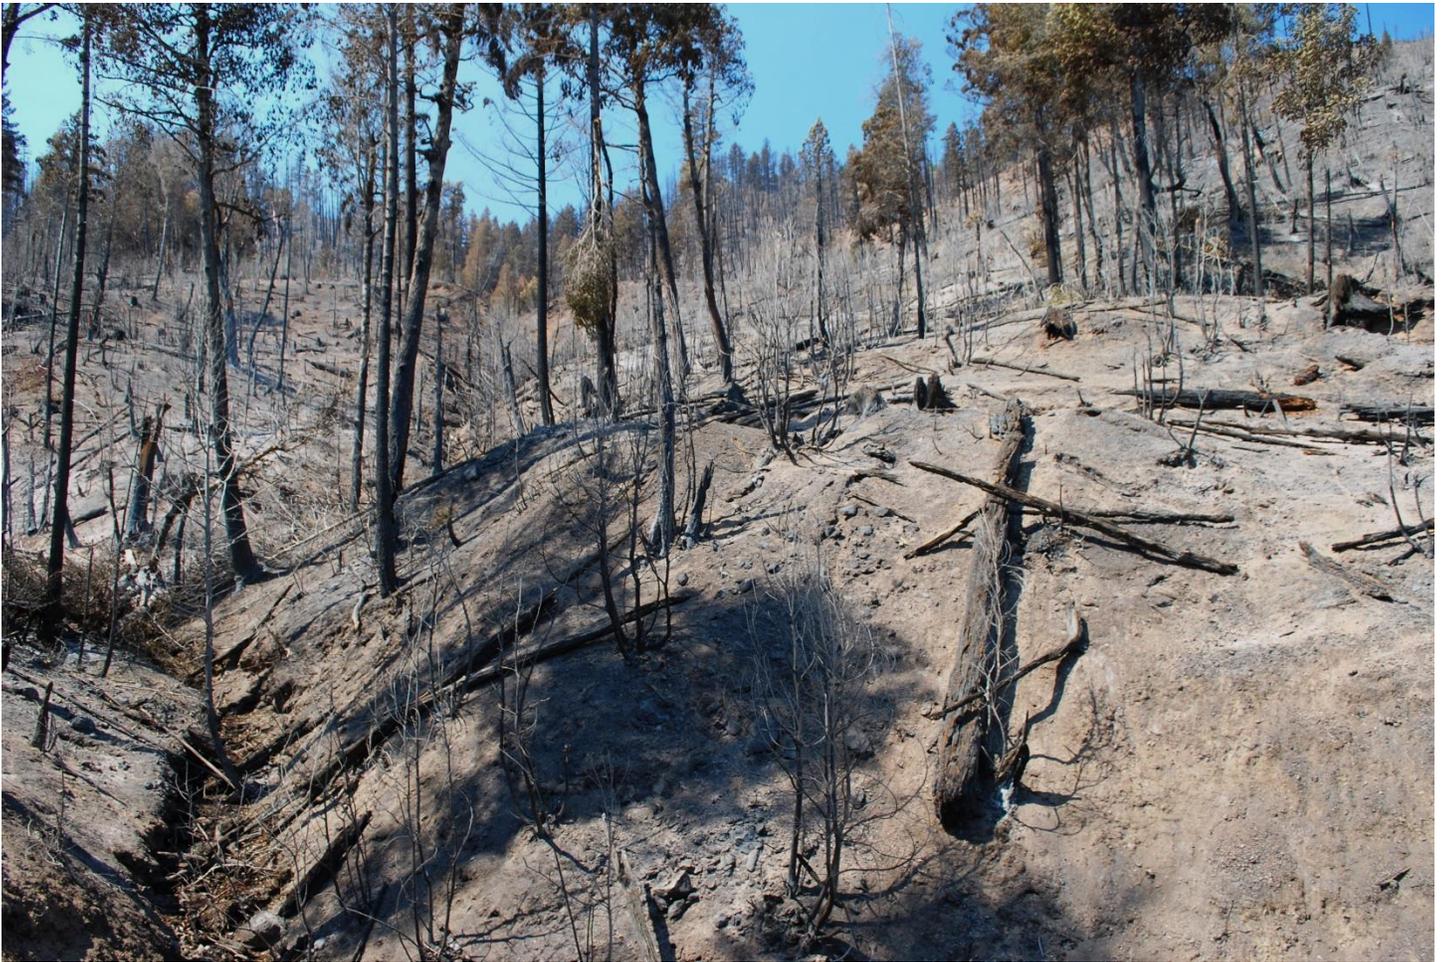
Saddle Gulch (0.2 miles² drainage area at County Road 311) was almost entirely burned with approximately 95% of the catchment characterized by moderate or high soil burn severity (Figure 3).

Figure 3 View of Saddle Gulch looking southwest on 6/26/15 showing typical high soil burn severity areas.

Saddle Gulch above TC311 flows across a debris flow fan deposit and the channel appears to have considerable potential for diversion during future floods. A diversion will likely force water on to TC311 north of the crossing. However, the road segment quickly slopes back toward the crossing so any diversion is expected to be contained. Additionally, live, mature hardwood and conifer trees along the channel above TC311 will provide protection to the crossing in the event of a debris flow. Brief inspection of these streamside trees suggests they do not date to the 1997 flood and that they are perhaps as old as the 1964 flood event.

Regarding infrastructure the main value at risk is the 36" culvert and road crossing over Saddle Gulch at TC311. We estimate that post-fire 5-year storm event will produce discharge of approximately 70 cfs, and this rate will likely exceed the culvert capacity. Beyond estimates of post-fire increased streamflow this catchment appears vulnerable to landsliding and potential resulting debris flows. However, mature streamside trees (alder, Douglas fir) remain unburned above the road crossing and will provide some protection to the culvert.

It is anticipated that the road crossing over Saddle Gulch is at risk for diversion/overtopping during winter 2015-16, particularly if the catchment produced debris flows. Recommend signage alerting the public to potential increased peak flows post-fire and storm patrol to assess impacts during winter 2015-16.
