Date of Report: July 28, 2015

**BURNED-AREA REPORT**

**PART II - BURNED-AREA DESCRIPTION**A. Fire Name: North FireB. Fire Number: CA-BDF-009001C. State: CAD. County: San BernardinoE. Region: 05F. Forest: San Bernardino National ForestG. District: Front Country (53)H. Fire Incident Job Code: 0512-P5JY2DI. Date Fire Started: 07/17/2015J. Date Fire Contained: 07/21/2015K. Suppression Cost: Approximately \$REDACTED as of July 21, 2015.

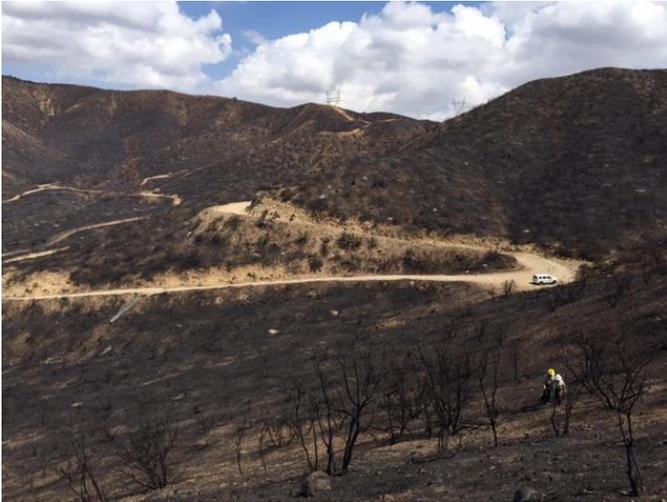
3N21 through moderate soil burn severity

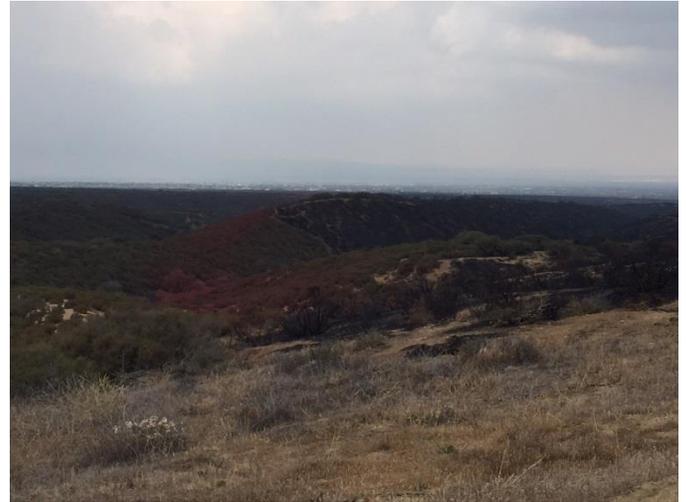
Retardant/fire line showing pre- and post-vegetation

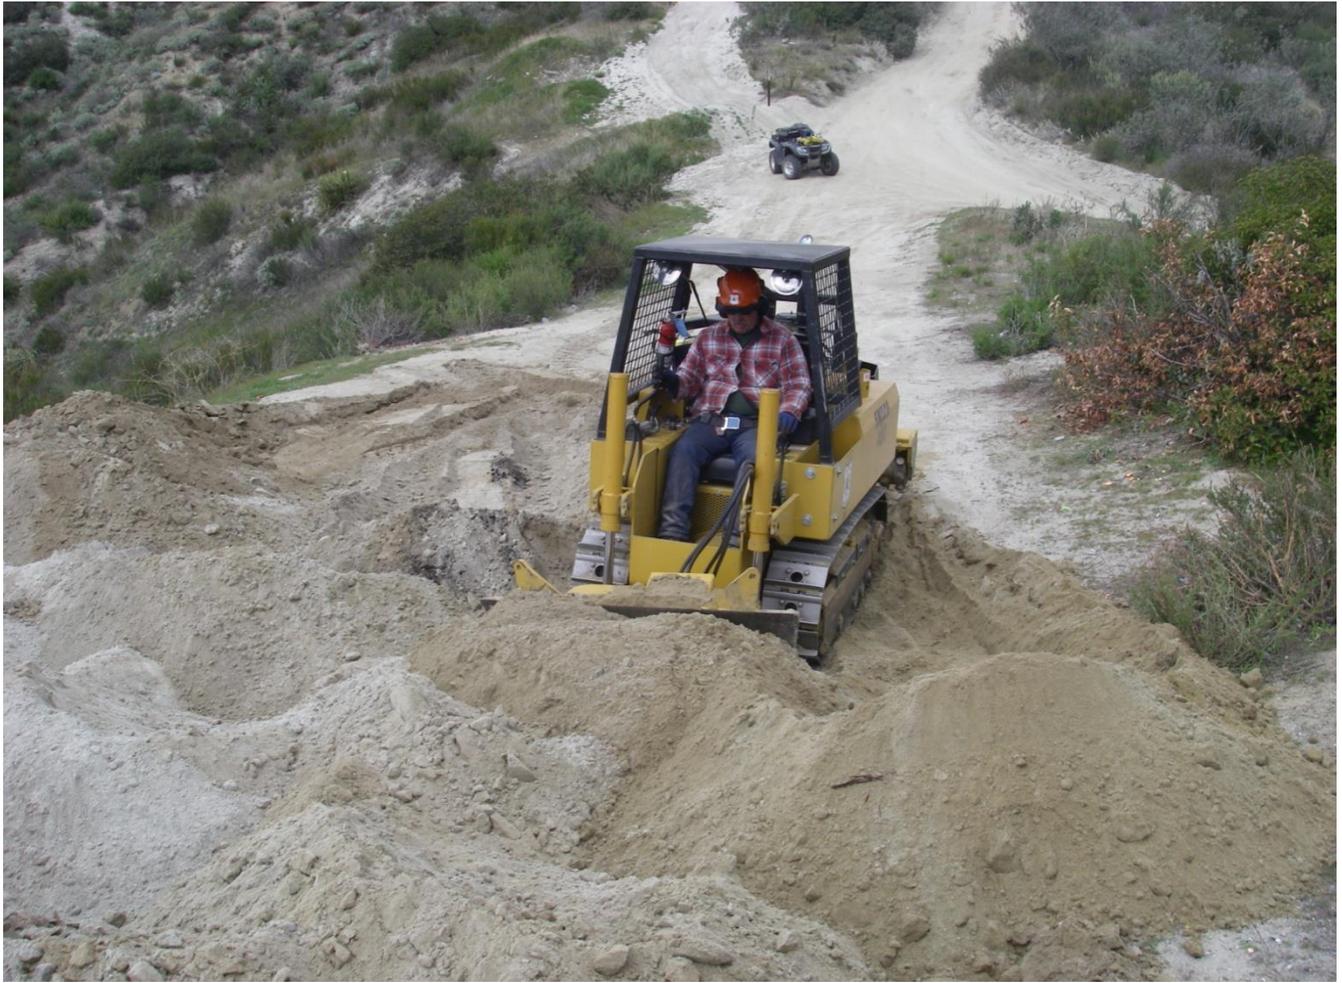
**Photo 1: Chunking with a small trail dozer that has an articulating blade.**

With the recreational use and vegetation types found in the Baldy Mesa area the Forest found the use of “chunking” with excavators an effective tool in protecting resources after a fire when combined with fencing, signs, and most importantly frequent patrols. Chunking is described as using the bucket of an excavator or articulating blade on small trail dozer to decompact roads/trails by digging into the compacted area and creating divets. These divets act as mini-catch basins (increasing infiltration), require minimal maintenance, and are found to collect seed and promote gemination (See photos below.)

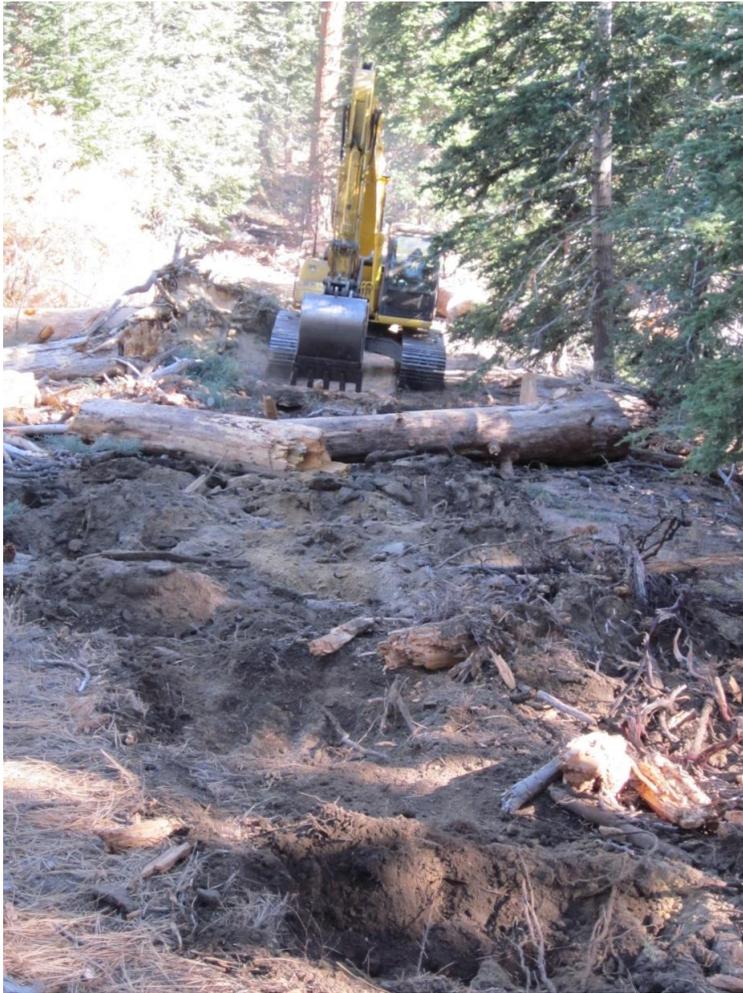
Photo 2: Chunking with an excavator along a dozer line. First chunking occurs, then the equipment spread topsoil and slash from the dozer piles over the treated area.

The North Fire burned a part of an OHV trail and also exposed some illegal trails from private onto forest lands. The recommended treatment is to use an excavator employing chunking and banked turns to help redirect the OHV trail and forest road recreation use away from cultural resources and out of the North burn area. The use of fence lines and fire recovery signage can help support the chunking along the impacted trail and road. With high levels of recreational use and the knowledge that we have gained from past fires in the Baldy Mesa area, using these multiple closure methods discussed will have the greatest success on the North Fire rehabilitation and resource protection.
