Kaibab National Forest

Forest Plan Monitoring Report

Fiscal Year 2014

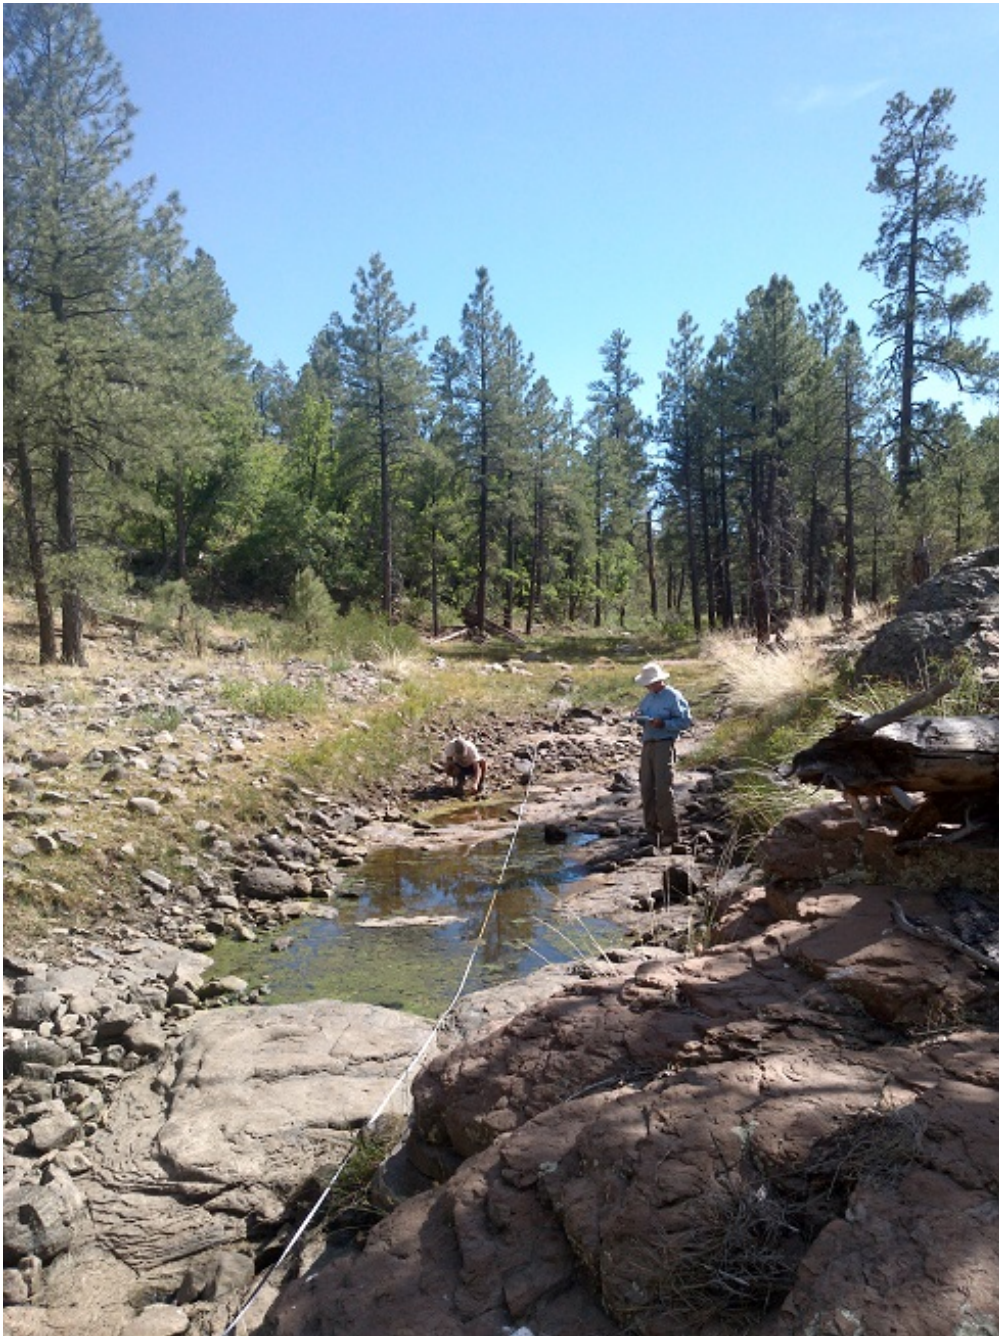
Fig 1.1 Campbell Spring SKNF.

Physical Description: Campbell Spring SKNF is a rheocrene spring. In 2014, Campbell Spring was depicted on the DRG, and was said to be PFC by a surveying hydrologist. It is located in a channel, with several sources emerging from fractured rock. The microhabitats associated with the spring cover 341 sqm. The site has 4 microhabitats, including A -- a 57 sqm pool, B -- a 88 sqm channel, C -- a 160 sqm terrace, D -- a 36 sqm terrace. Geomorphic diversity is 0.54, based on the Shannon-Weiner diversity index.

Management Recommendations: Remove crayfish and monitor periodically.

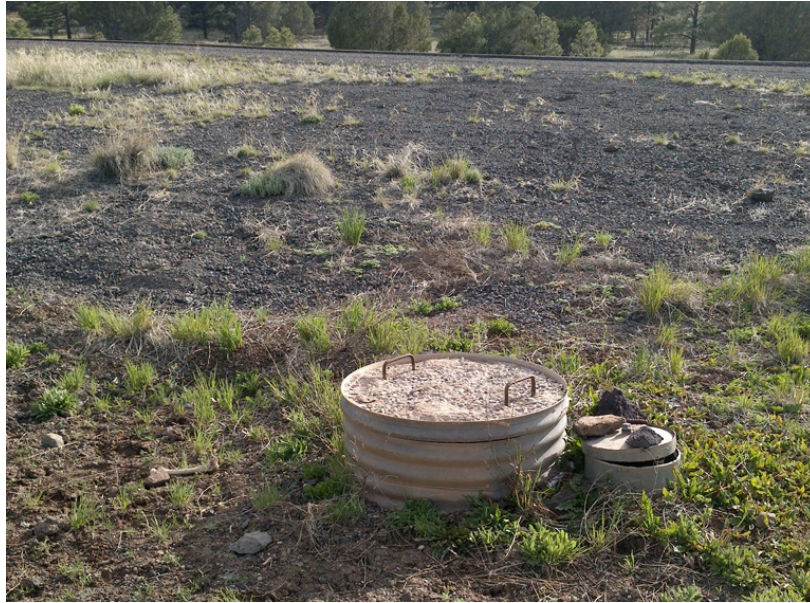
Fig 2.1 Fues Spring.

Physical Description: This named site is depicted on the DRG. This site consists of a large pipe in the ground with a circular man-hole type cover over a cylindrical vertical culvert that is 80 cm wide in diameter with water in it. The site is eight meters from Hwy 64. There are four pipes on the inside of the cylindrical tank. The microhabitats associated with the spring cover 9.62 sqm. The site has 2 microhabitats, including A -- a 0.64 sqm pool, B -- a 8.98 sqm colluvial slope. Geomorphic diversity is 0.11, based on the Shannon-Weiner diversity index.

Assessment: Assessment scores were compiled in 6 categories and 39 subcategories, with 3 null condition scores, and 1 null risk score. Aquifer functionality and water quality are very poor with very limited restoration potential and there is very high risk. Geomorphology condition is very poor with very limited restoration potential and there is very high risk. Habitat condition is poor with limited restoration potential and there is high risk. Biotic integrity is very poor with very limited restoration potential and there is high risk. Human influence of site is poor with limited restoration potential and there is moderate risk. Administrative context status is poor with limited restoration potential and there is low risk. Overall, the site condition is poor with limited restoration potential and there is high risk.

Management Recommendations: This site can be used to monitor roadway salt contribution to shallow groundwater, which is alarmingly high here. The site has been sacrificed to ADOT and road construction/maintenance.

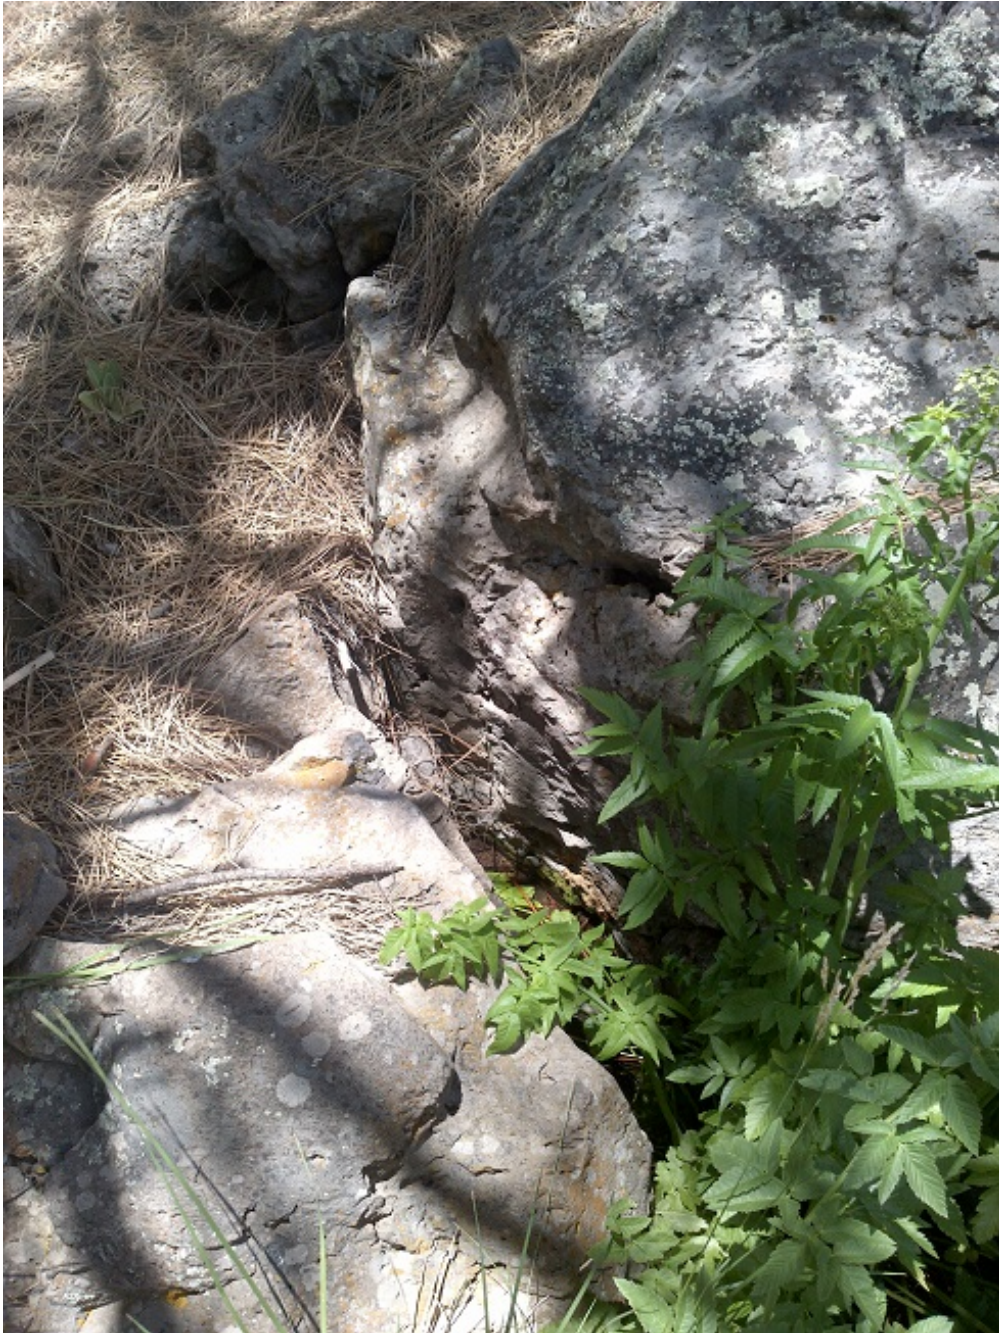
Fig 3.1 L O Spring.

Physical Description: L O Spring is a hillslope/rheocene spring. This named site is located in the headwaters of Sycamore Canyon, and is depicted on the DRG. Surveyed by Flora in 2004, it was reported to be a limnocene spring emerging from a basalt layer. In 2014, SSI surveyors found a large springs complex with four discrete hillslope sources, and probably diffuse emergence, in a wide, shallow channel, heavily influenced by runoff. The site is in a forested area, within 500 meters of a parking lot. The flow was reported in 1949 as 0.0631 in the Arizona GWSI database. The microhabitats associated with the spring cover 6563 sqm. The site has 7 microhabitats. Geomorphic diversity is 0.25, based on the Shannon-Weiner diversity index.

Survey Notes: The site was in good condition with limited trampling. There were large areas of dead typha. Polygons were designated but no areas given so polygon areas are from the 2015 survey. Polygons were surveyed for plants but not percent cover so there is a flora list for each polygon but no diversity index.

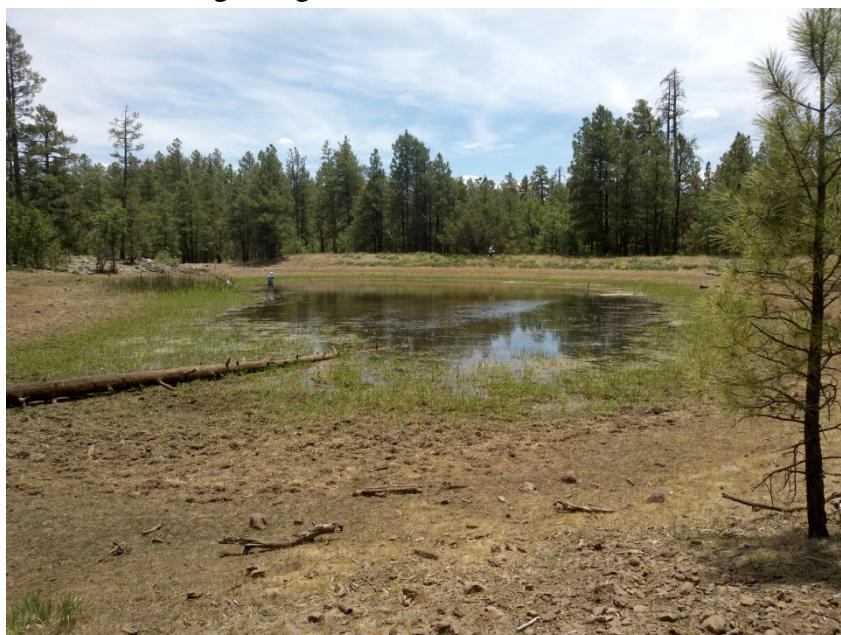
Fig 7.1 Metate Tank.

Physical Description: Metate Tank is a limnocrene spring. This site is marked as a tank on the topographic map. Surveyors suspect it is groundwater supported, as it had water during a very dry period in late June 2014. The site has 4 microhabitats.

Assessment: Assessment scores were compiled in 5 categories and 33 subcategories, with 9 null condition scores, and 9 null risk scores. Aquifer functionality and water quality are good with significant restoration potential and there is low risk. Geomorphology condition is poor with limited restoration potential and there is high risk. Habitat condition is good with significant restoration potential and there is moderate risk. Biotic integrity is good with significant restoration potential and there is moderate risk. Human influence of site is moderate with some restoration potential and there is moderate risk. Administrative context status is undetermined due to null scores and there is undetermined risk due to null scores. Overall, the site condition is moderate with some restoration potential and there is moderate risk.
