SOILS

A. MONITORING AND EVALUATION

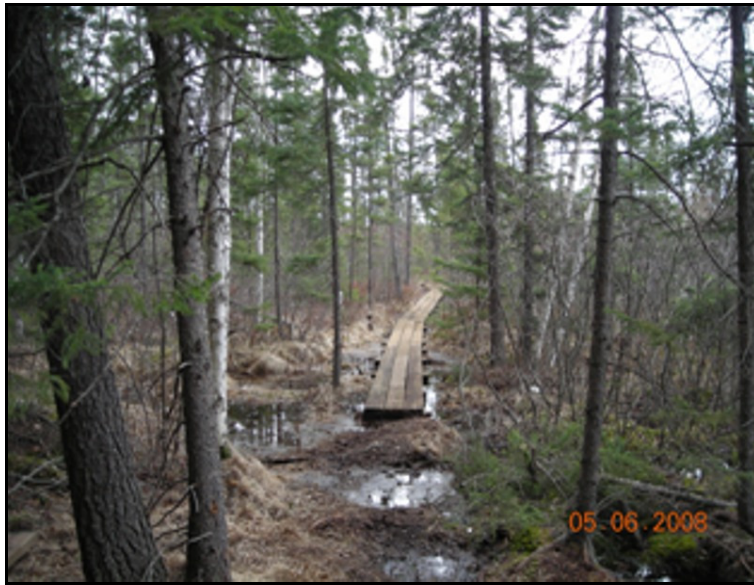
Figure 3.1. Pear Lake boardwalk constructed to facilitate access to Pear Lake across a wetland while preventing damage to the wetland on the Superior National Forest.

One of the projects occurred on Pear Lake located on the Kawishiwi Ranger District where a boardwalk was constructed to reduce impacts caused by user-created recreation motor vehicle trails (Figure 3.1).

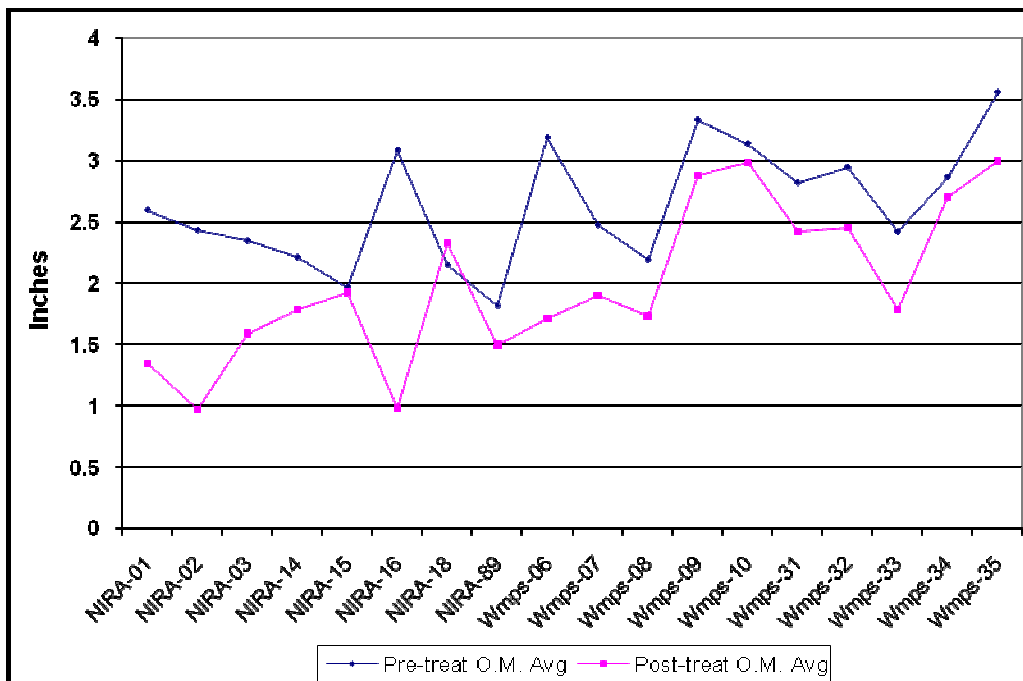
Post-harvest treatment monitoring data collected for organic matter showed minimal changes in organic matter thickness (Figure 3.2). Changes in organic matter thickness, from pre-treatment to post-treatment, varied from a decrease of 2.1 (-2.1) inches to an increase of 0.19 (+0.19) inches with an average decrease of 0.64 (-0.64) inches across all sites monitored. Four sites on nutrient sensitive soils, ELT 11, were included in monitoring activities. Ecological Land Type 11 can be susceptible to nutrient loss if a significant amount of the organic layer was lost. Ecological Land Type 11 sites also showed minimal changes in organic matter thickness. The minimal changes would not be expected to have any impact on nutrient cycling and therefore no expected effect to the regeneration of vegetation.

Figure 3.2: Average organic matter both pre-treatment and post-treatment on all sites with post-treatment monitoring completed during 2008 on the Superior National Forest.

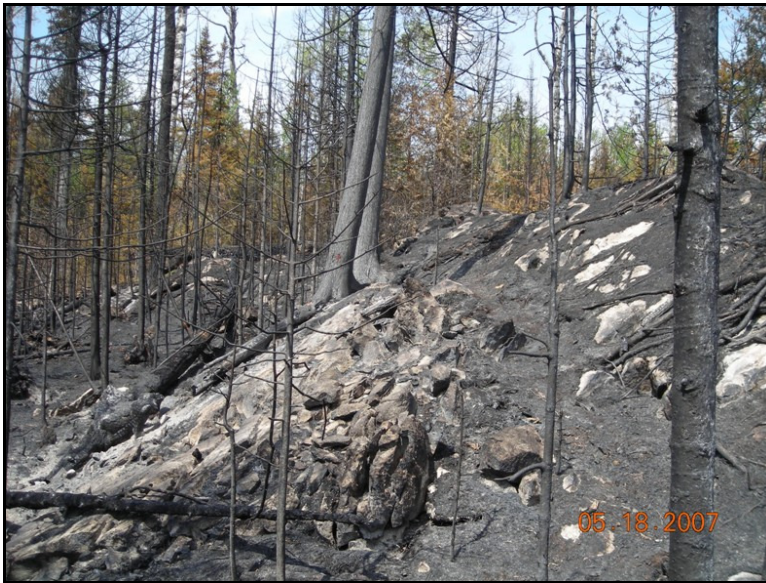
Figure 3.3. The area burned over by Ham Lake Fire in the Boundary Waters Canoe Area Wilderness (BWCAW), picture taken after the fire (5/18/2007).

Wildfires are more likely to impact soil resources than prescribed fire, especially on ridge tops and where shallow soils occur. Impacts to soils from the Famine Lake and Ham Lake Fires (77,000 acres) were monitored during the summer of 2008 as part of the Burned Area Emergency Rehabilitation (BAER) process (Figure 3.3). In the areas where resource assessments were completed during the BAER visits there was moderate burn intensity in which 95 percent of the forest floor was consumed. However, no measurable erosion was observed and there was no water repellency (Figure 3.4). The natural re-establishment of vegetation in these areas, along with the residual organic matter and downed debris remaining from the fires, has provided adequate material to protect the soil resource from erosion.

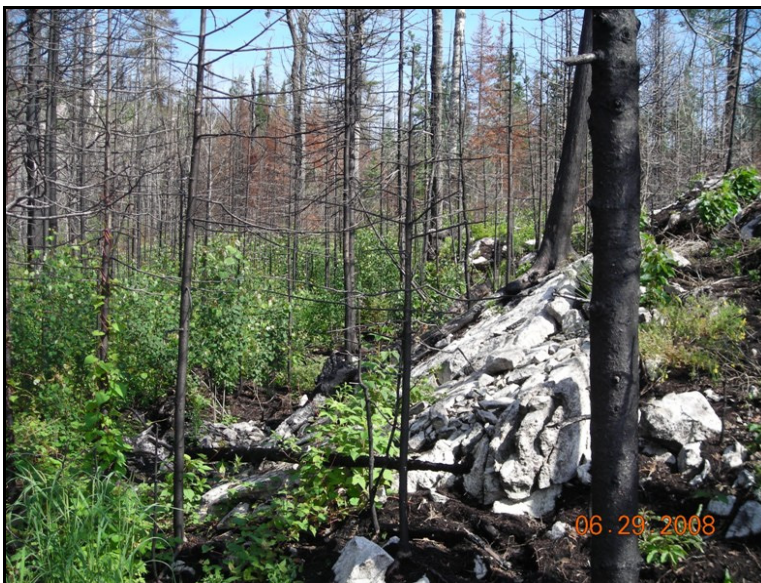
Figure 3.4. Thirteen months after the Ham Lake Fire in the Boundary Waters Canoe Area Wilderness (BWCAW), note the regeneration and the absence of erosion (6/29/2008).
