MINERALS

A. MONITORING AND EVALUATION

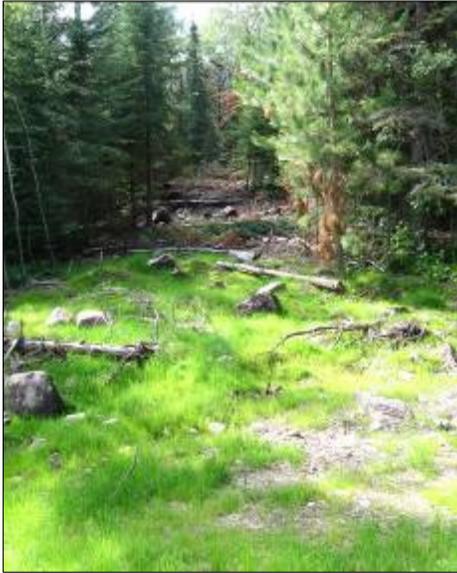
Monitoring showed that closures were effective on all roads that were visited (Figure 10.1). Further information on exploration road closures is referenced in the Project Monitoring File.

Figure 10.1. Reclaimed access road with an effective vehicle use closure on the Superior National Forest.

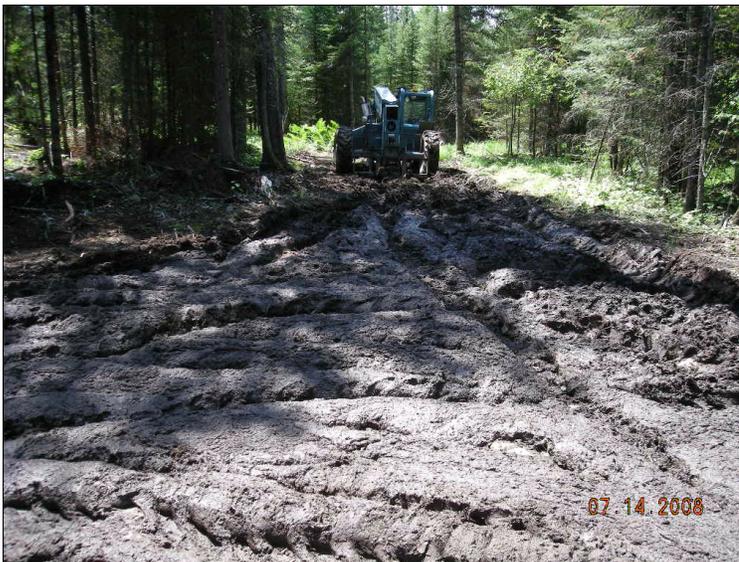
One compliance issue was identified during a field review was that the access road had been unreasonably rutted, drainage was disrupted, and mud was moving off the road. The access road issue was resolved when the SNF contacted the permittee who appropriately graded and graveled the road surface and installed proper drainage in a timely manner (Figures 10.2 and 10.3).

Figure 10.2. Rutting of an access road during a minerals exploration project on the Superior National Forest.

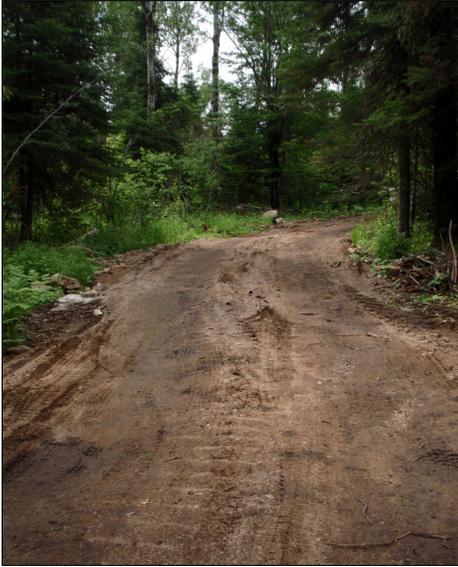
Figure 10.3. Access road repaired by grading and graveling after a minerals exploration project (see Figure 10.2) on the Superior National Forest.
