**BURNED-AREA REPORT**  
(Reference FSH 2509.13)

A. Fire Name: Hotlum

**Hotlum Fire – Noxious Weed Monitoring Report  
May 2006 –September 2006  
Rhonda Posey, Eastside Planning Botanist  
December 4, 2006**

# Hotlum Fire Wind Erosion Monitoring Results

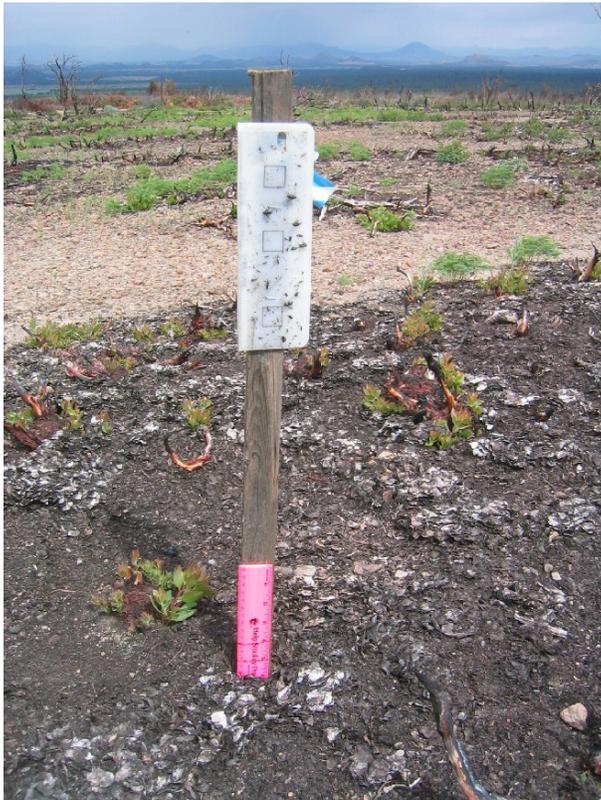
Concerns were expressed about the possibility of wind erosion after the Hotlum Fire in the Hwy. 97 corridor. Ten wind erosion-monitoring stations were set-up in the perimeter of the fire focusing on areas that burned the hottest throughout from the upper elevation areas to the lower elevation areas. Along Hwy. 97 corridor most

soil erosion occurred in the less than 1 ft zone and didn't travel over 20ft. Stations higher than 2 ft, mostly picked up bugs and very little sediments were captured, showing saltation occurs in the less than 1 ft zone. Soil is moving and being deposited in manzanita patches where it is held thus creating erosional pavement areas between brush. These soils are somewhat coarser sandy loams so the wind didn't pick up these sands and move them very far.

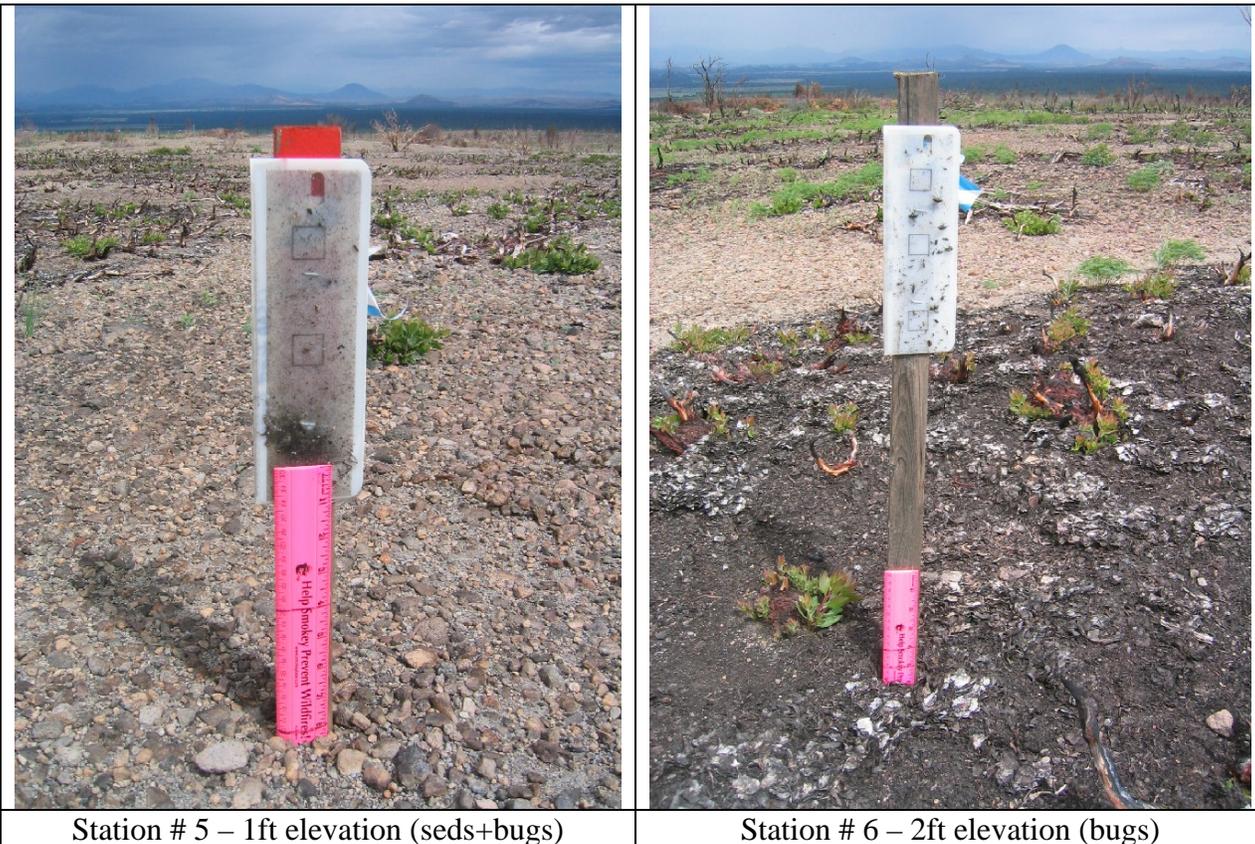
Three elevations (3ft., 2ft., 1ft.) were chosen to evaluate wind erosion extent using catchment and accretion measuring devices (see pic of sticky plates and rulers).

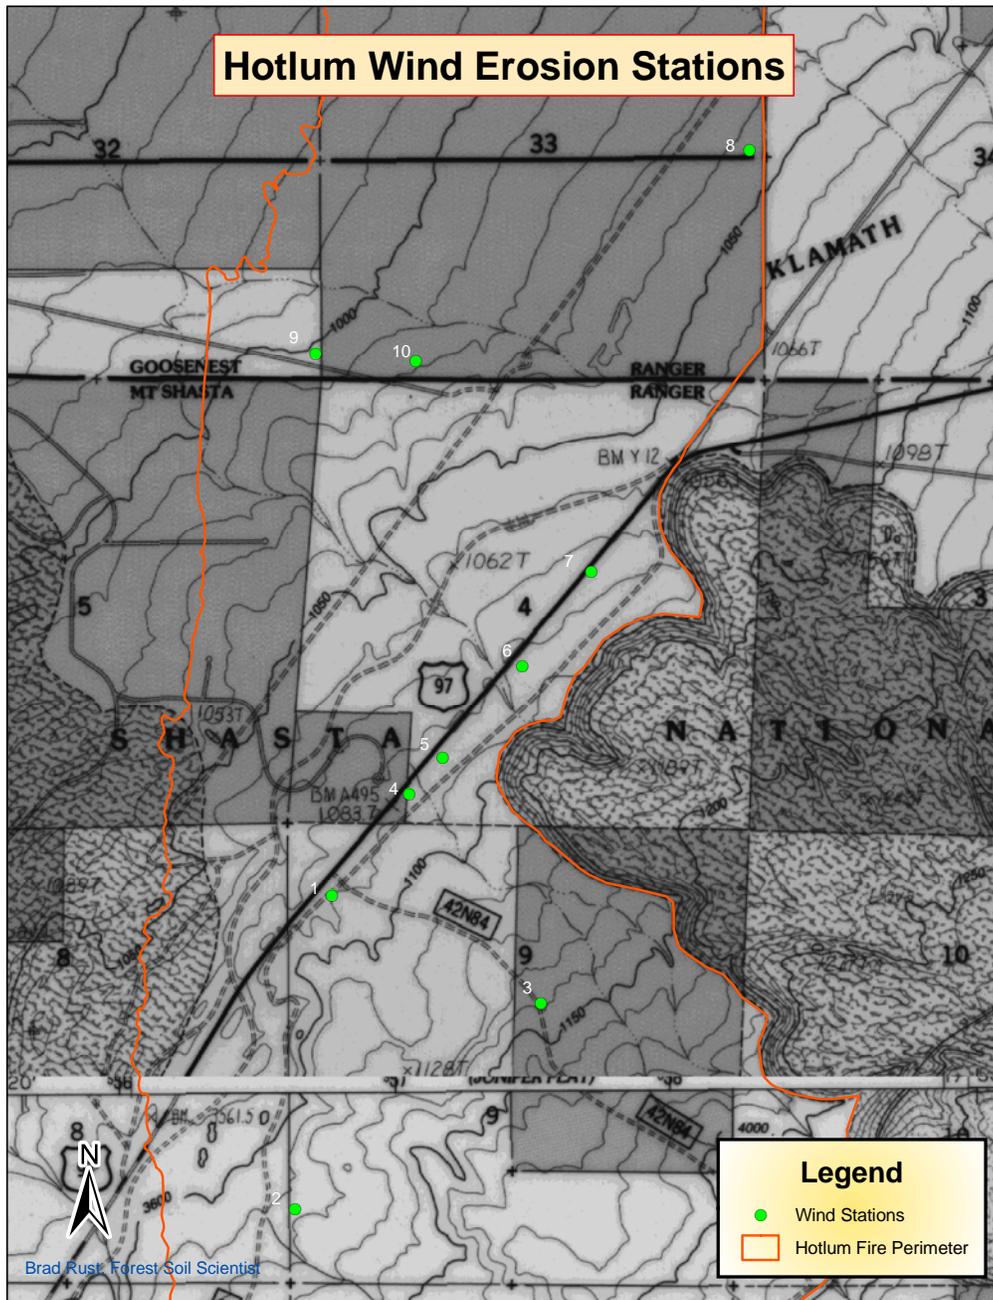
Wind Erosion Stations:

Ten wind erosion-monitoring stations were set-up in the perimeter of the fire focusing on areas that burned the hottest throughout from the upper elevation areas to the lower elevation areas (see map below).

Stations 1, 4, 5, 6, 7 focused on Hwy 97 corridor in various conditions and heights. Station 3 was in an upland position and stations 8, 9, 10 were on lowland positions in Whitney Ck. outwash sediments, where past wind erosion had been observed (see map below).

The Whitney ck. outwash area (stations 8,9,10) has finer sands and silt due to being glacial outwash mixed with fine ash which did blow and move at higher elevations greater than 3ft (see map and table above). These silts and fine sands can create dust clouds (as seen driving NE on Hwy 97 looking on a windy day towards Lassen Nursery fields to the north) but pose no threat to highway safety on hwy 97.
