**Eyak – Heney Landscape Assessment
Cordova Ranger District
Chugach National Forest**

09/30/2002

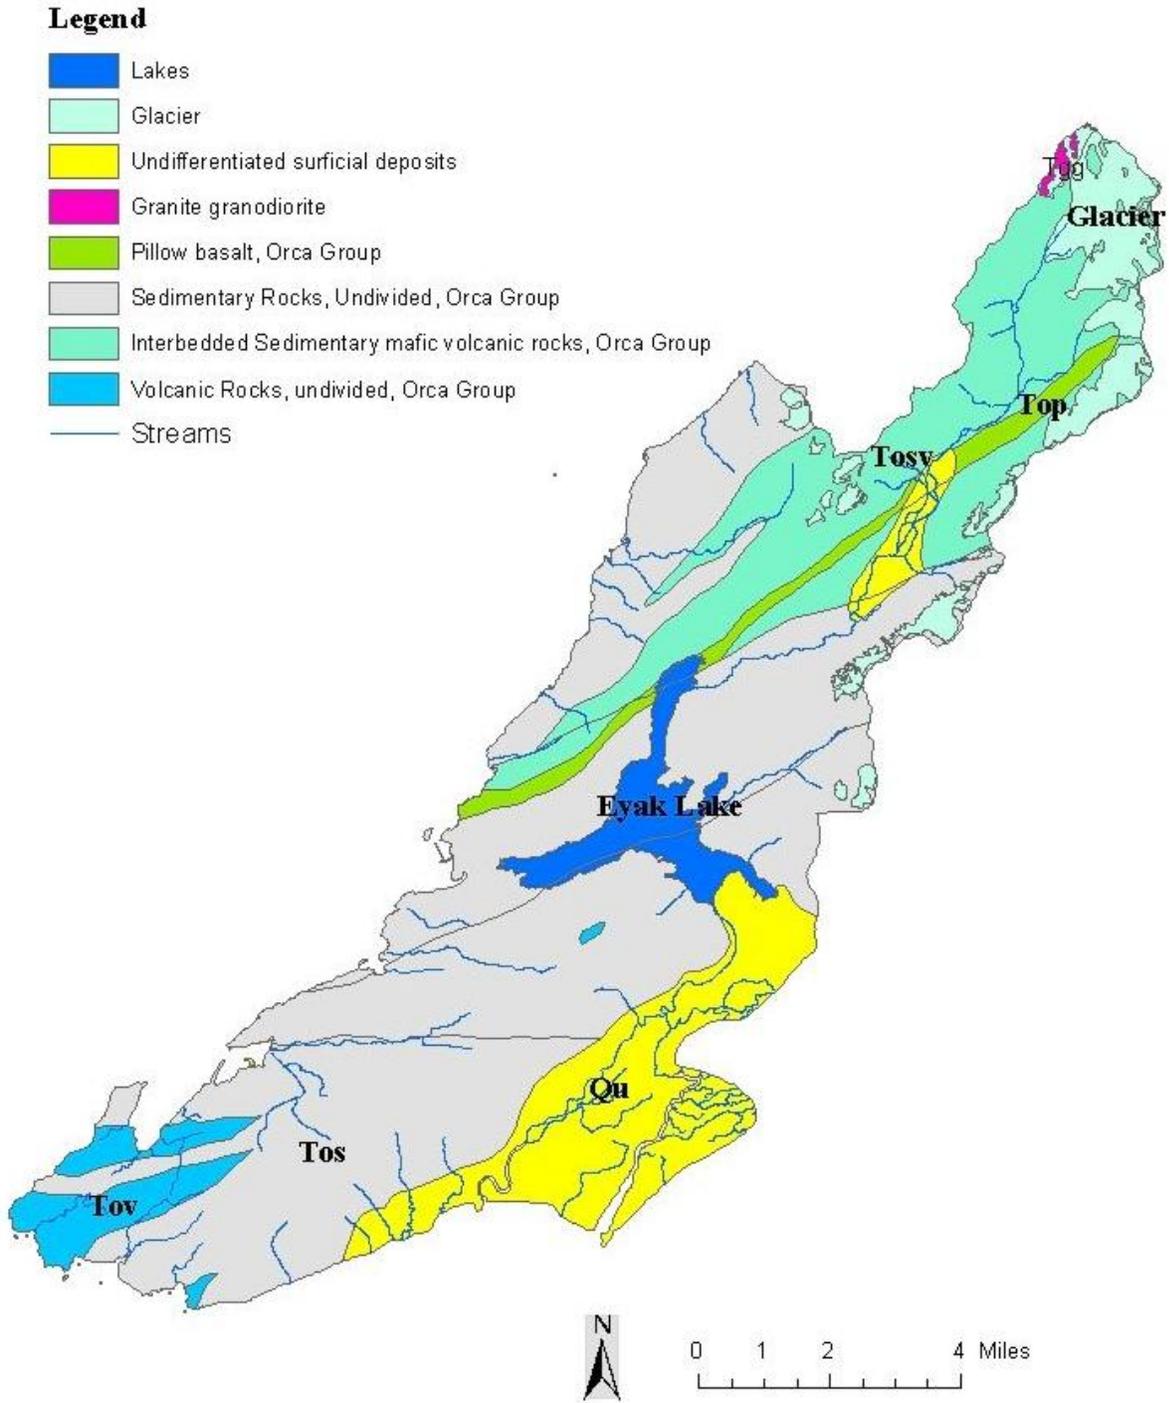
Figure 2.3: Geology of the Eyak-Heney analysis area.

Data from USDA Forest Service (1997).

glacial till (Walters, 1963; Professional Fishery Consultant, 1982). This is possibly an end moraine from a more recent glacial advance. The earthquake of March 27, 1964 caused a tectonic uplift of about 6 feet in the Cordova area and from 6 to 11 feet in the Copper River Delta, causing extensive damage to port facilities as well as all of the bridges in the Copper River Delta (Plafker et al., 1969; Dorava and Sokup, 1994). Figure 2.3 on the next page displays the geology of the area.

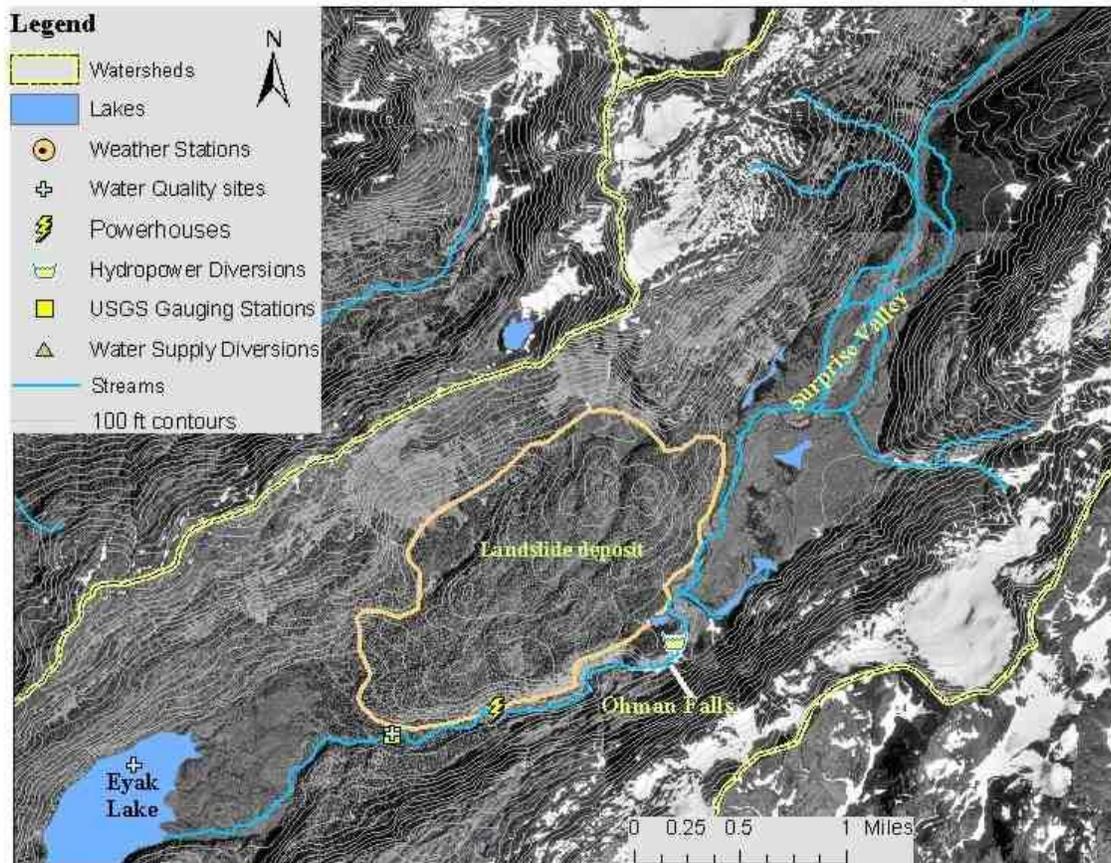
Figure 2.4: Power Creek canyon, showing ancient landslide deposit.

Just upstream of Ohman Falls lies a large run out path for avalanches from the south side of the valley. Snow depths of 70 feet have been observed in the Power Creek canyon in late June (Professional Fishery Consultant, 1982). Large avalanches have been documented at the Power Creek Hydroelectric project site. Twenty-one documented avalanches recently affected the work site between December 1998 and April 2001. An avalanche killed a worker at the project site in April 1999 (Cordova Times, 2001). As a result of this avalanche debris, there is a semi-permanent ice bridge over Power Creek immediately upstream of the falls, spanning Power Creek most months of the year (Whitewater Engineering Corporation, 1996b).

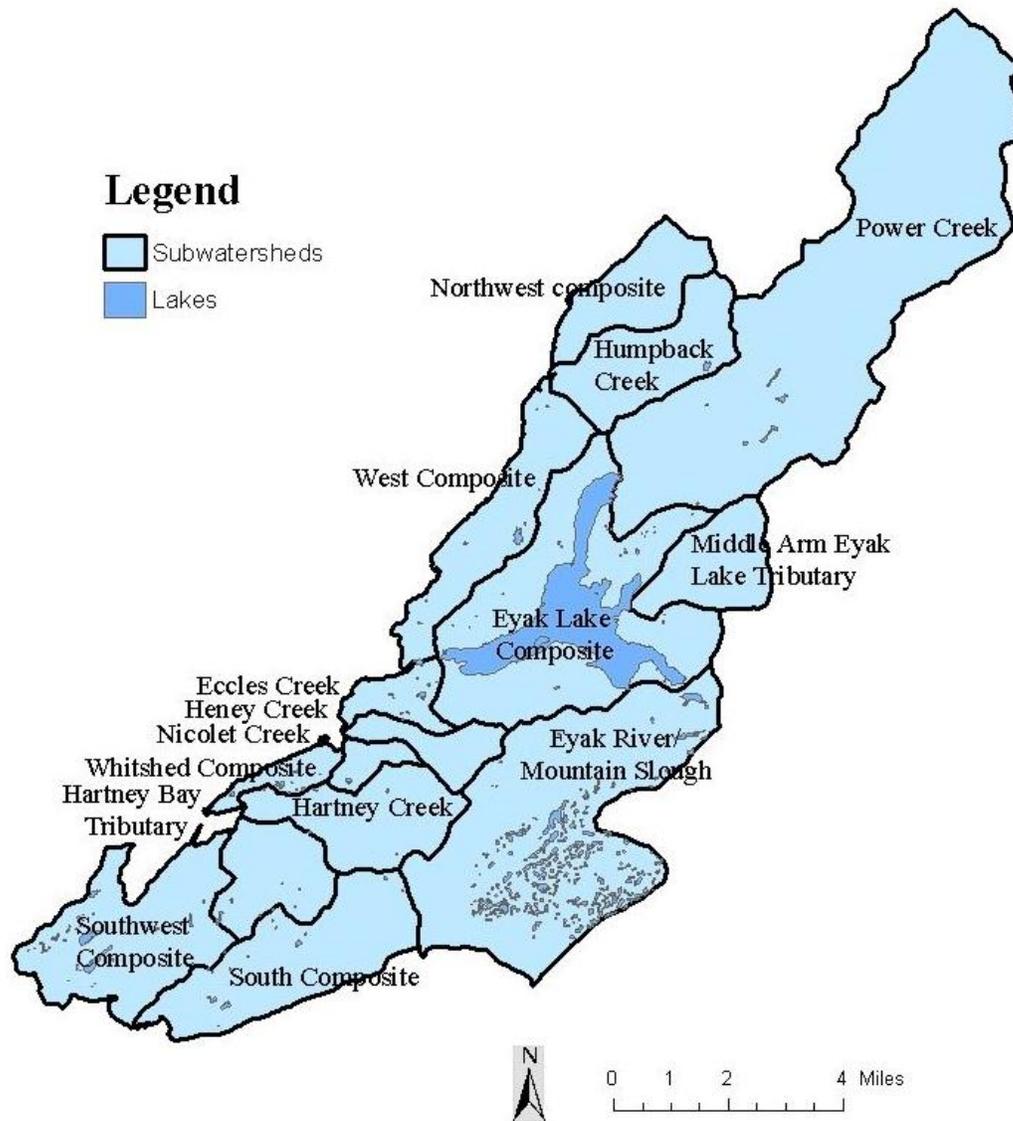
Figure 2.6: Eyak-Heney analysis area subwatersheds.

Stream and contour data are from USDA Forest Service (1998). Subwatersheds were delineated for significant larger streams, gauged streams, and composites of multiple small drainages.

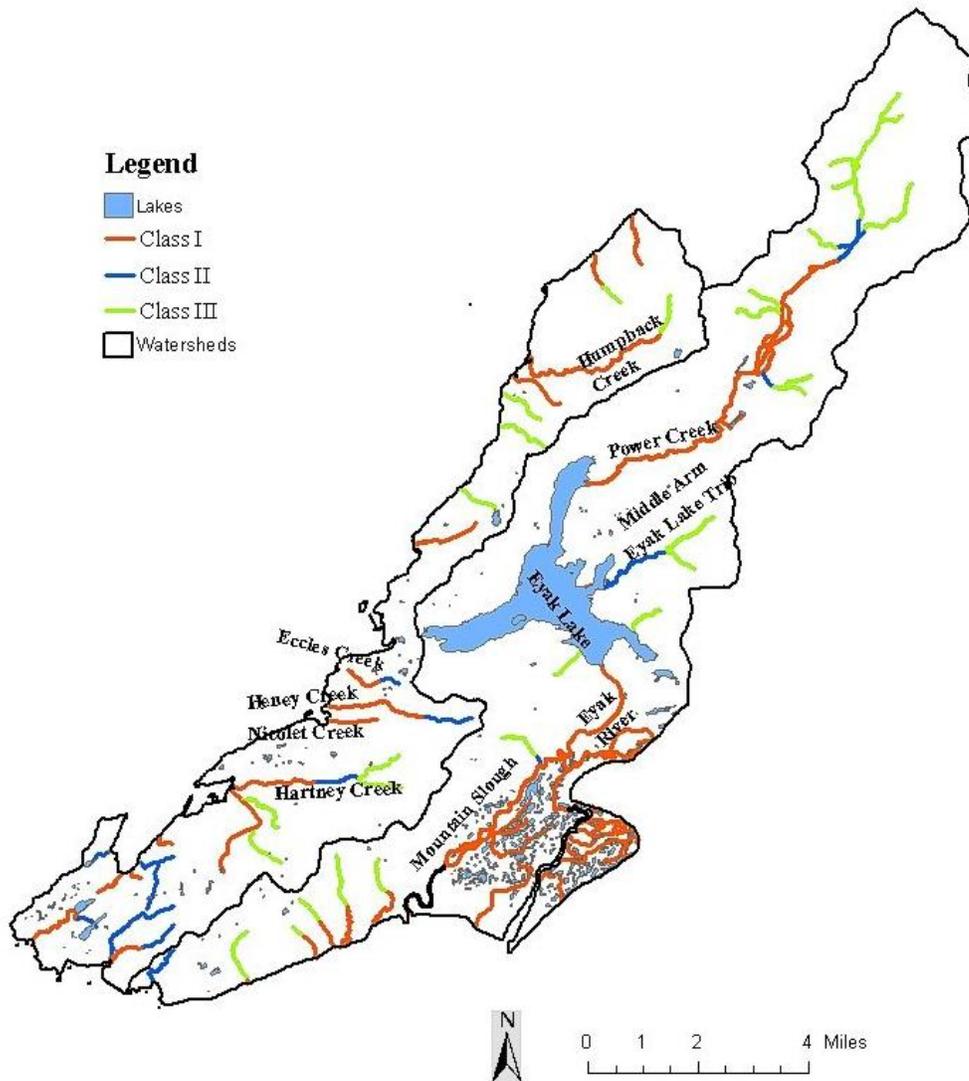
Figure 2.7: Stream classes based on fish habitat. Data from USDA USFS (1998).

Class	Description	Miles of stream	Percent of total
Class I	Streams with anadromous or adfluvial lake and stream habitat.	89.0	70.6
Class II	Streams with resident fish populations. Generally steep (6-15% gradient), can include streams from 0-5% gradient without anadromous fish	11.8	9.4
Class III	Streams with no fish populations that have potential water quality influence on downstream aquatic habitats	25.2	20.0

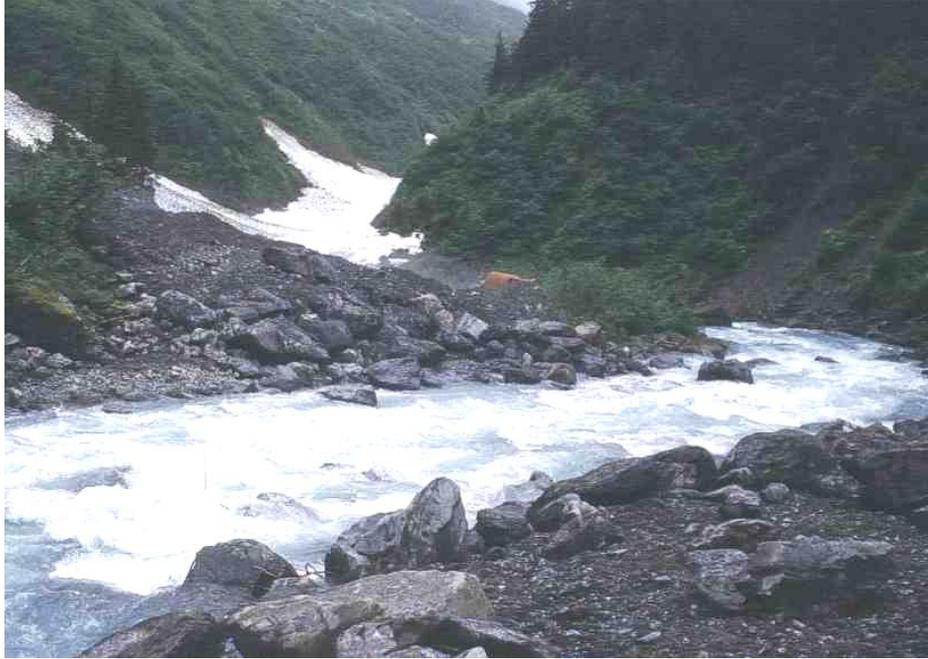
Figure 2.9: Power Creek Canyon downstream of dam site, looking downstream.

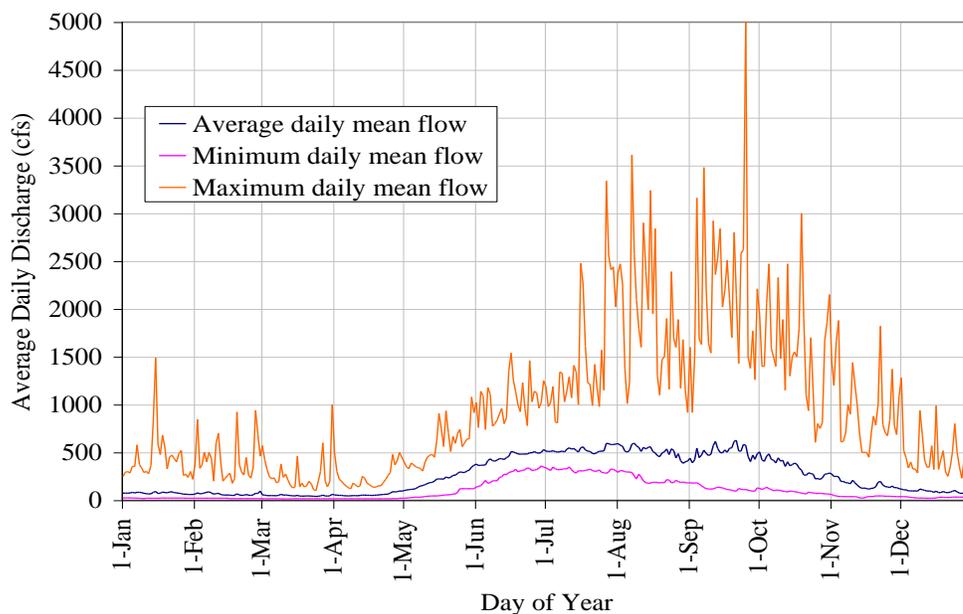
Figure 2.10: Average daily streamflows for Power Creek near Cordova, AK.
USGS station # 15216000 period of record 8/6/47 to 9/30/95 (USGS, 2002).

precipitation during the summer and fall creates a series of flashy peaks throughout September and October (Dorava and Sokup, 1994). This bimodal pattern is more pronounced in watersheds that drain glaciers and snowfields, such as Power Creek. Smaller watersheds with smaller alpine drainage areas have a larger potential for flashy peaks created by intense rainfall, and a lesser influence from summer snowmelt runoff. In all watersheds, the potential for the highest flows is during September and October, although these high flows often last only one to three days. Late fall conditions of impermeable land surfaces created by frozen soils with little snow cover can sometimes lead to large flash floods resulting from intense late fall rainstorms. Low flows generally occur from mid-December to mid-April, and many of the smaller streams are frozen during this period and have very little flow. Following is information about streamflows for the watersheds in the area. The hydrograph for Power creek is included since it represents much of the analysis area (Figure 2.10). Other streamflow hydrographs and flow statistics are located in the Eyak-Heney Hydrologic Condition Assessment in the planning record.

Power Creek. The USGS gauging station on Power Creek, located 1.6 miles upstream of Eyak Lake, has a drainage area of 20.5 square miles. The gauging station has 48 years of daily flow records, from 1947 to 1995. Streamflow in Power Creek is highly variable, as it is affected by snowmelt, glacial melt water, and precipitation. The average annual low flow, approximately 50 cfs, generally occurs in late March. Flows increase drastically in May and June as a result of snowmelt, and glacial melting begins in late June. On average, a first streamflow peak occurs in late July or Early August, averaging about 600 cfs. Extreme high flows can occur any time depending on duration and intensity of precipitation, and flow response is rapid because of steep topography and shallow soils, leading to a flashy hydrograph (Whitewater Engineering Corporation, 1996a). A second, larger peak flow generally occurs as

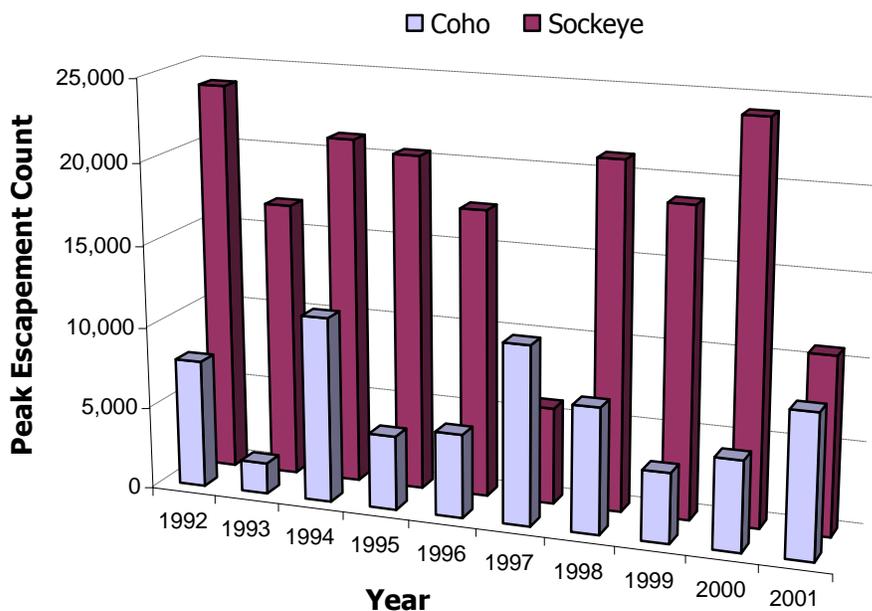
Figure 2.11: Peak aerial escapement counts for sockeye and coho salmon in the Power Creek-Eyak Lake drainage from 1992 to 2001.

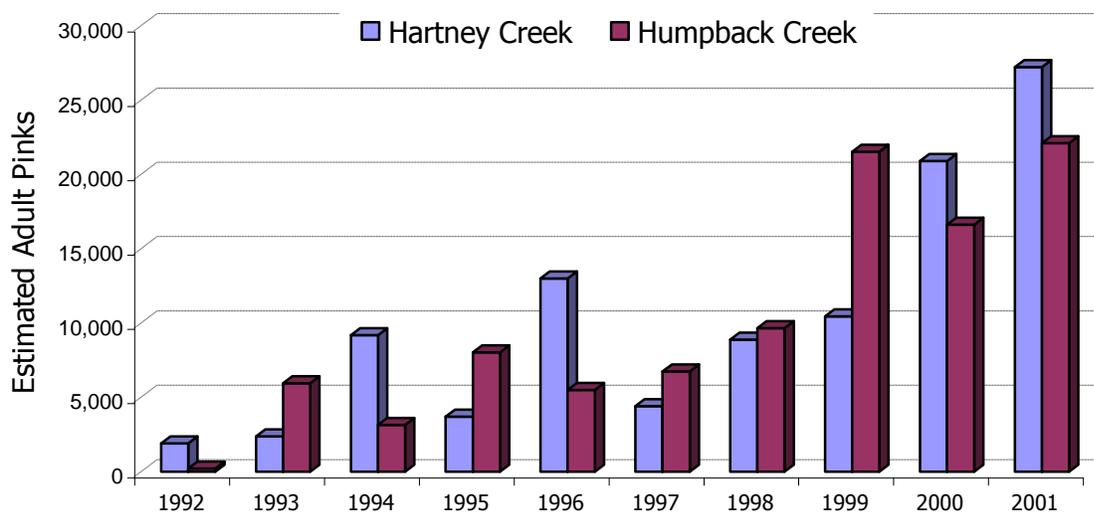
Figure 2.12: Adjusted aerial estimates of pink salmon escapement for Hartney Creek and Humpback Creek, 1992 to 2001.

Aerial surveys on these streams from 1992 to 2001 indicate that Hartney Creek and Humpback Creek produce the greatest numbers of returning pink salmon. After adjusting the aerial counts to compensate for a 17.5-day stream life of adult pink salmon, Hartney Creek had an estimated low of 1,911 fish in 1992 and an estimated high of 27,226 fish in 2001 (Figure 2.12). Humpback Creek had an estimated low of 222 fish in 1992 and an estimated high of 22,111 in 2001 (ADF&G, unpublished data). Chum salmon are less numerous than pink salmon in these streams.

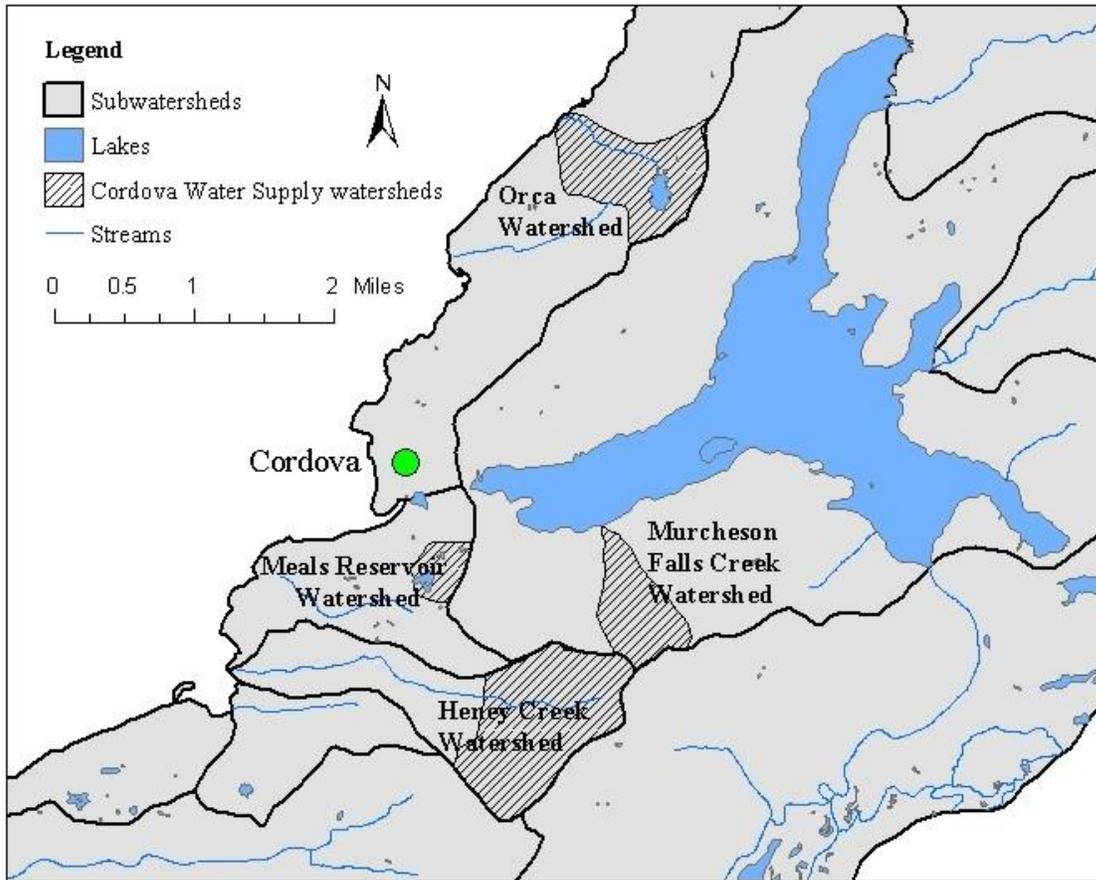
Figure 2.17: Cordova water supply watersheds.

Orca Watershed - The Orca watershed and Crater Creek serve as a source of water for Cordova. A small catchment dam on Crater Creek, located at 263 ft elevation and 0.2 miles from the Orca Inlet, diverts water through a chlorination building and into the city water system (CH2M Hill and Steph Engineers, 1997). The Orca watershed receives frequent recreational use. In 1997, the US Forest Service estimated that 1200 to 2000 people use the area each year for hiking and berry picking. Some erosion occurs on the trail that circles Crater Lake (CH2M Hill and Steph Engineers, 1997).

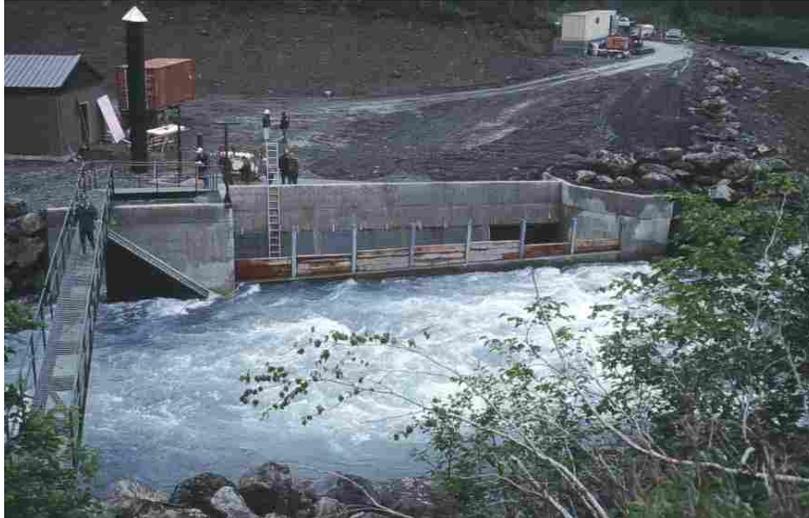
Figure 2.18: Power Creek diversion dam and intake.

The impoundment created by the Power Creek diversion dam has a surface area of 1 acre and a gross storage of 5 acre-feet. The dam was constructed on alluvial and landslide deposits consisting of boulders and cobbles with a sand and silt matrix. Grouting and a clay blanket were used to minimize seepage through this material (Whitewater Engineering Corporation, 1996b). Because of the high sediment load in Power Creek, the weir is operated in a manner to provide for unimpeded sediment transport. The forebay water level is adjusted in response to flows. The overflow section will handle the 100-year flood event (Covel, personal communication). Because there is little ponding upstream of the dam, the Power Creek hydroelectric project has little impact on water quality. Water temperature and streamflow should be the same above and below the project (Whitewater Engineering Corporation, 1996b).

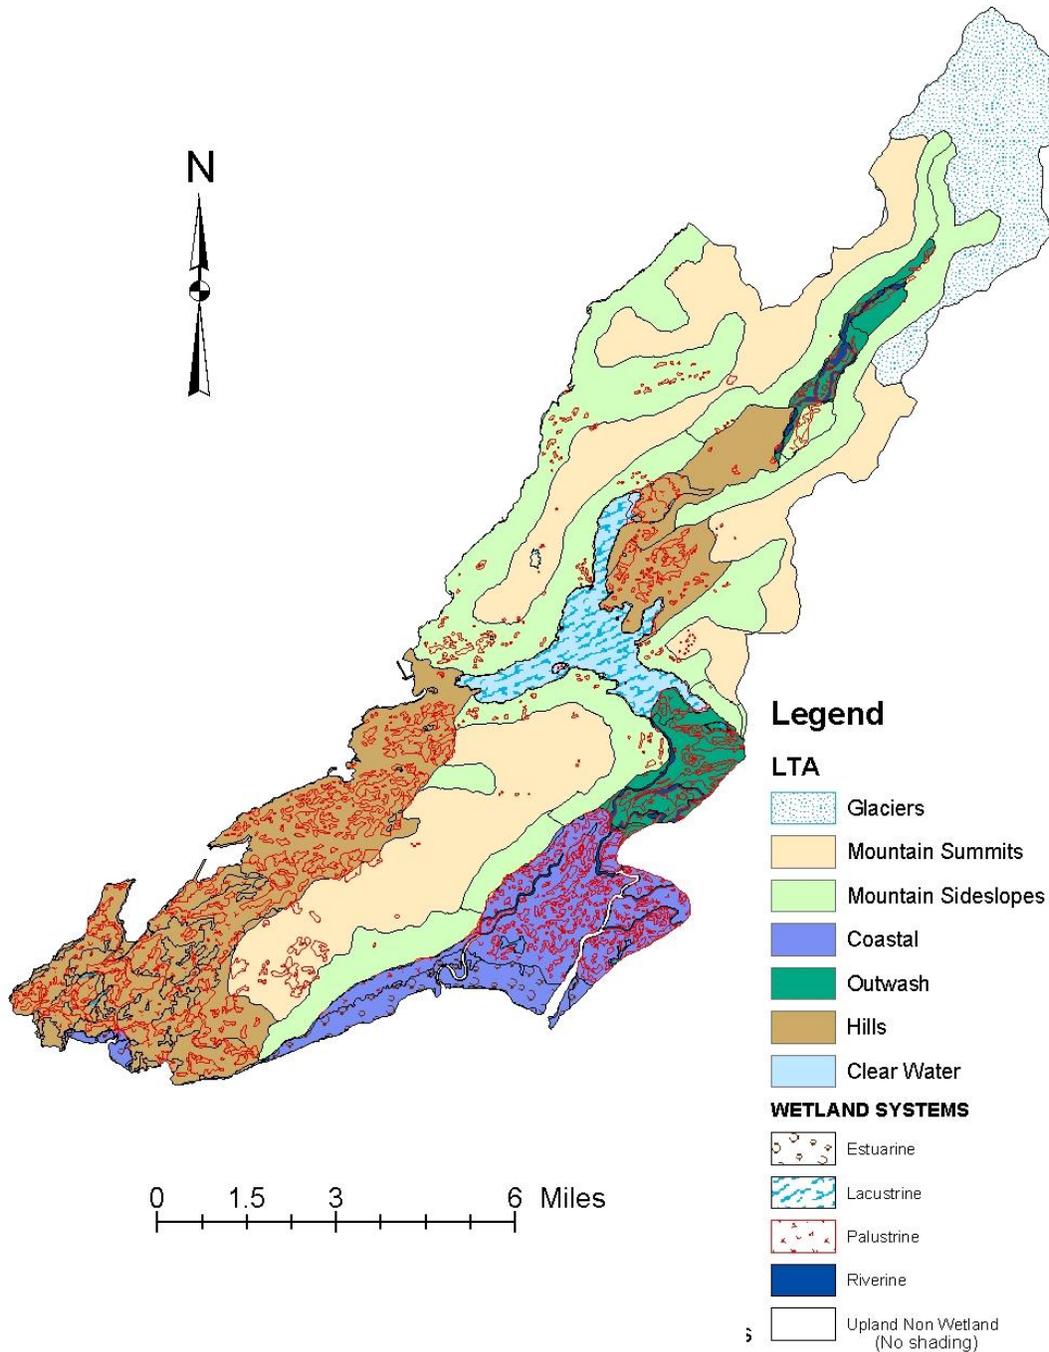
Figure 4.1: Landtype Associations in the analysis area and type of wetland associated with each.

The National Wetlands Inventory developed by the National Resources Conservation Service delineated four types of wetlands: Estuarine, Palustrine, Riverine, and Lacustrine. Figure 4.1 on page 62 displays where each type of wetland occurs in the analysis area. It may appear that some wetlands occur in Landtype Associations where they would not be expected; however, the landtype associations are large somewhat general units, and it is common for small inclusions of contrasting landforms to be included during mapping.

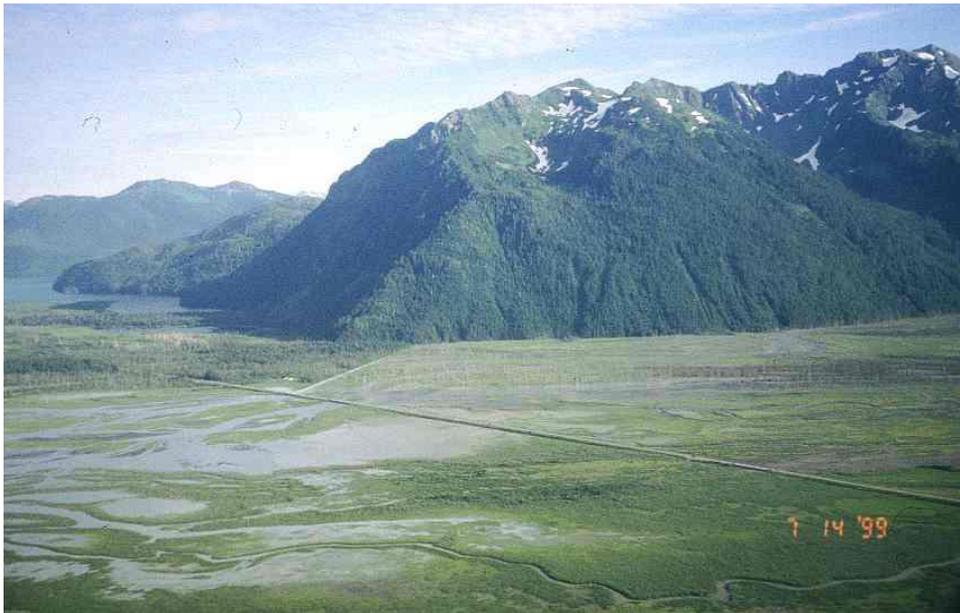
Figure 4.2: Scott River outwash plain, looking northwest toward Eyak Lake on the left side of the photograph. The Copper River Highway and the flood control dike are visible in the center of the photograph.

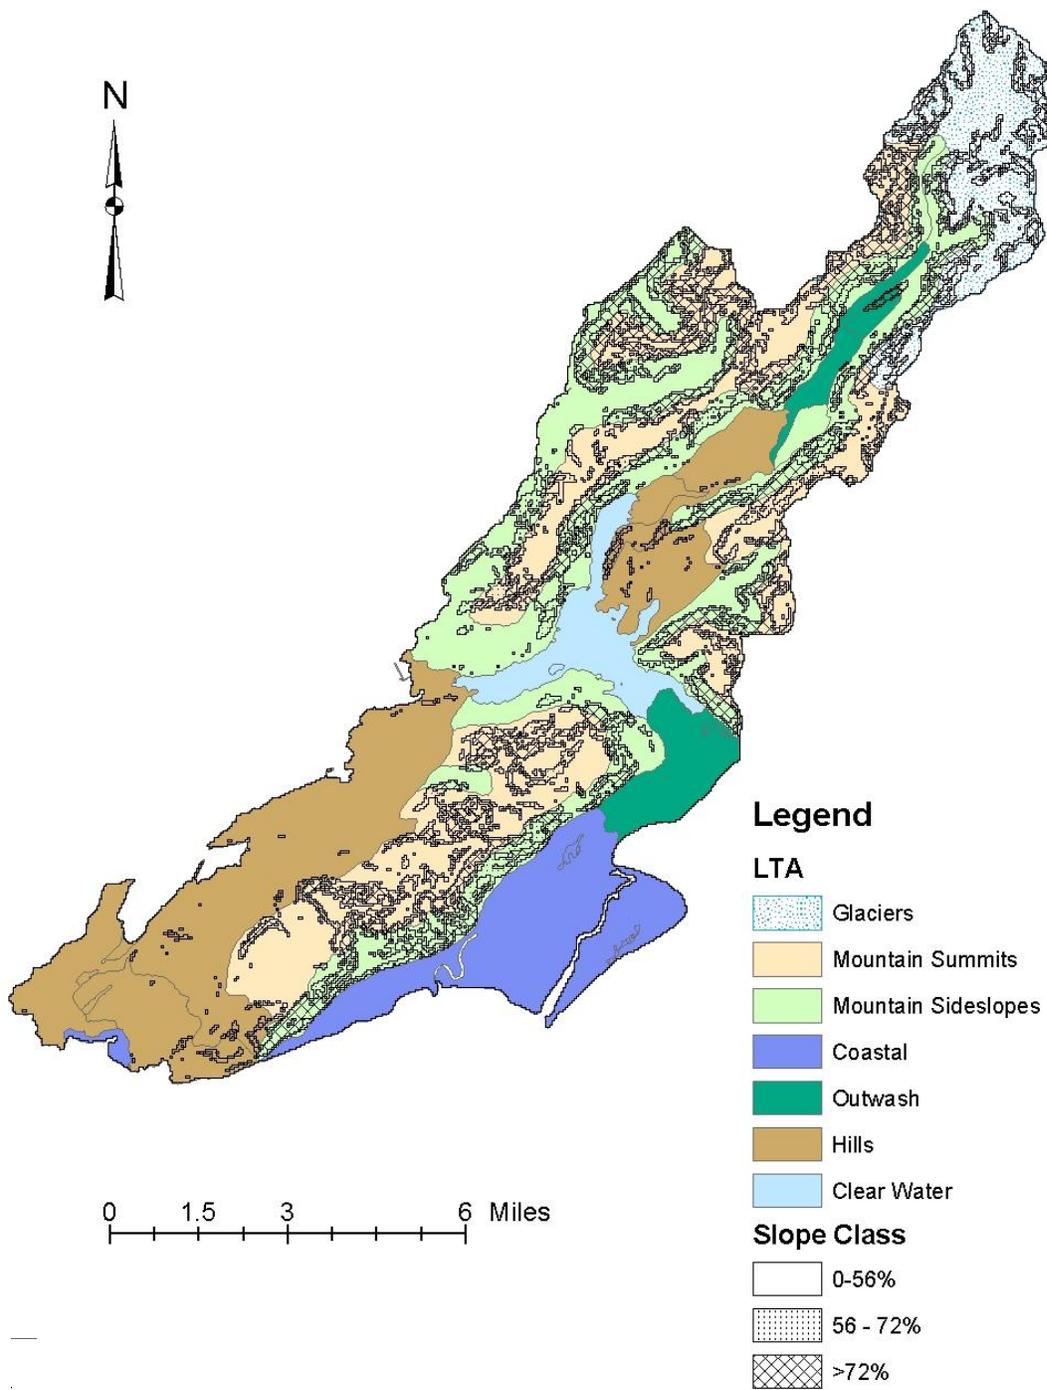
Figure 4.3: Distribution of slope by landtype for the analysis area

Landtype Association	Acreage for each Slope Category		
	Slopes < 56%	56 to 72%	Slopes > 72%
Glaciers (00)	3,318	983	743
Mountain Summits (10)	9,187	3,265	2,939
Mountain Sideslopes (30)	9,472	3,579	3,108
Coastal (70)	5,764	2	0
Outwash (80)	2,692	24	30
Hills (90)	13,160	360	119

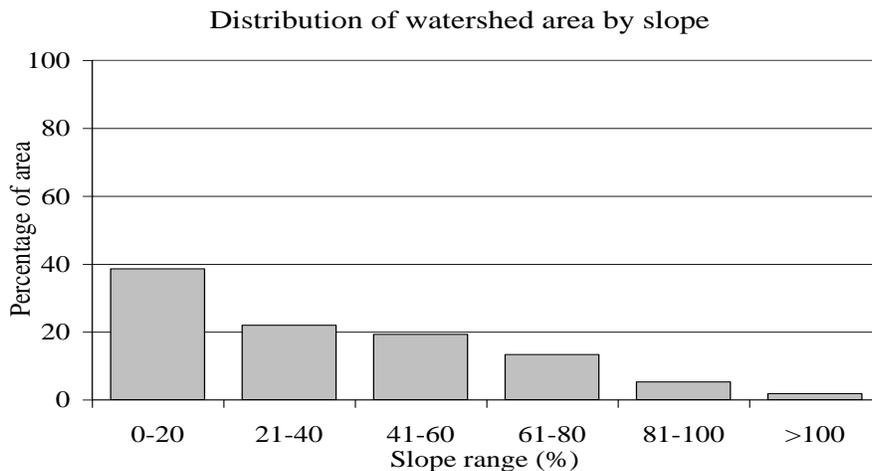
Figure A-2: Distribution of analysis area by slope. Data from USDA USFS (1997).

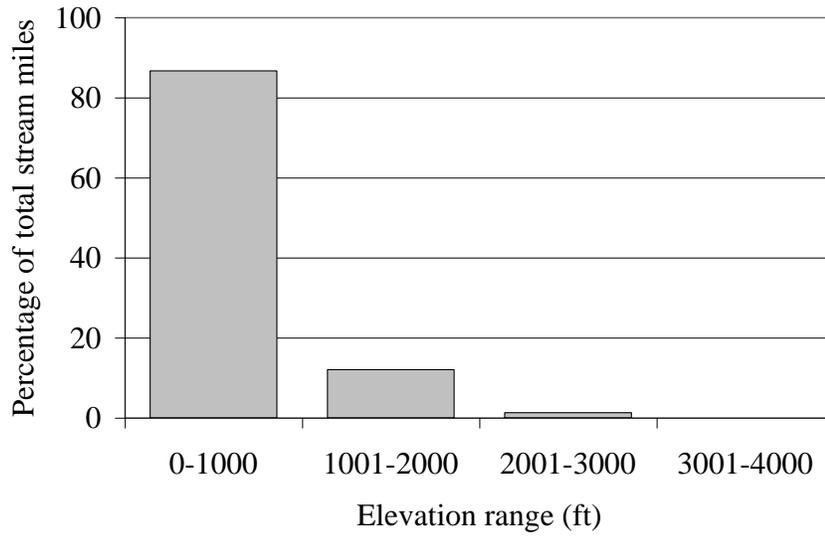
Figure A-4: Distribution of stream miles by elevation. Data from USDA USFS (1996).

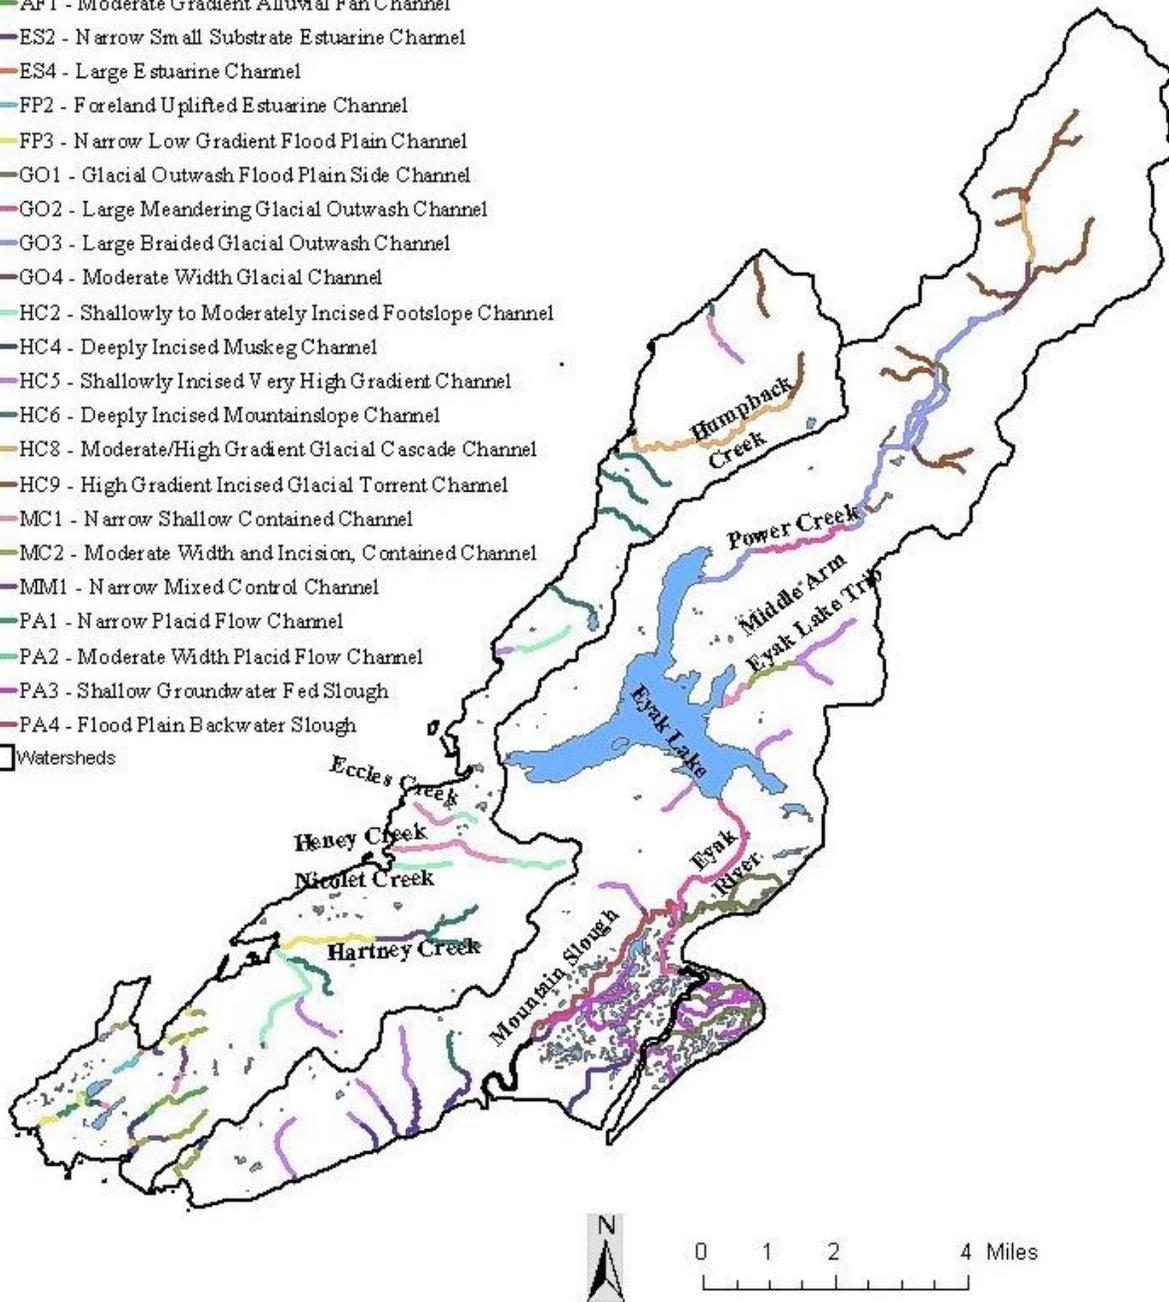
Figure A-5: Stream classification for the area, based on USDA USFS (1992).

- PA2 - Moderate Width Placid Flow Channel
- PA3 - Shallow Groundwater Fed Slough
- PA4 - Flood Plain Backwater Slough
- Watersheds
