Appendix A.
Investigation Photographs

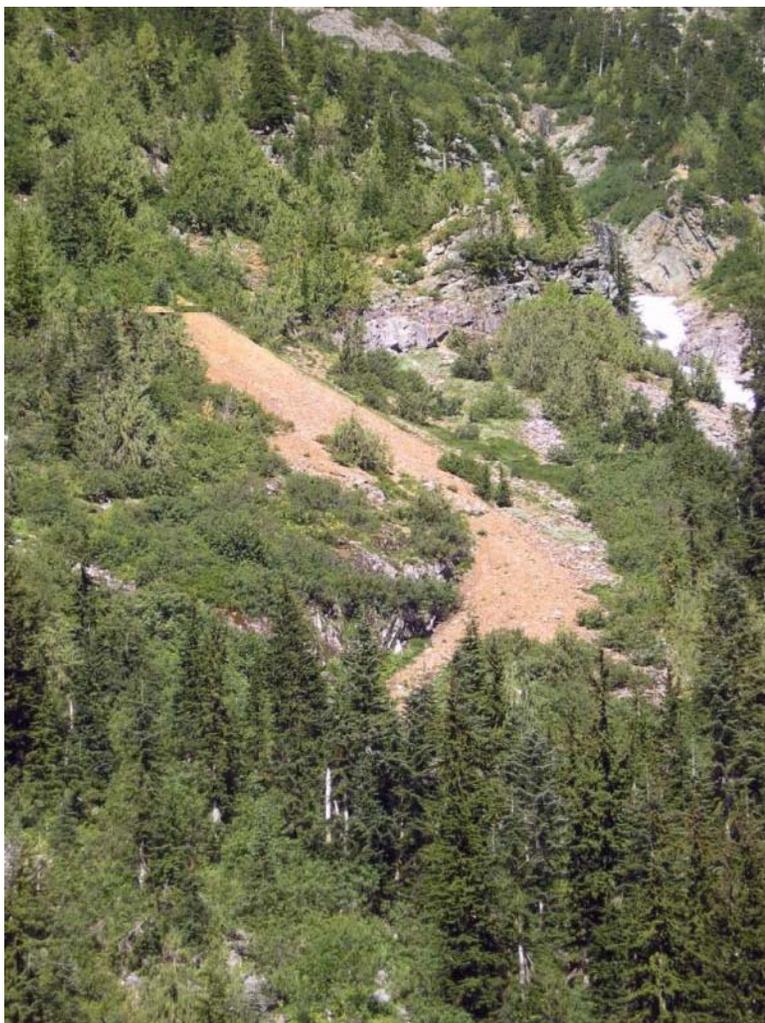
Photograph 1. Pride of the Mountains Mine viewed from Glacier Creek; CES waste rock samples MCEE-WR-PM-01, MCEE-WR-PM-02, and MCEE-WR-PM-03 (Moyle, August 2008).

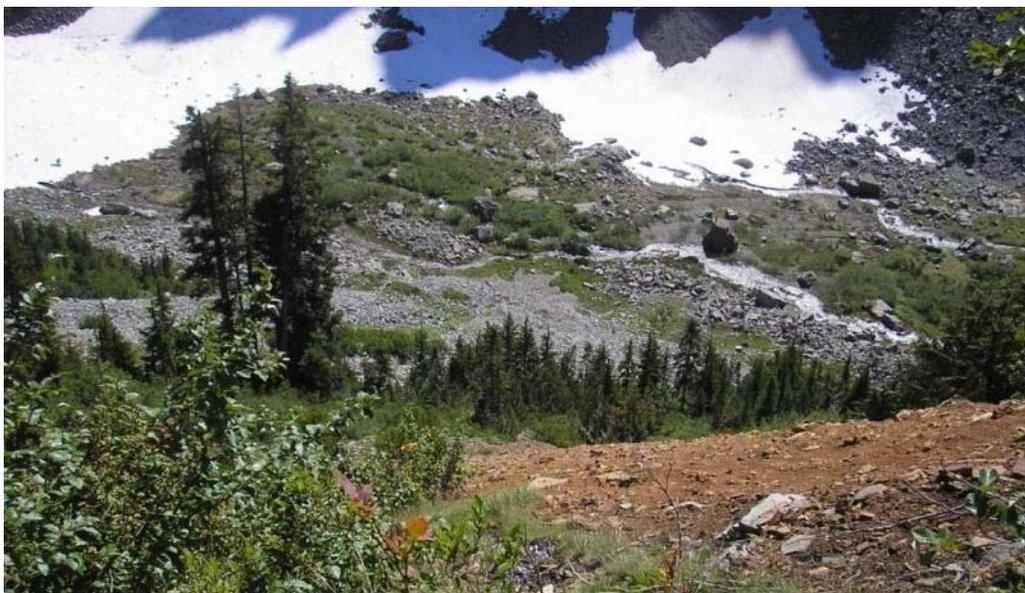
Photograph 2. Pride of the Mountains Mine, view of waste rock at looking toward Glacier Creek from the east side of the dump (Moyle, August 2008).

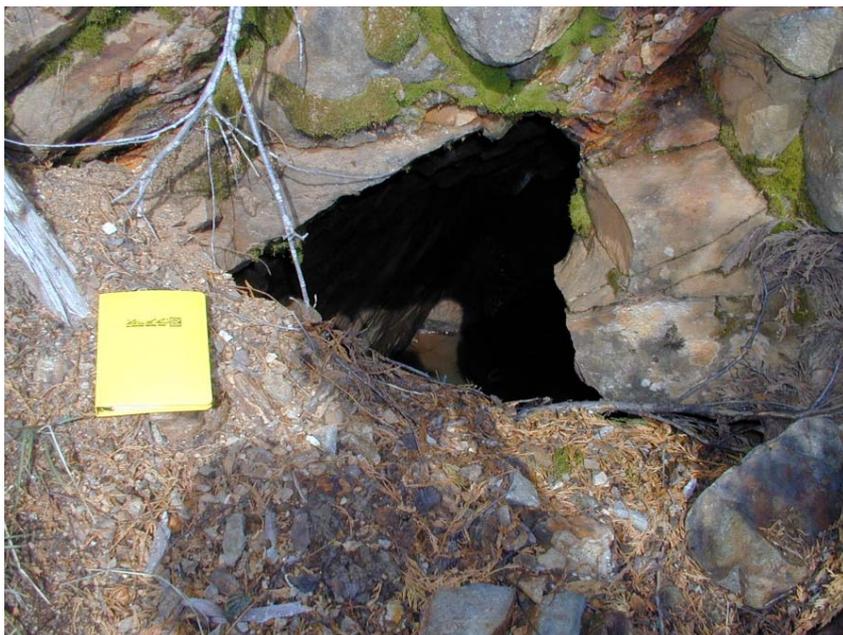
Photograph 3. Pride of the Mountains Main Adit, showing water behind surface sloughing; CES drainage water sample MCEE-DW-PM-01 (photo from Wolff and others, 2003).

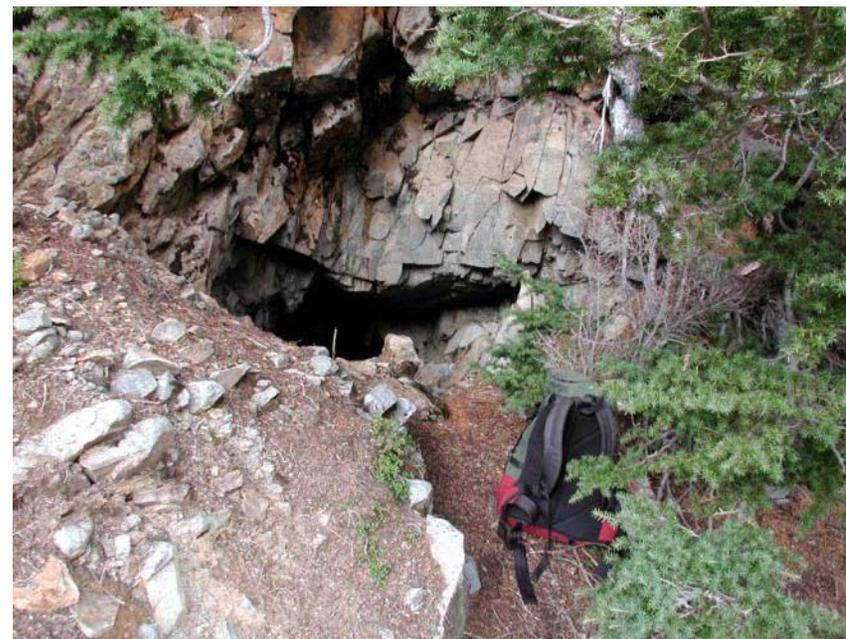
Photograph 4. Pride of the Mountains adit, possibly the “Mukilteo” tunnel (photo from Wolff and others, 2003).

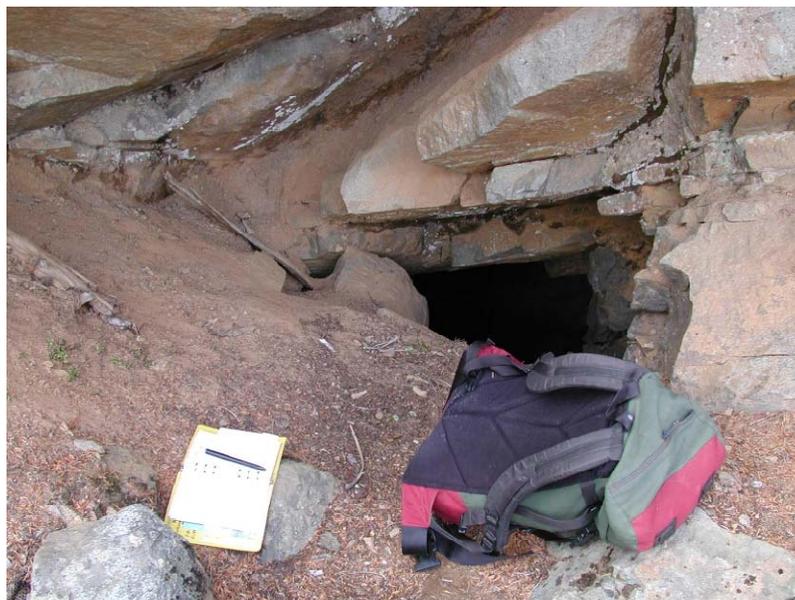
Photograph 5. Collar of inclined shaft at the Pride of the Mountains Mine (photo from Wolff and others, 2003).

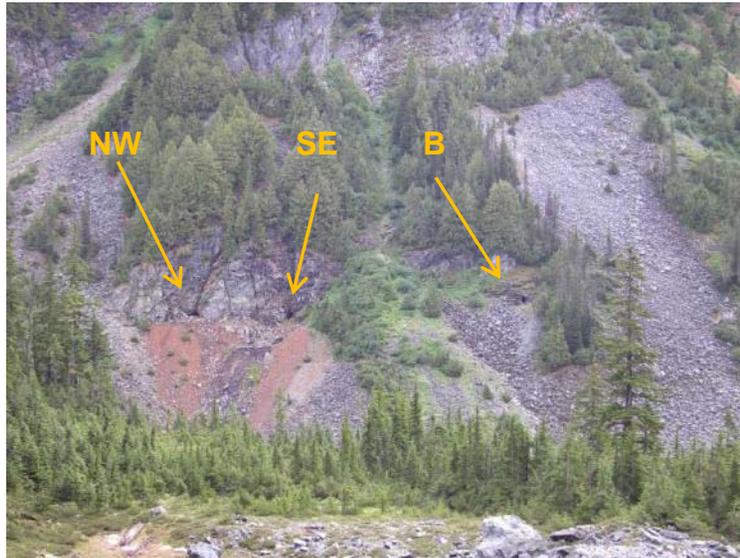
Photograph 6. New Discovery Mine viewed from Mystery Ridge; showing Northwest (NW), Southeast (SE), and Barren (B) Adits (Moyle, August 2008).

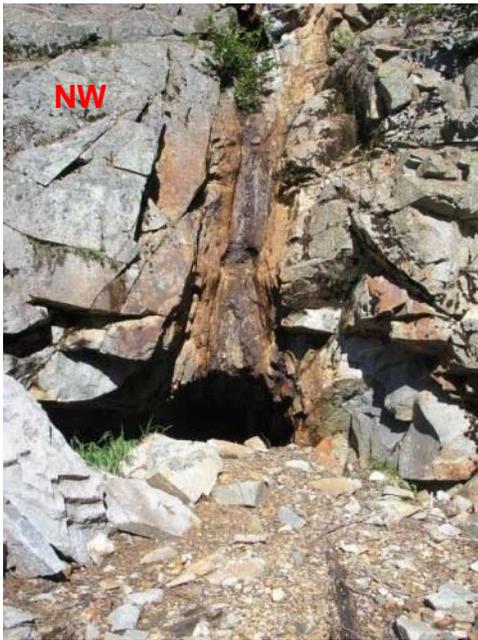
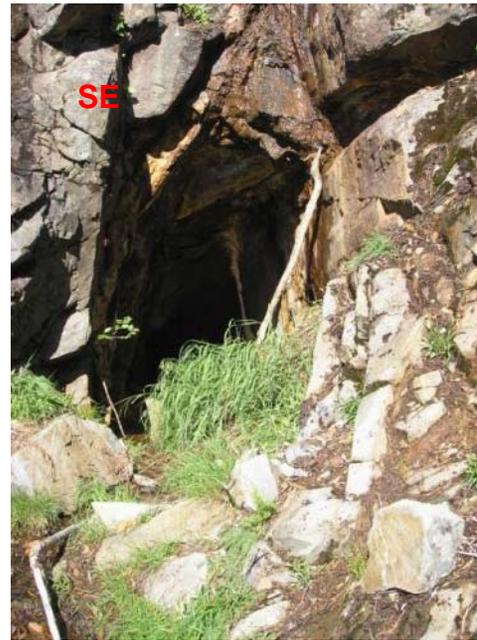
Photographs 7 and 8. Two main adits of New Discovery Mine viewed from waste rock dump – Northwest (NW) Adit on left and Southeast (SE) Adit on right. Note drainage water discharging from the Southeast Adit, CES sample MCEE-DW-ND-01 (Moyle, August 2008).

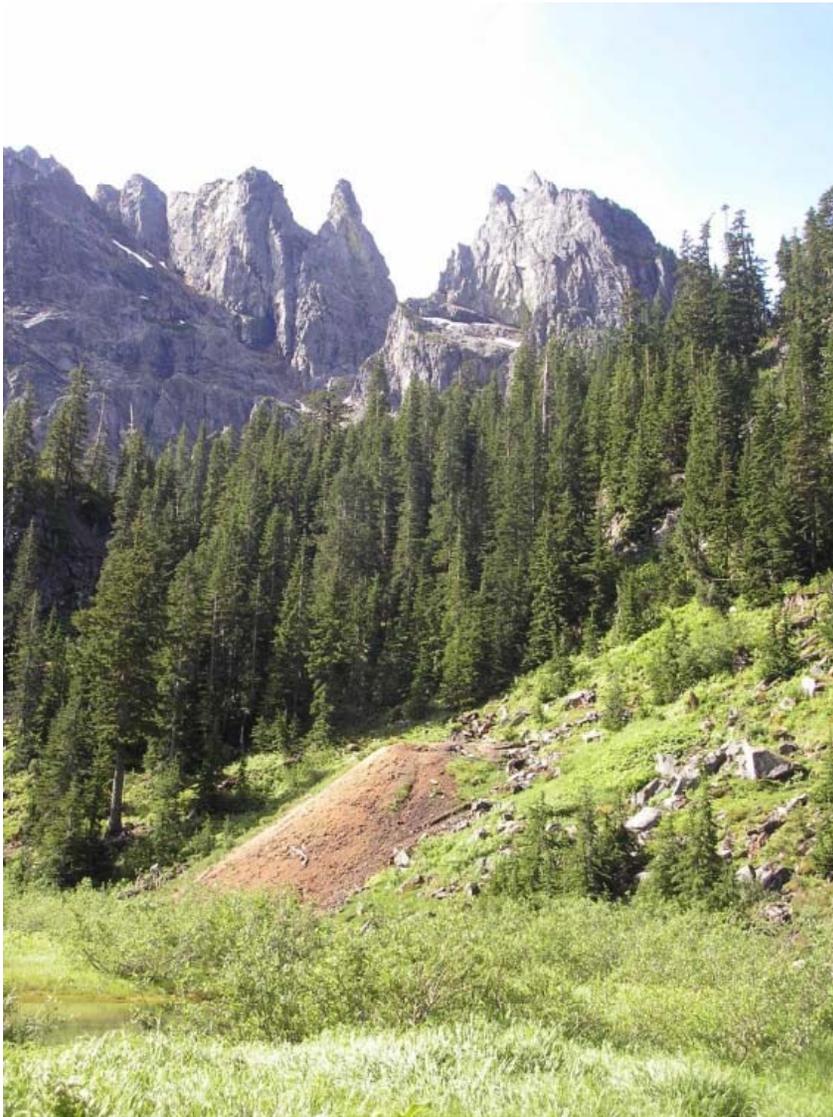
Photograph 9. Pride of the Woods Mine viewed from east along Glacier Creek; CES waste rock samples MCEE-WR-PW-01, MCEE-WR-PW-02 (Moyle, August 2008).

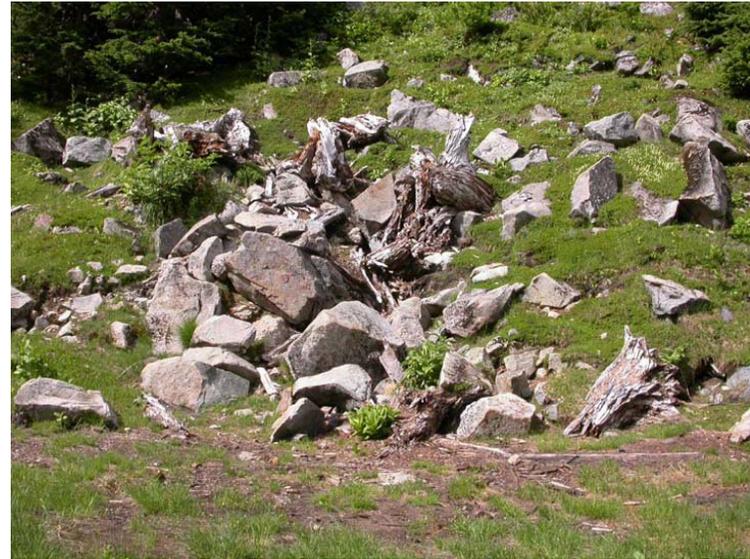
Photograph 10. Adit portal at Pride of the Woods Mine, view to the west (photo by Graham; Forest Service, 2006b).

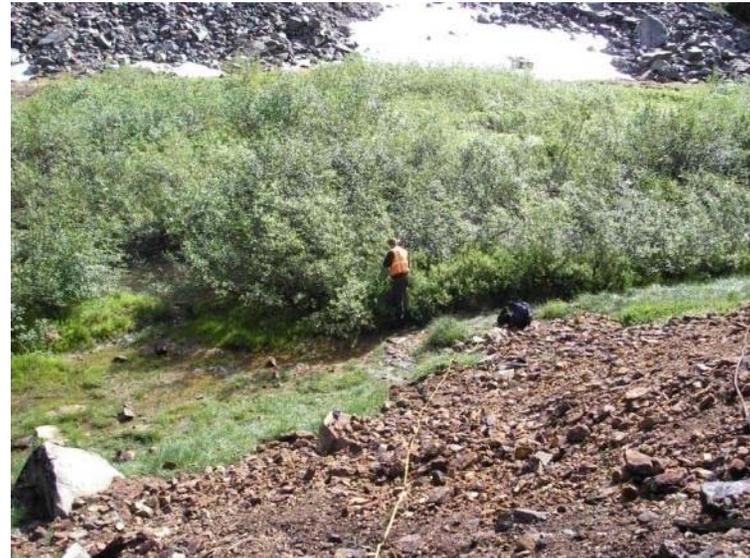
Photograph 11. View of toe of Pride of Woods Mine waste rock dump near bank of Glacier Creek; CES seep sample MCEE-DW-PW-01 (Moyle, August 2008).

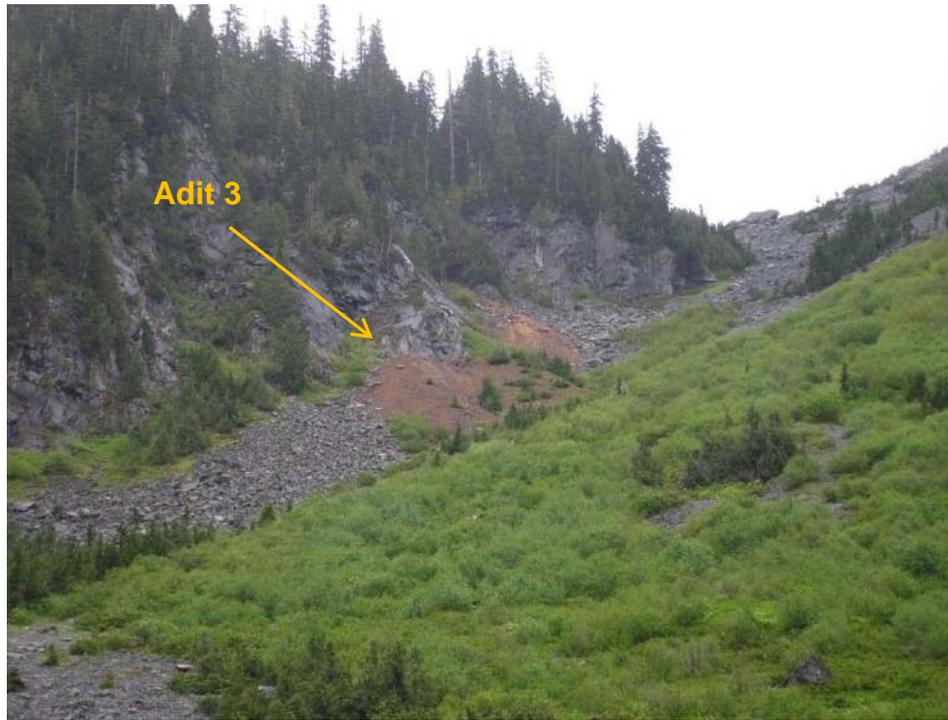
Photograph 12. Mystery Mine; note location of Adit 3 (Beyke, August 2008).

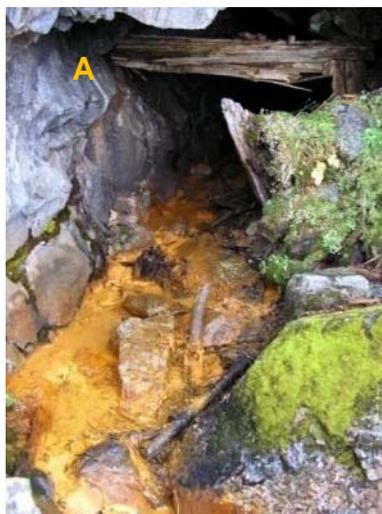
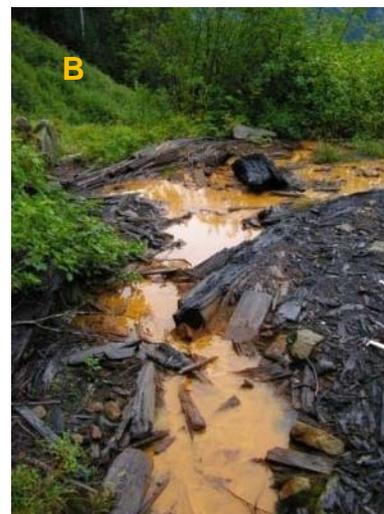
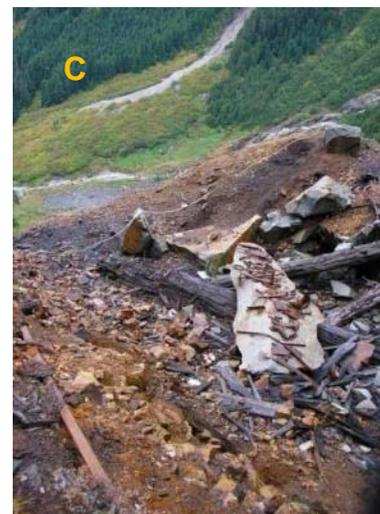
Photographs 13 to 15. Selected views of the Mystery Mine: A-water discharges from Adit 3; B-drainage water flows across Adit 3 waste rock dump; and C-debris on Adit 3 dump (CES, August 2005).

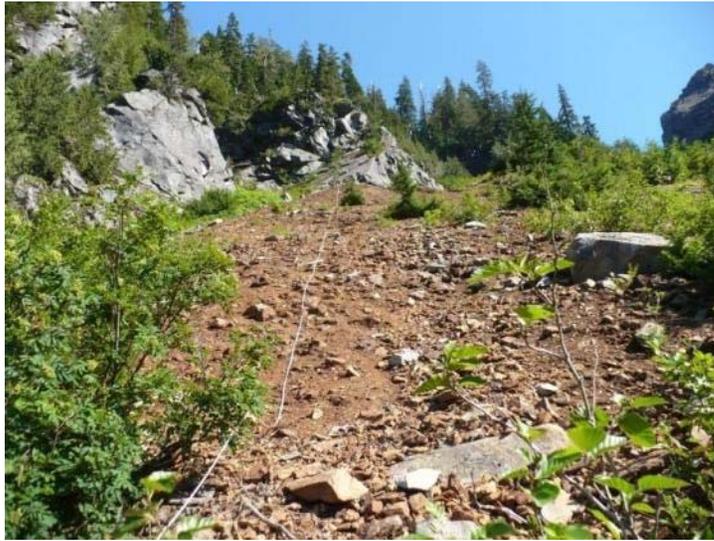
Photograph 16. Mystery Mine, mapping lower waste rock dump (Beyke, August 2008).

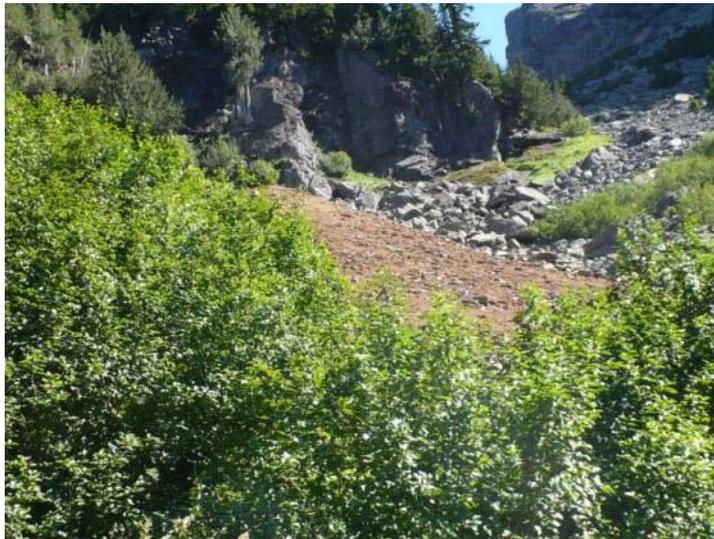
Photograph 17. Mystery Mine, upper waste rock dump (Beyke, August 2008).

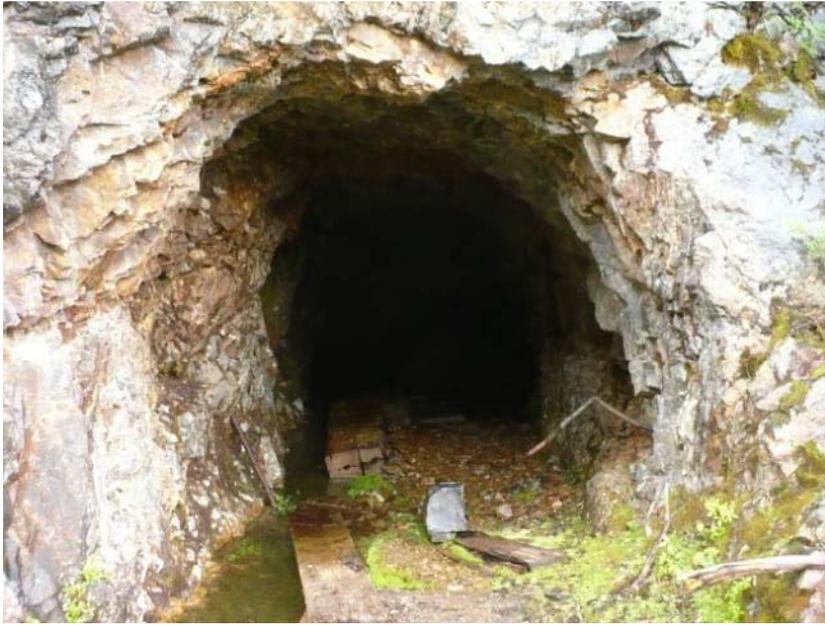
Photograph 20. Justice Mine, Main Adit portal. Note flowing water in lower left corner; CES sample MCEE-DW-JU-01 (Moyle, August 2008).

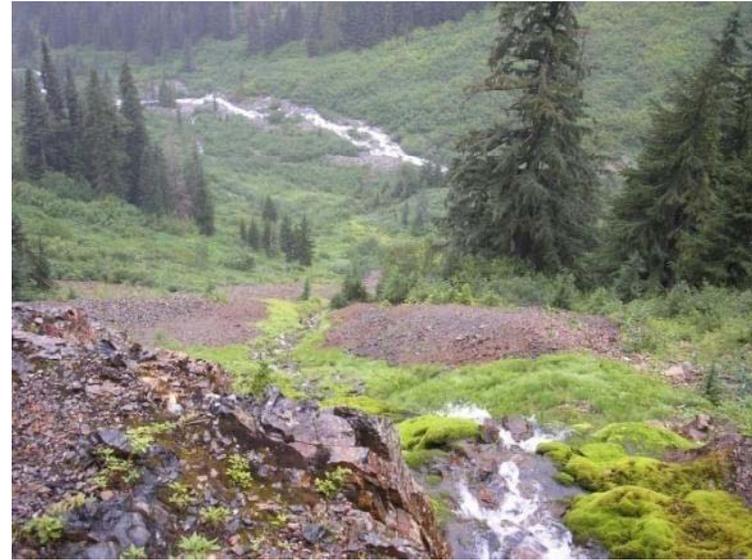
Photograph 21. Justice Mine waste rock dump, viewed from the working ledge by the main portal looking northwest towards Glacier Creek (Moyle, August 2008).

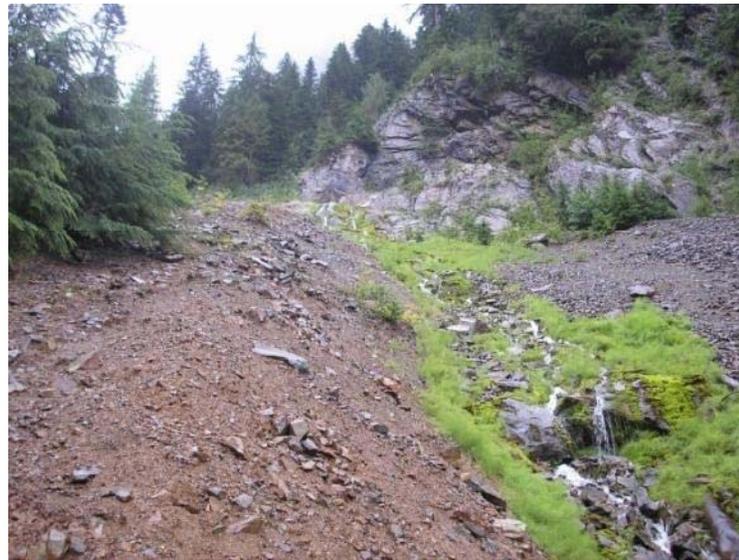
Photograph 22. Upper part of the Justice Mine waste rock dump and working ledge; view southeast from the dump (Moyle, August 2008).

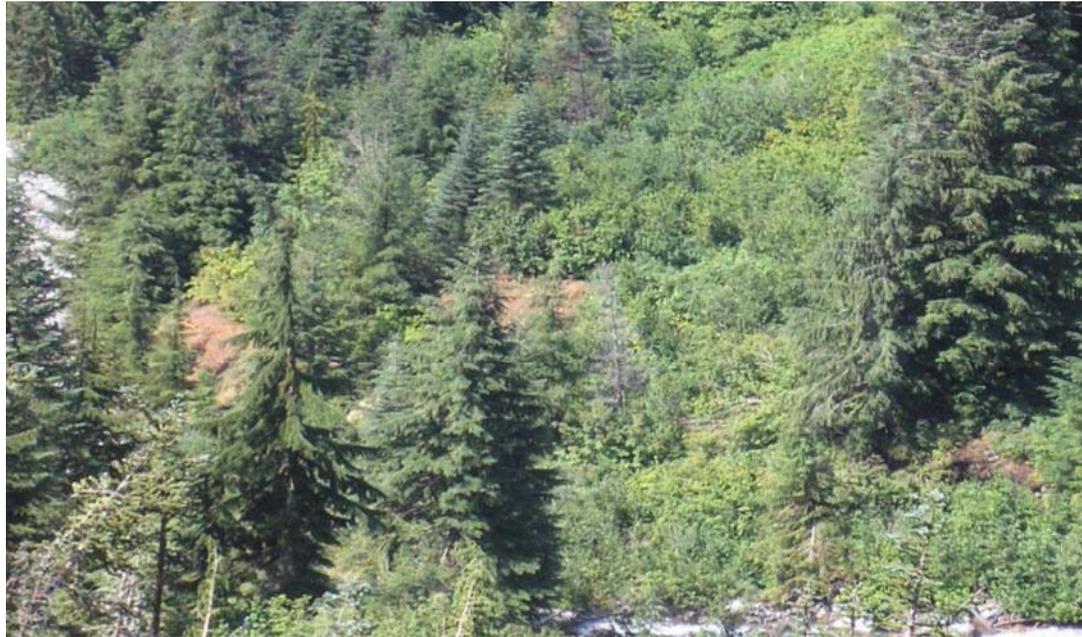
Photograph 23. View west of Rainy Mine waste rock dump on the north bank of Glacier Creek; CES waste rock samples MCEE-WR-RY-01 and MCEE-WR-RY-02 (Moyle, August 2008).

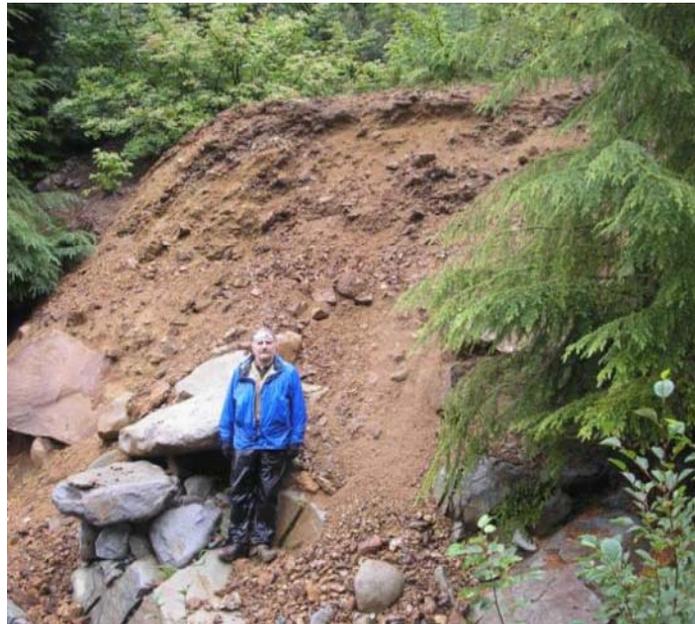
Photograph 24. Rainy Mine, view showing toe of the lower waste rock dump eroded by Glacier Creek (Moyle, August 2008).

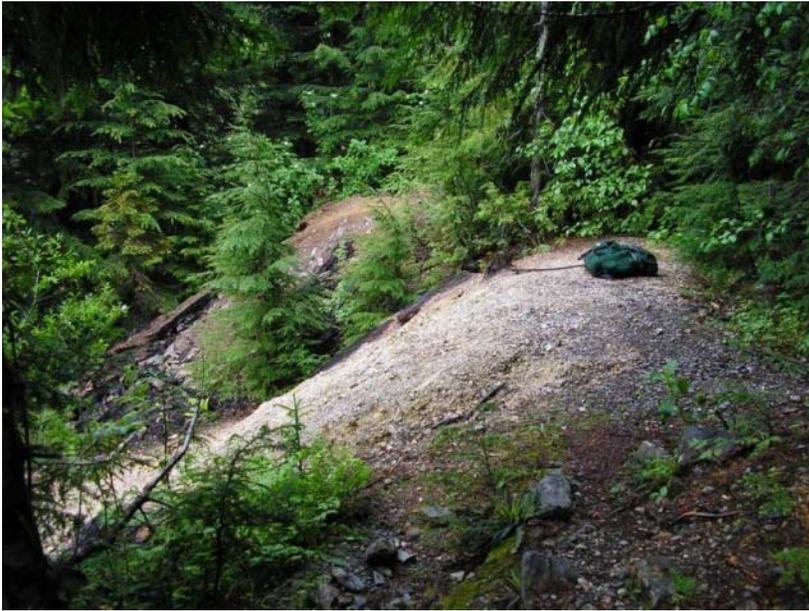
Photograph 25. Top of Ore Collector spillage area (CES, August 2006).

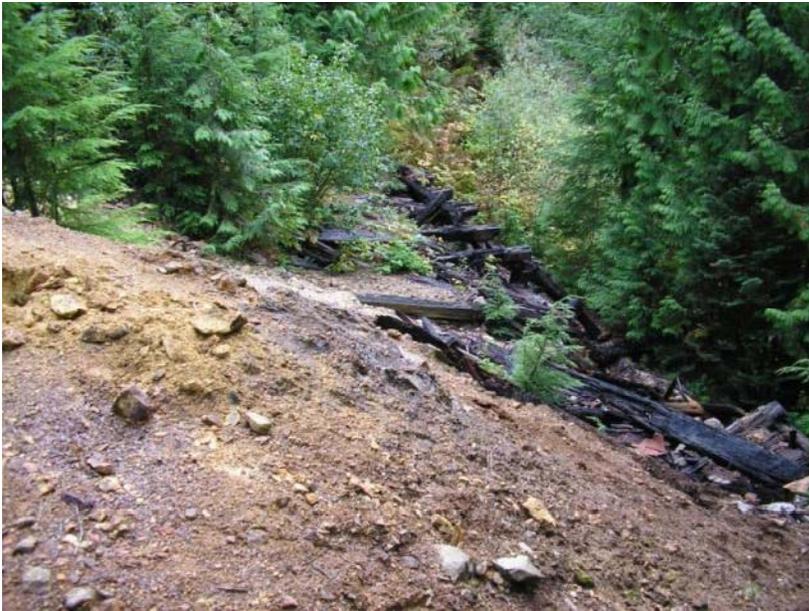
Photograph 26. View of base of Ore Collector spillage area (CES, August 2006).

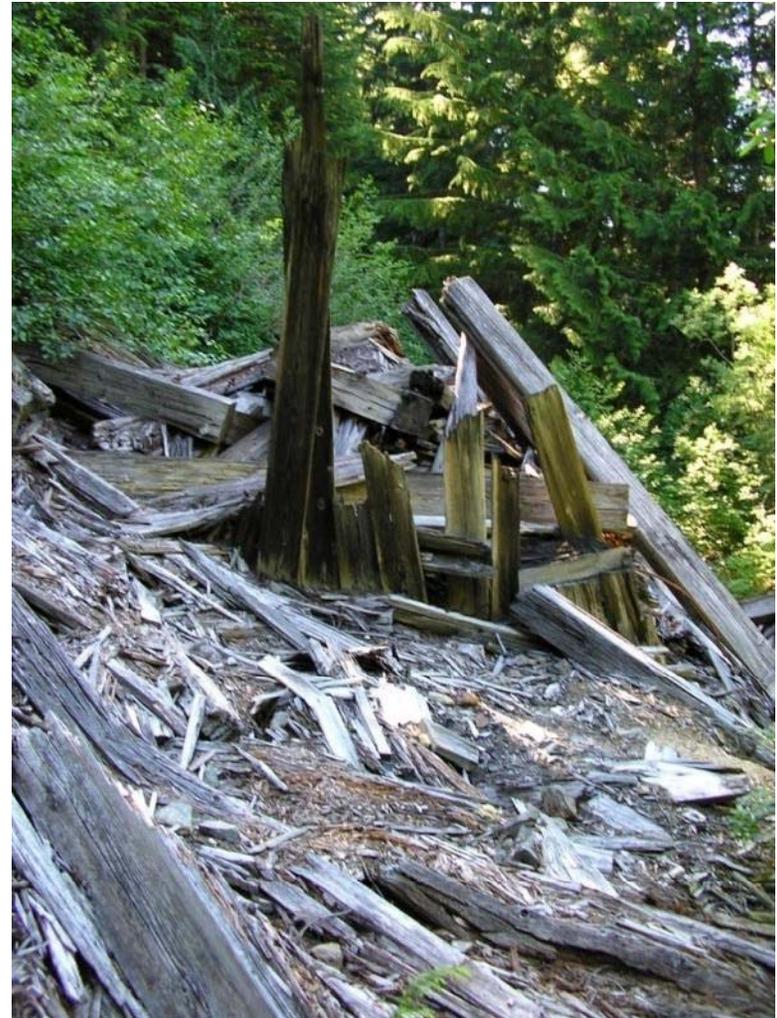
Photograph 27. View of ore bin ruins at base of Ore Collector spillage area (CES, August 2006).

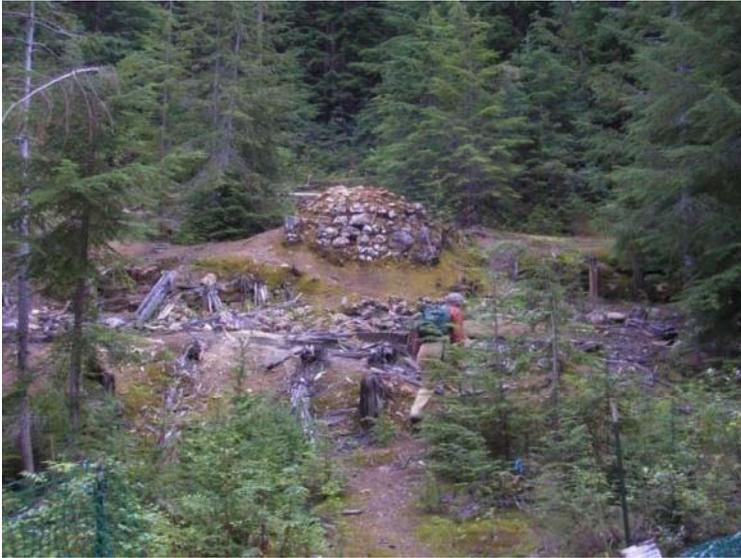
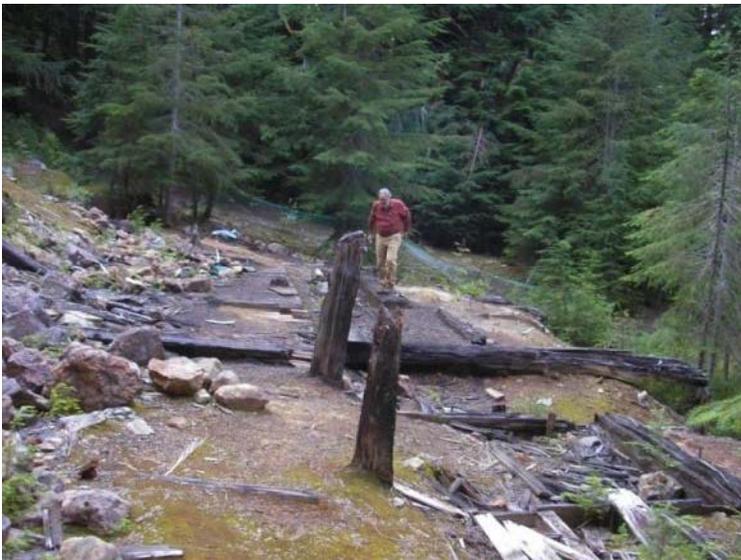
Photographs 28 and 29. Concentrator foundations; view west (above), and view north across mill (below); note temporary security fencing (Moyle, August 2008).

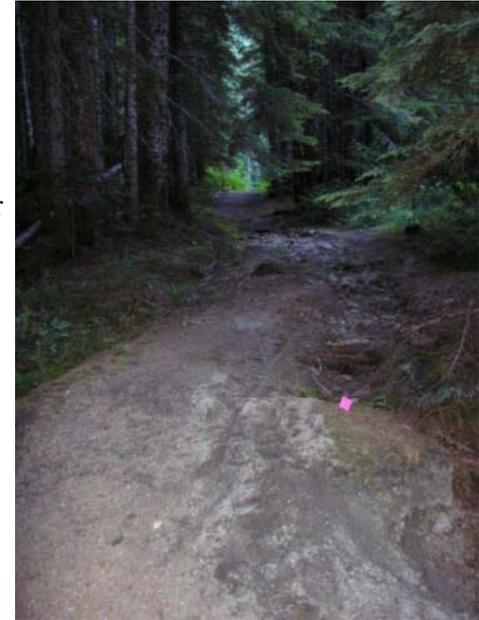
Photograph 30. Concentrator tailings; view shows CES sample site CON-19 with portion of Haulage Ways in background (CES, August 2006).

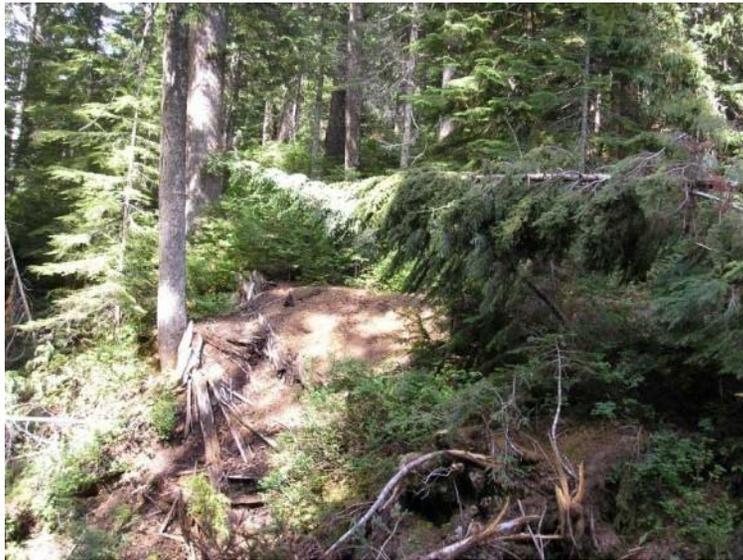
Photograph 32. Sidney Mine, view south of recent avalanche debris on edge of waste rock dump (Moyle, August 2008).

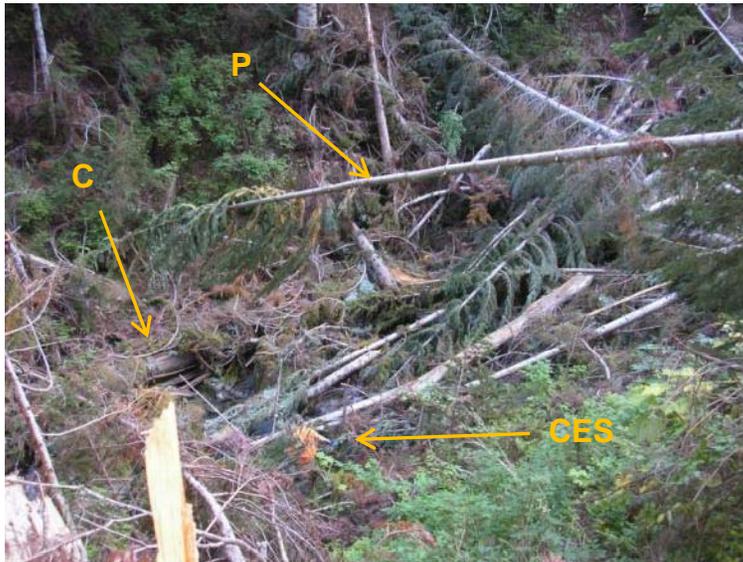
Photograph 33. Sidney Mine, view east of avalanche debris that covers Seventysix Creek and the adit portal (P); note rail haulage way cribbing (C), along shore of creek, and CES employee (Lambeth, September 2008).

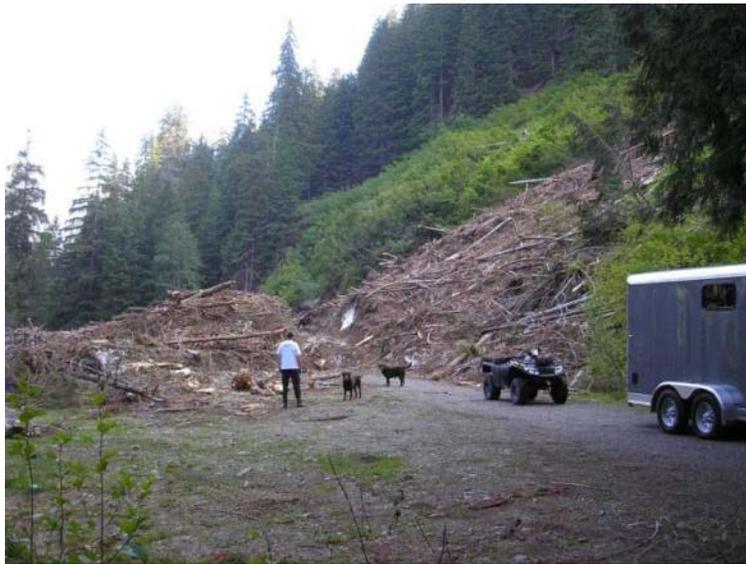
Photograph 36. View south of the snow/debris avalanche across Barlow-Monte Cristo road, approximately 0.1 mile south of Barlow Summit (Moyle, August 2008).

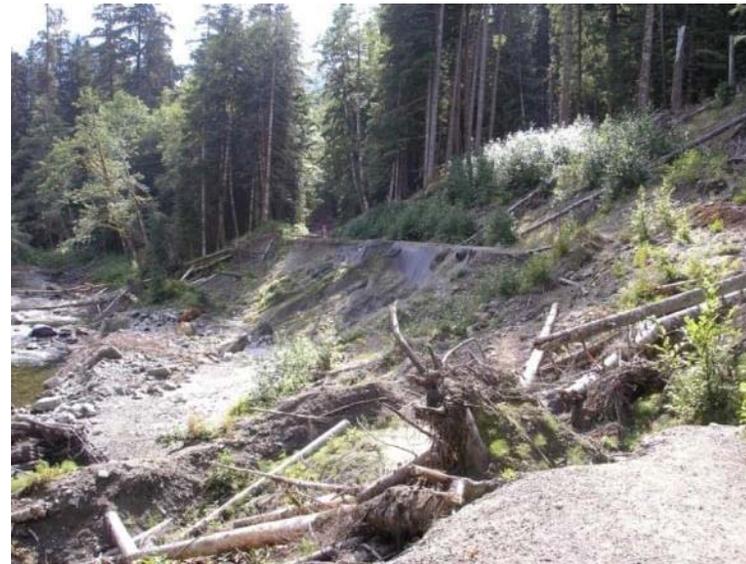
Photograph 38. View south of the landslide across Barlow-Monte Cristo road, approximately 0.4 mile south of Barlow Summit (Moyle, August 2008).

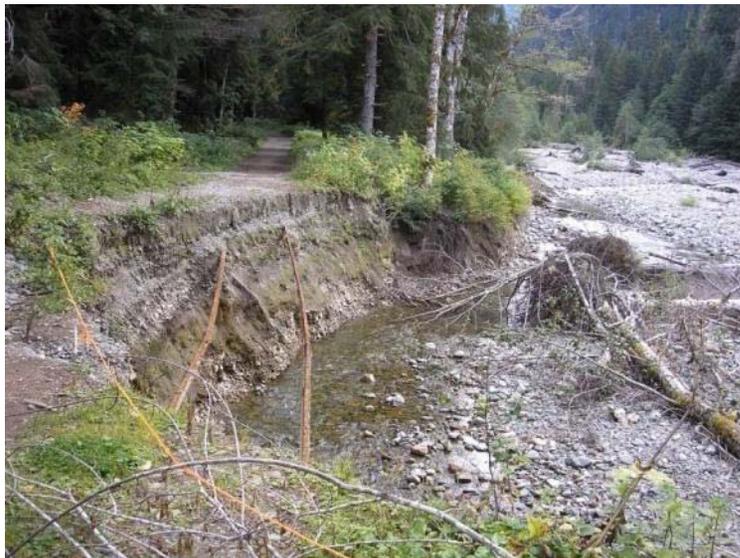
Photograph 37. View north of washout along Barlow-Monte Cristo road, on east side of South Forth Sauk River; note exposed rail from old railroad route (Moyle, September 2008).

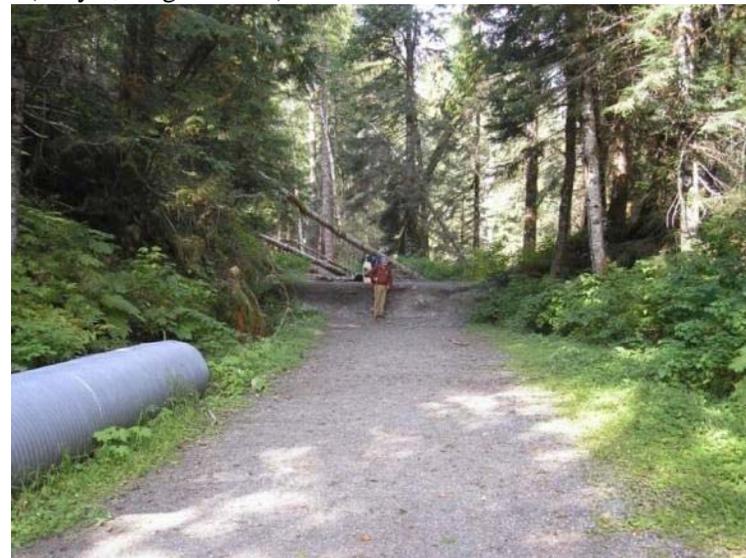
Photograph 39. View north of 3-foot land slip escarpment associated with landslide along Barlow-Monte Cristo road (Moyle, September 2008).
