USDA Forest Service
Shasta-Trinity National Forest

Brad Rust, Forest Soil Scientist

Gulch Fire Road Treatment Monitoring Report 2009

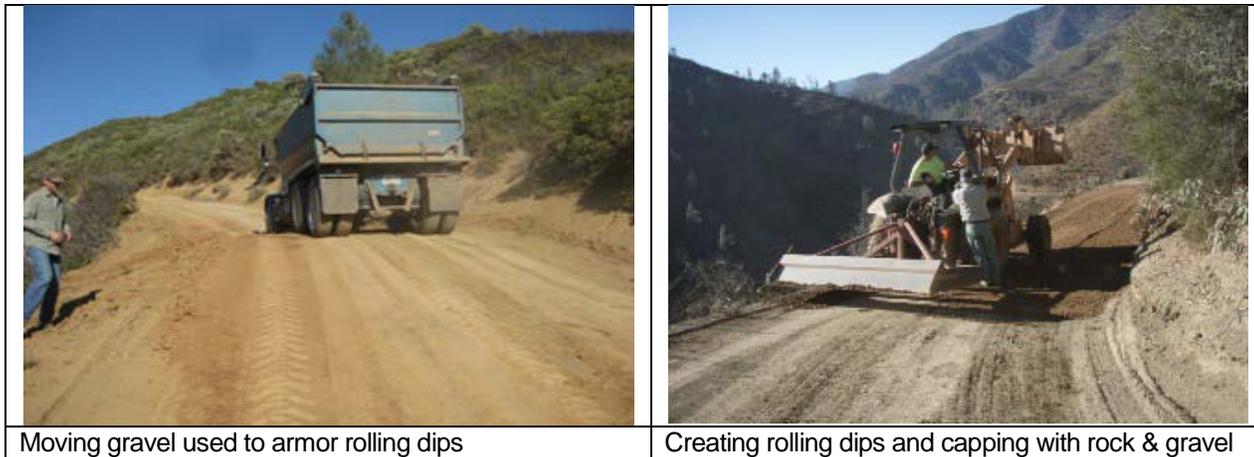
Moving gravel used to armor rolling dips

Creating rolling dips and capping with rock & gravel

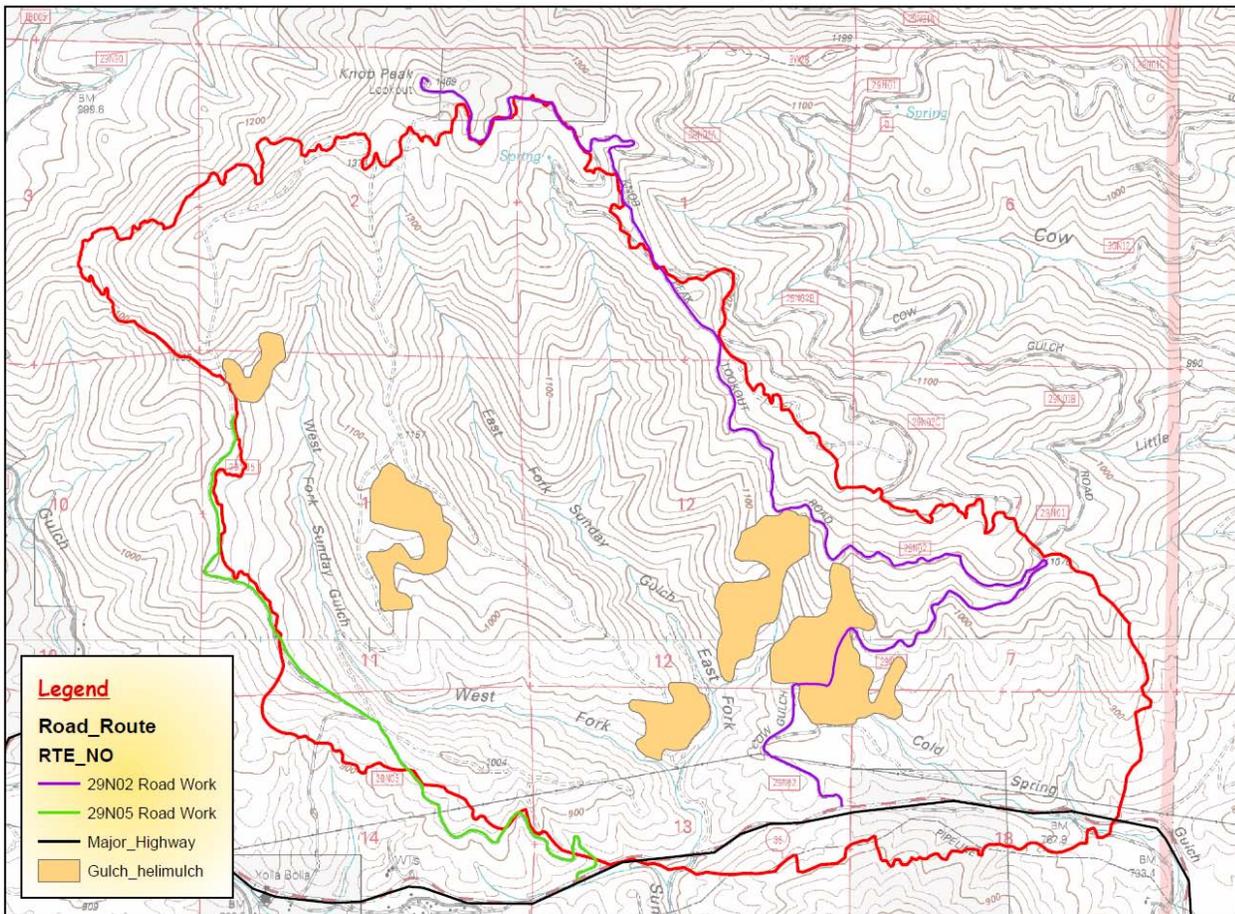
Figure 1: Gulch Fire of 2008 Treatment Locations (except helimulching units)

Methods: Representative road were driven and pictures were taken of before and after treatments along with terrain data (hillslope cover, aspect, slope, soil type, soil map unit, and dominate overstory vegetation) to evaluate treatment effectiveness after one year (see treatment map, Figure 1 below).

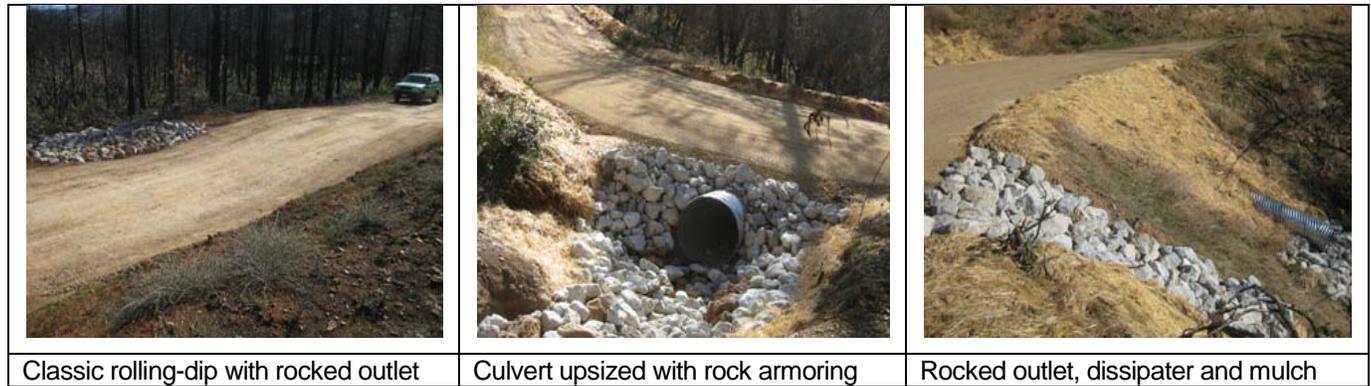
Figure 2: Road Repair on 29N02 of rolling-dips, culvert replacements, and rocked outlets.

Results: On the average for areas that were timbered with low to moderate soil burn severity road treatments were highly effective (29N05 see Table 1 below). In areas with timber/brush cover that was burned moderate to hot (29N02), road treatments were still highly effective due to excellent construction (see Figures 2 and 3 below). With areas that had dominate brush (29N02, s-facing steep slopes) and high soil burn severity, road treatments were moderately effective due to increased overland flows eroding road prism.

Gulch Fire Road Treatment Effectiveness:				
Road	Terrain	Burn Severity	Treatment	Effectiveness
29N02	SW-facing, 15-45% slopes, Holand and Neuns loam, timber/brush	Mod - high	Rolling-dips, culvert upsize, rockd outlets	High
29N05	S-facing, 35-60% slopes, Holland and Goulding loams, timber/brush	Mod	Rolling-dips, culvert cleanout, rockd outlets	High - Mod - Mod

Recommendations: Well done project with excellent construction but was late in implementation due to slow process of contracting. For BAER work that needs timely implementation force account work is preferred since they are done quickly with forest crews and with less cost.
